25 SIGOURNEY ST. BUILDING CONDITION SURVEY  
XEROX CENTRE  
BI-2B-877 HOFFMAN ARCHITECTS SEPTEMBER 30, 1992

BUILDING CONDITION SURVEY

XEROX CENTRE  
25 SIGOURNEY STREET  
HARTFORD, CONNECTICUT

STATE PROJECT NO. BI-2B-877  
ARCHITECT'S FILE NO. 192046

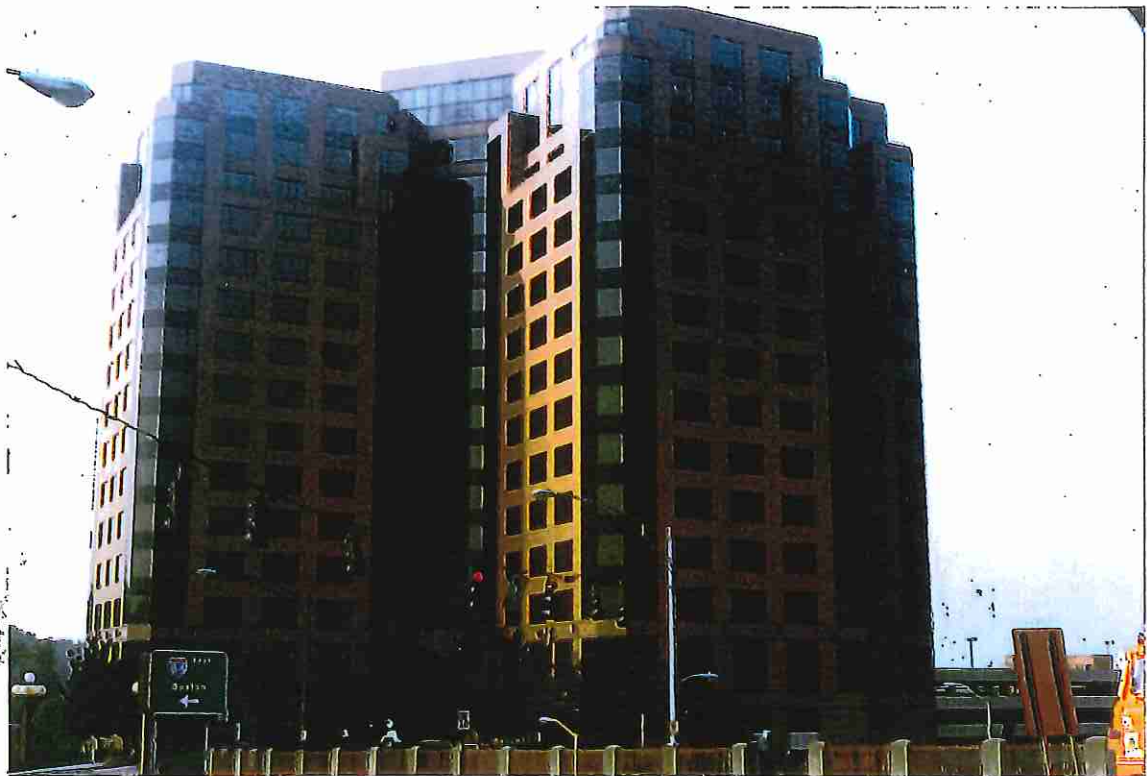
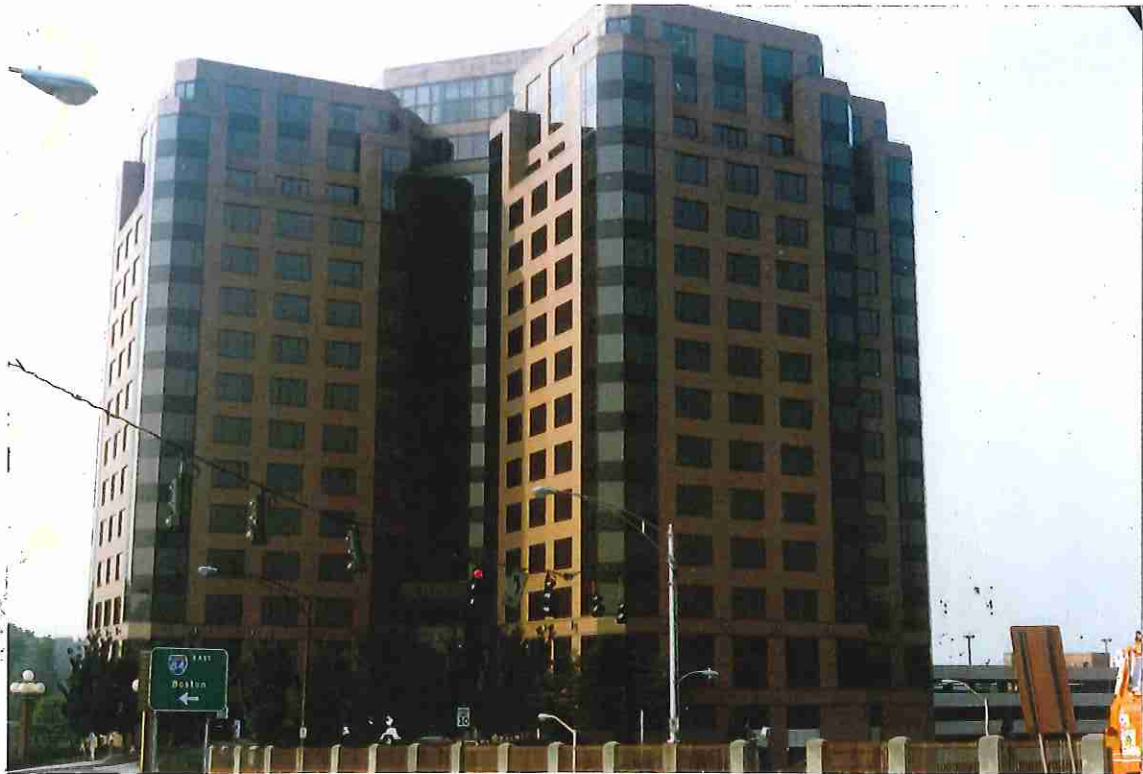
#1 Front view of the building from the northeast, viewed from Sigourney Street ramp to I-84.

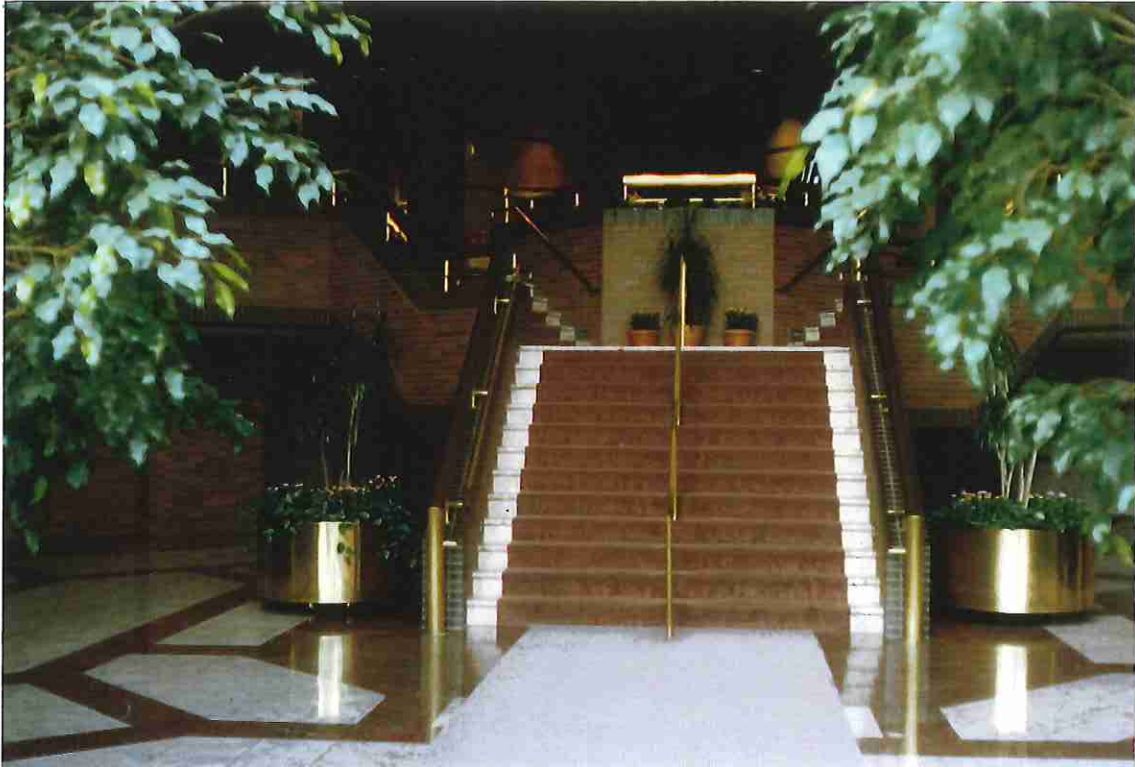
#2 Lobby grand stair, looking up toward the concierge/security station.

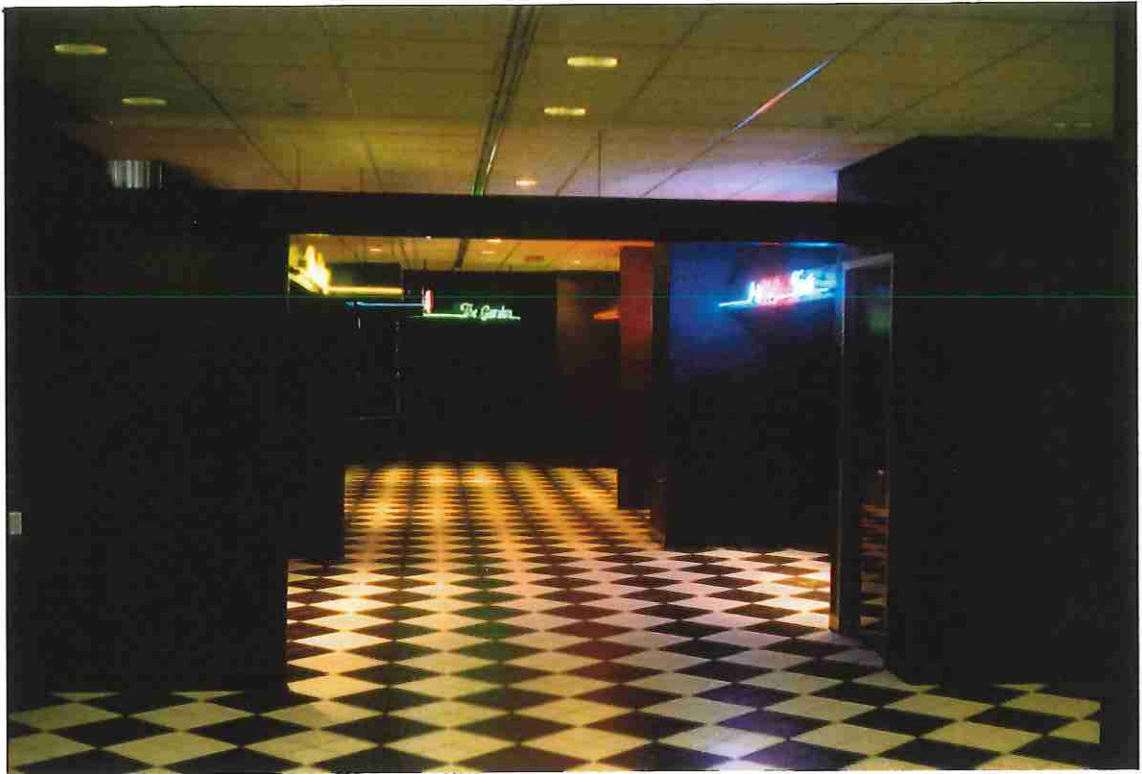
#3 Vacant serving area of the former cafeteria.

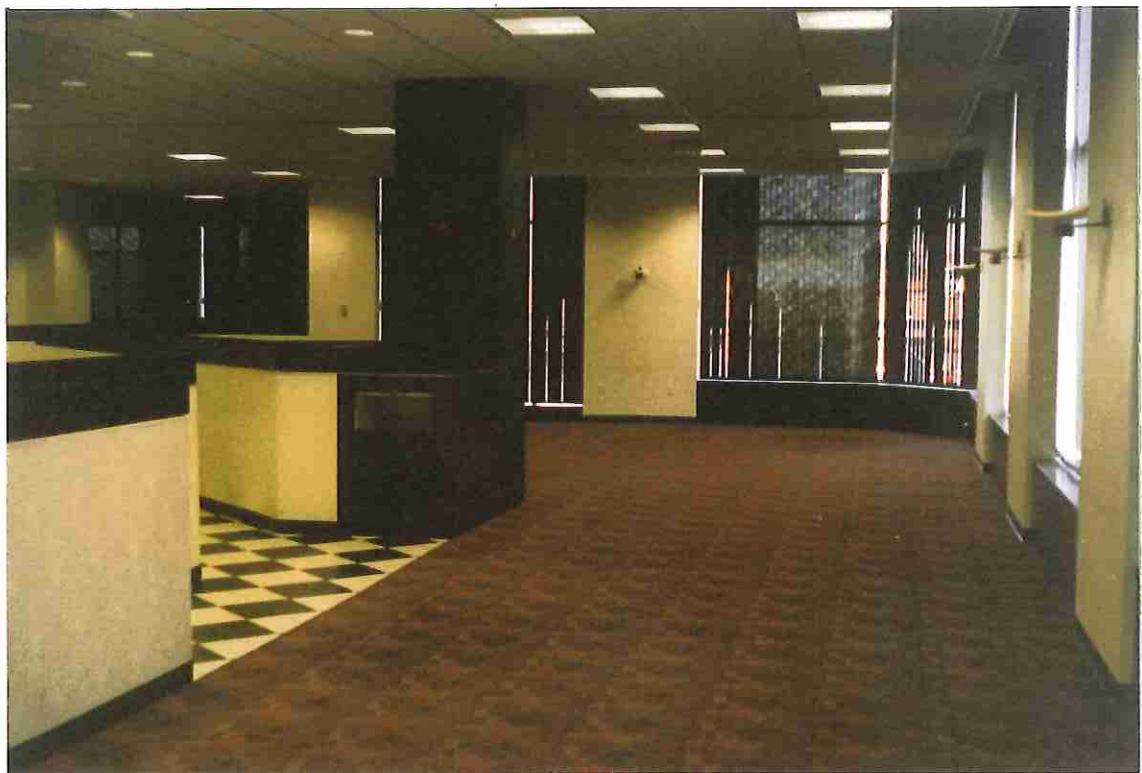
#4 Dining area of the former cafeteria, mezzanine level.

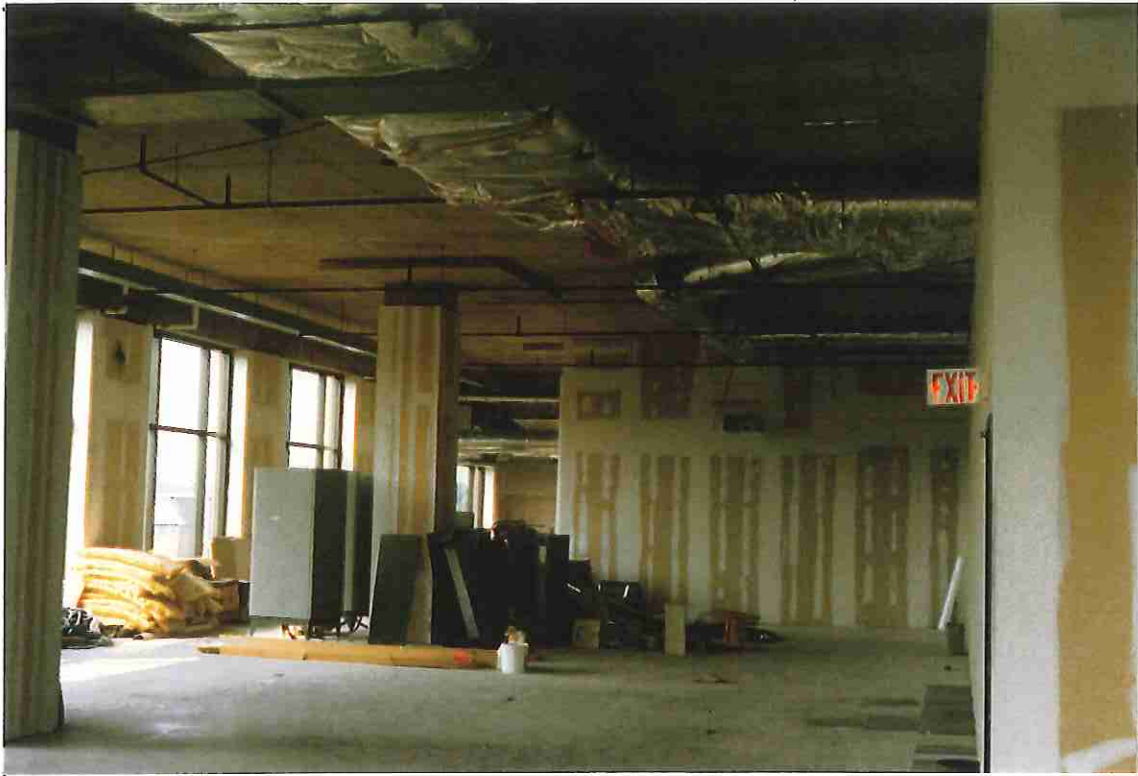
The building structure was mostly concealed, except for one portion of the mezzanine floor, which has never been finished out. The structure at that location appeared normal for the type of building involved. There were no apparent serious cracks or other evidence of structural problems. It was visibly apparent that the structural slab was not very level, and that a leveling fill would be needed at the time of tenant fit-out. The building manager reported that many of the floor slabs were distinctly out of level, and that some floors required two or more inches of leveling compound to bring them within acceptable limits. This is generally considered acceptable practice. Although the depth of the leveling compound required in the most extreme cases seems excessive. Even though the slab was not within published standards for plane and level, the structural integrity does not appear to be adversely affected.

#5 Exposed structural slab in unfinished space on mezzanine level.

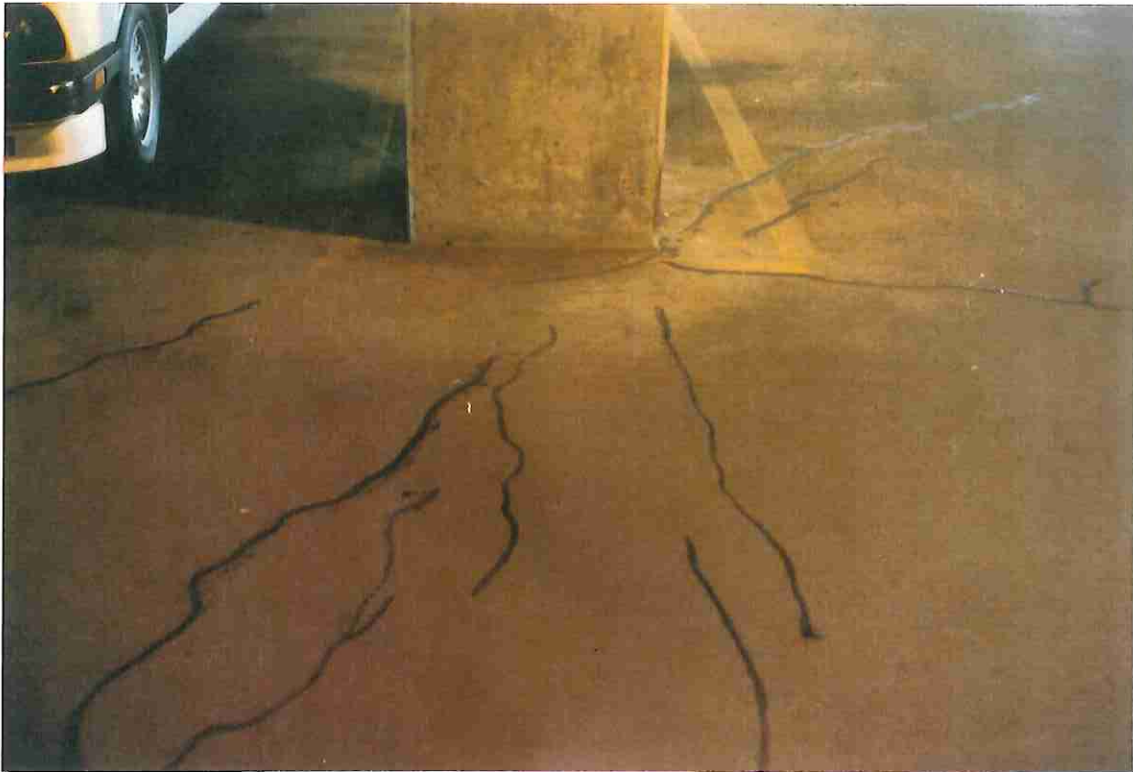
In the portions of the parking garage which occur within the building footprint, there were numerous cracks radiating out from the columns. The magnitude of the cracking was impossible to determine because the cracks have been routed out and sealed. This has the dual effect of calling attention to the cracks, and making them appear much more evident than might be the case if they had not been treated.

#6 Cracks radiating from column in garage area.

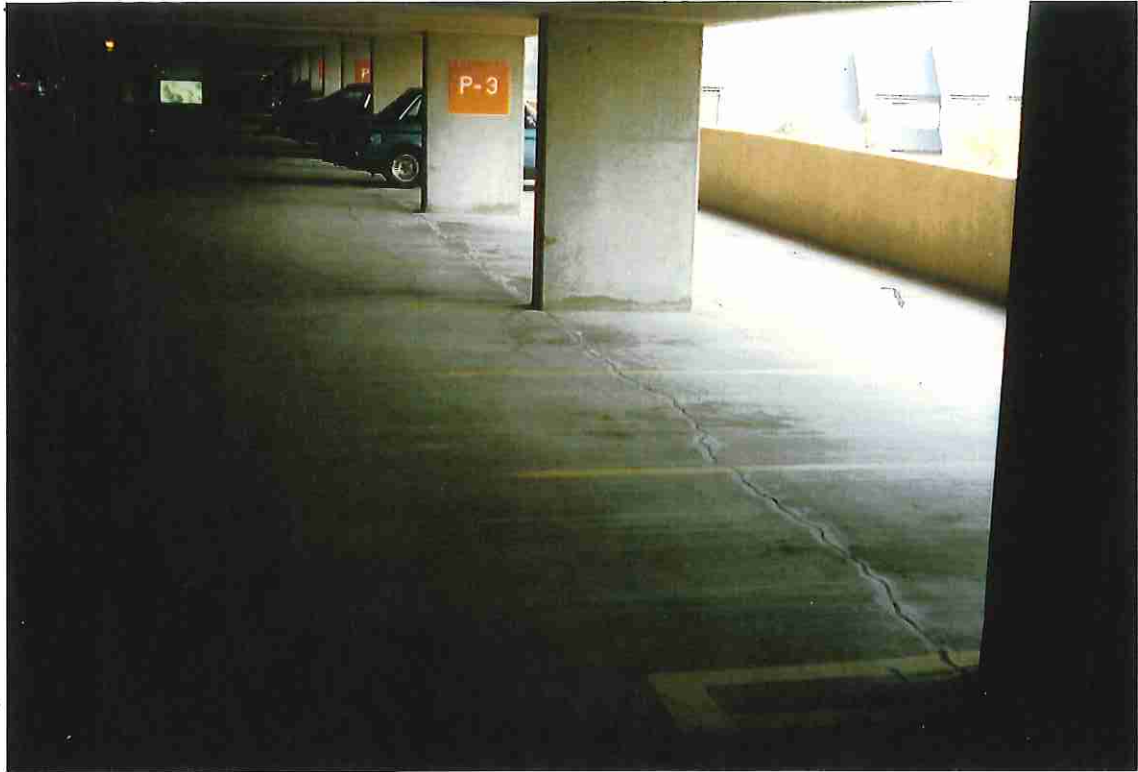
The slabs also show a considerable amount of other cracking, which generally follows a consistent pattern on all levels and on both sides of the traffic aisles. All these cracks have been routed and sealed, so it was not possible to form any conclusion regarding the severity of the cracking. The remedial work does, however, illustrate the extent.

#7 Typical crack running along column line in garage floor slab.

The open parking structure presents major concerns. The apparent severity of the cracks in the slabs is visibly magnified by the fact that the cracks have been routed out and filled with sealant. Nonetheless, the extent and the pattern of the cracks gives rise to concerns. The cracks typically run parallel to the long axis of the structure, which means that they run parallel to the direction of the post-tensioning tendons. The worst of the cracks are located toward the outer edges of the slabs, such that the cracks generally correspond to the position where the supporting beams pass over the columns and become cantilevers. The cracks suggest that there is insufficient reinforcing in the beams (and, possibly, in the tops of the slabs) to resist the negative bending moment induced where the beams pass over the columns. There are additional cracks toward the "inboard" sides of the slabs. Since these edges are not cantilevered, under theoretical conditions there should be no bending moment at the edge, and increasing compression in the top surface of the slabs progressing toward the middle of the span. However, zero moment is possible only where the end support condition is a hinged joint, free to rotate. This is impossible to accomplish with concrete construction such as this. We feel that the end conditions may have unintentionally created a moment connection which imparted some tension to the upper surface of the slabs toward the "inboard" edges, and that the reinforcing in the top of the slabs was insufficient to resist this tension.

We have two recommendations regarding the open parking structure. First, we suggest that a consultant experienced in parking structure rehabilitation be engaged to conduct an analysis of the design of the garage structure. This should be based on the final construction drawings (or even shop drawings) for the garage, if those can be obtained, rather than preliminary drawings such as we reviewed, which may not be accurate. The analysis should be conducted by an engineer experienced in both post-tensioned and convention concrete construction.

Our second recommendation is to coat the top surface of all suspended slabs in the garage structure with an elastomeric, traffic-bearing waterproofing coating, such as 3M's "ScotchClad" traffic membrane. This is to prevent chloride-laden water from penetrating the slabs and attacking the reinforcing steel. If an engineering review indicates that the reinforcing is at all marginal, it will become especially important to prevent any deterioration of the reinforcing in order to preserve the integrity of the structure.

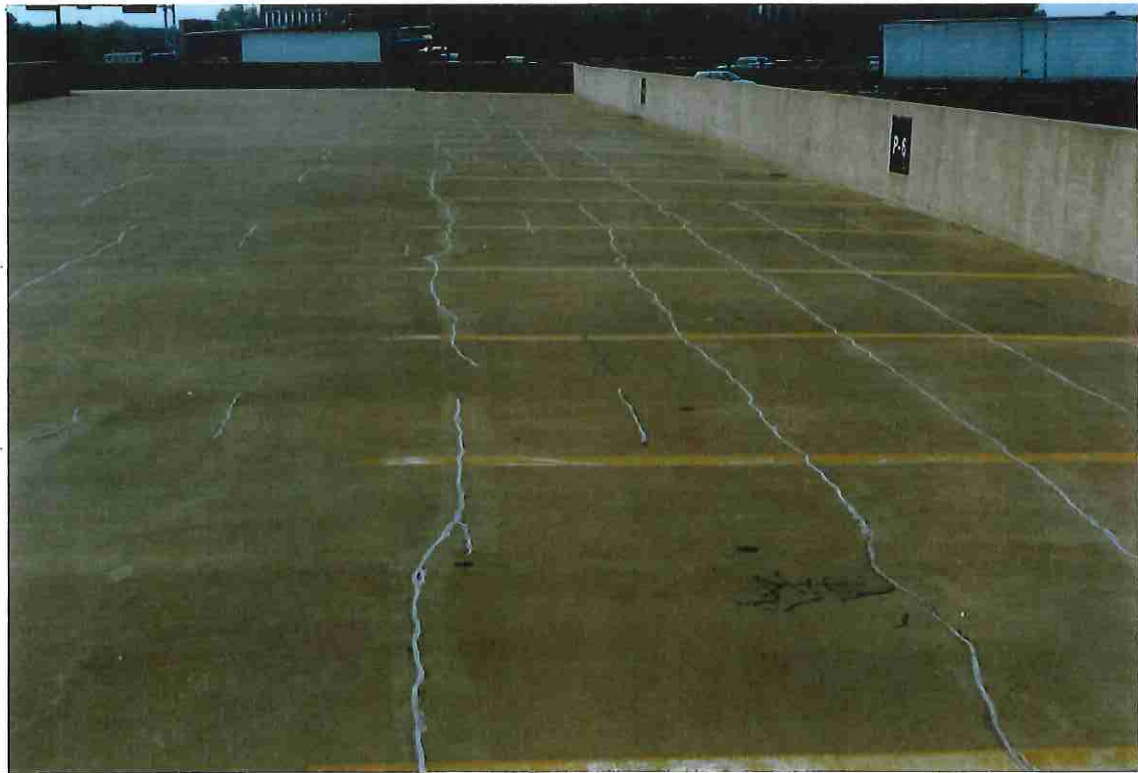
#8 Network of cracks parallel to long axis in garage slab (Level 6).

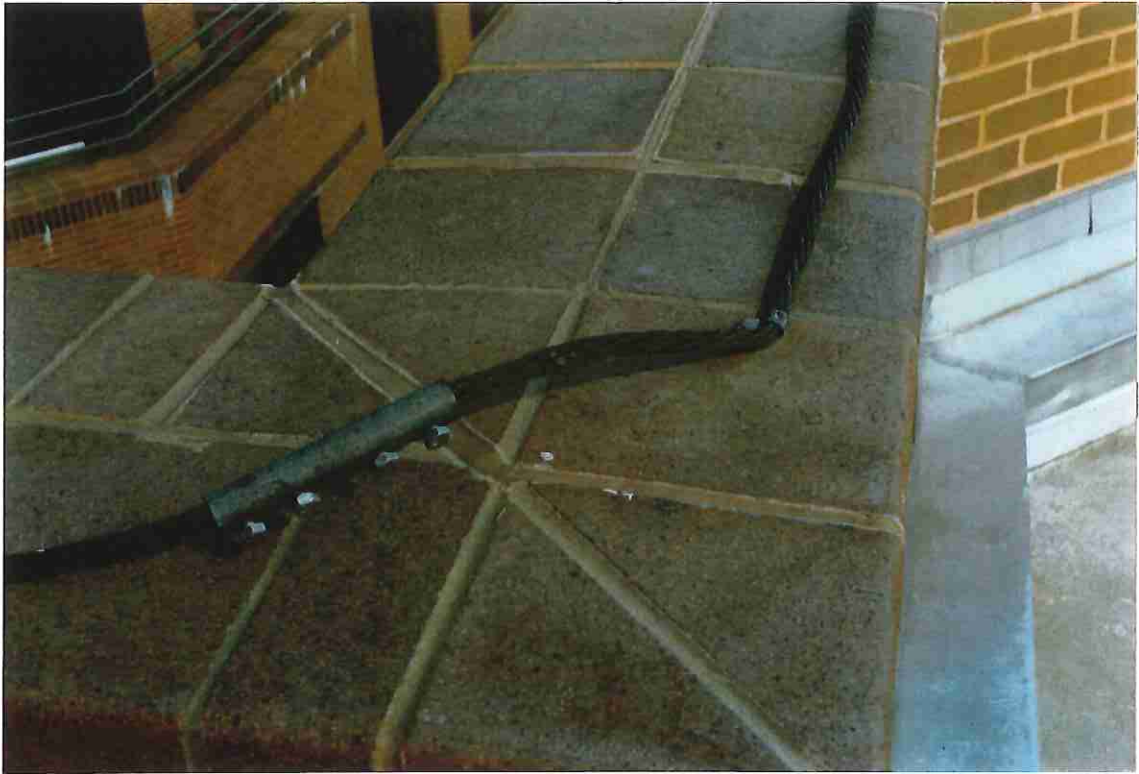
Parapets extend approximately four feet above the roof on all levels. The back (roof side) of the parapets is finished in the same brick as the outside face. The drawings show the parapets covered with a metal cap flashing/coping cover assembly. The actual construction used exposed bricks to form the top of the parapets, with conventional mortar in the horizontal joints on the top surfaces. Many of these joints were cracked, and a significant number of them had been covered with an elastomeric caulking compound. The building manager reported that she had had the parapet caps "repointed" a couple of years ago, and that "control joints" were created at that time. It appeared that the work actually done was simply applying elastomeric sealant over existing mortar in the joints, in some cases not even covering the entire length of a single joint.

#9 Exposed and spot-repaired mortar joints in typical parapet coping.

The tops of the parapets of the office building were not constructed as shown on the drawings we reviewed. The drawings showed a metal coping cover, while the actual construction used exposed brick as a coping. We believe the change was driven by aesthetics. The problem is that brick joints in horizontal surfaces exposed to weather deteriorate very quickly and are not watertight. Although the building manager reported that she has had the copings "repointed," it appears that the contractor (or contractors) involved did not cut out the mortar, but rather applied a thin coating of some kind of caulking or sealant on top of the existing mortar joints. This was not done consistently, but sporadically around the parapets. Such "repairs" are not adequate, and have a limited efficacy and duration.

The less costly approach to correcting this problem would be to install a metal coping cover system, such as shown on the drawings on file in the building. Although we consider stainless steel and lead-coated copper to be more durable materials, a coping cover system could be fabricated from aluminum that could be painted to closely match the color of the brick. Although this would be an aesthetic change, if the color is closely matched, most observers from the street level would not be aware of the difference.

A more costly approach, but one which would maintain the existing appearance of the building, is to cut out all the mortar joints in the copings and to properly seal them with backer rod and elastomeric sealant. Since we feel that this is the more expensive repair, we offer a budget projection for this approach with the understanding that it should be adequate to provide for a metal coping cover if that approach should be favored.

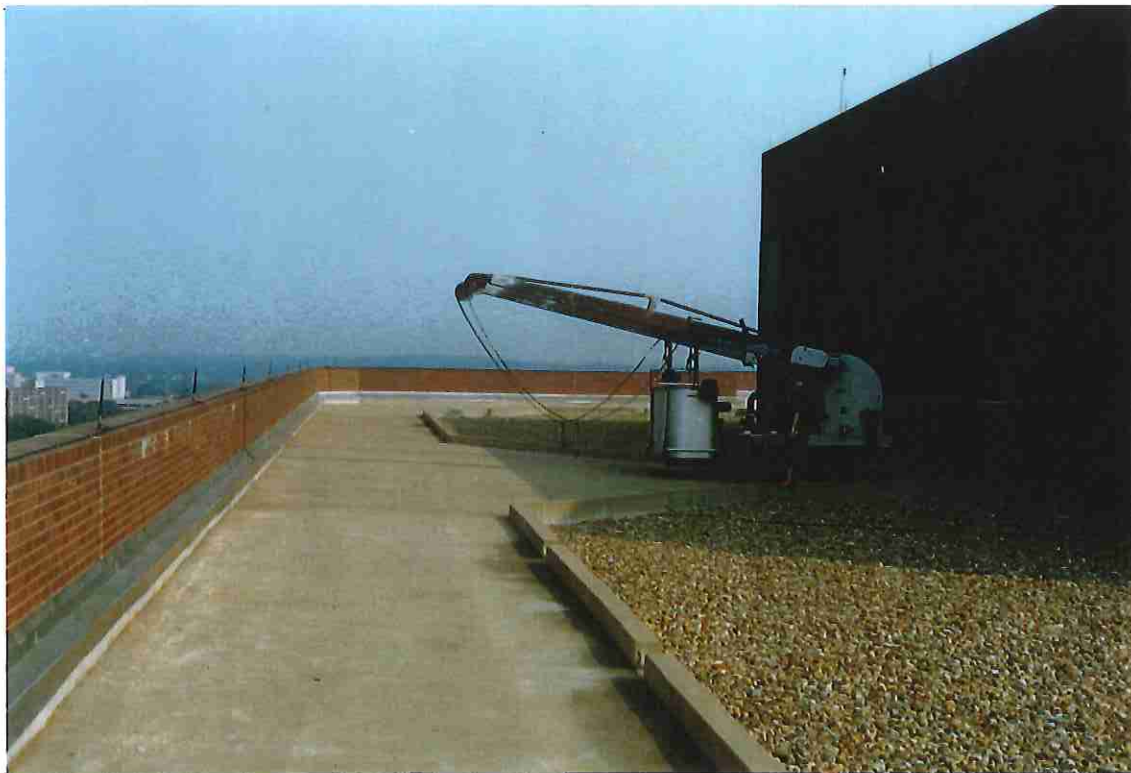
On both the main roof and the roof over the penthouse, there is a poured concrete runway for a window washing hoist. The runway was poured directly over the EPDM membrane; we were not able to ascertain whether or not any sort of protection board was provided to protect the rubber membrane under the concrete runway. The runway extends around the building perimeter; between the runway and the penthouse the roof membrane is secured with an application of round stone aggregate. Base flashings at the perimeter parapets are covered with stainless steel. At the penthouse, base flashings are exposed EPDM rubber. Both rubber and stainless steel flashing appeared to be in good condition and to have been well executed.

#10 Main roof, looking north from southwest corner, showing concrete runway and window washer rig "garage".

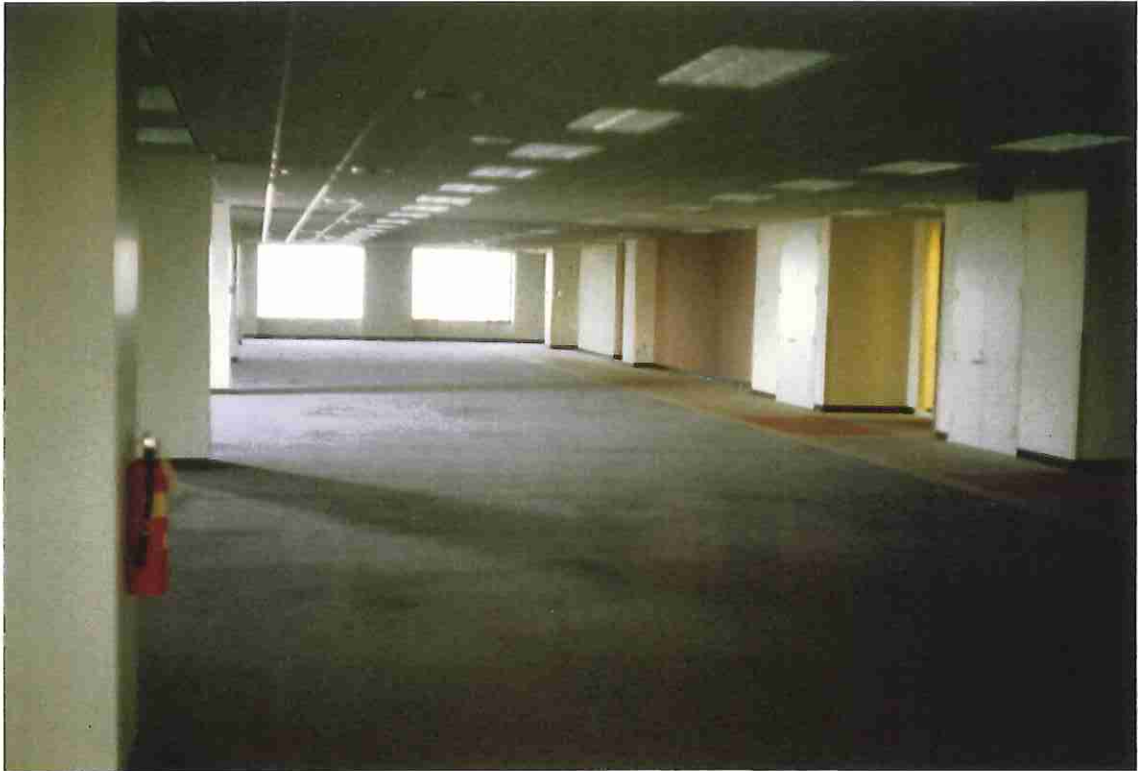
Interior finishes throughout tenant spaces are unexceptional. Walls typically are finished in gypsum wallboard painted an off-white color. Ceilings are virtually all 2' x 2', tegular-edge (half-recessed) lay-in acoustical tile in a pebble finish. Most floors are covered with 12" x 12" carpet tiles. For the most part, walls and floors are in good condition. Most of the carpet tiles are in reusable condition, although in some areas previous furniture layouts are obvious either because of aisles denoted by different color tiles, or because of fading where carpet tiles were not protected by furniture.

#11 Typical tenant floor.

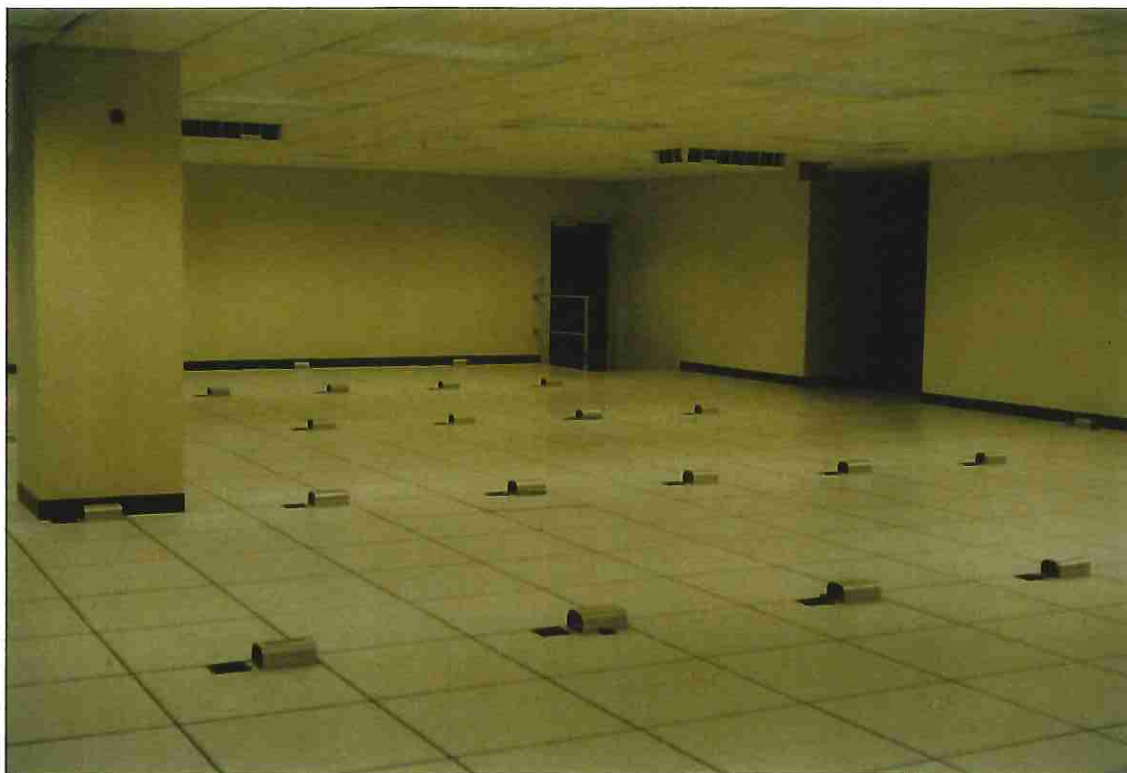
#12 16th floor computer room.

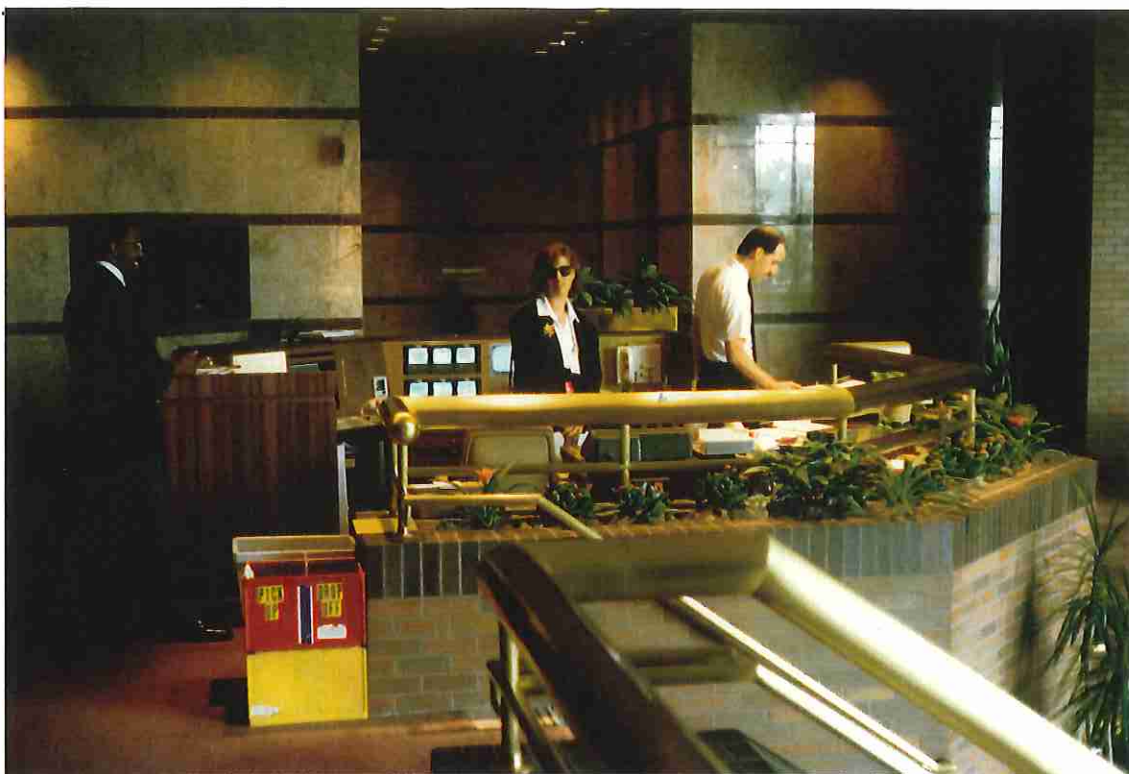
The main lobby and public area of the mezzanine level are finished almost exclusively in marble, in two colors. The lobby floors exhibit extensive crazing and appeared to have chips loose and coming out. The building manager reported that the former cleaning service had ignored instructions and used vinegar in the water used to clean the marble, upsetting the p.h. balance of the stone and causing the natural fissures in the stone to open up.

#13 Mezzanine level concierge station. High rise elevator lobby in background.

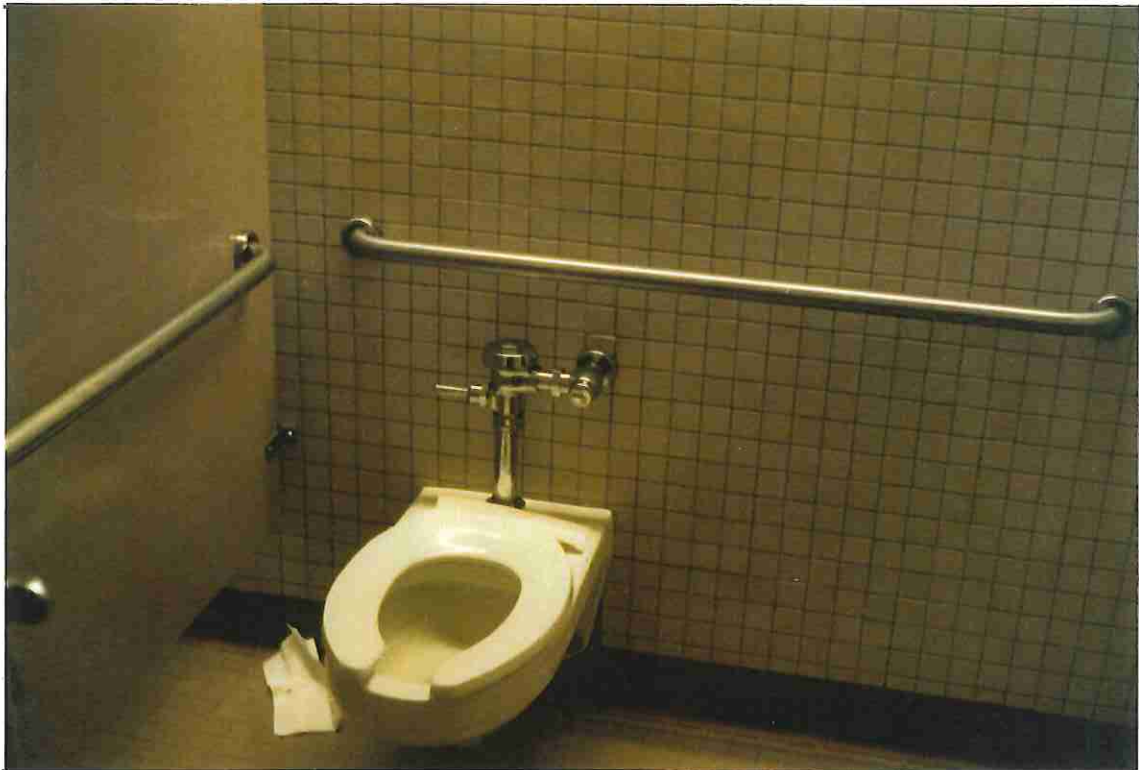
#14 Typical accessible toilet stall.

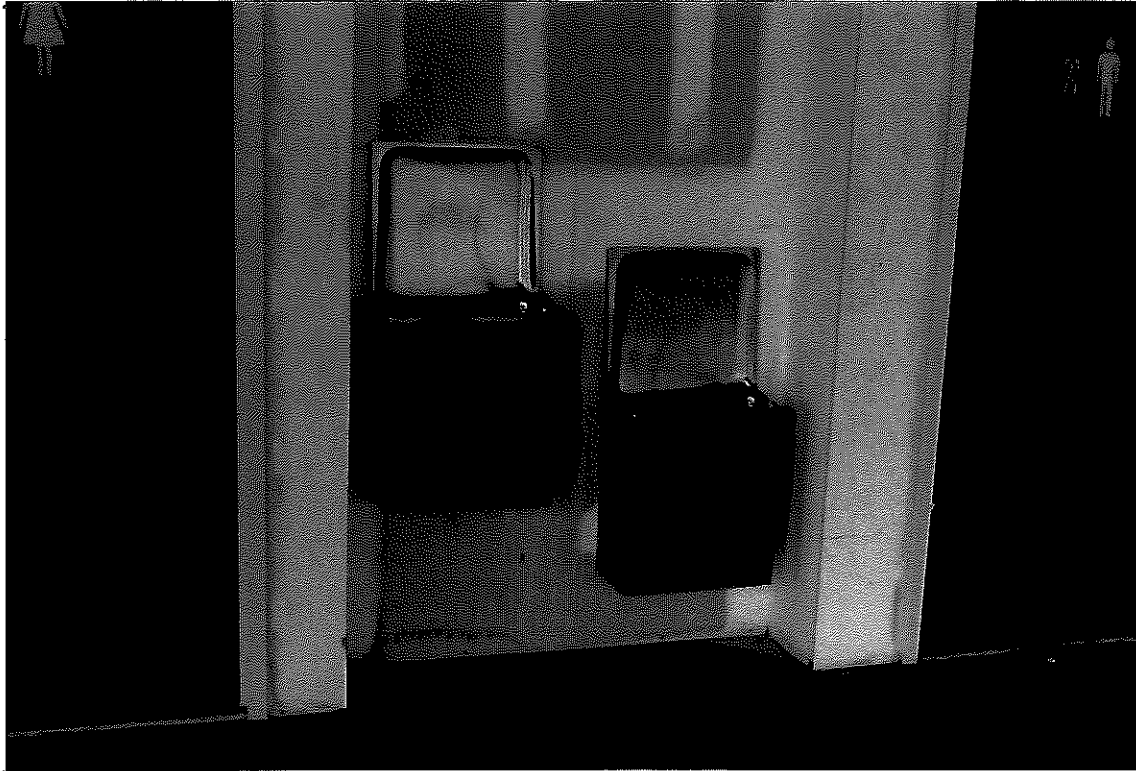
Each floor is equipped with at least two drinking fountains, one with the bubbler at 42 inches from the floor and one with the bubbler at 32 inches from the floor. A number of floors have additional fountains located toward the north or east ends of the wings, on "wet" columns. Where additional fountains are provided on tenant floors, they are set with the bubblers at 42 inches from the floor.

#15 Typical paired drinking fountains. "Accessible" unit is not cantilever design for wheelchair access.

Probable cost to replace accessible drinking fountains . . \$12,000
