Investigate Reported Areas of Water Infiltration

For
25 Sigourney Street
Hartford, CT 06106
DPW Project Number B1-2B-033L

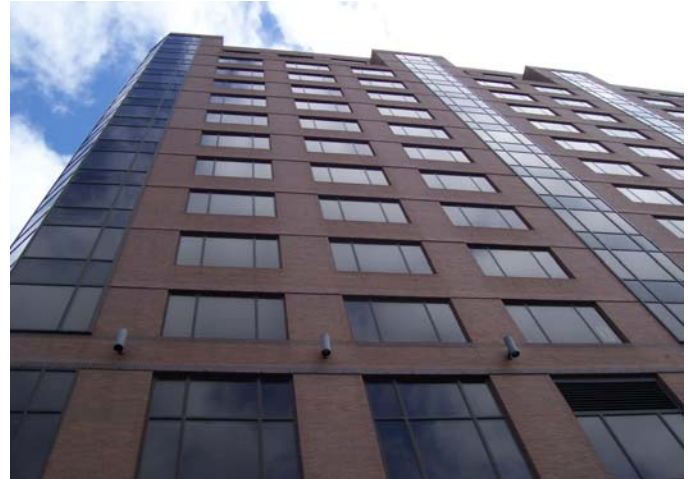
1. 25 Sigourney Ave. Building Facade

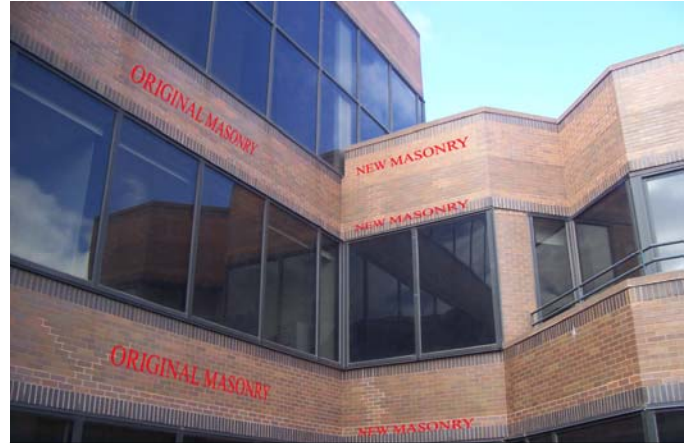
2. Representative Areas of Masonry Repairs Done by Kelly Enterprises (19th floor)

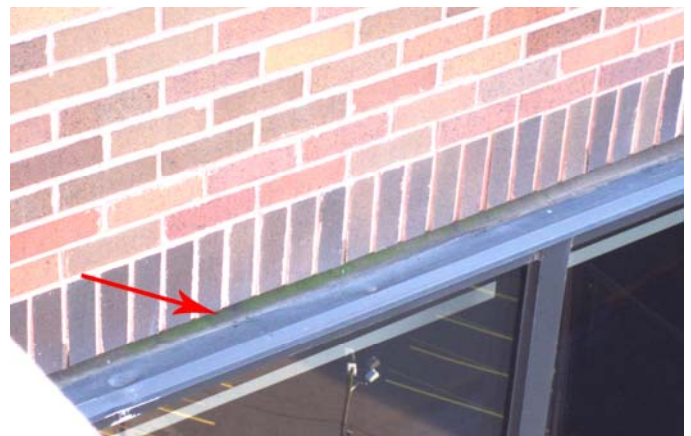
3. Moss Growing on Flashing above Window Sign of Water Pooling and Possible Infiltration (18th floor "zipper")

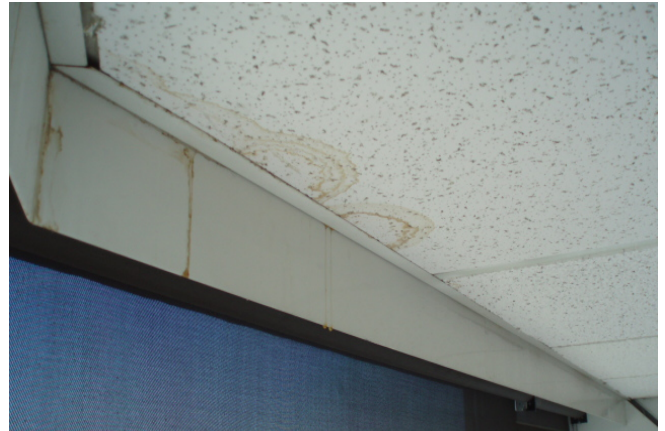
4. Visible Stains on Ceiling Tile & Fascia
(18th floor)

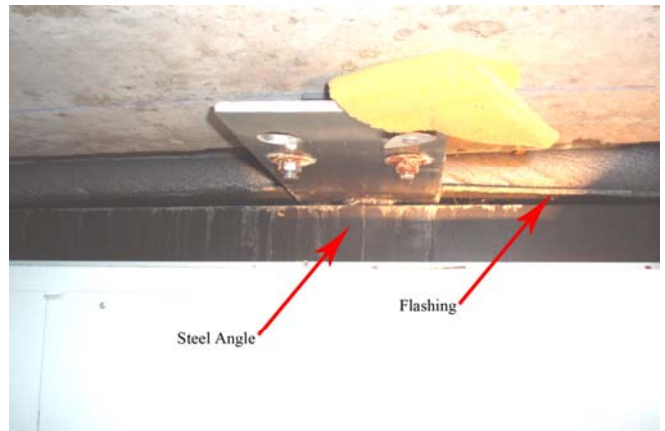
5. Rusted Steel Angle & Missing Bend in Flashing
(Typical Throughout Building)

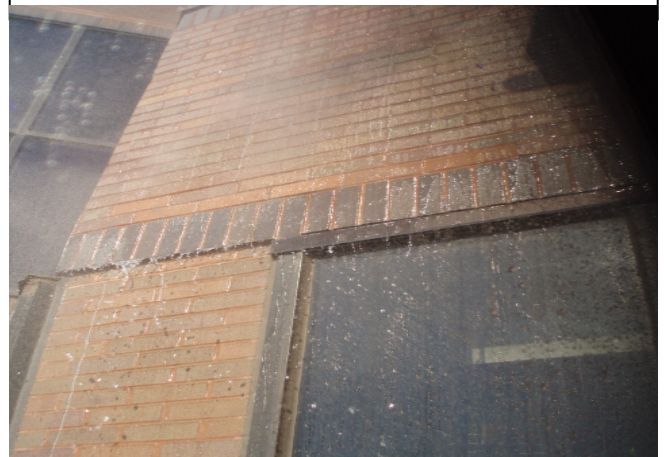
6. Flood Testing
(19th Floor Interior Balcony)

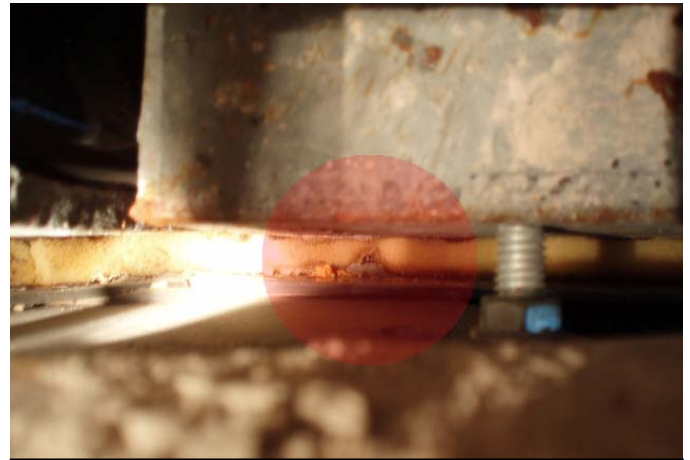
7. Water Leaking Thru Sealant and Backer Rod (19th Floor North West Corner Office)

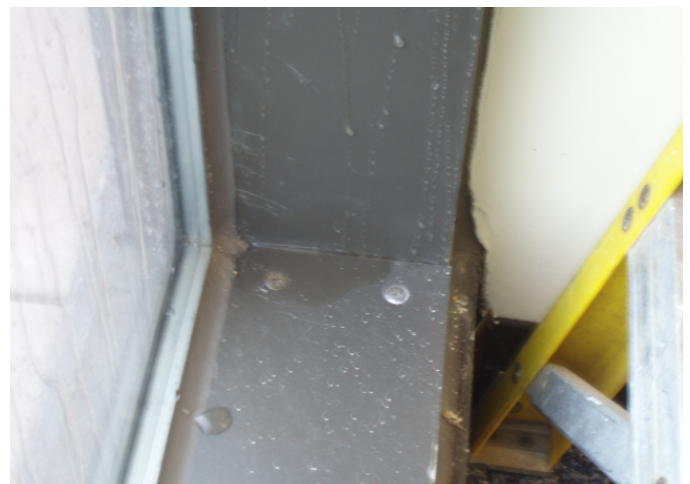
8. Water Pooling at Window Sill (19th Floor North West Corner Office)

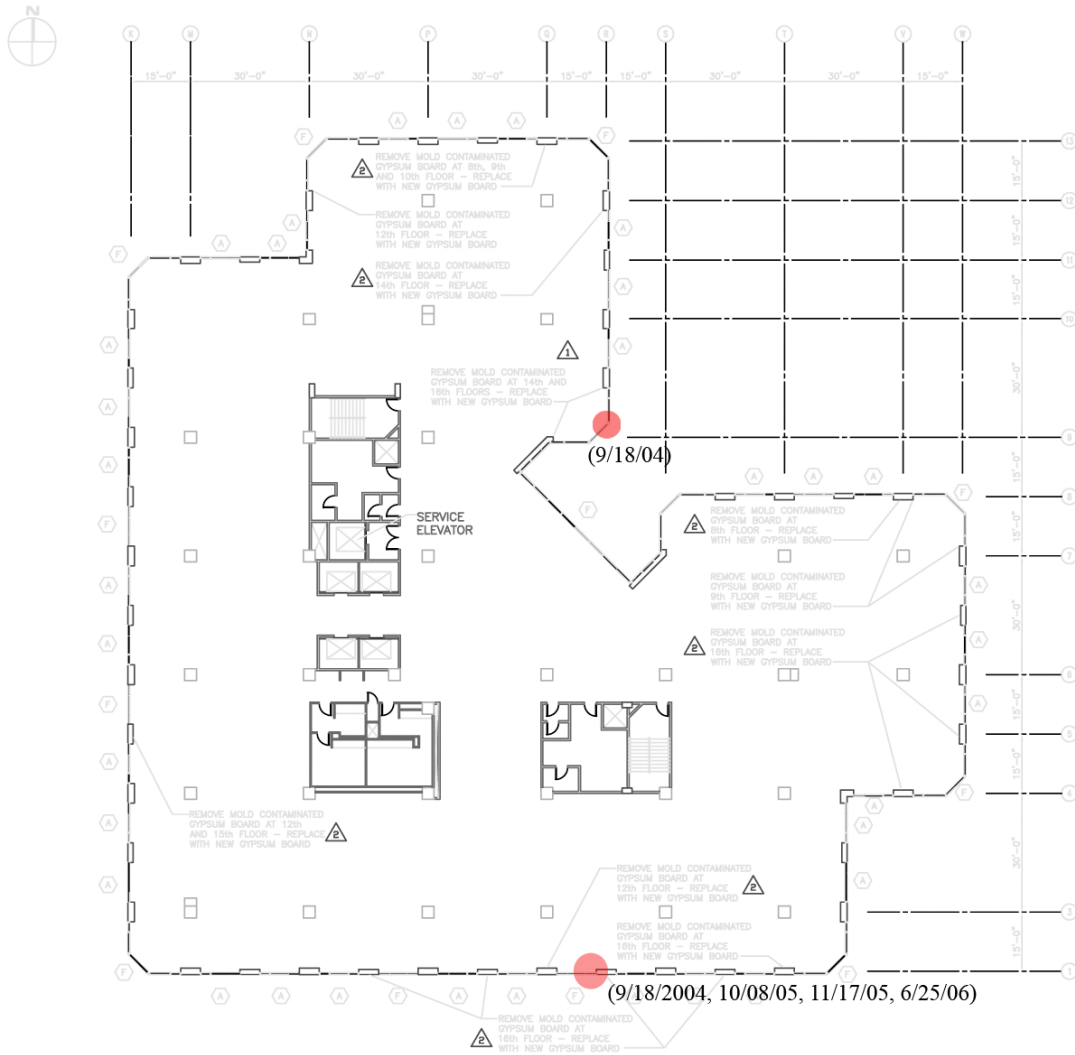
SIXTEENTH FLOOR PLAN

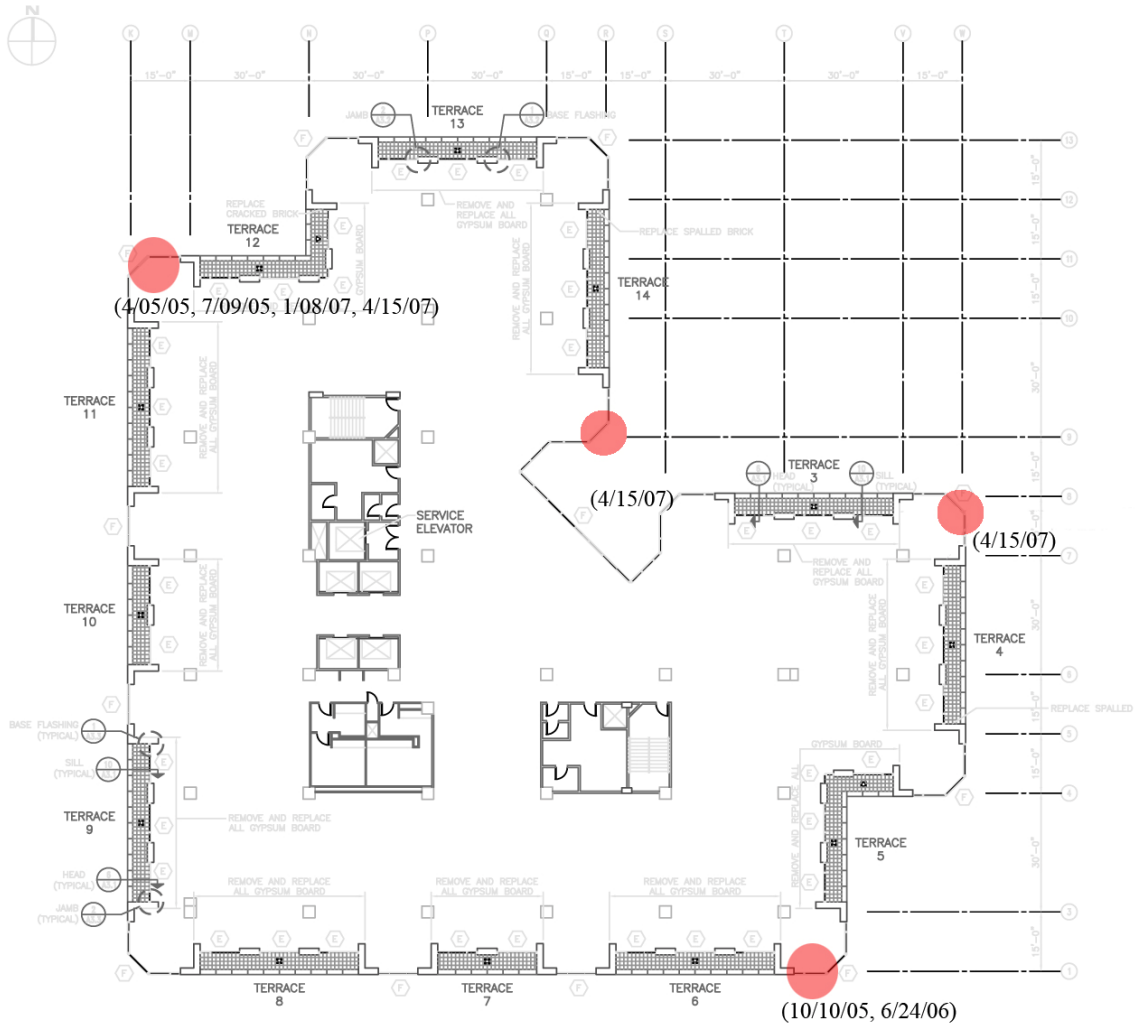
SEVENTEENTH FLOOR PLAN

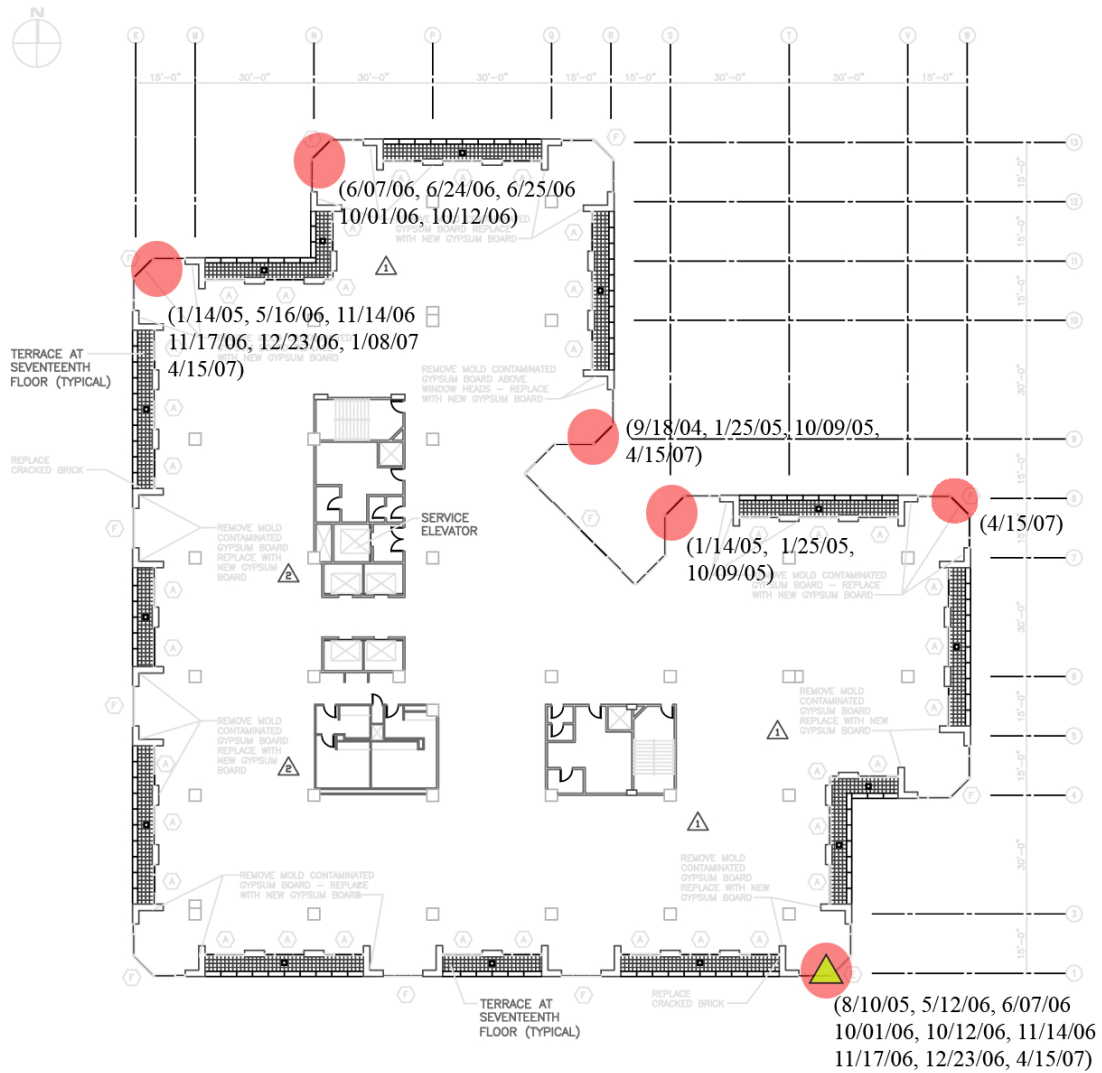
EIGHTEENTH FLOOR PLAN

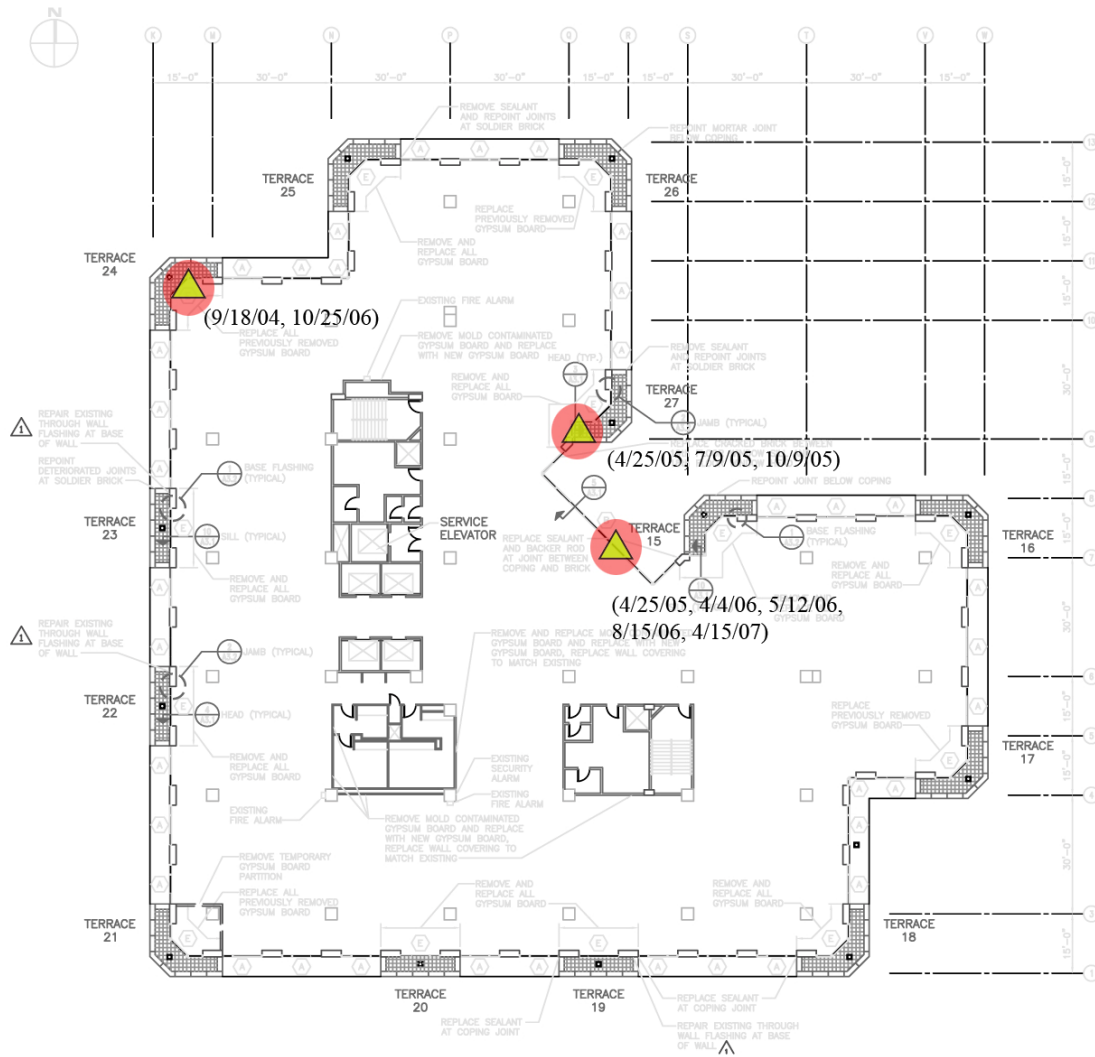
NINETEENTH FLOOR PLAN

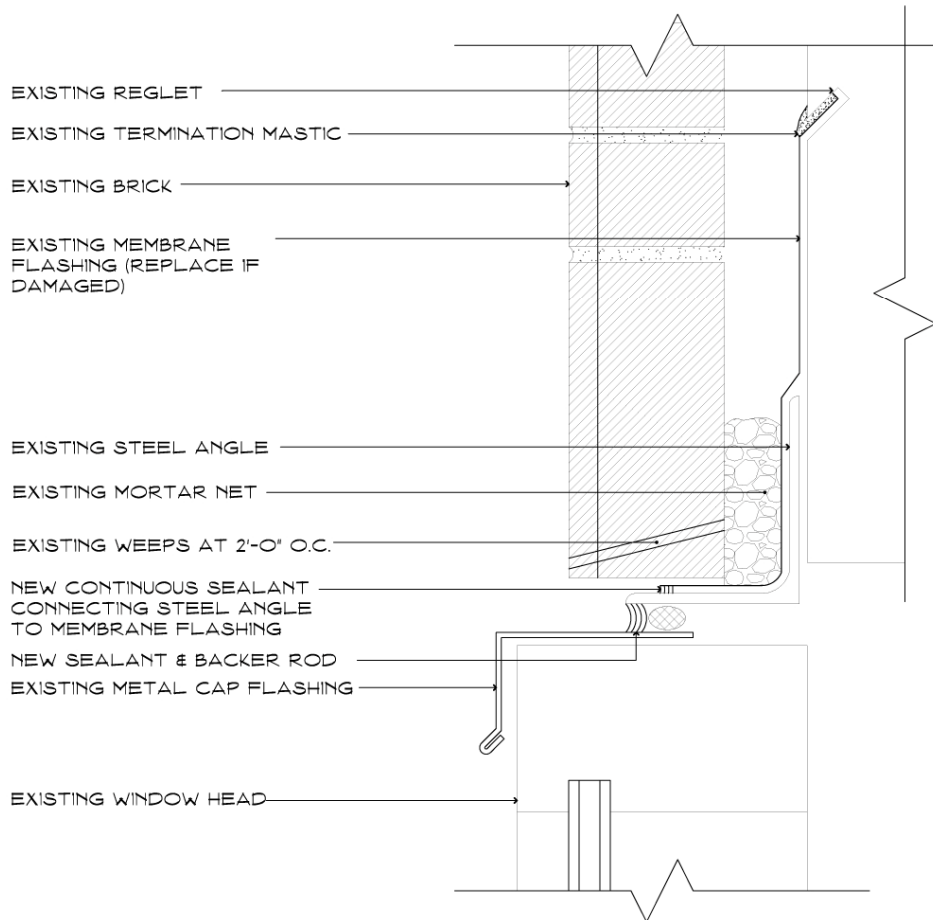
After these modifications have been made to the building at one or two locations, the repairs should be flood tested again to determine if the modifications are successful in keeping the water from infiltrating the building. Only after these tests have been conducted can it be assumed that the proposed solutions are proven and that the rest of the known leak locations can be sent to contractors and eventually repaired. At this time it is important to determine if it is feasible to fix only the windows that have had reported leaks or if all windows with deficient detailing should be repaired.

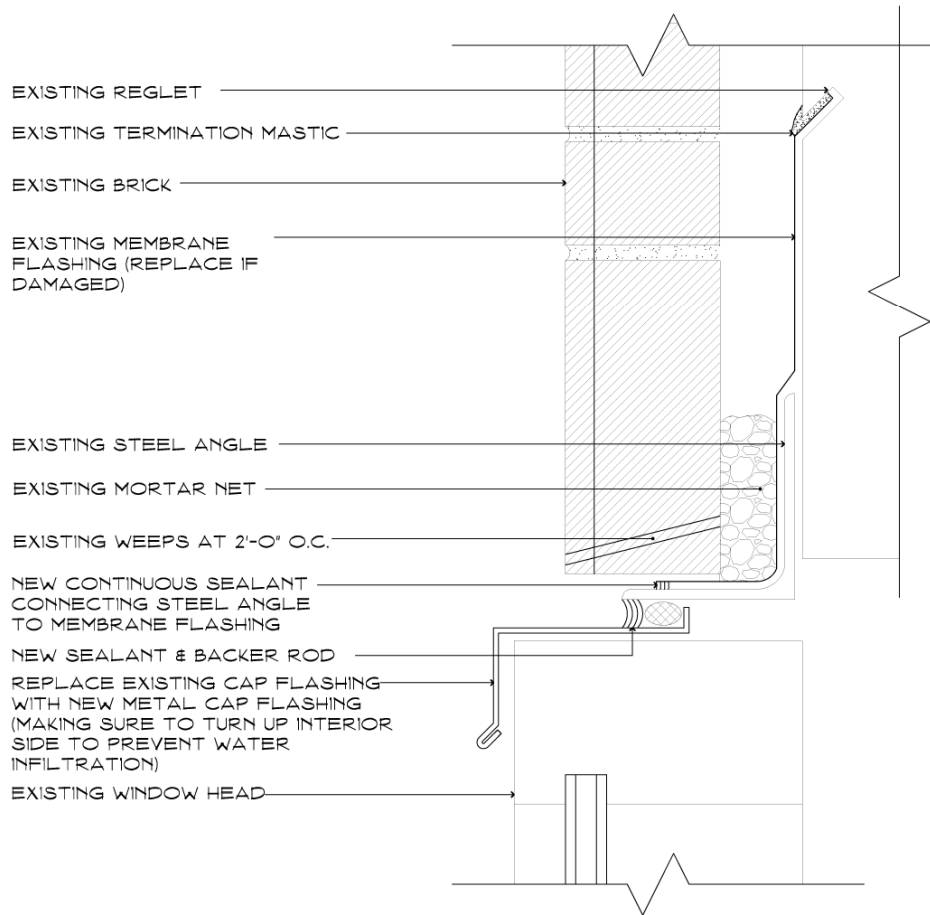
Flashing Detail for First Step Recommendations
