18/20 AND 30 TRINITY STREET
Pre-Design Study
Project: BI-2B-445

18/20 and 30 Trinity Street
Hartford, CT 06106

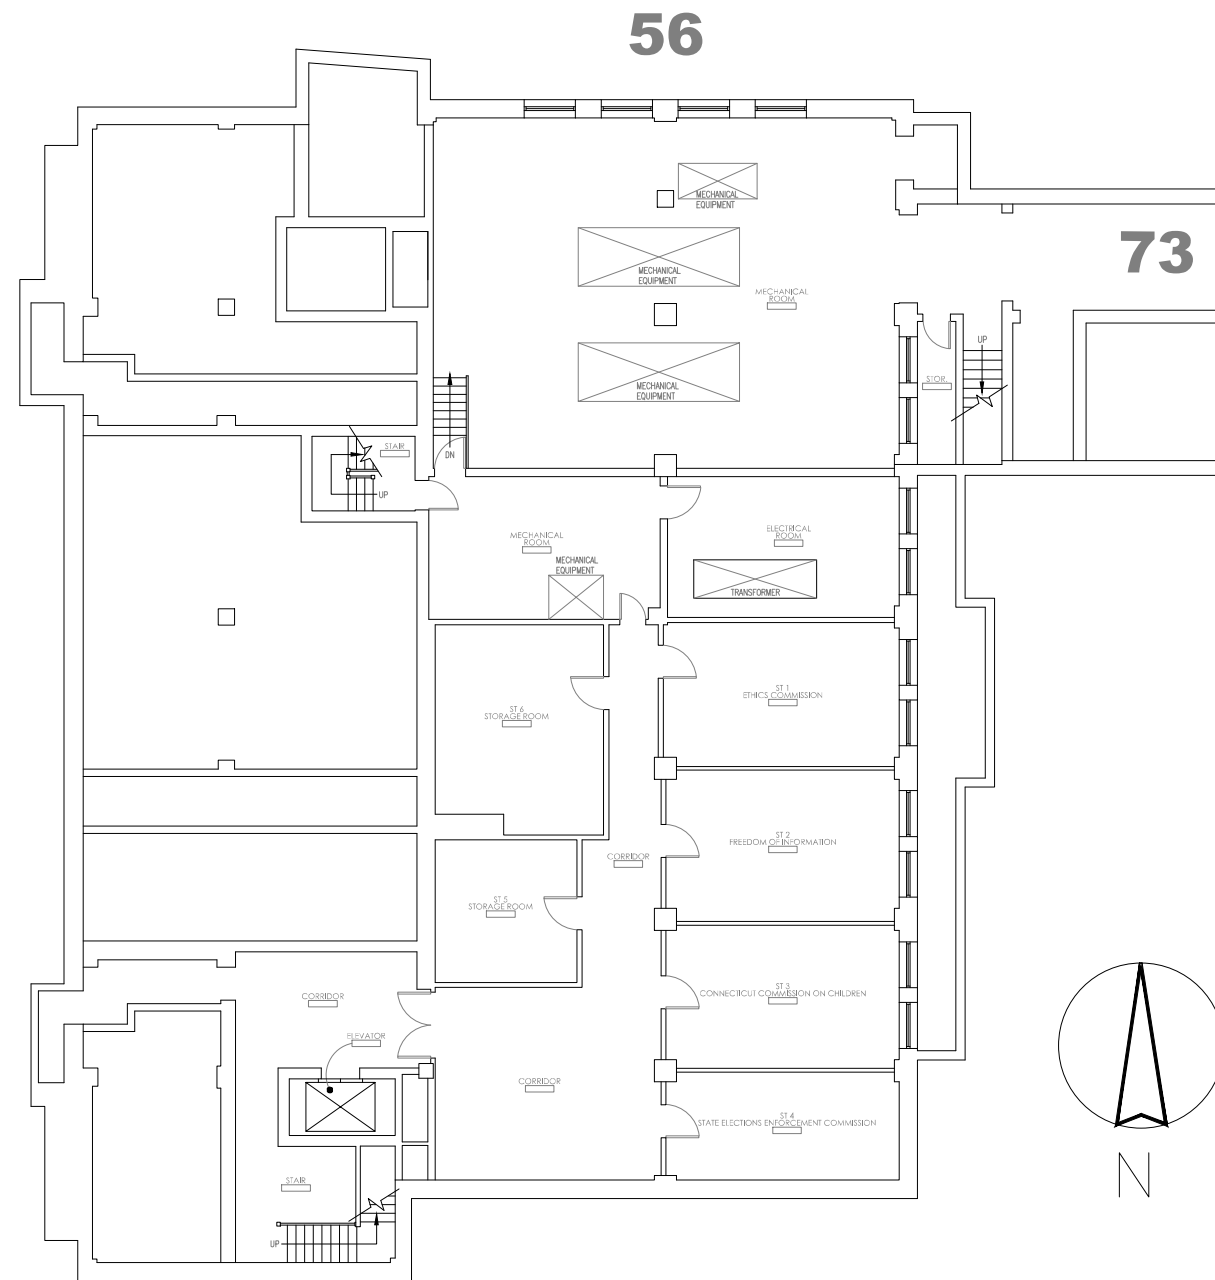
Figure Locations
Basement Floor Plan
18-20 Trinity St.

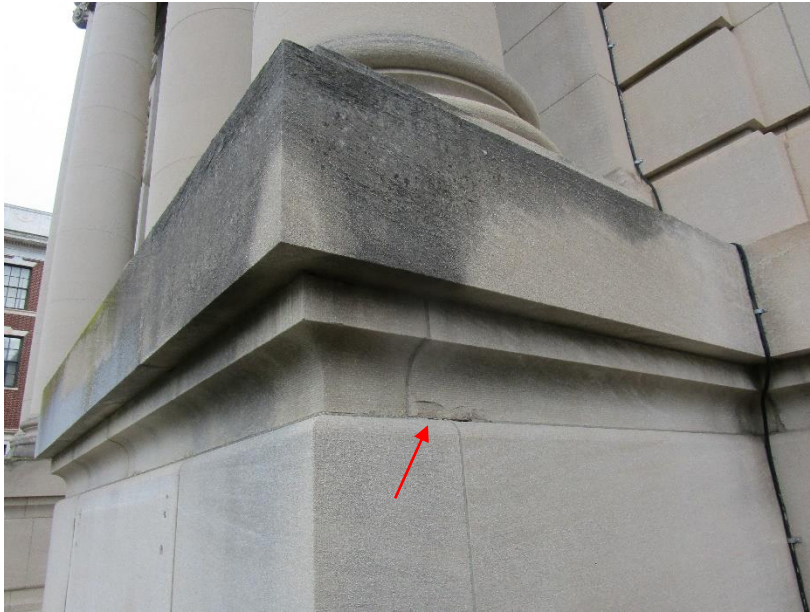
Figure 3. Soiling and small spall on limestone.

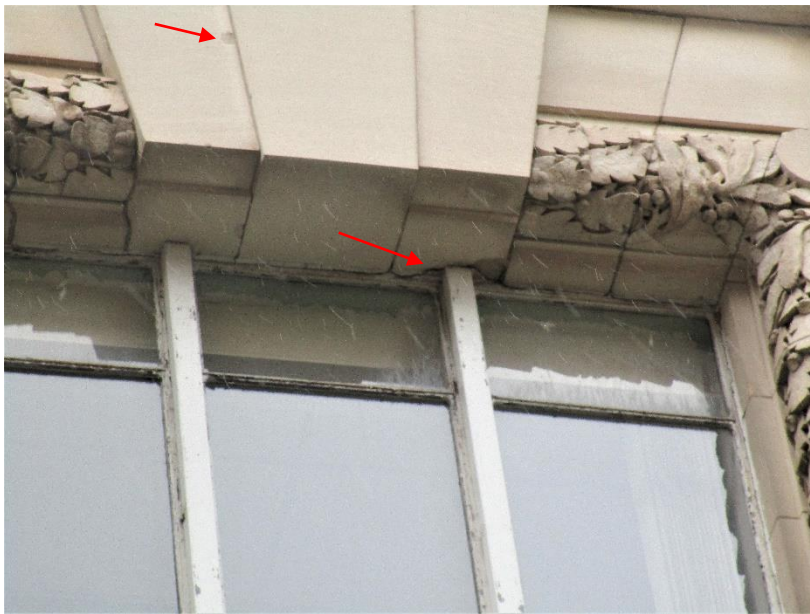
Figure 4. Spalled stone at intersection with window mullion at north elevation of 20 Trinity Street. Also note small spall at keystone.

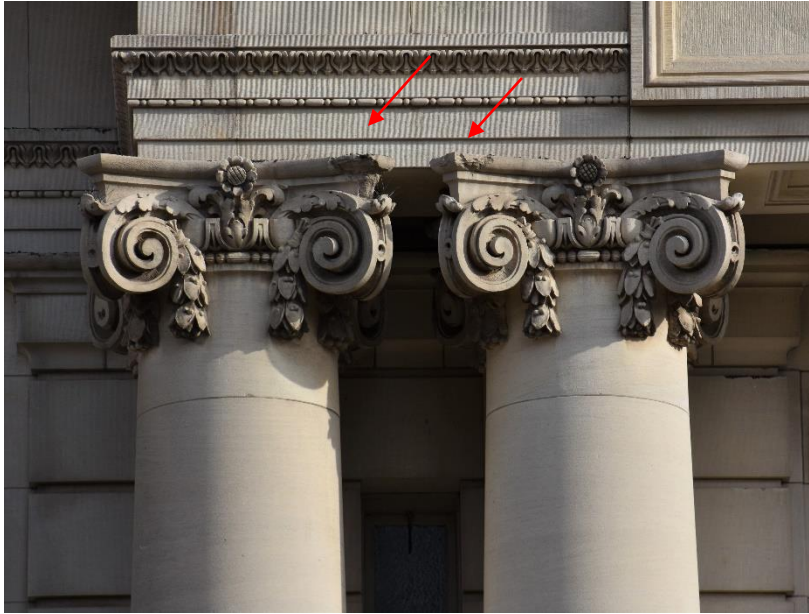
Figure 5. Erosion of limestone at column capitals.

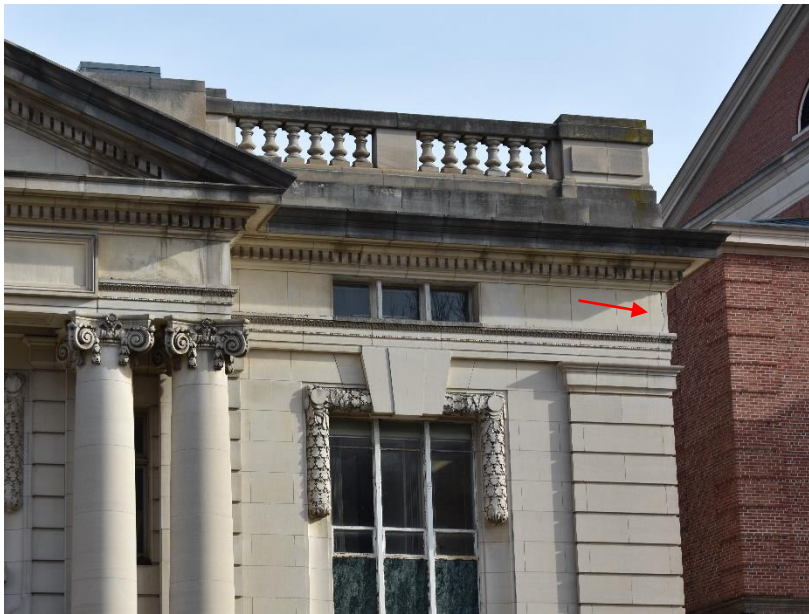
Figure 6. Crack in limestone at southwest corner of 20 Trinity Street. Also note soiling at cornice, balustrade and pediment.

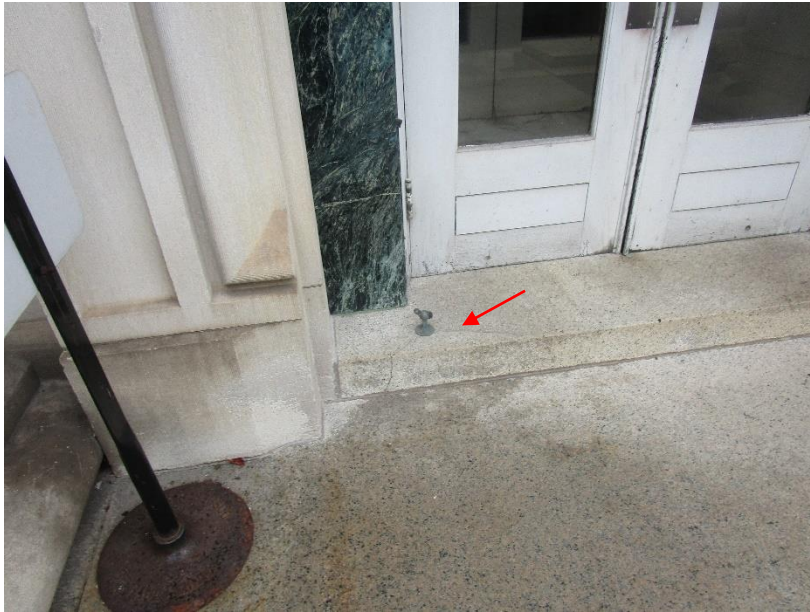
Figure 7. Crack at granite door sill.

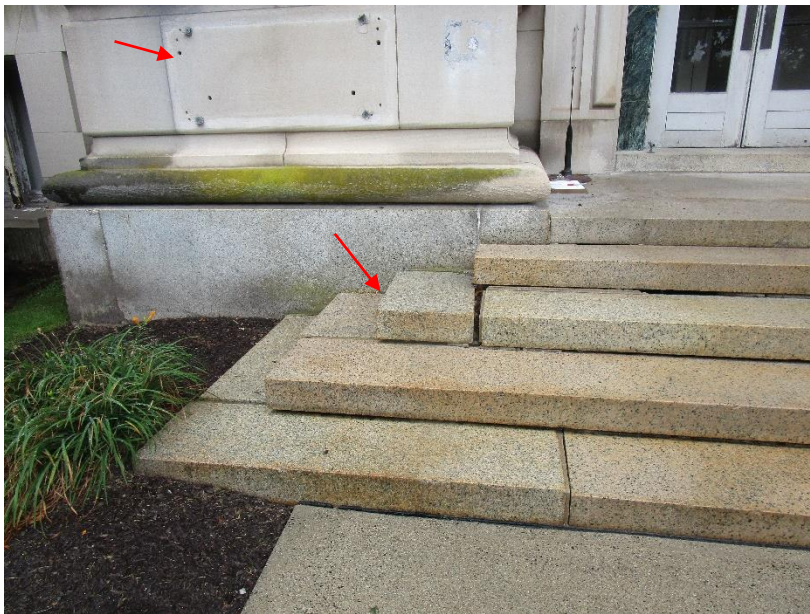
Figure 8. Granite displacement at west entrance stair and anchors in stone left after signage removal.

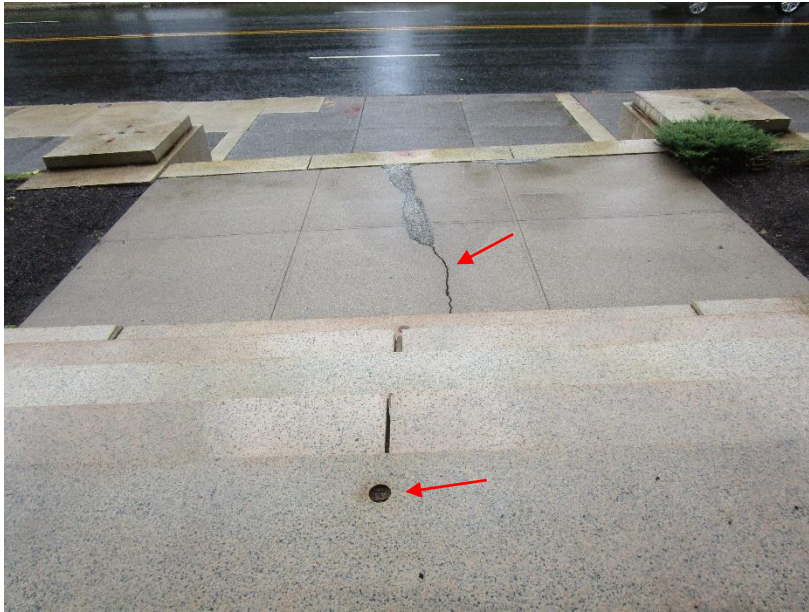
Figure 9. Crack and surface loss in concrete landing at stair to west entrance. Also note sleeve for missing handrail post.

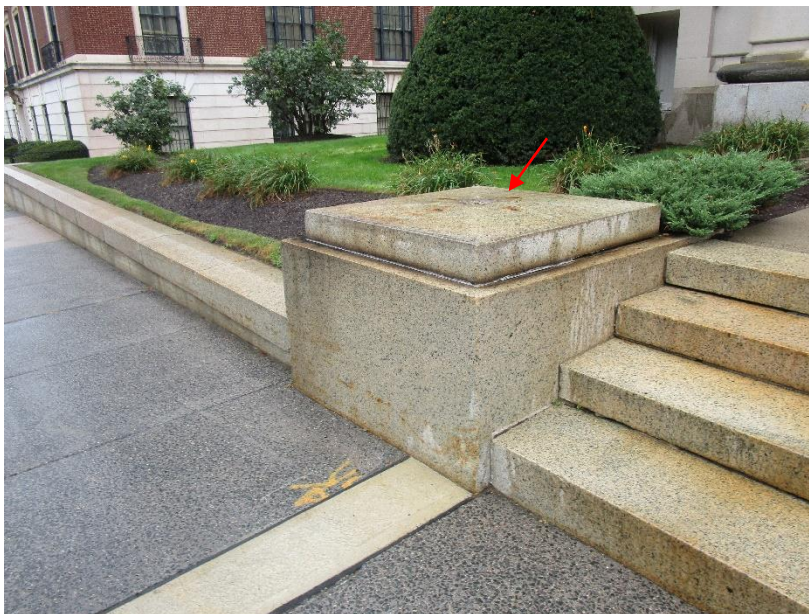
Figure 10. Anchors for missing light fixture. Staining on granite at stair and retaining wall.

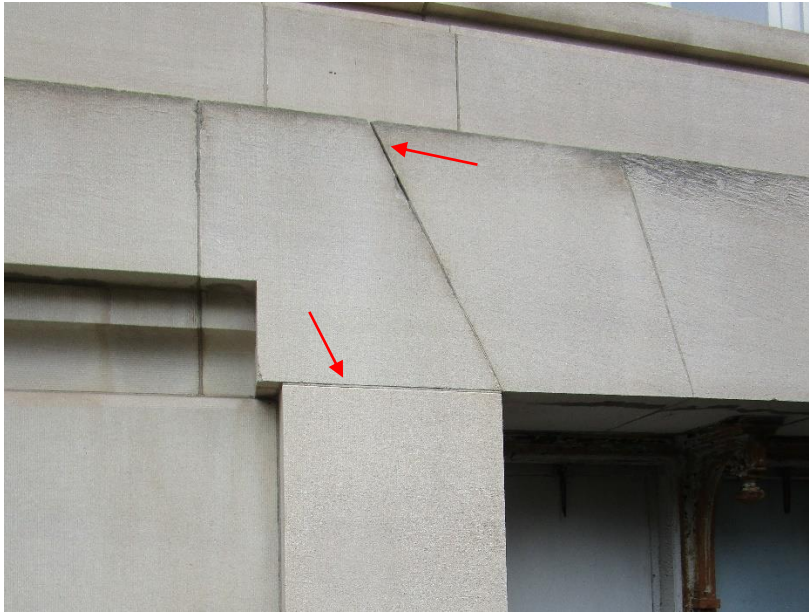
Figure 11. Loose and missing mortar and separation at stone to mortar interface at the north elevation of 20 Trinity Street.

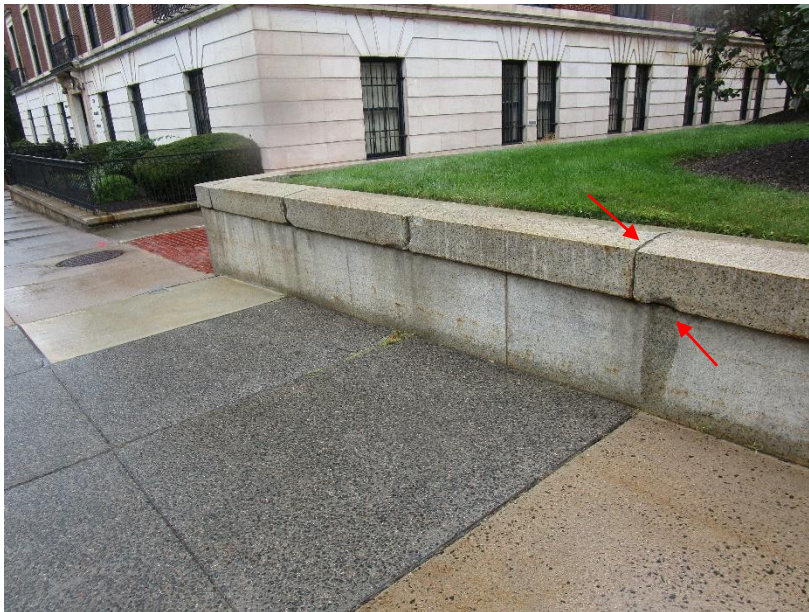
Figure 12. Spalls and mortar deterioration at granite retaining wall.

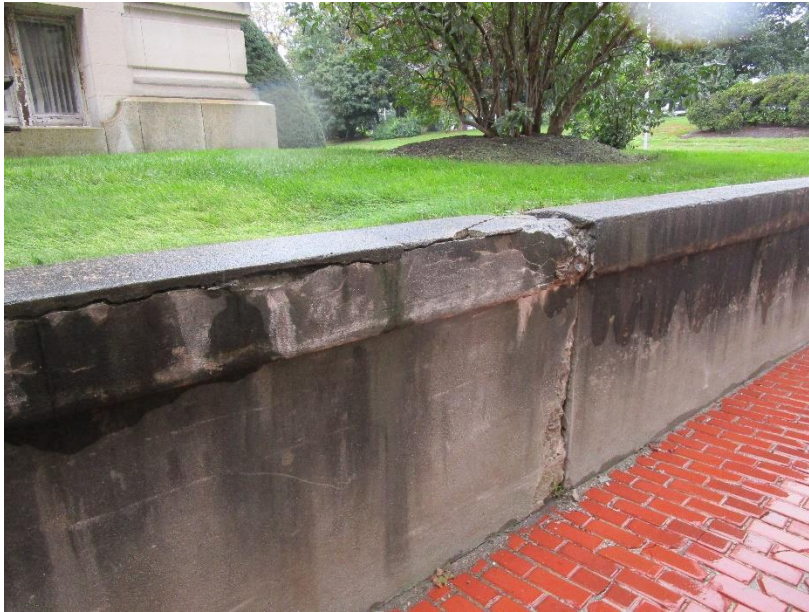
Figure 13. Concrete deterioration at retaining wall at the north side of 20 Trinity Street.

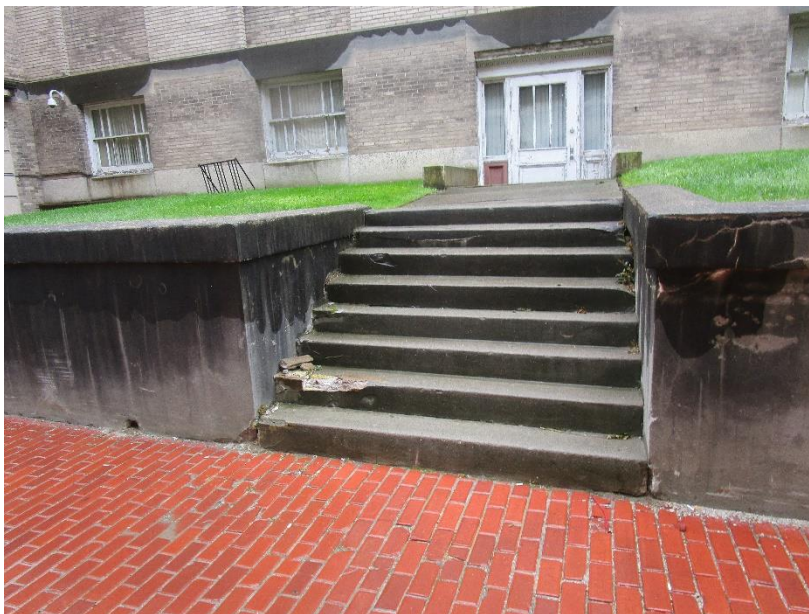
Figure 14. Concrete deterioration at stair and retaining wall at 20 Trinity Street.

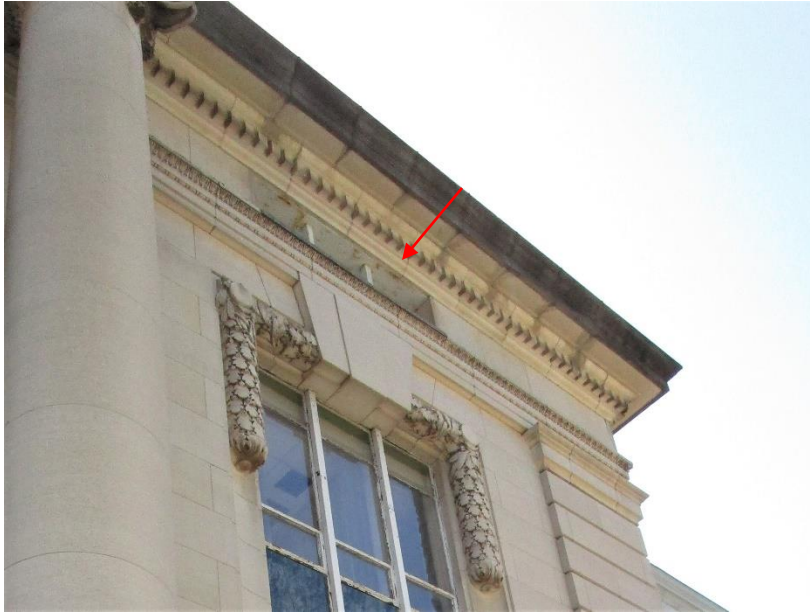
Figure 15. Peeling paint and surface rust at steel lintel.

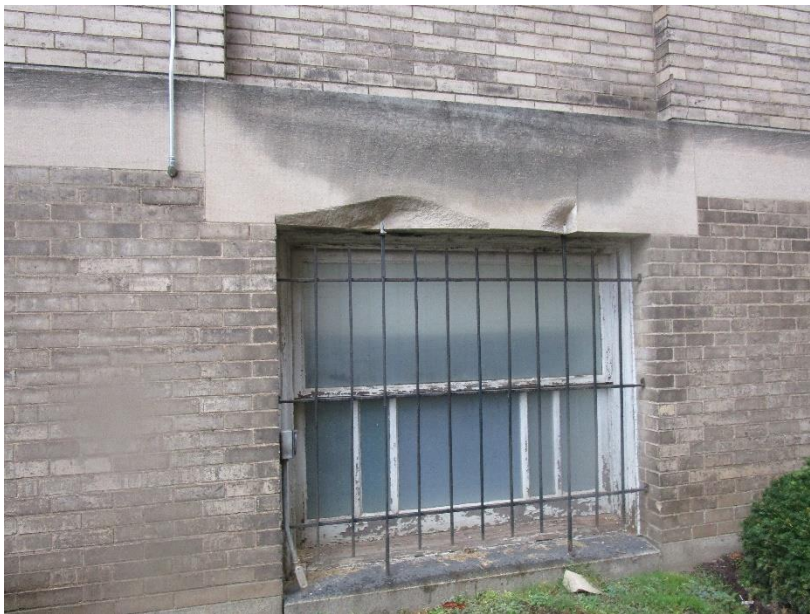
Figure 16. Spalls at stone lintel.

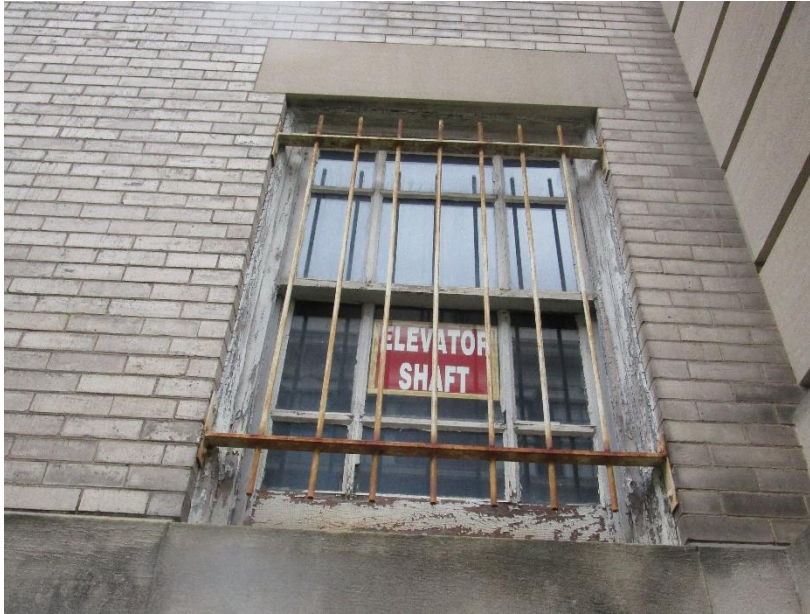
Figure 17. Paint failure and surface rust at window security grille.

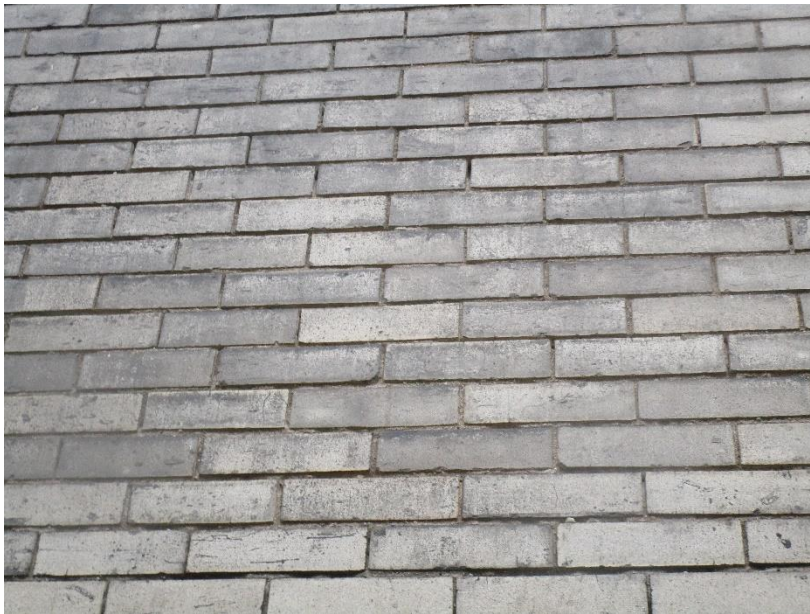
Figure 18. Mortar in brick joints at north elevation.

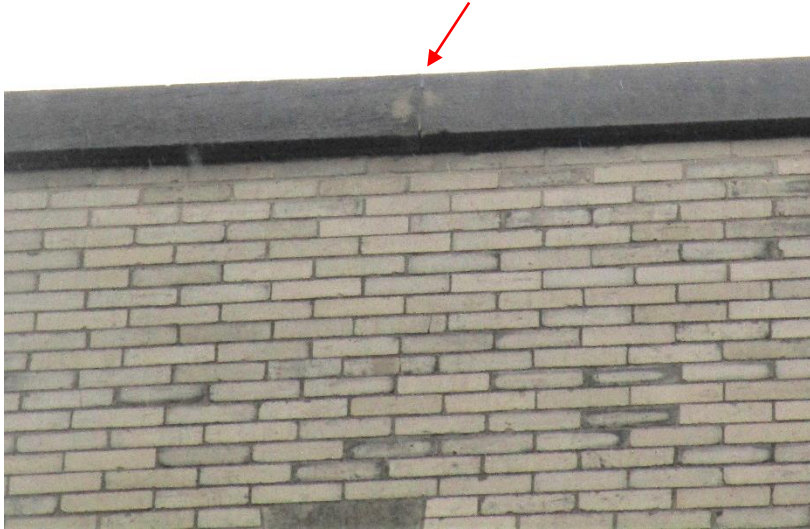
Figure 19. Mortar deterioration at coping joint.

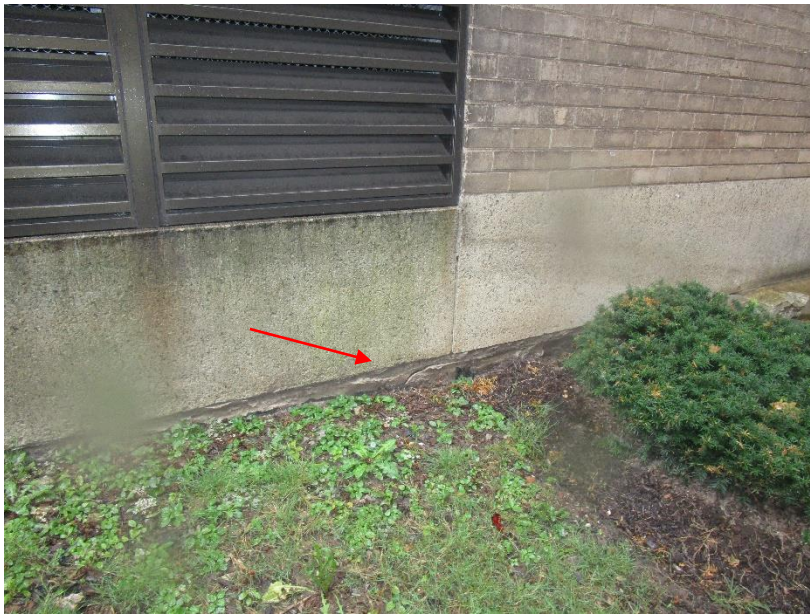
Figure 20. Spalls at concrete foundation.

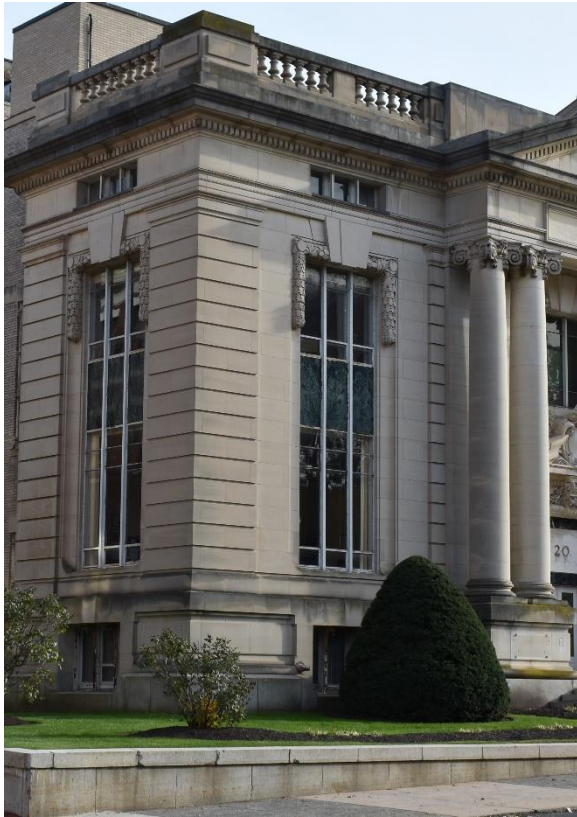
Figure 21. Windows at the northwest corner of 20 Trinity Street.

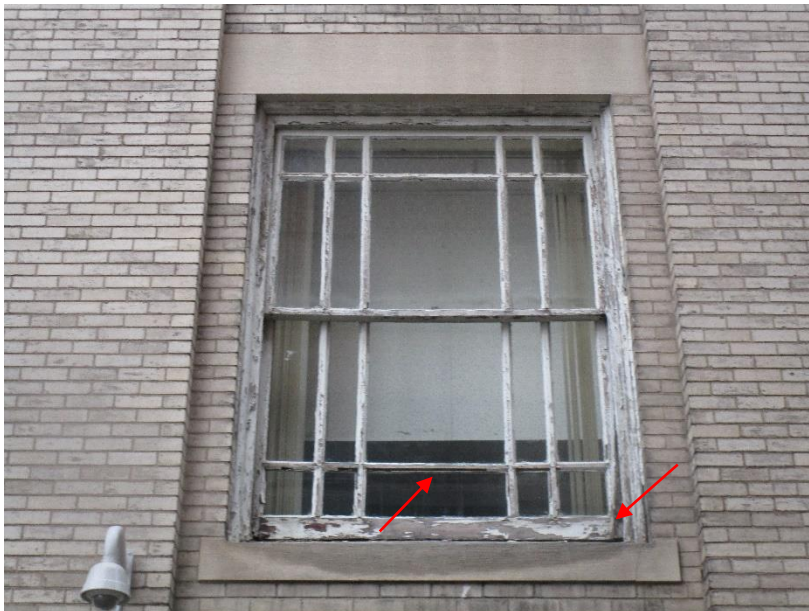
Figure 22. Double hung wood window at south elevation of 20 Trinity Street. Arrows point to damage and decay at wood sash and muntin.

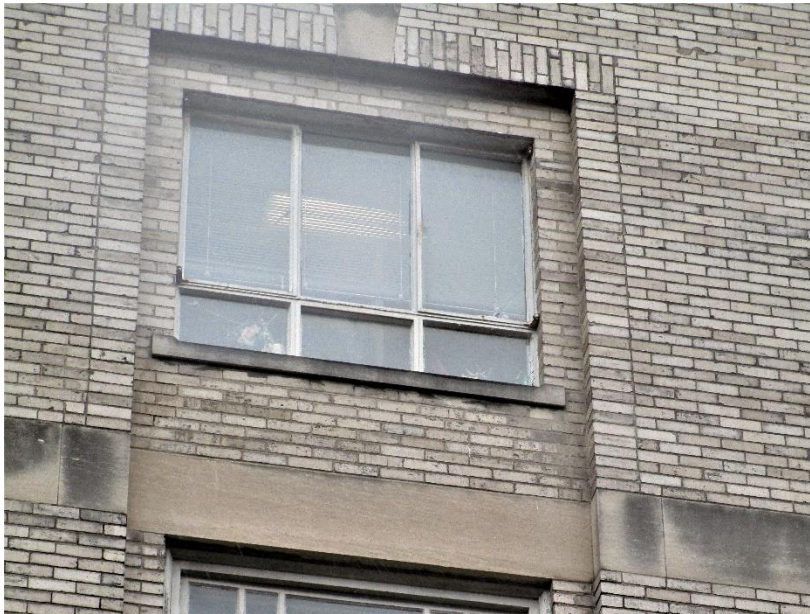
Figure 23. Steel casement window at third floor of 20 Trinity Street.

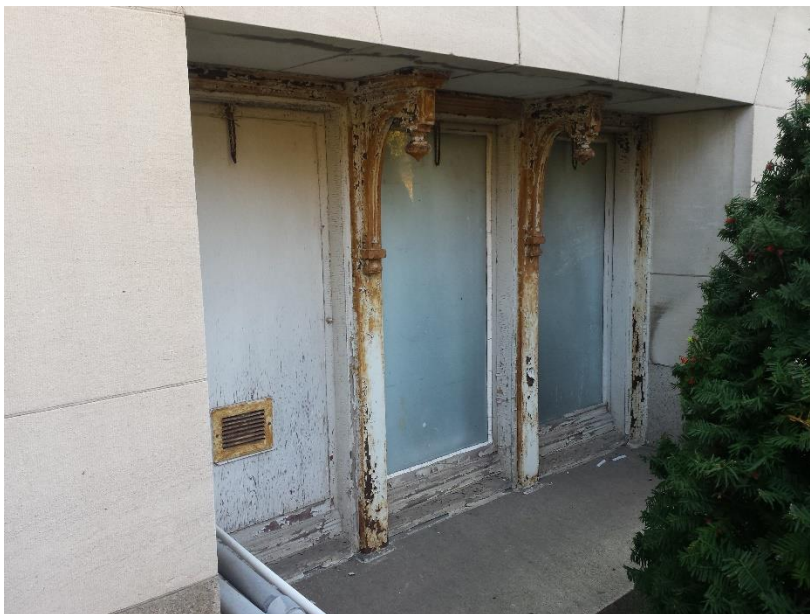
Figure 24. Peeling paint at wood and iron surfaces as well as surface rust on iron at ground level window.

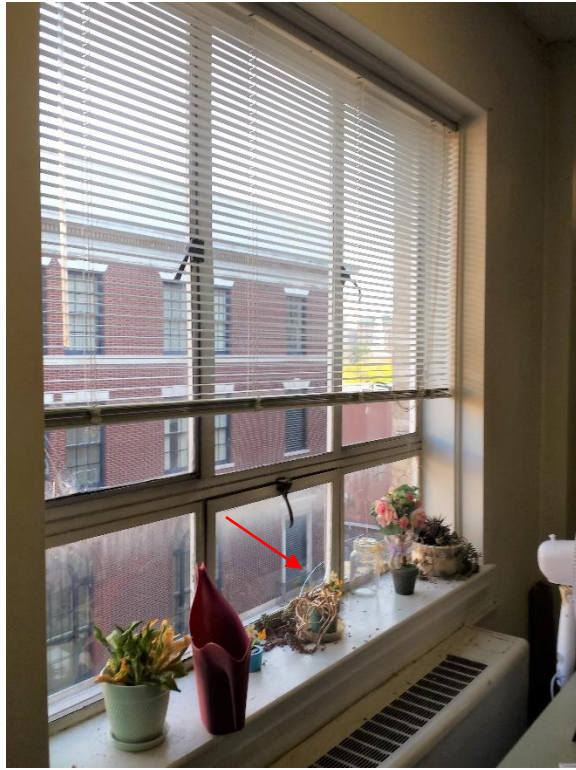
Figure 25. Cracked glass at window.

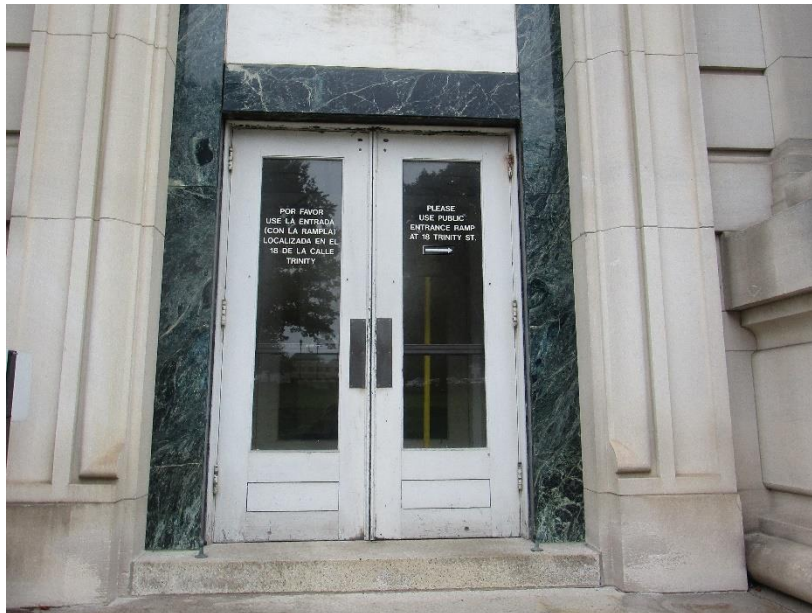
Figure 26. Door at west entrance.

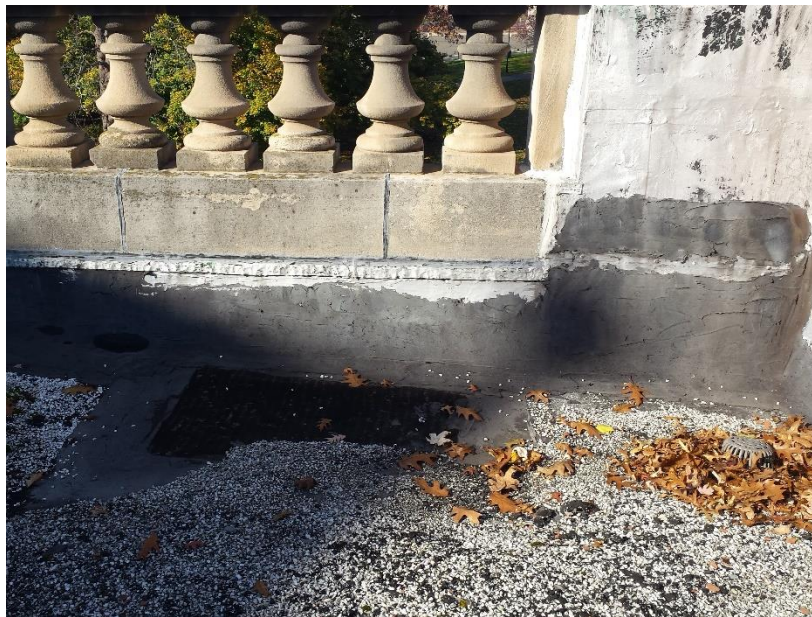
Figure 30. Roofing mastic applied to repair the base flashing.

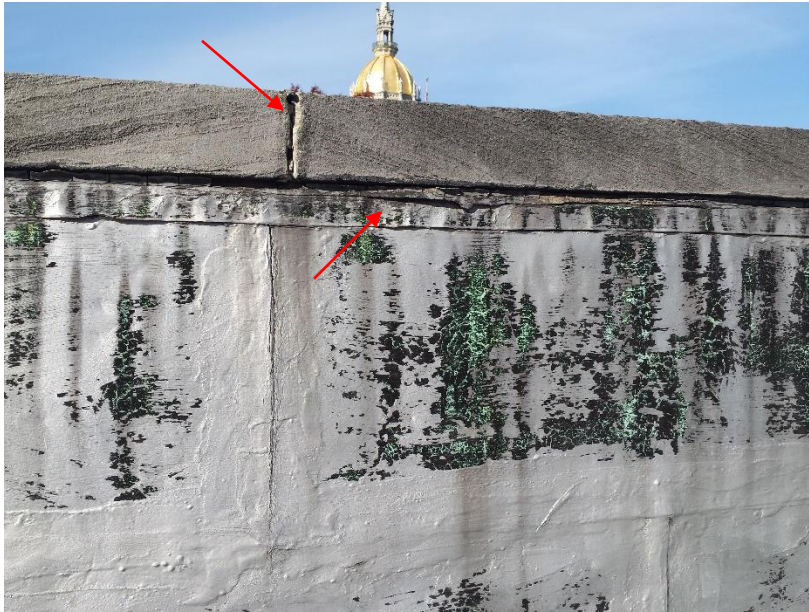
Figure 31. Aluminized coating failure at copper panels at roof parapet as well as mortar and sealant failure at coping stones.

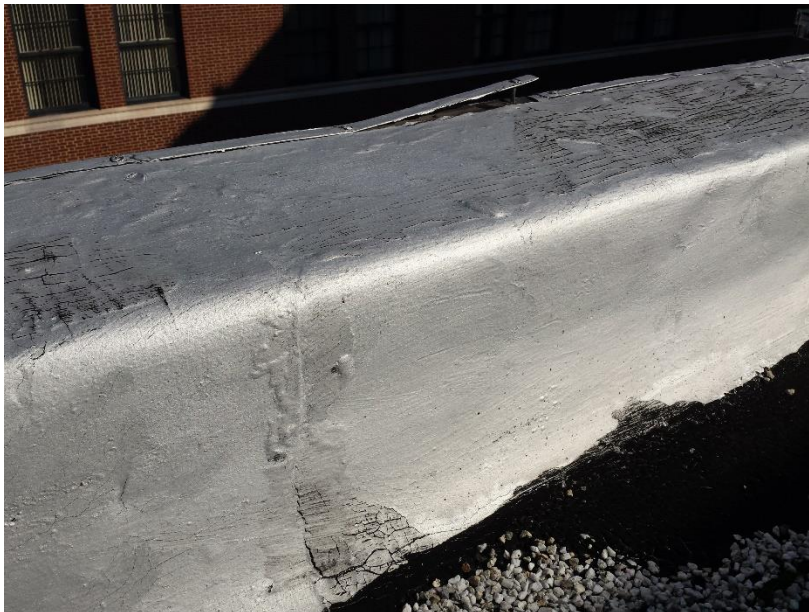
Figure 32. Loose termination bar at coping stone flashing.

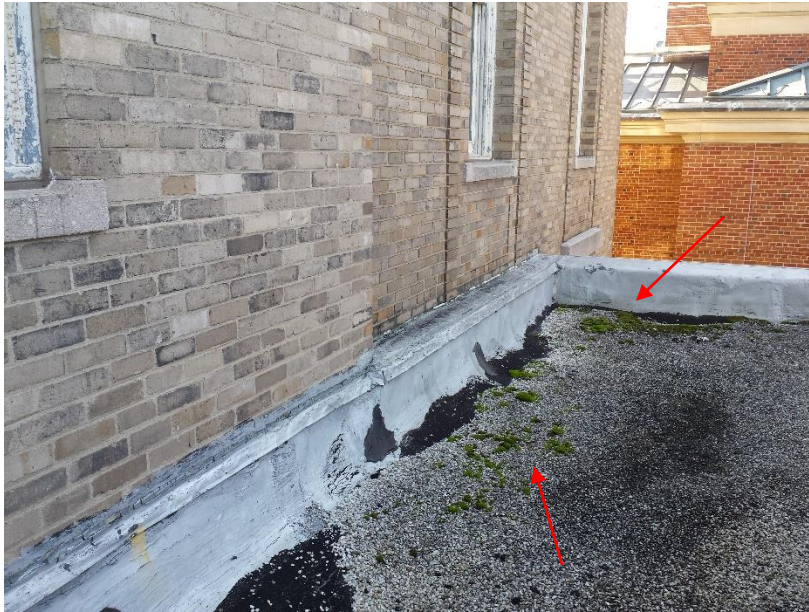
Figure 33. Organic growth on roof surface.

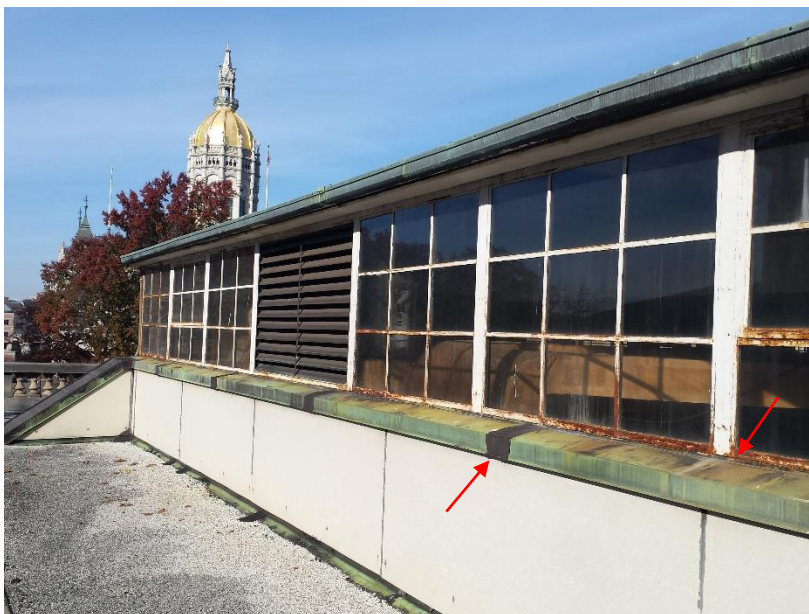
Figure 34. Corrosion at steel windows and repairs at copper sill joints at 20 Trinity Street mechanical penthouse.

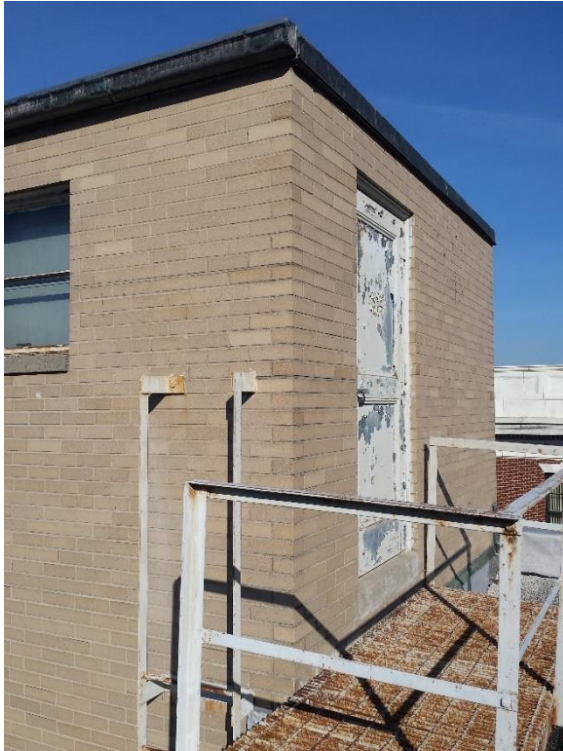
Figure 35. Elevator penthouse at 20 Trinity Street.

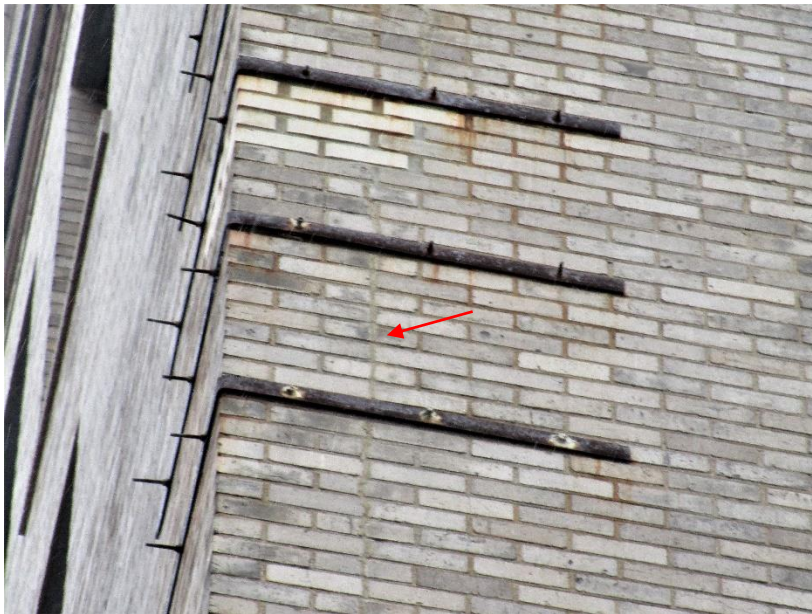
Figure 40. Corrosion at steel reinforcement straps and fasteners. Also note crack filled with elastomeric sealant.

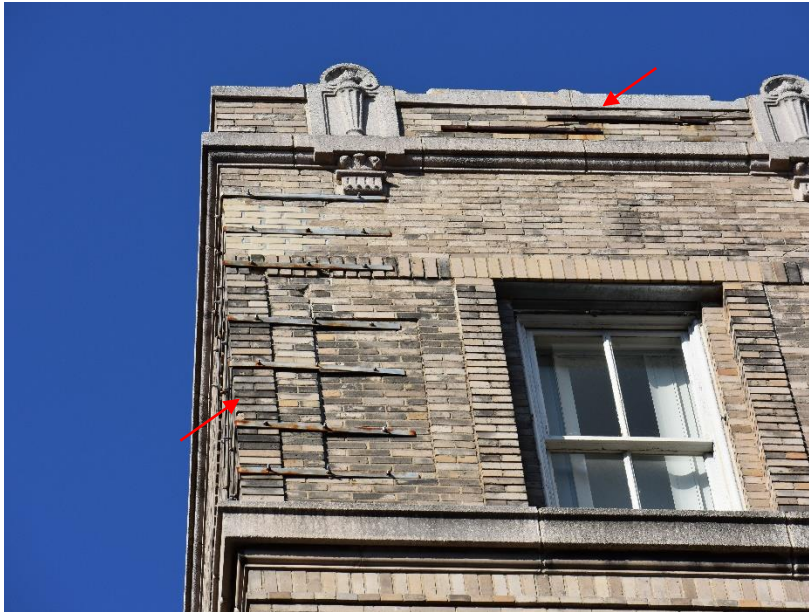
Figure 41. Strap repairs at east roof parapet at 18 Trinity Street. Also note soiling and staining on the brick and cast stone surfaces.

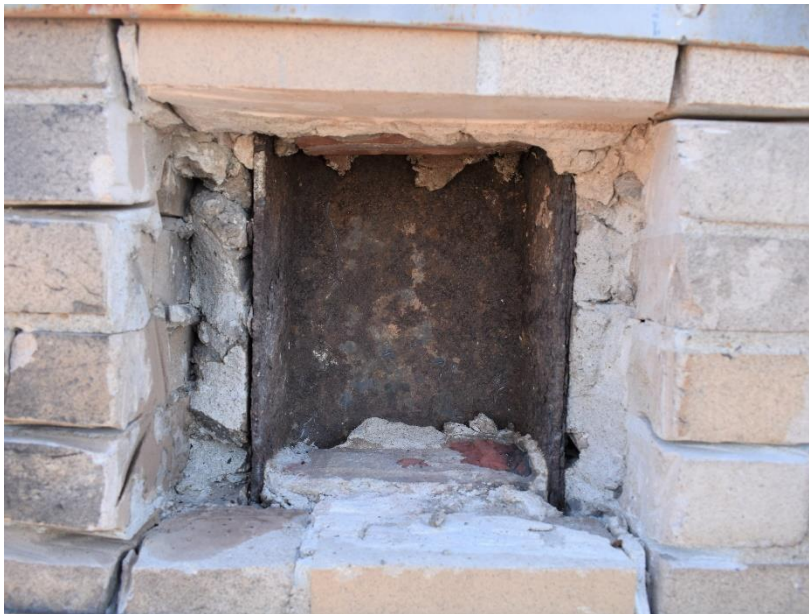
Figure 42. Steel column at the southeast corner of 18 Trinity Street.

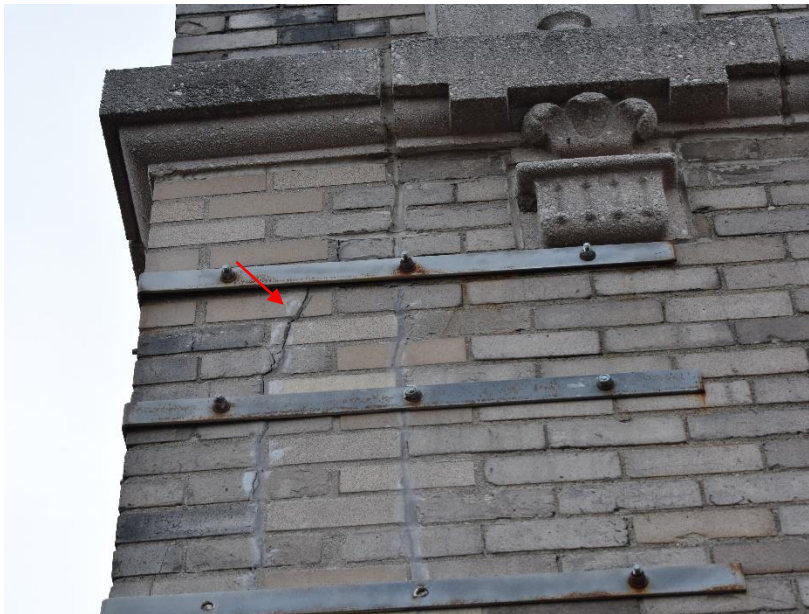
Figure 44. Cohesive sealant failure at crack repair.

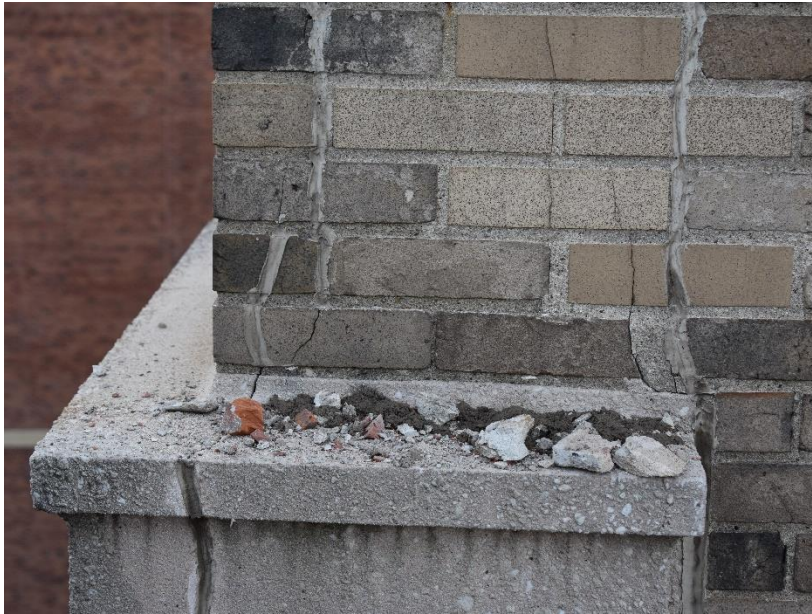
Figure 45. Cracks adjacent to and below sealant crack repairs.

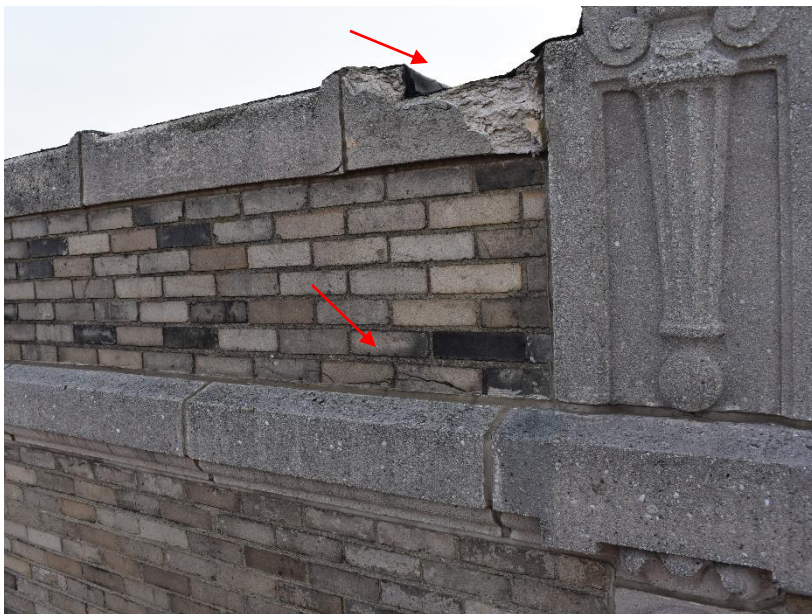
Figure 46. Delamination of cast stone coping. Also note cracks at face bricks.

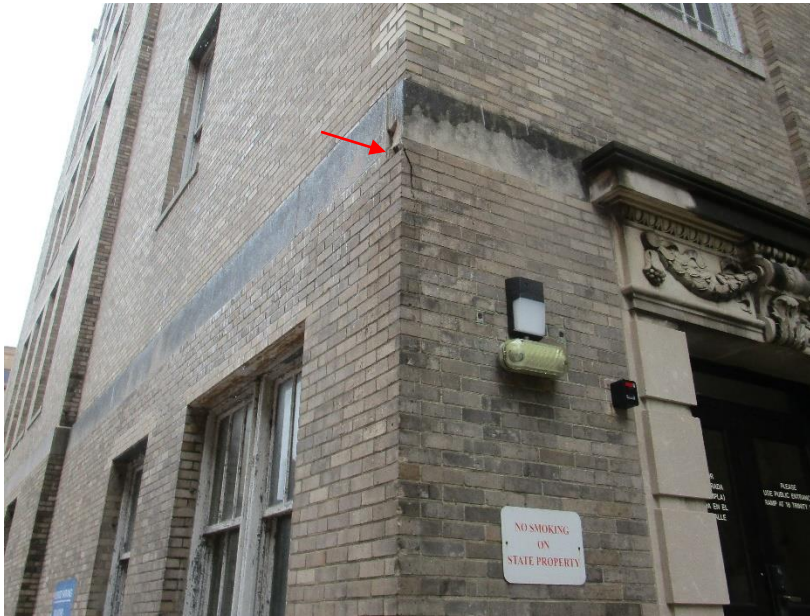
Figure 47. Spall at band stone and cracked bricks at the southwest corner of 18 Trinity Street.

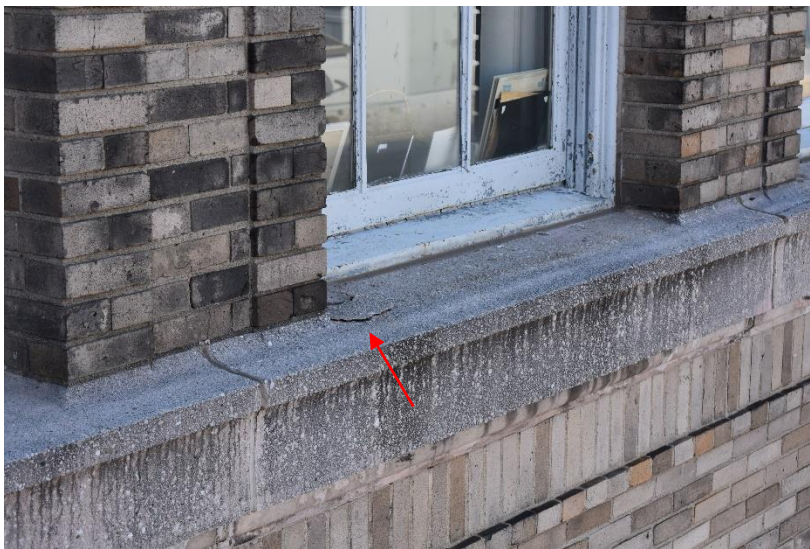
Figure 48. Spall at cast stone window sill at 18 Trinity Street.

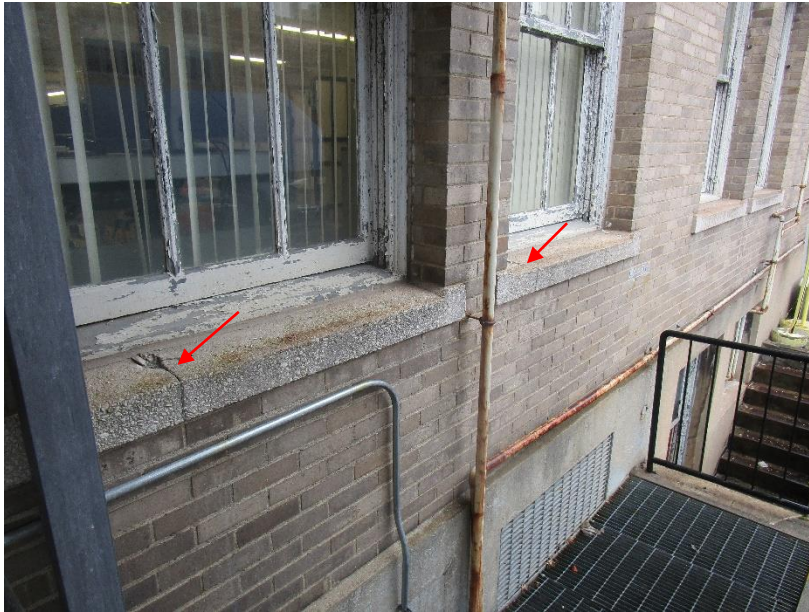
Figure 49. Cracks at cast stone window sills. Also note peeling paint at windows. This paint failure is typical at all windows.

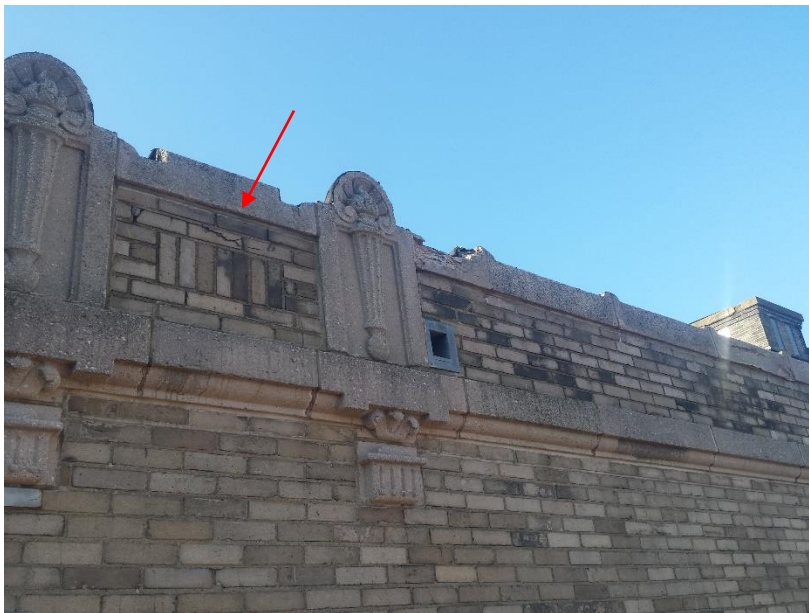
Figure 50. Spalled face brick at roof parapet.

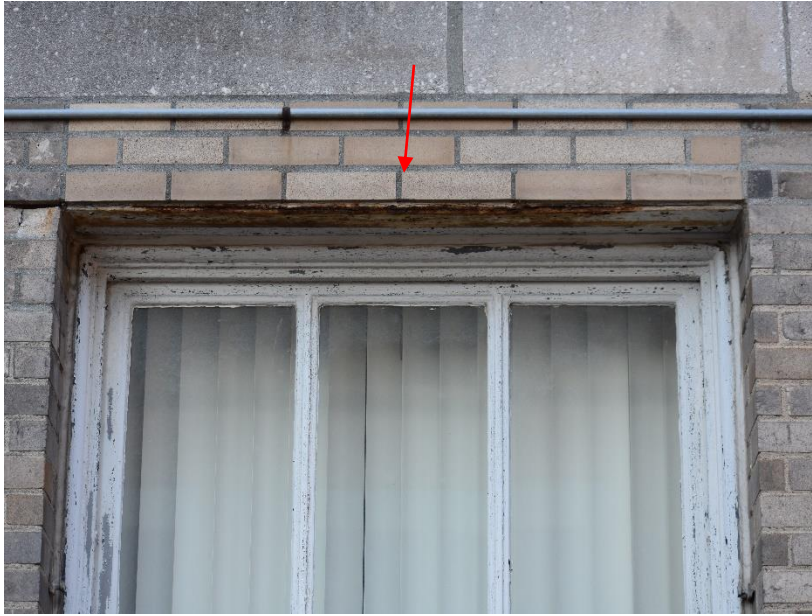
Figure 51. Corrosion and deflection at steel lintel.

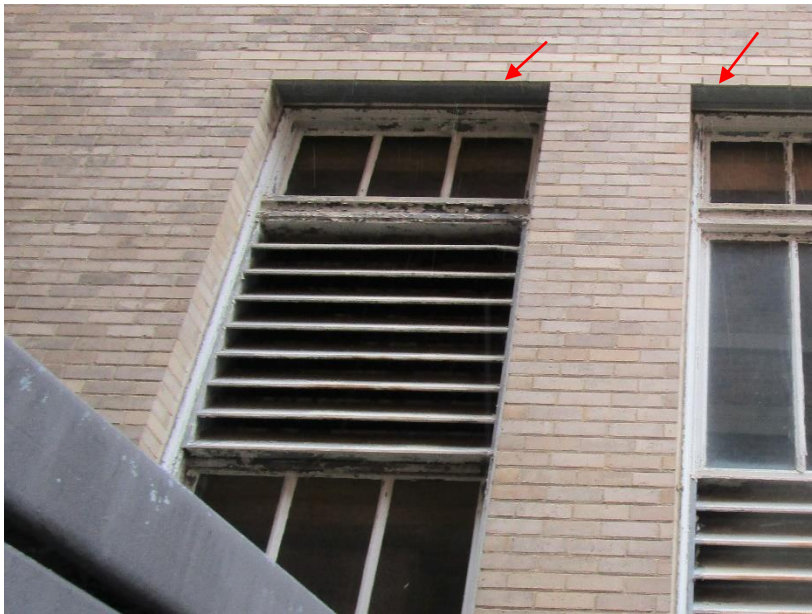
Figure 52. Galvanized steel replacement lintels.
