18/20 AND 30 TRINITY STREET
Pre-Design Study
Project: BI-2B-445

18/20 and 30 Trinity Street
Hartford, CT 06106

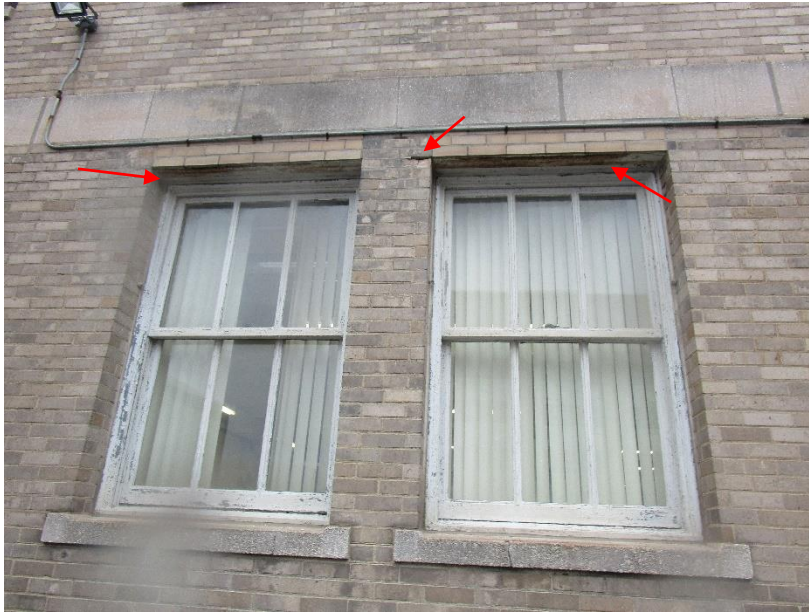
Figure 53. Surface rust on steel lintels at window openings. Also note spalled brick where the lintel bears on the masonry.

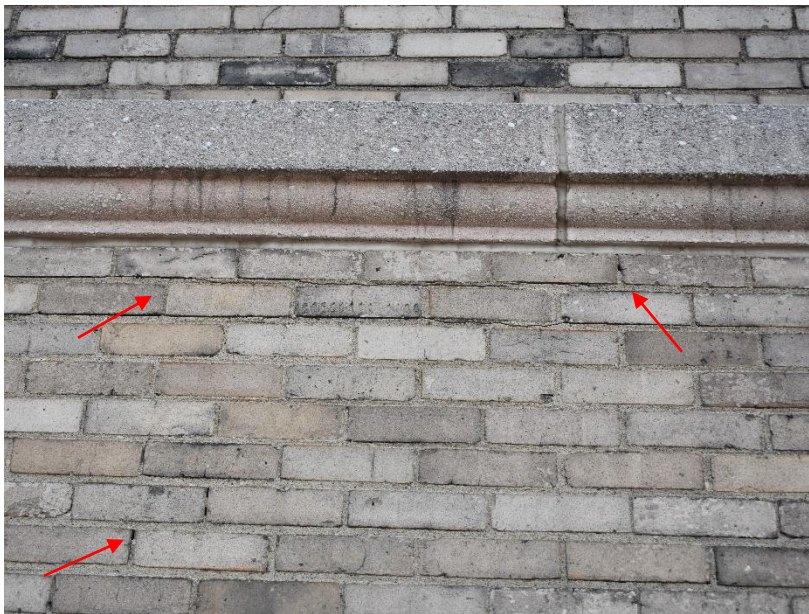
Figure 54. Mortar cracks in brick joints at 18 Trinity Street.

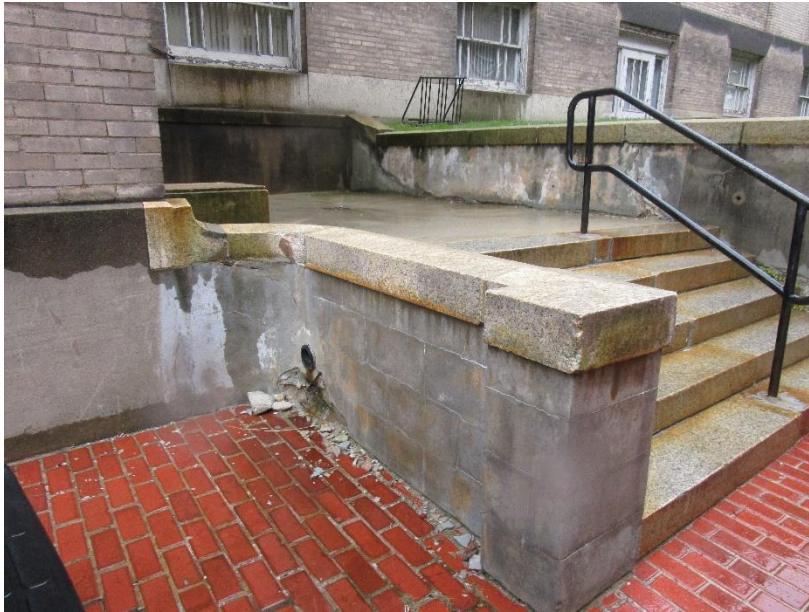
Figure 55. Concrete deterioration at stair and retaining wall at the northwest corner of 18 Trinity Street.

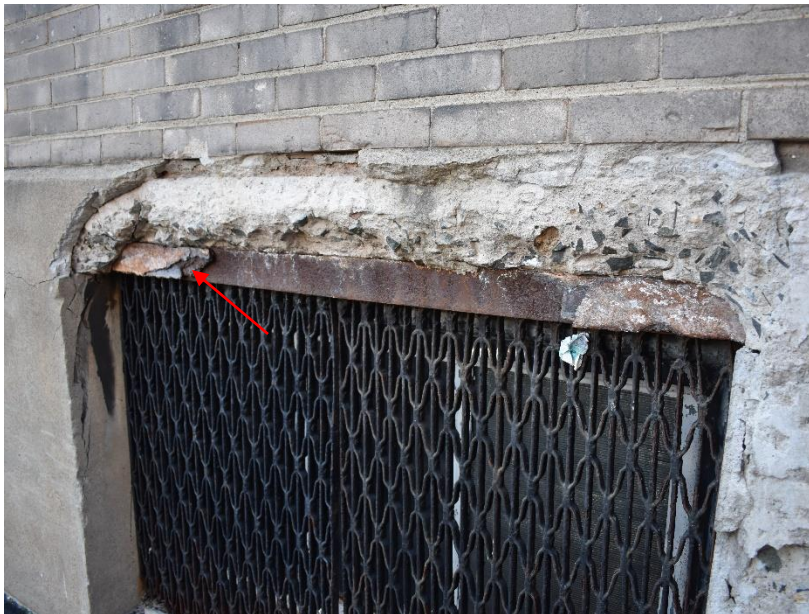
Figure 56. Concrete deterioration at ground floor of north elevation. Note the volume of the corrosion at the steel frame at the left hand side of the figure.

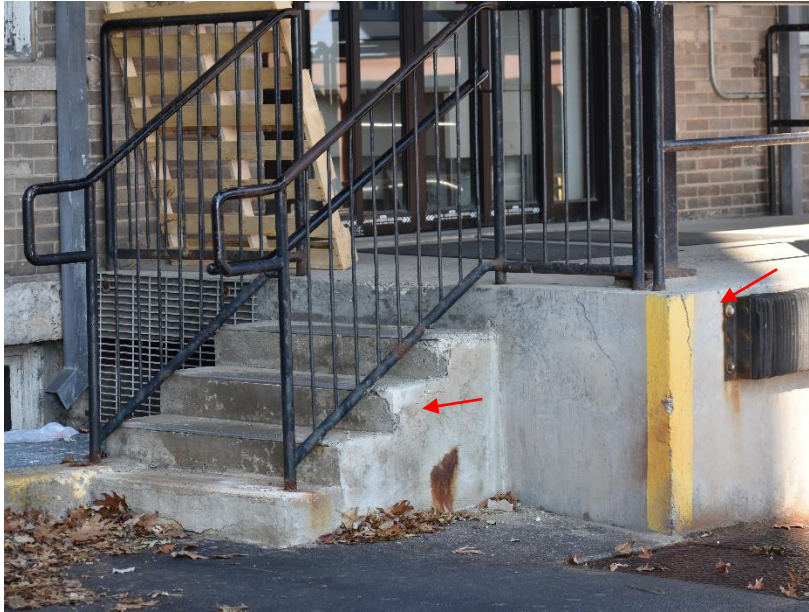
Figure 57. Concrete spalls at treads and cracks in concrete at loading dock.

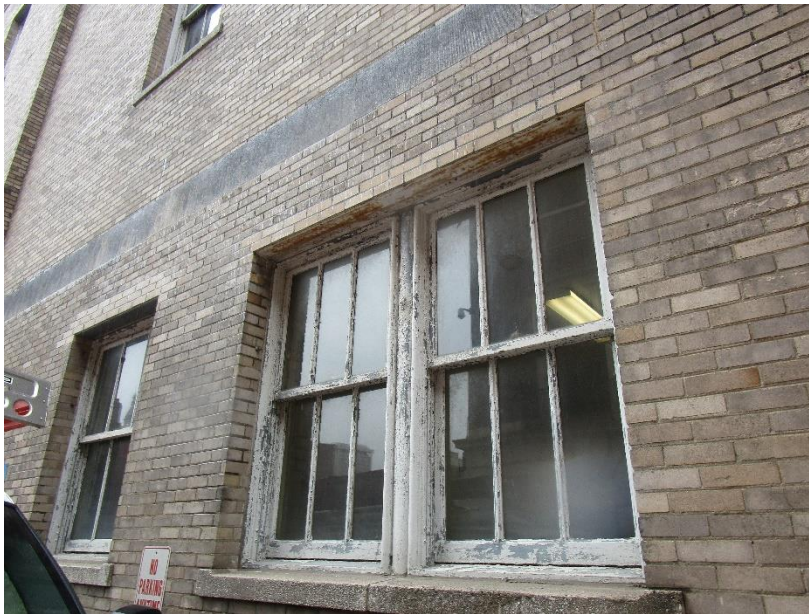
Figure 58. Windows at north elevation of 18 Trinity Street.

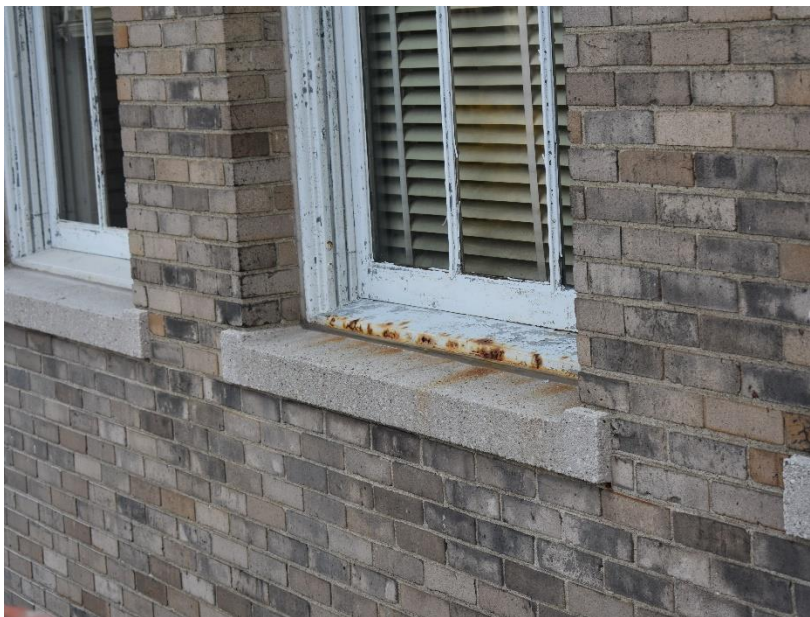
Figure 60. Corrosion through a steel window sill.

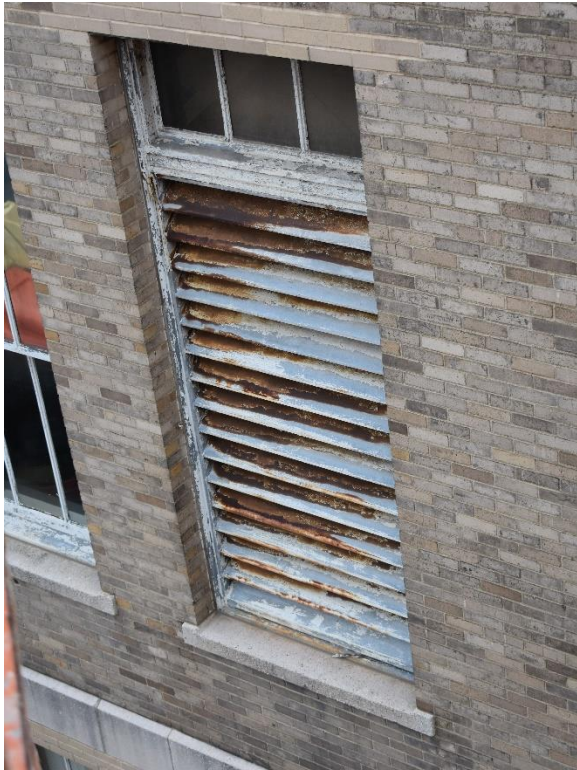
Figure 61. Corrosion at steel louver.

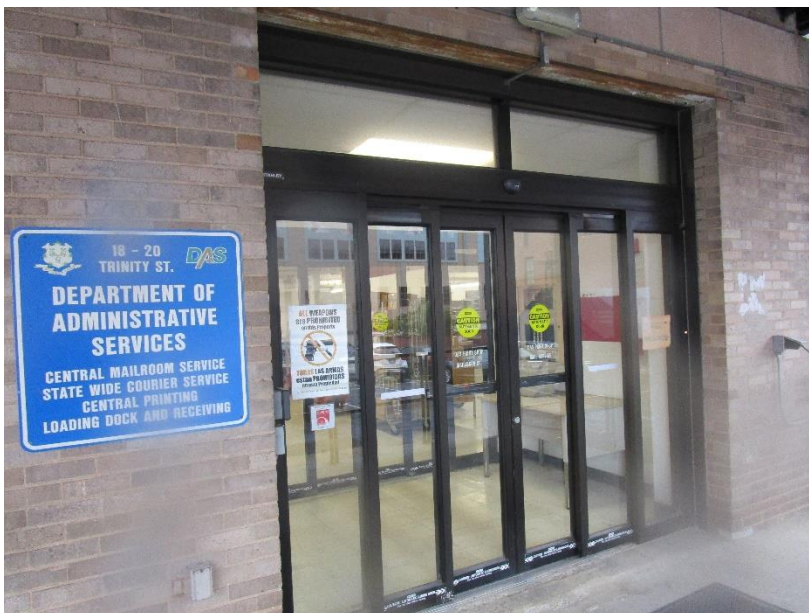
Figure 62. Sliding aluminum/glass doors at loading dock.

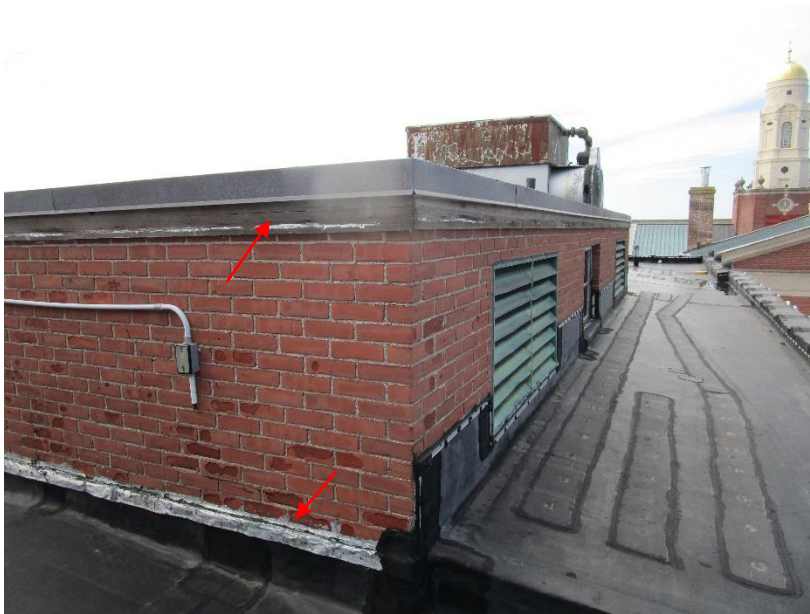
Figure 64. Patches at roof membrane. Also note deteriorated sealant in the joint above the counter flashing and exposed wood nailer below the roof edge.

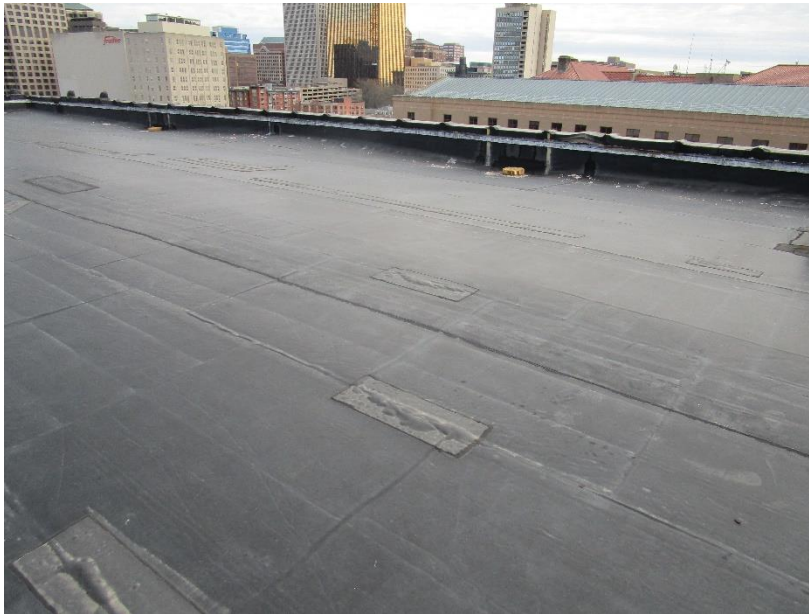
Figure 65. Blisters under roof patches at 18 Trinity Street.

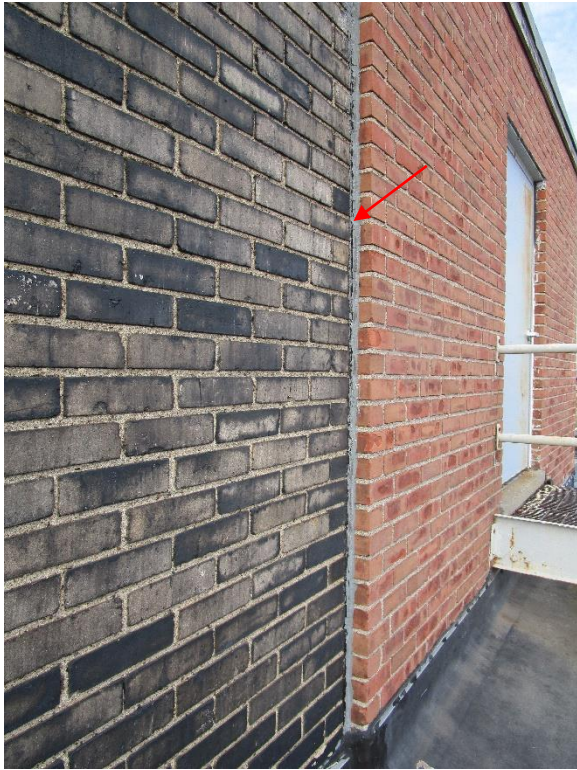
Figure 69. Adhesive sealant failure at vertical joint between chimney and penthouse. Also note faded paint and surface rust on stair and door to penthouse.

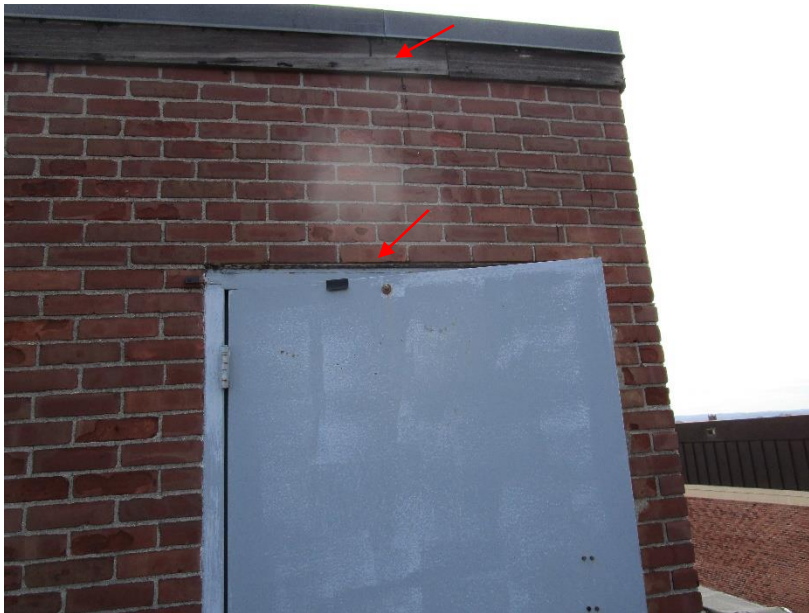
Figure 70. Corrosion at steel lintel at top of door opening and exposed wood nailer below roof edge.

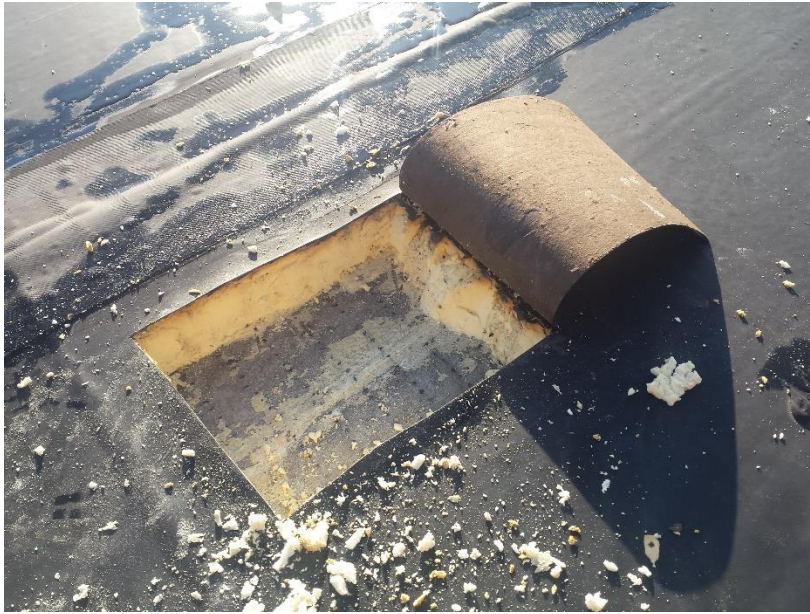
Figure 71. Roof probe at field of roof at 18 Trinity Street.

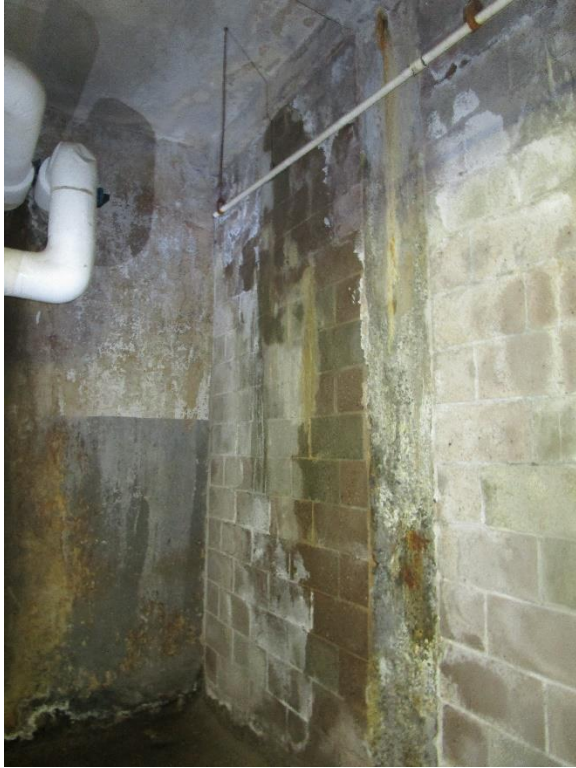
Figure 73. Leak into basement vault at 18 Trinity Street.

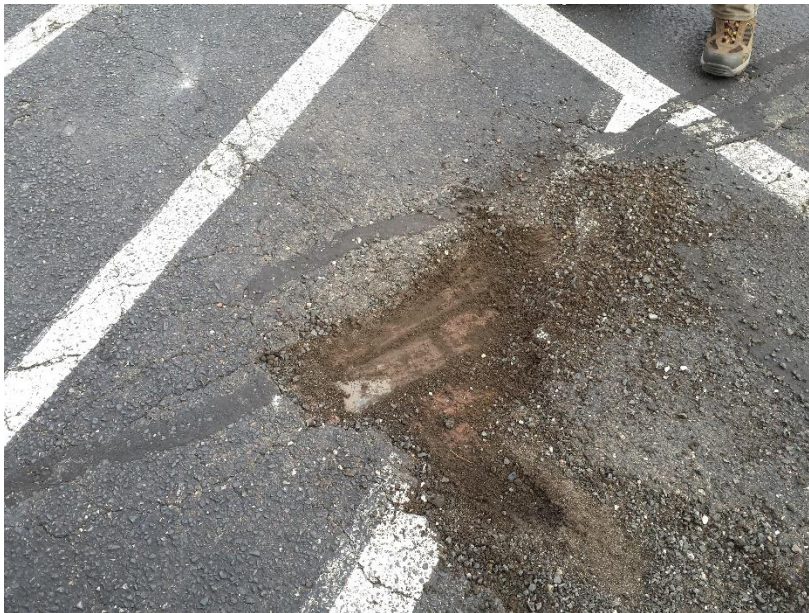
Figure 74. Driveway above vault at 18 Trinity Street.

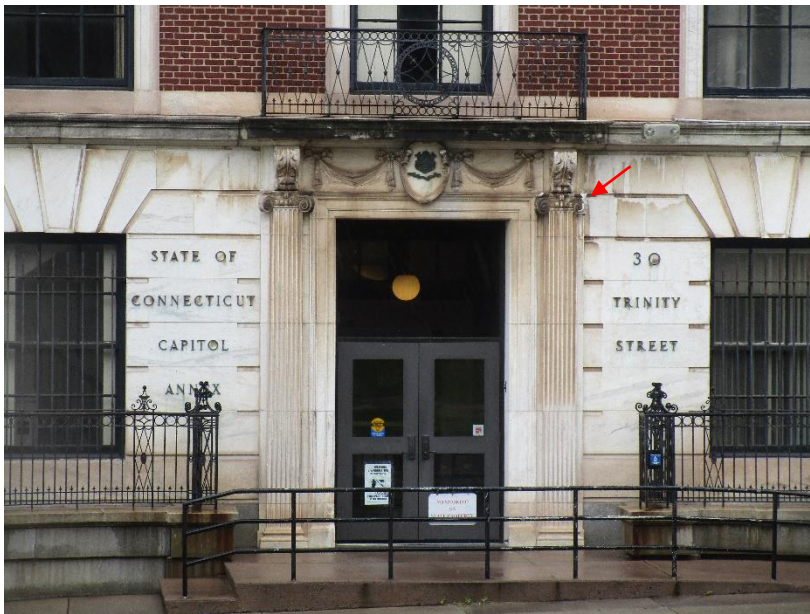
Figure 78. Soiling on marble at east elevation. Also note spall at column capital.

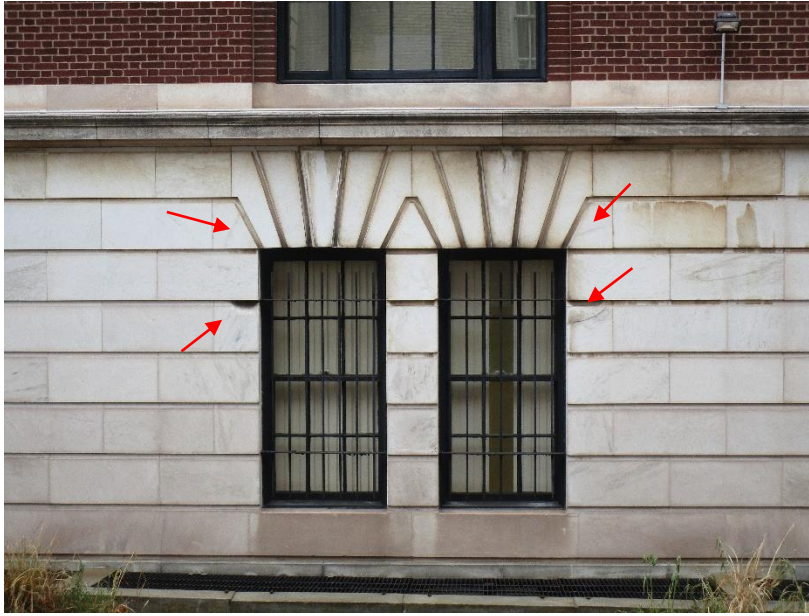
Figure 79. Spalls and cracks at marble where steel security grilles are set into the stone.

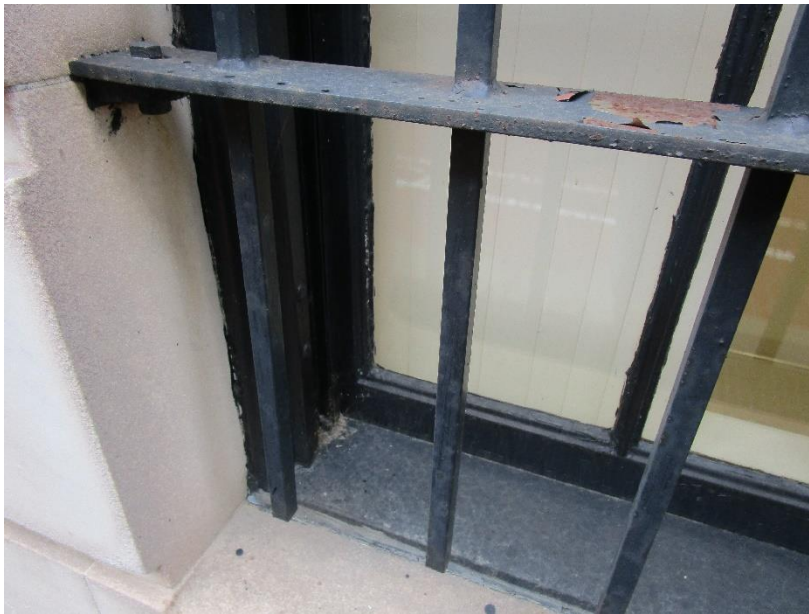
Figure 80. Peeling paint and surface rust at window security grille.

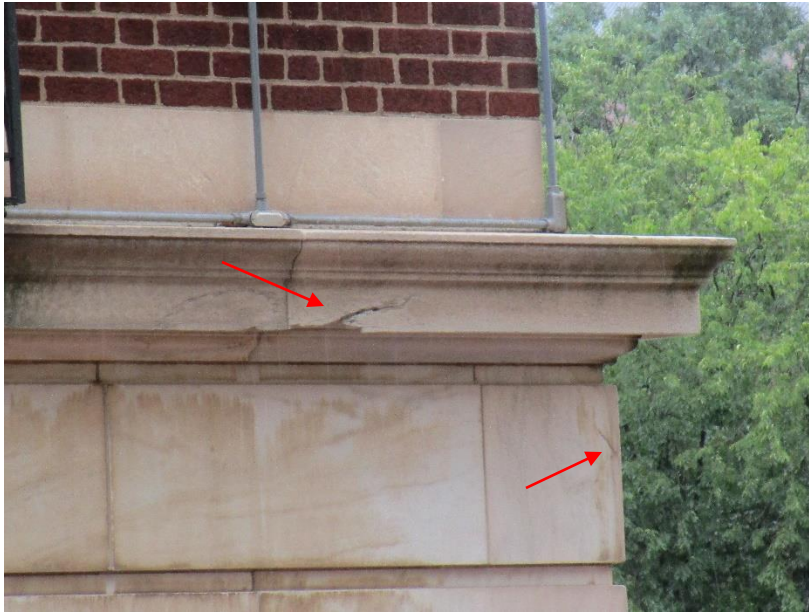
Figure 81. Spall at first floor cornice and cracked stone below cornice at the southeast corner of 30 Trinity Street.

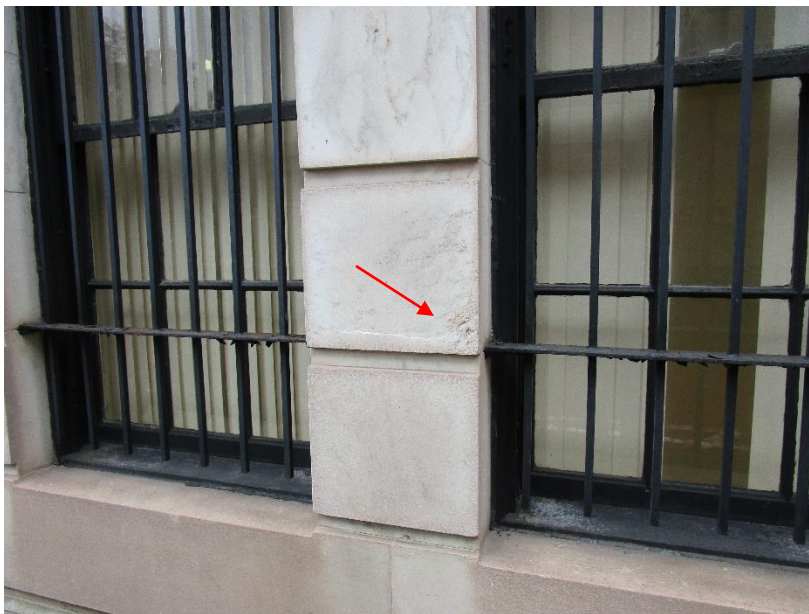
Figure 82. Surface erosion at marble unit.

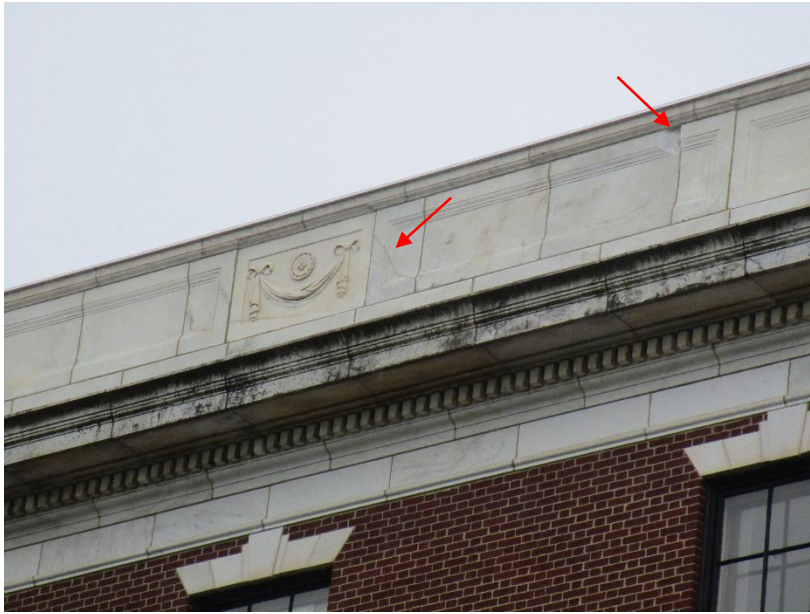
Figure 83. 30 Trinity - Spall and crack at north elevation roof parapet.

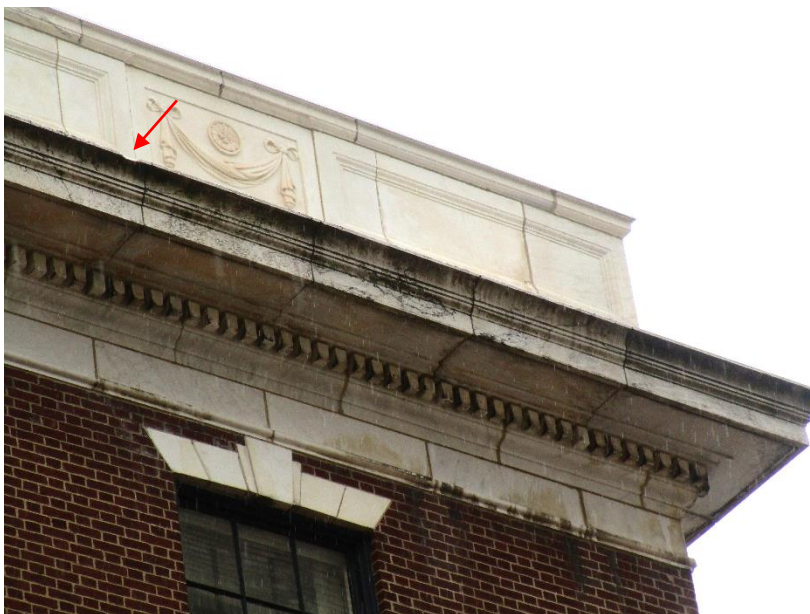
Figure 84. Spall at cornice.

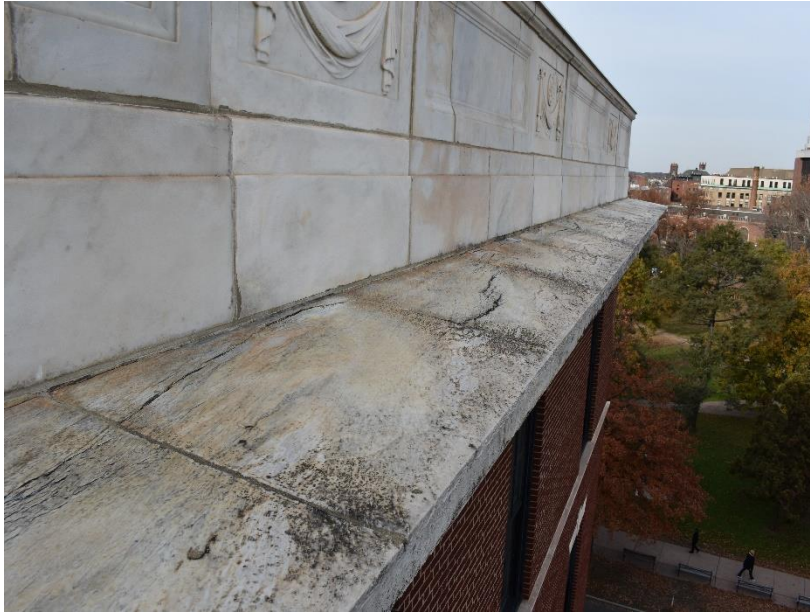
Figure 85. Cracks at upward facing surface of the parapet cornice.

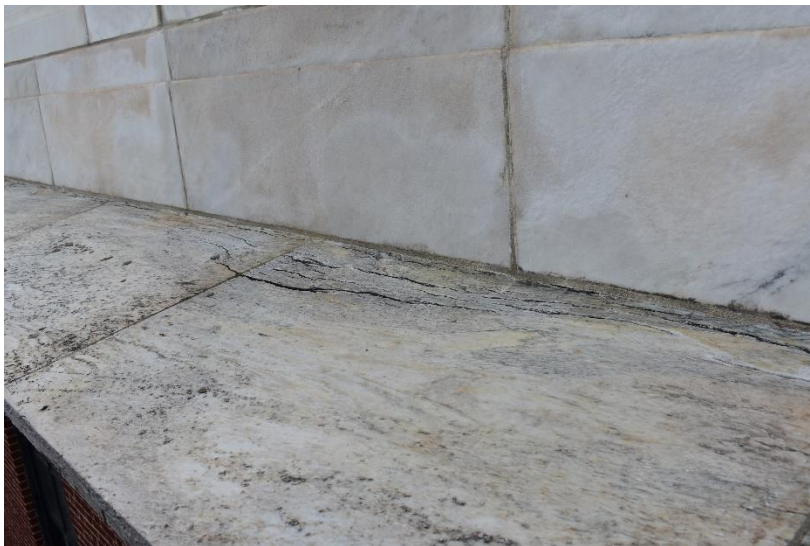
Figure 86. Cracks at upward facing surface of the parapet cornice.

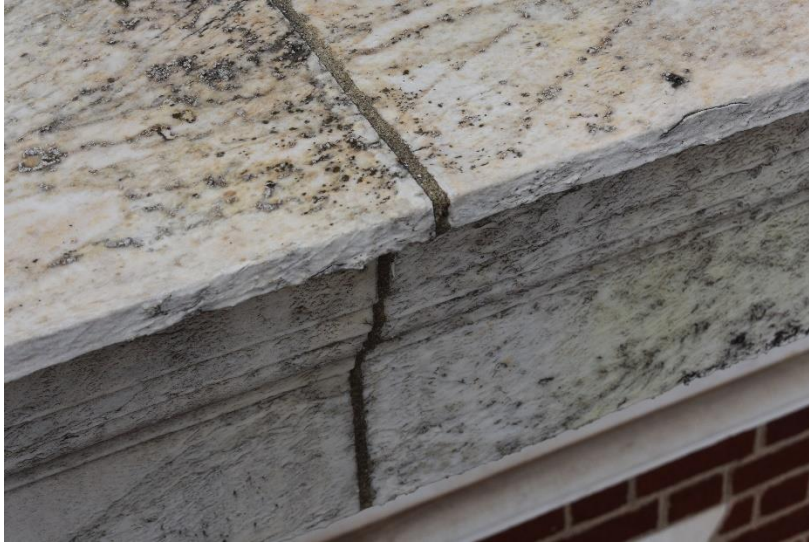
Figure 87. Stone crumbling at edge of cornice.

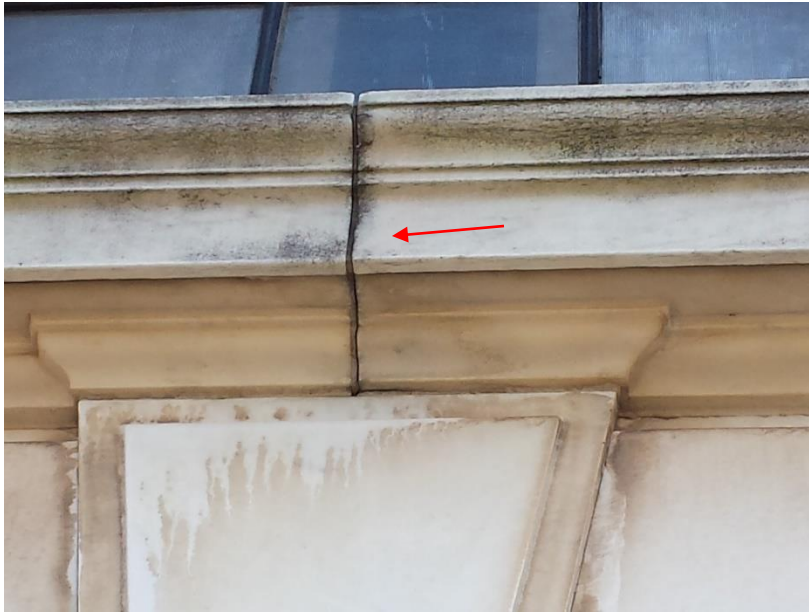
Figure 89. Loose mortar in marble cornice joint.

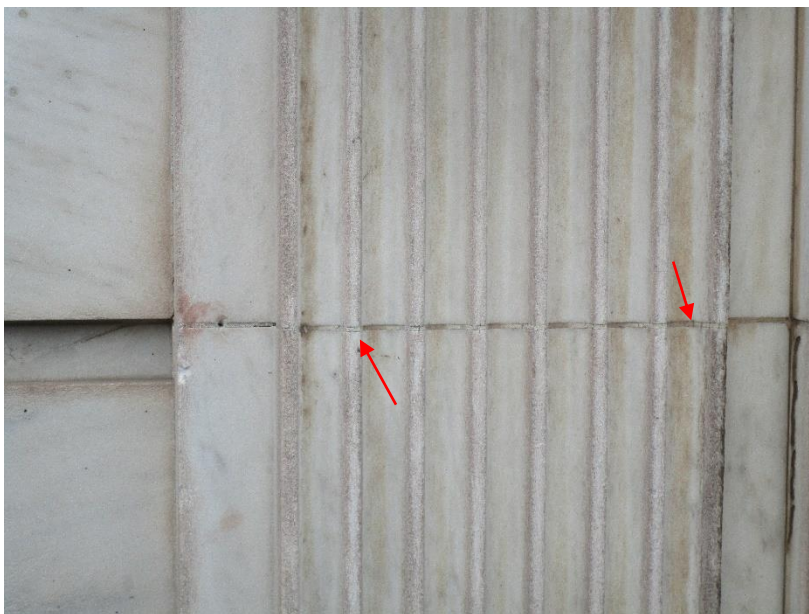
Figure 90. Cracked mortar and separation of the mortar at its interface with the marble.

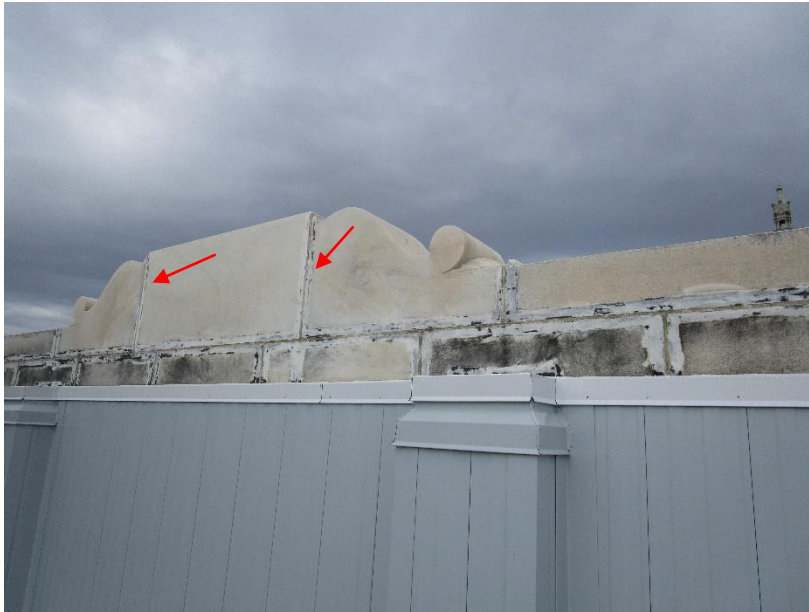
Figure 91. Adhesive sealant failure at joints between coping stones at the roof parapet.

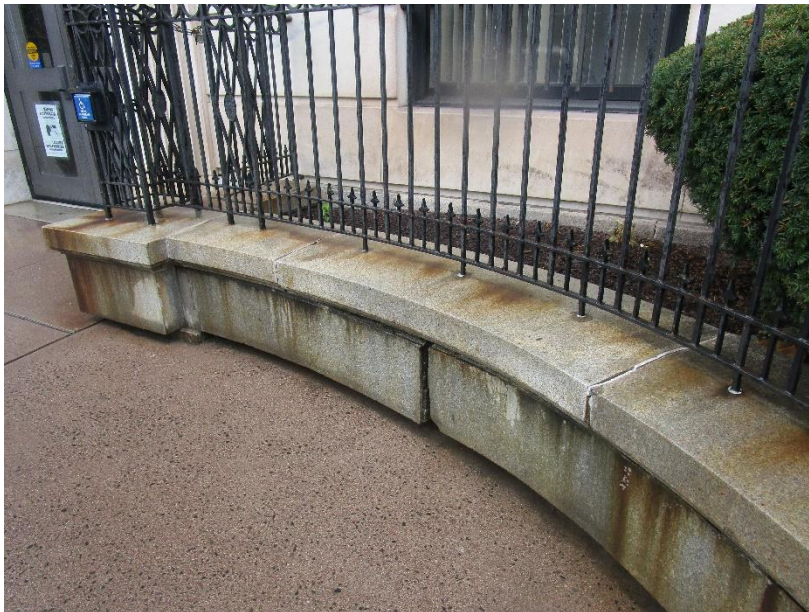
Figure 92. Stone displacement, spalls, mortar deterioration, rust staining, and joint sealant deterioration at retaining wall.

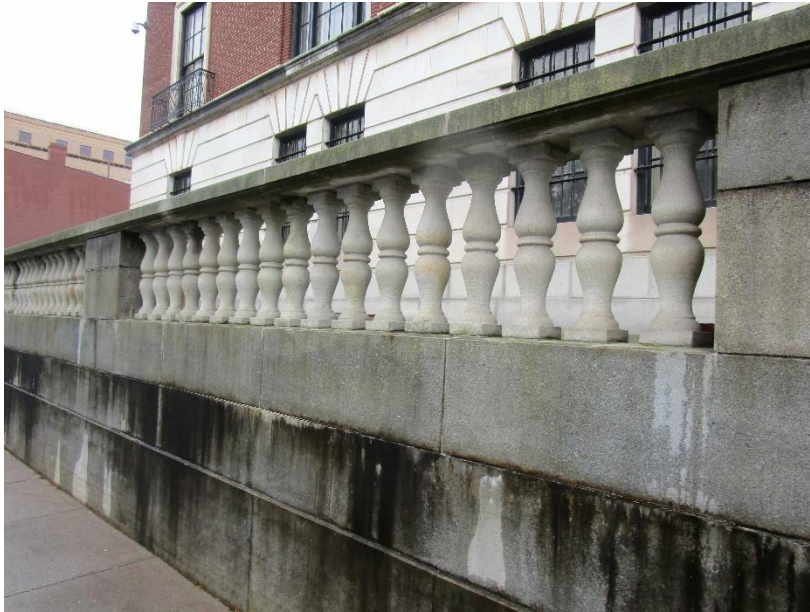
Figure 93. Organic soiling and mortar deterioration at north retaining wall.

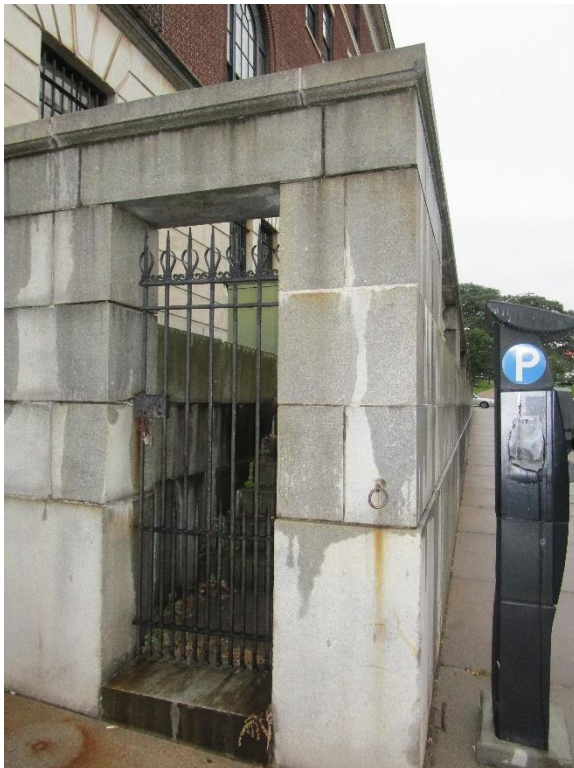
Figure 94. Mortar deterioration and rust stains at east retaining wall.

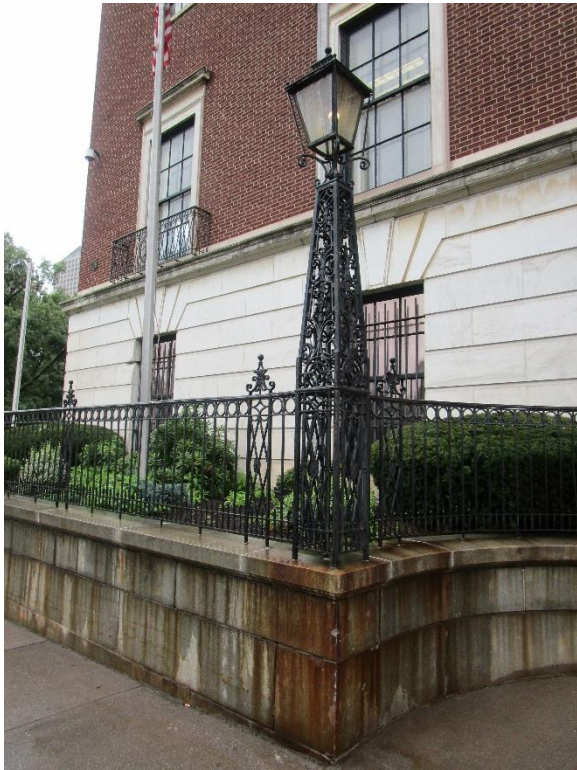
Figure 95. Peeling paint and surface rust on iron railing and light fixture causing rust stains on the stone retaining wall.

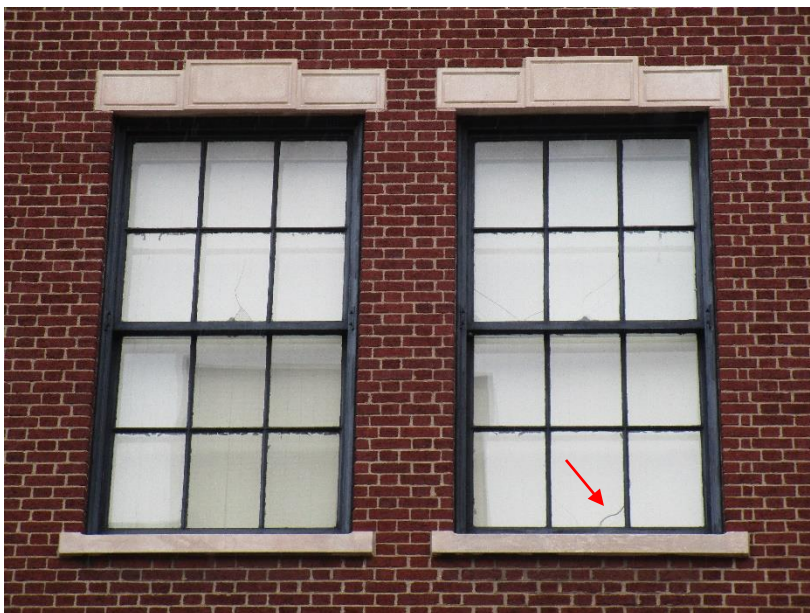
Figure 96. Faded paint finish at steel window and cracked glass at window panes.

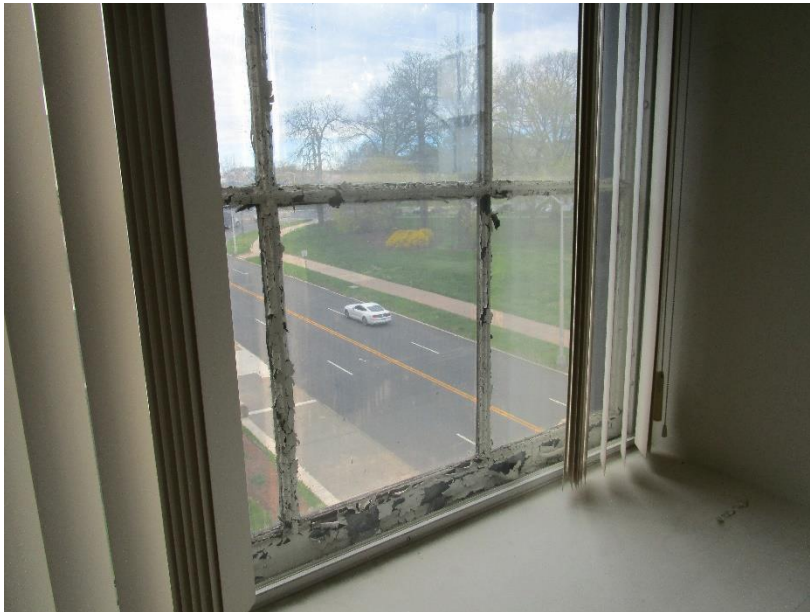
Figure 97. Peeling paint at interior surface of window.

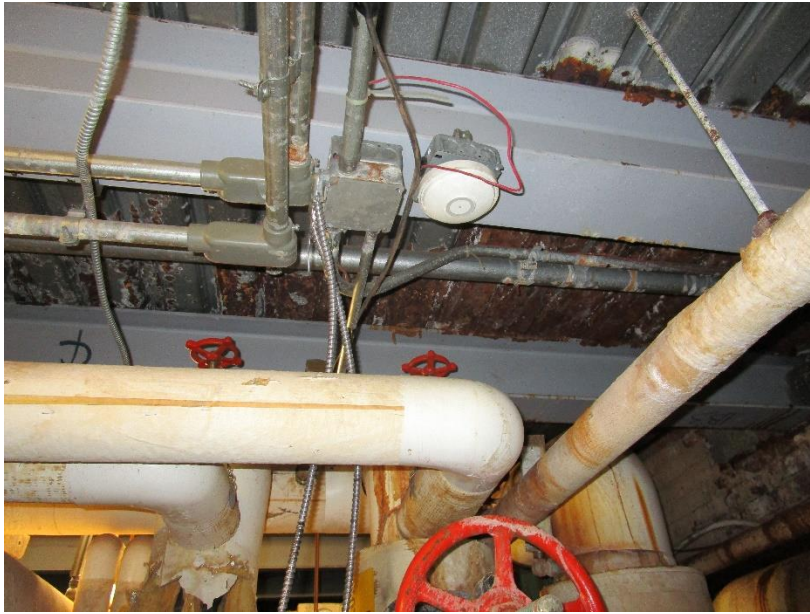
Figure 105. Corrosion at roof deck at vault at 30 Trinity Street.

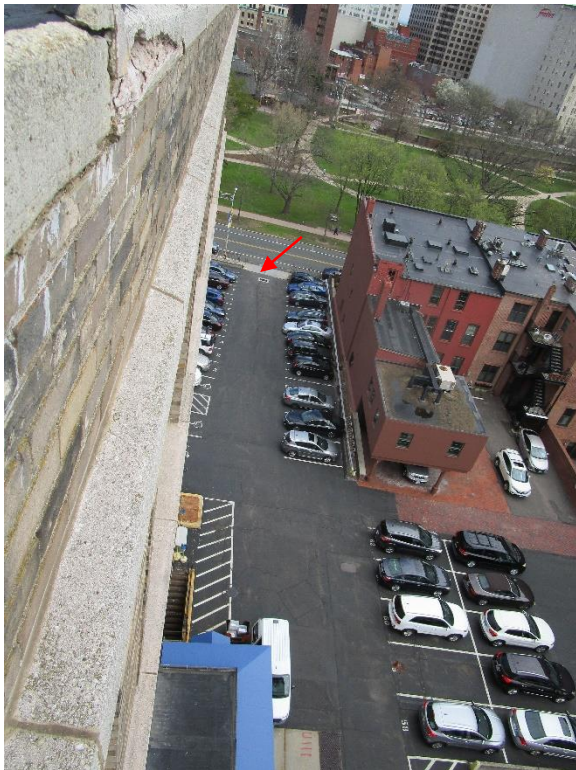
Figure 106. Parking lot. Note storm drain.

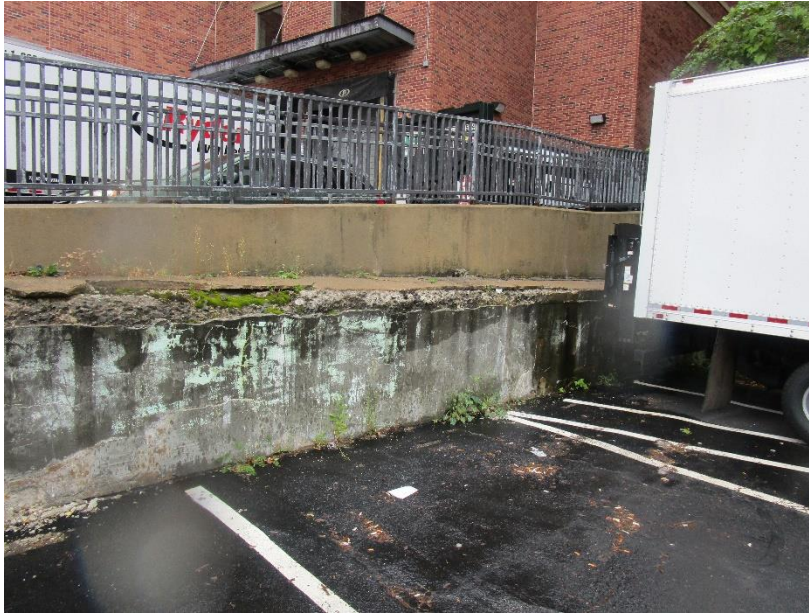
Figure 109. Concrete deterioration at parking lot retaining wall.

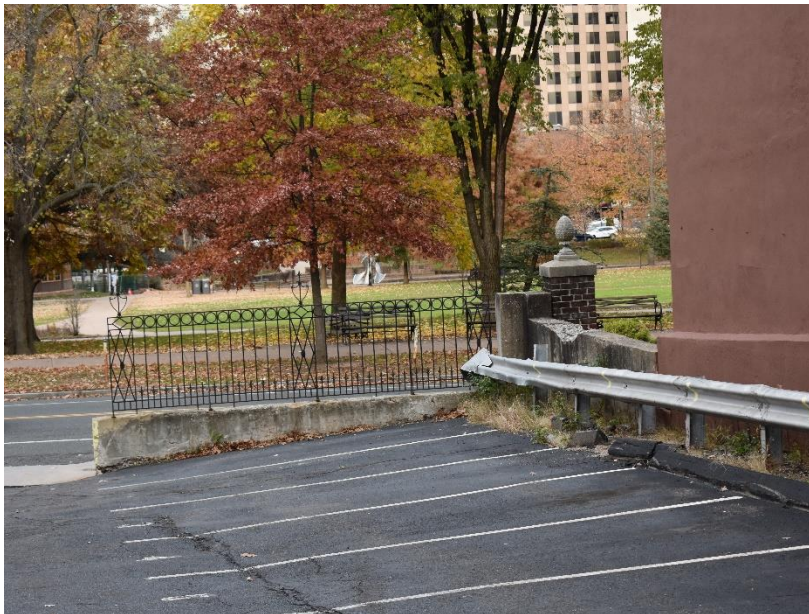
Figure 110. Concrete knee wall and iron fence facing Elm Street.

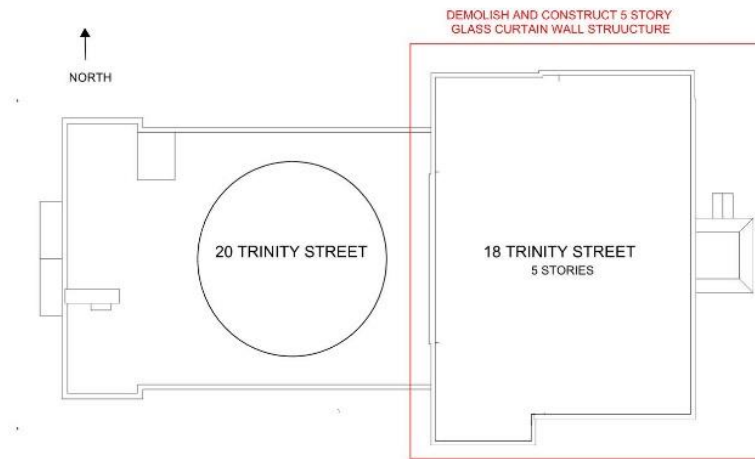
Figure 135. Plan of option to replace 18 Trinity Street.

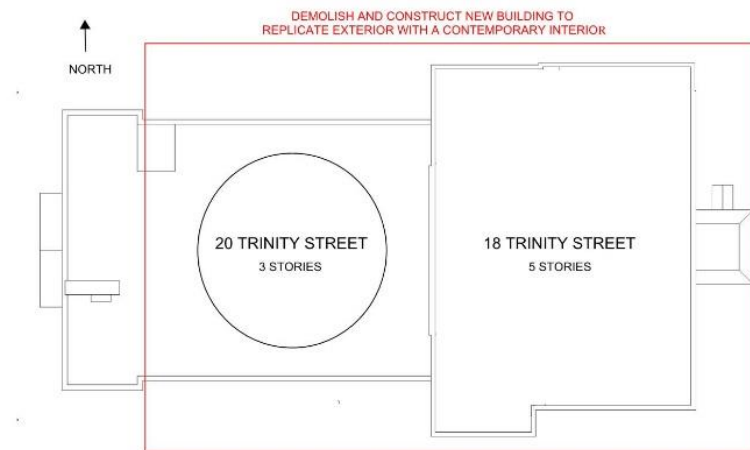
Figure 136. Plan of option to replace 18 Trinity Street and partially replace 20 Trinity Street.

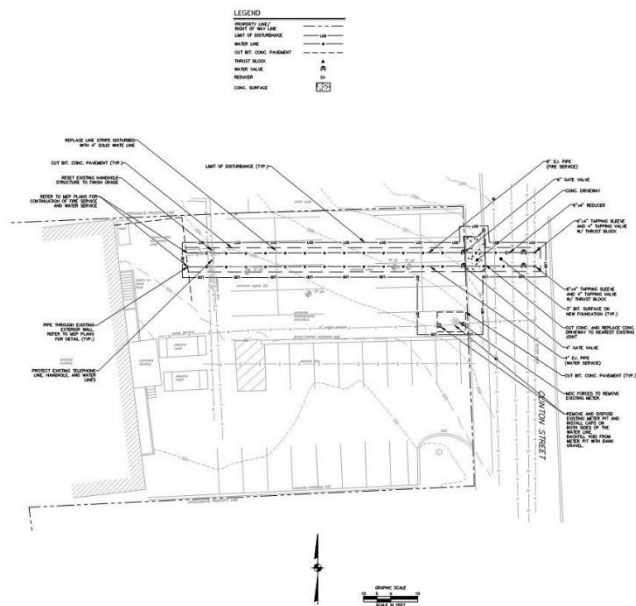
Figure 137. Replace main water line and fire service line to 18/20 Trinity Street from Clinton Avenue. Design by Freeman Companies LLC.

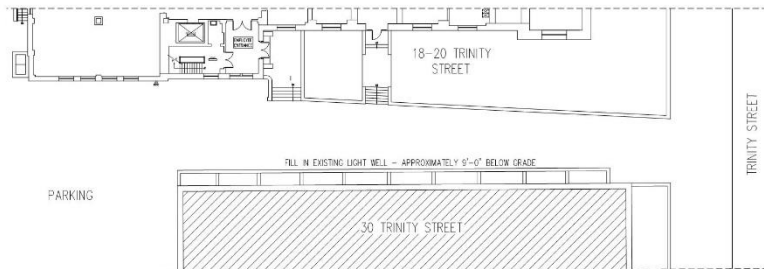
Figure 138. 30 Trinity Street light well infill.

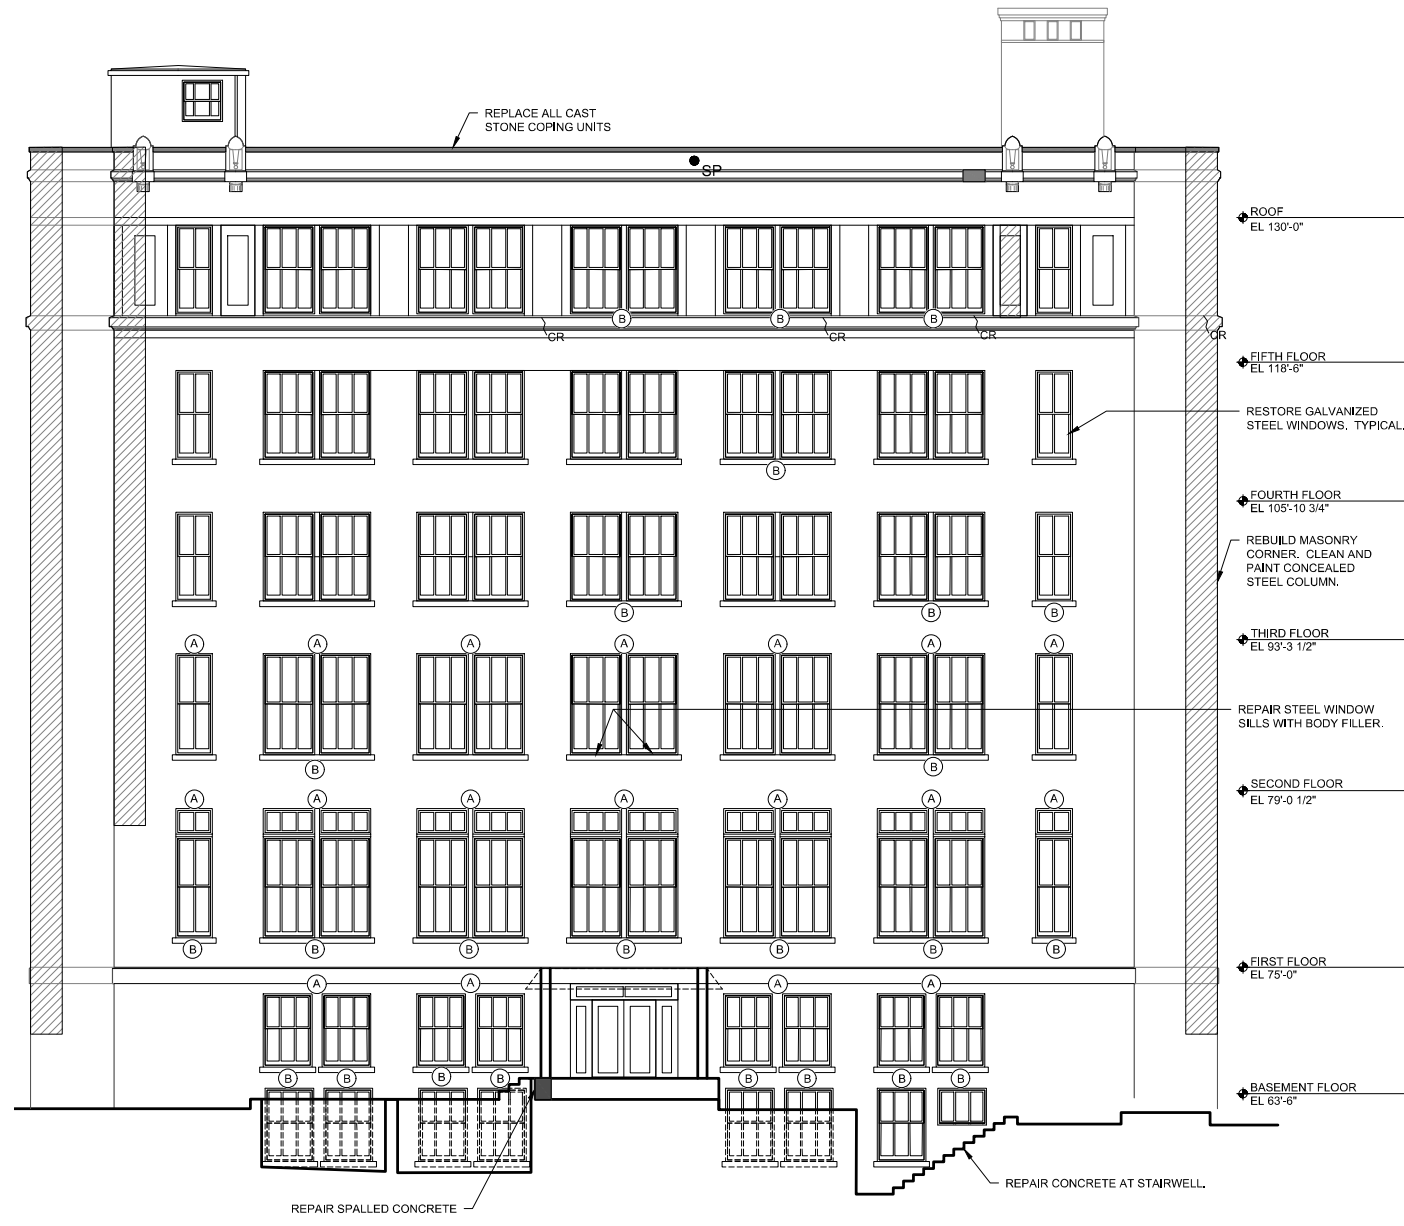
1 18 TRINITY STREET - EAST ELEVATION
SCALE: 1/8" = 1'-0"
