18/20 AND 30 TRINITY STREET
Pre-Design Study
Project: BI-2B-445

18/20 and 30 Trinity Street
Hartford, CT 06106

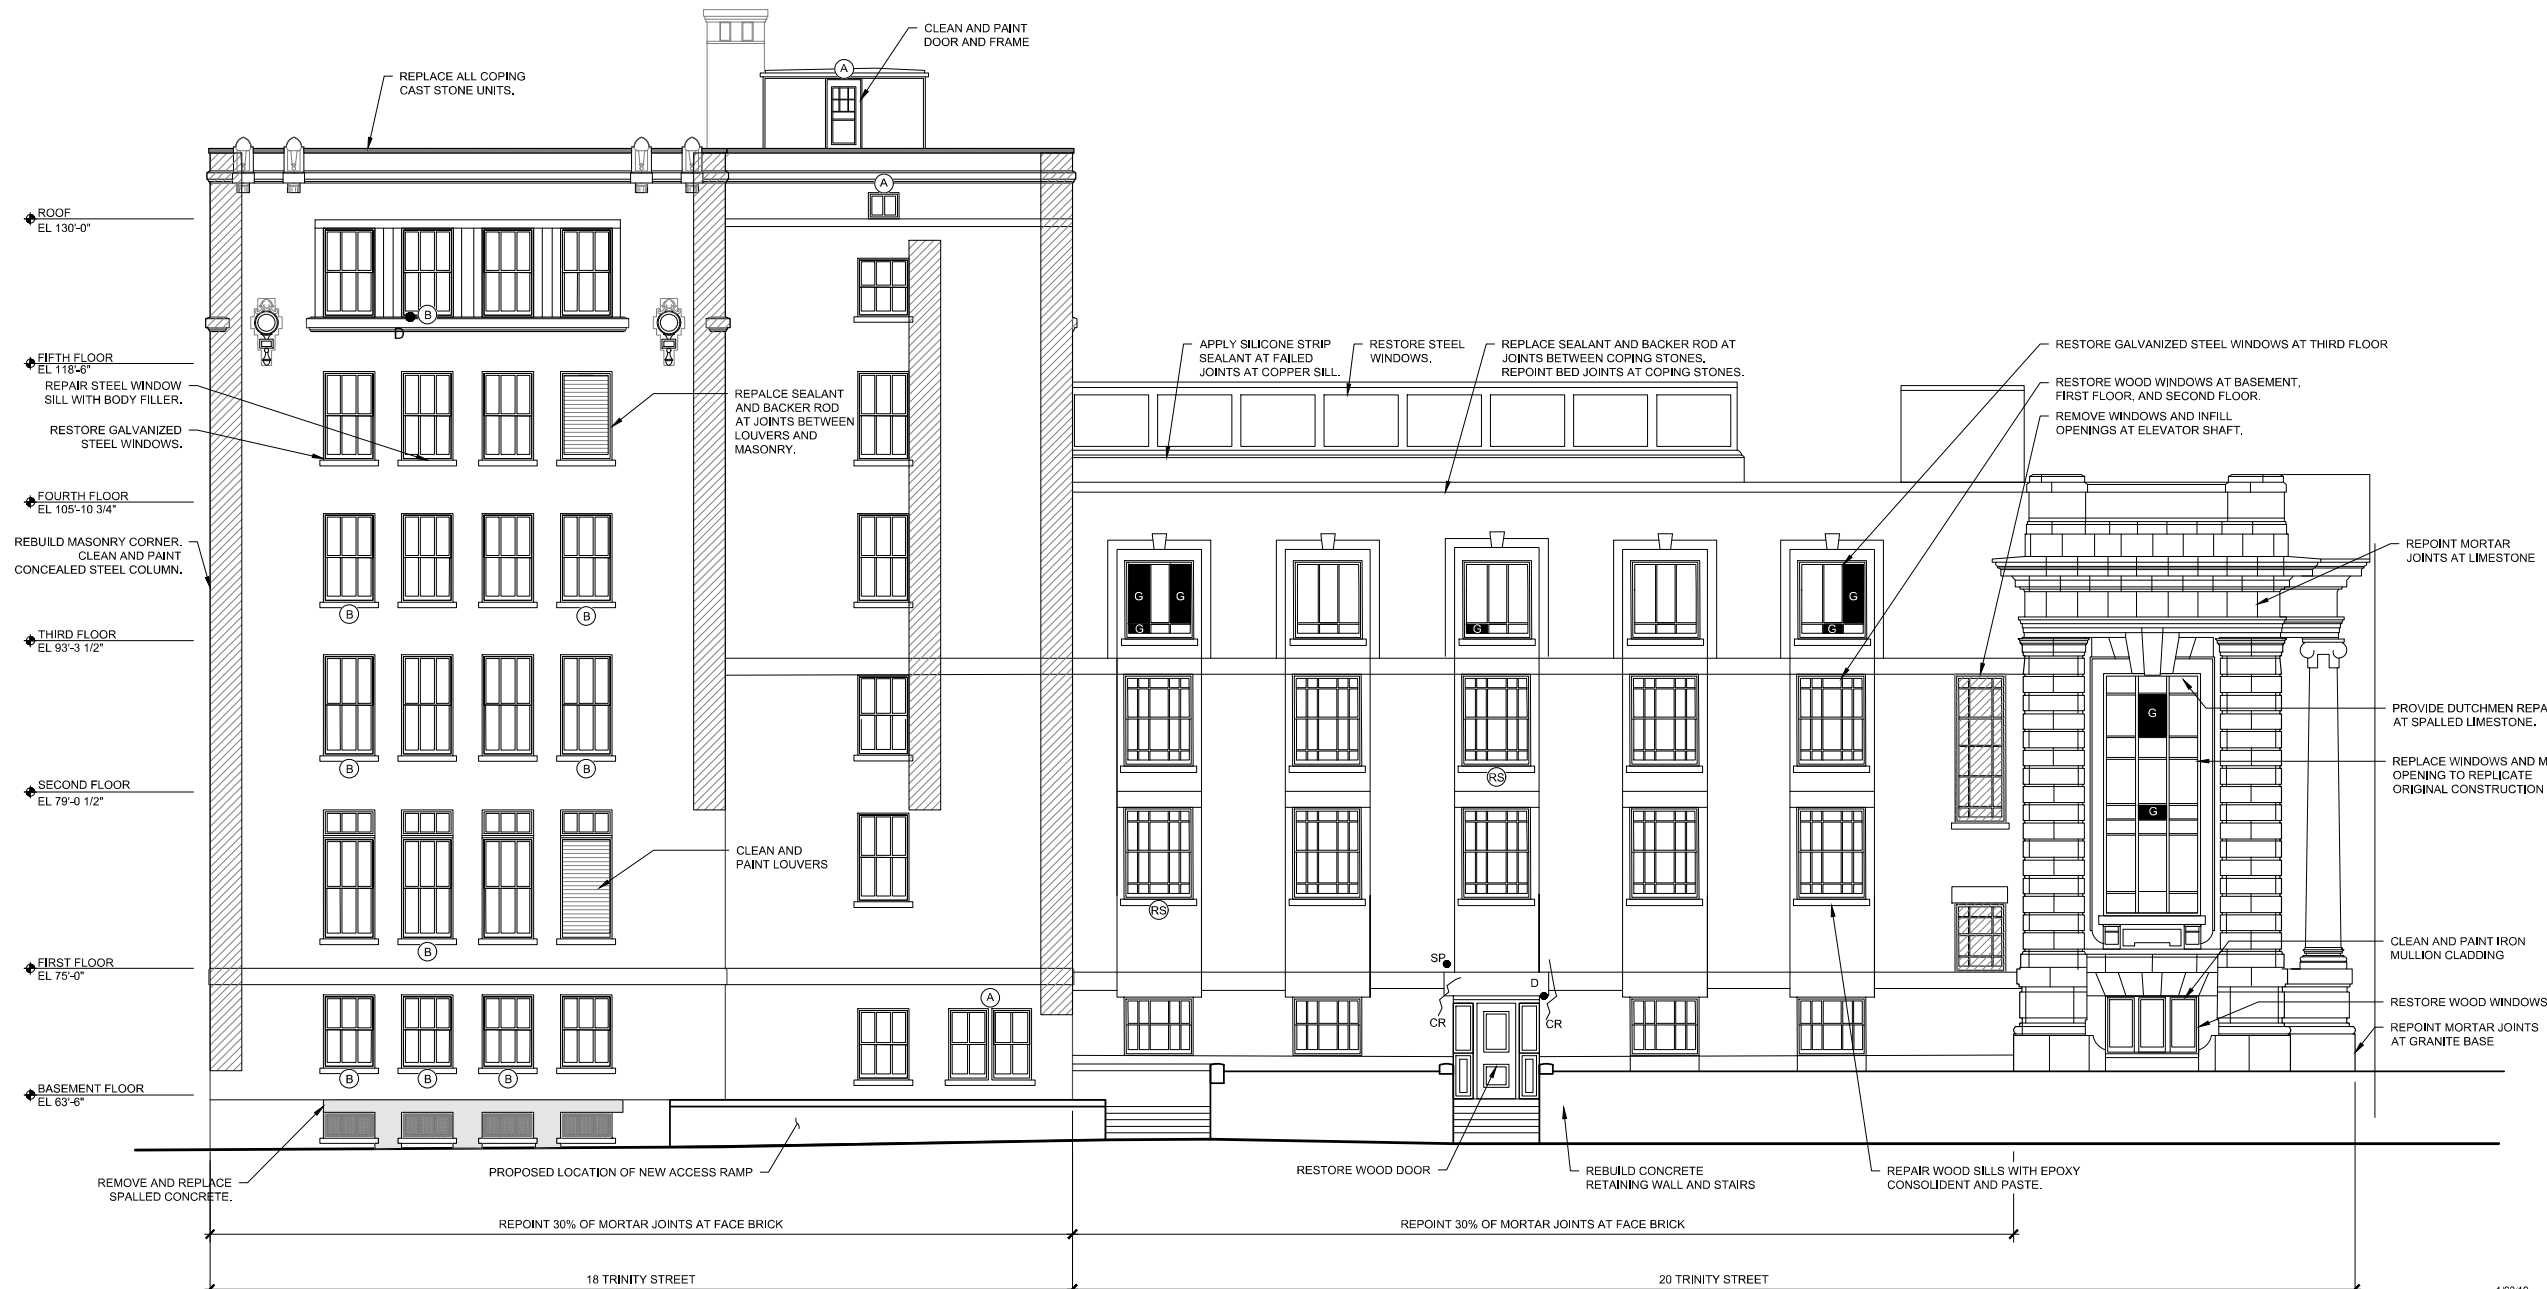
1 18-20 TRINITY - NORTH ELEVATION
SCALE: 1/8" = 1'-0"

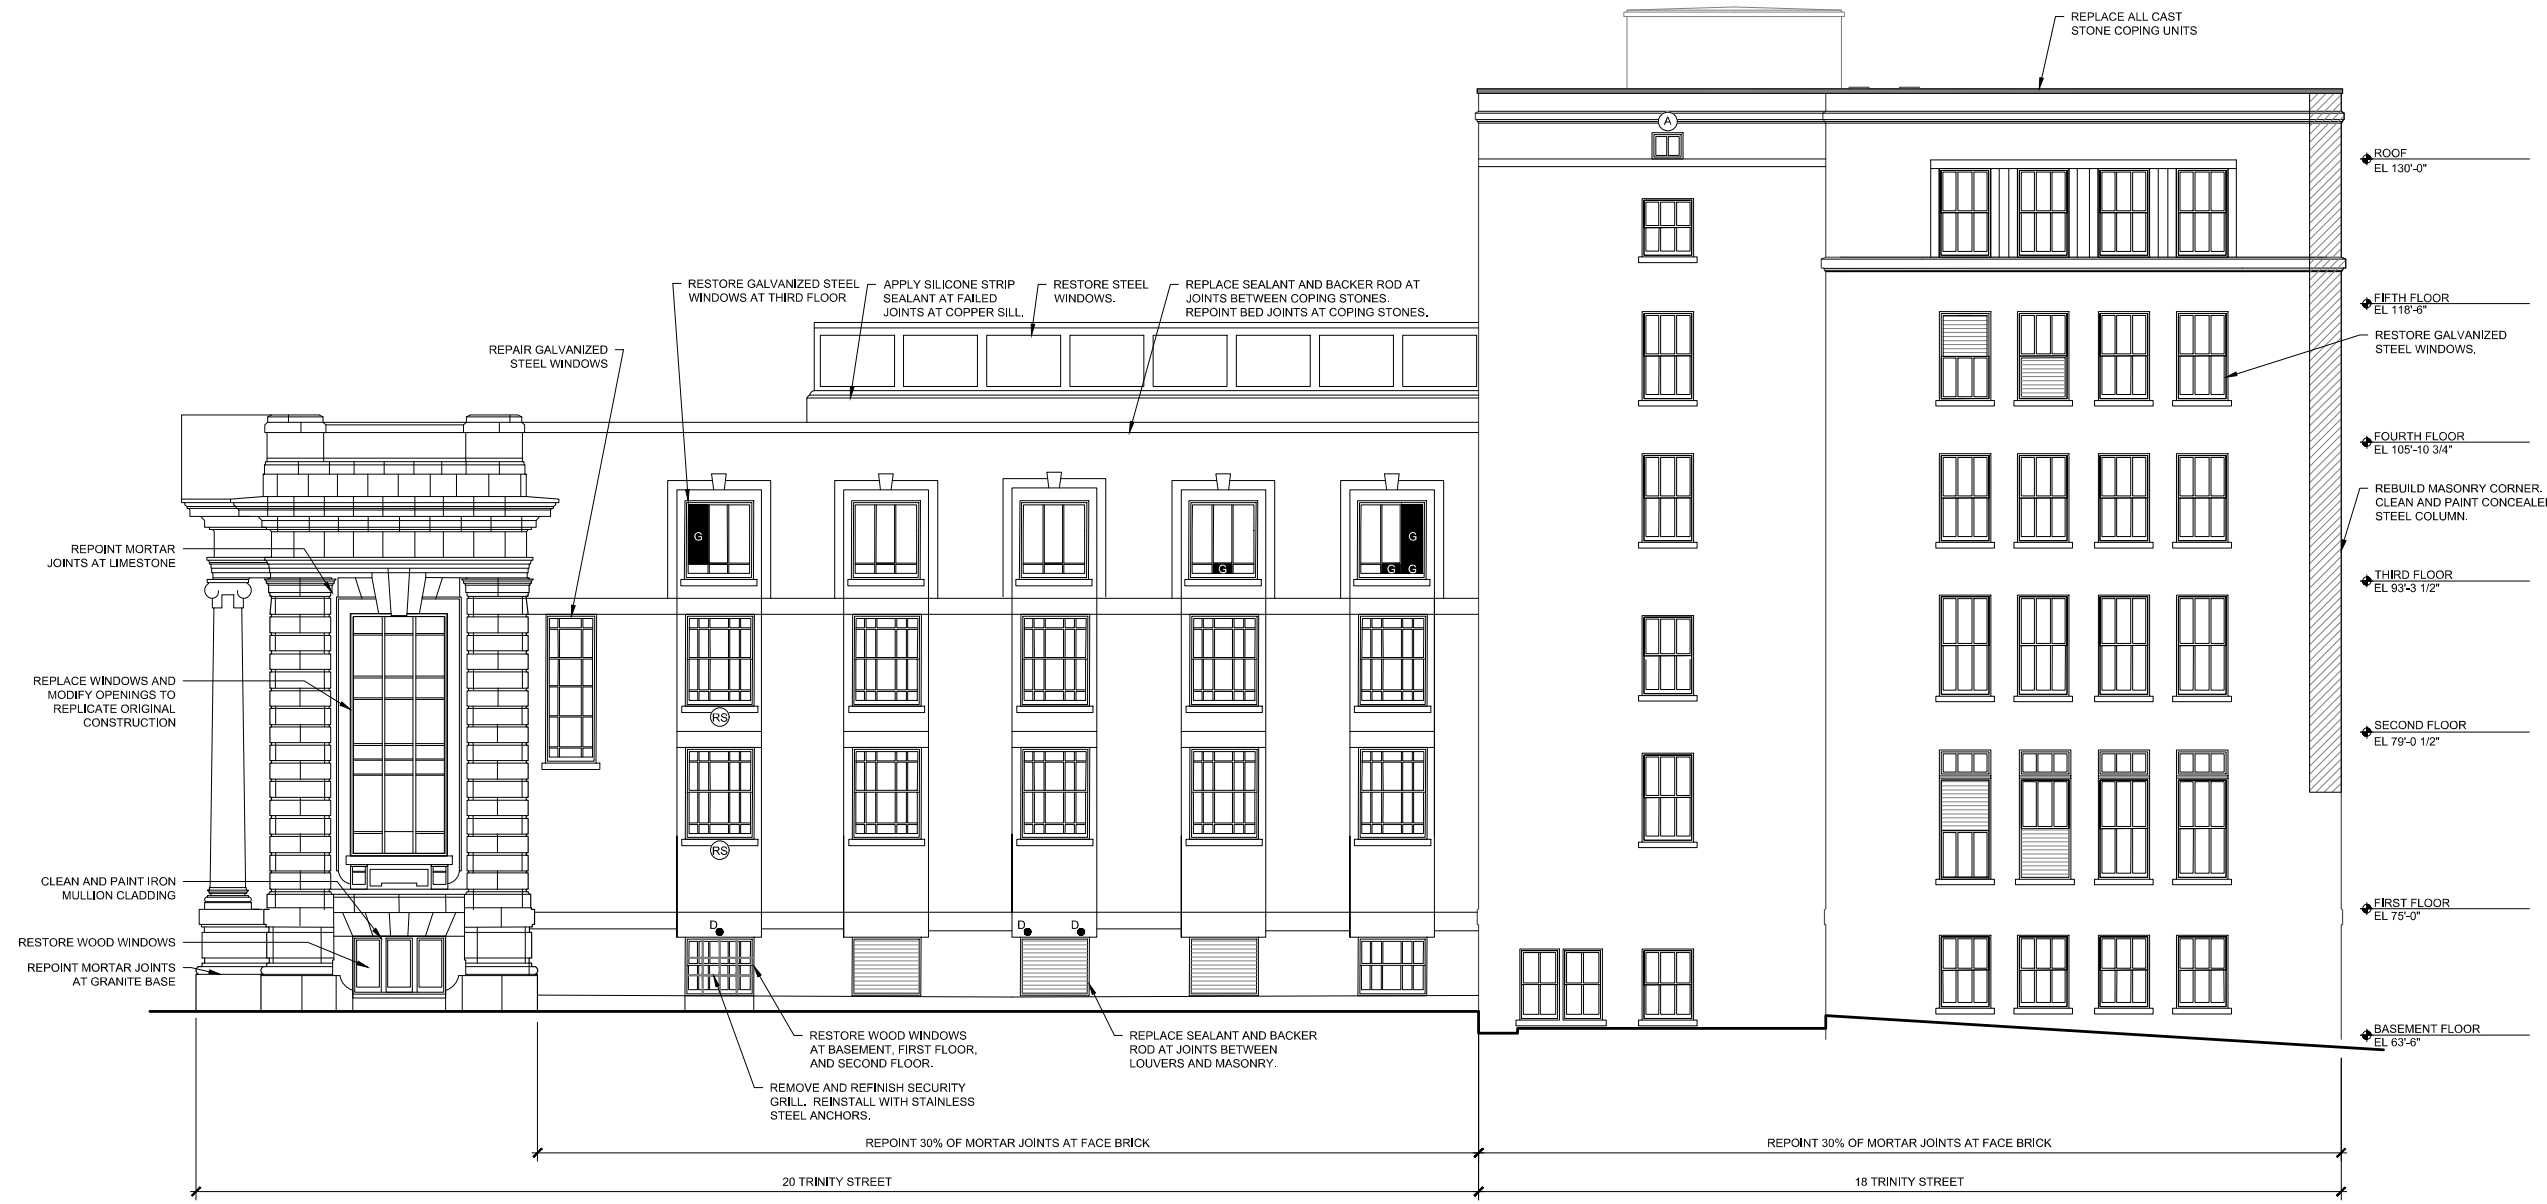
1 18-20 TRINITY - SOUTH ELEVATION
SCALE: 1/8" = 1'-0"

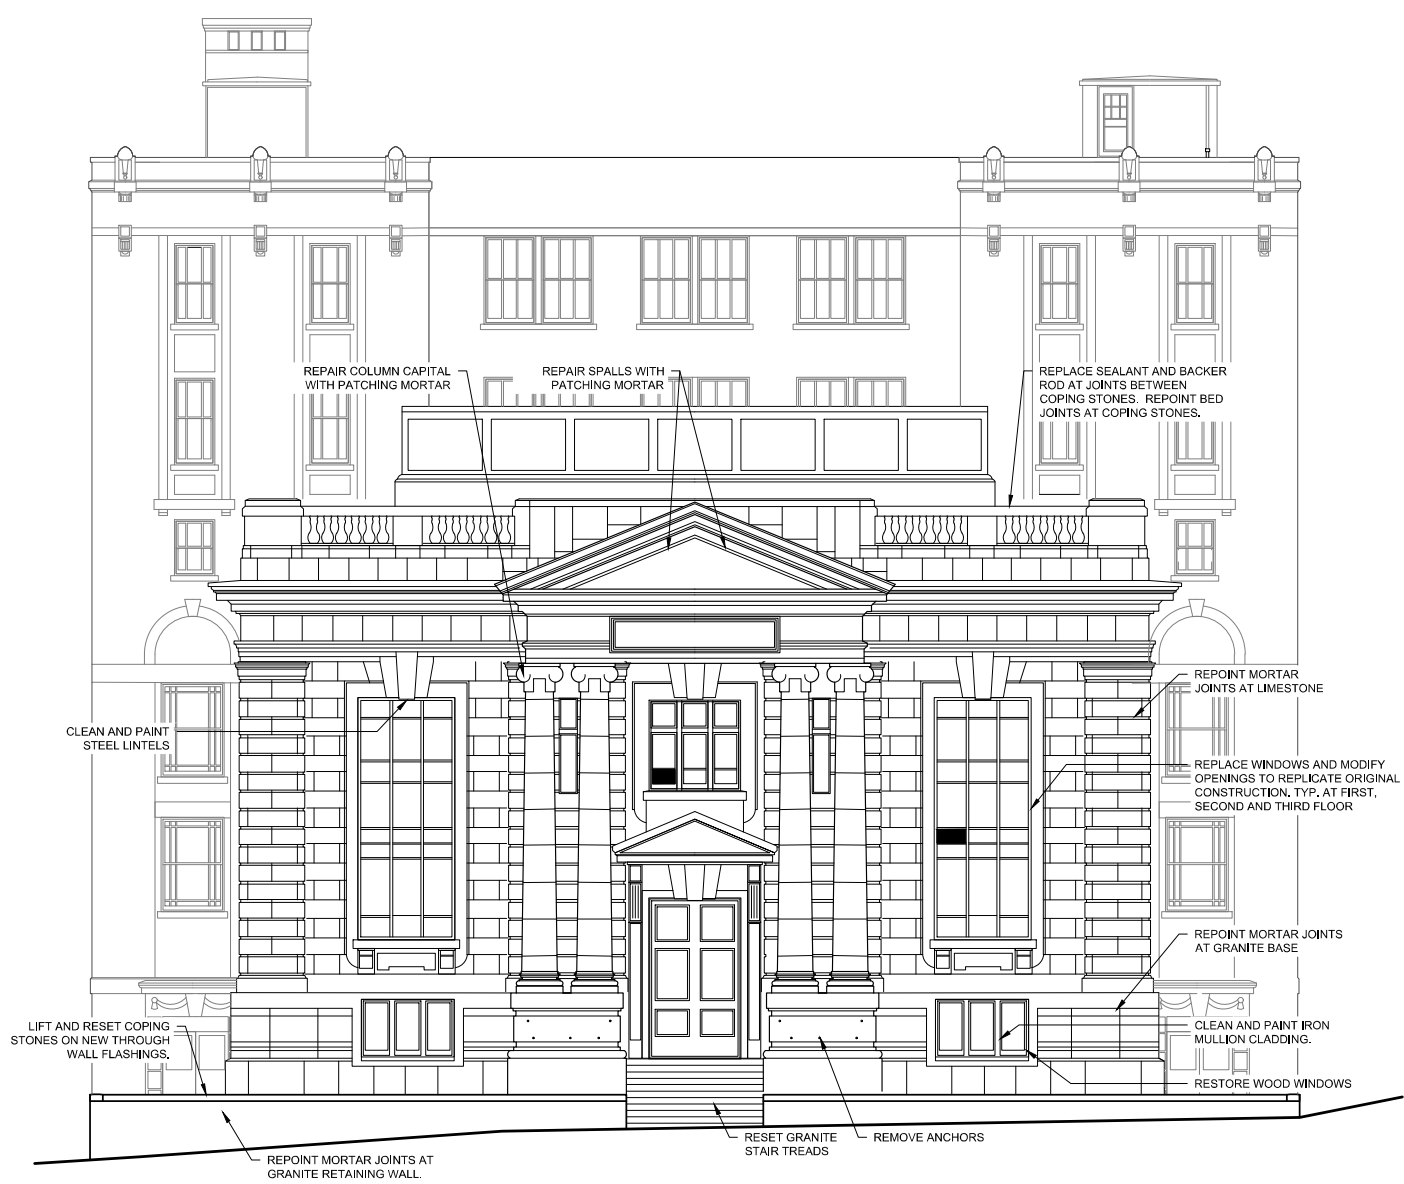
1 20 TRINITY STREET - WEST ELEVATION
SCALE: 1/8" = 1'-0"

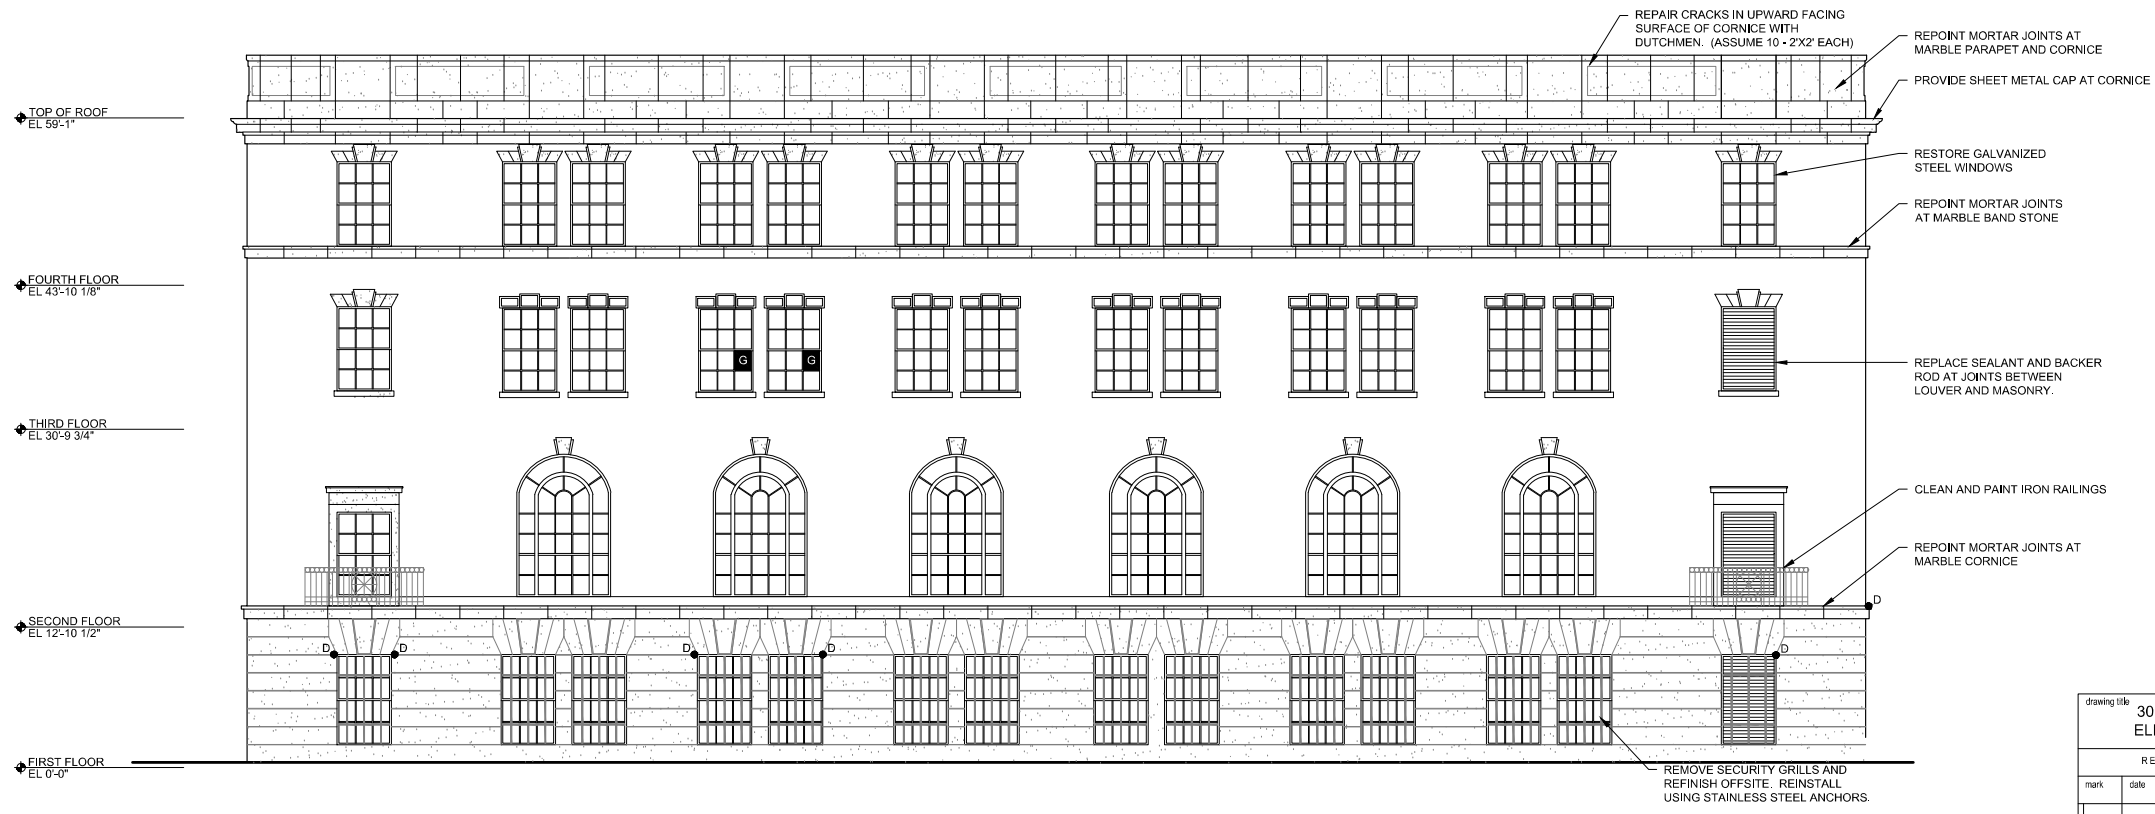
2 30 TRINITY STREET - SOUTH ELEVATION
SCALE: 1/8" = 1'-0"

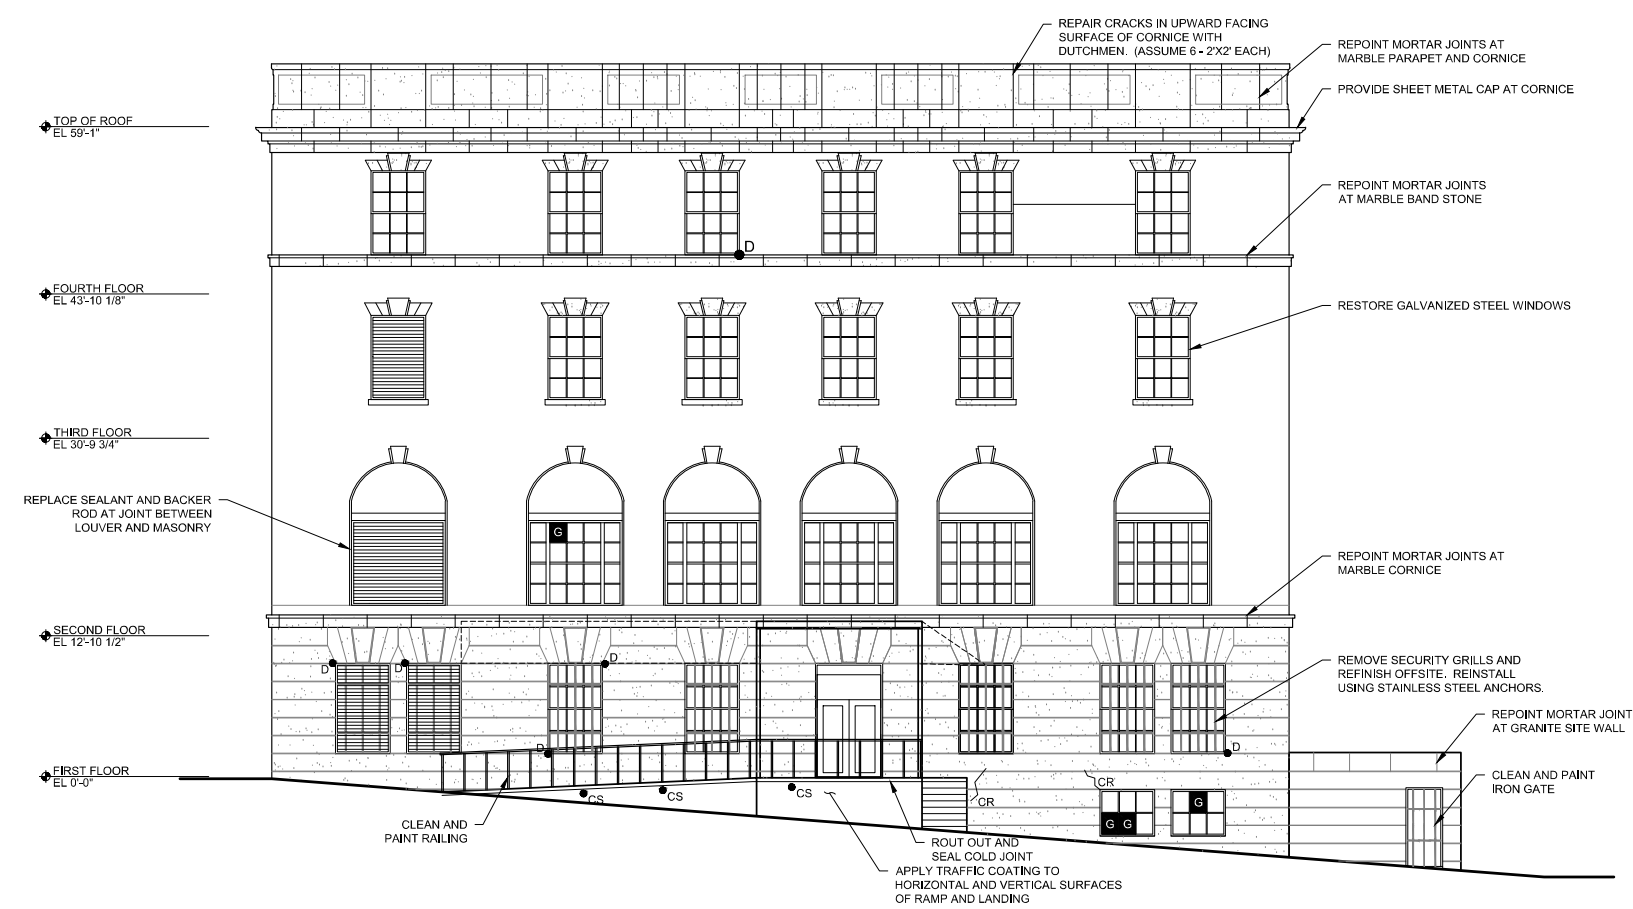
1 30 TRINITY STREET - EAST ELEVATION
SCALE: 1/8" = 1'-0"

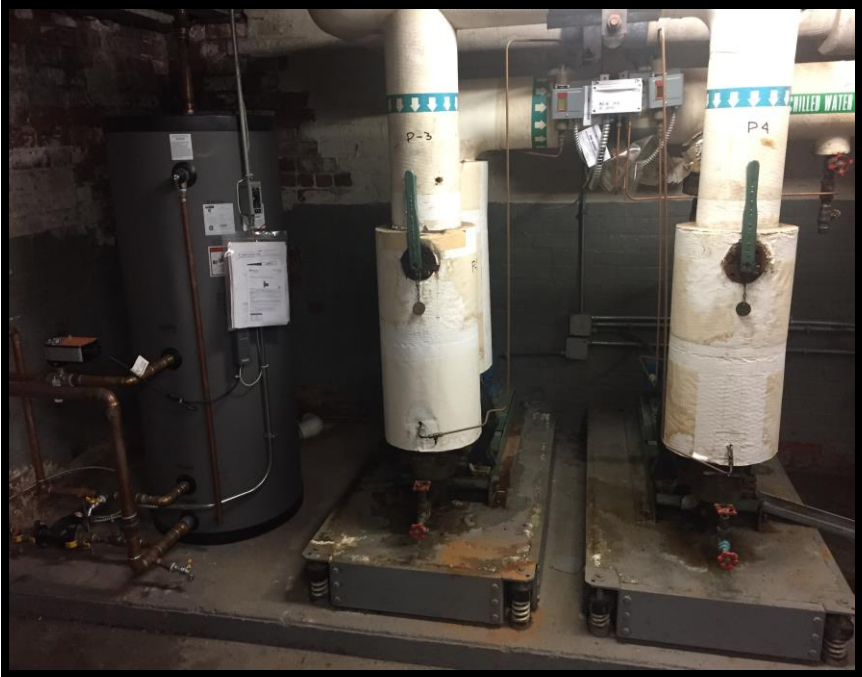
Exhibit "M1"
Recently Replaced Water Heater

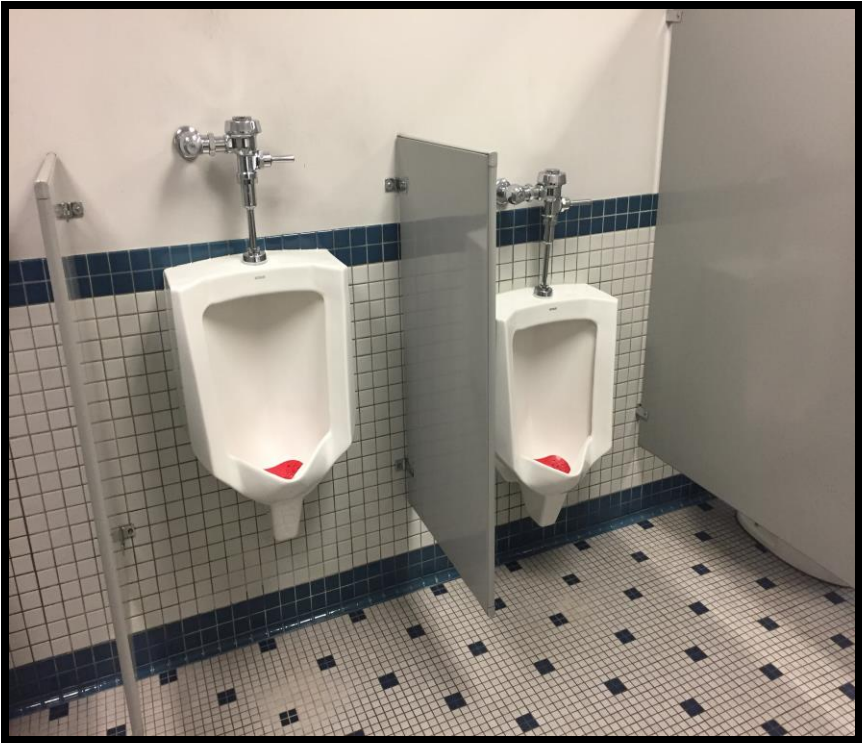
Exhibit "M2"
Toilet Plumbing Fixtures
