Southbury Training Farm Various Buildings - Adaptive Reuse Study

Project No. BI-2B-444

January 16, 2019

O’Riordan Migani Architects LLC, 22 Bank Street, Seymour, CT 06483

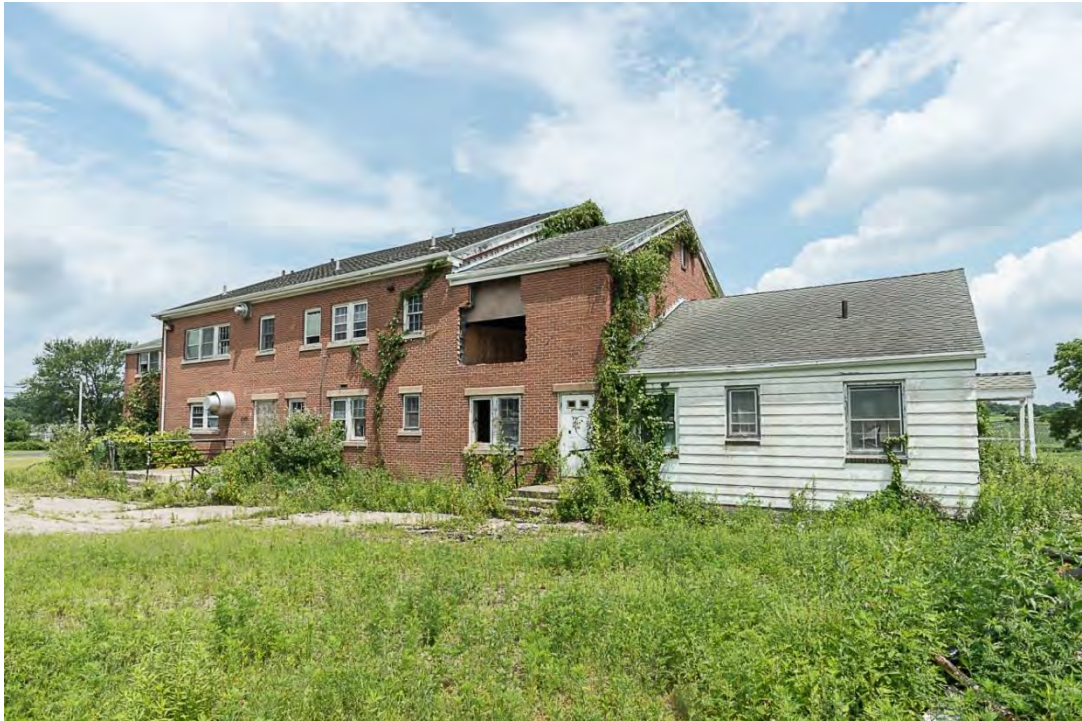
Photo 4. Building 1, view north showing south elevation with hole on second floor.

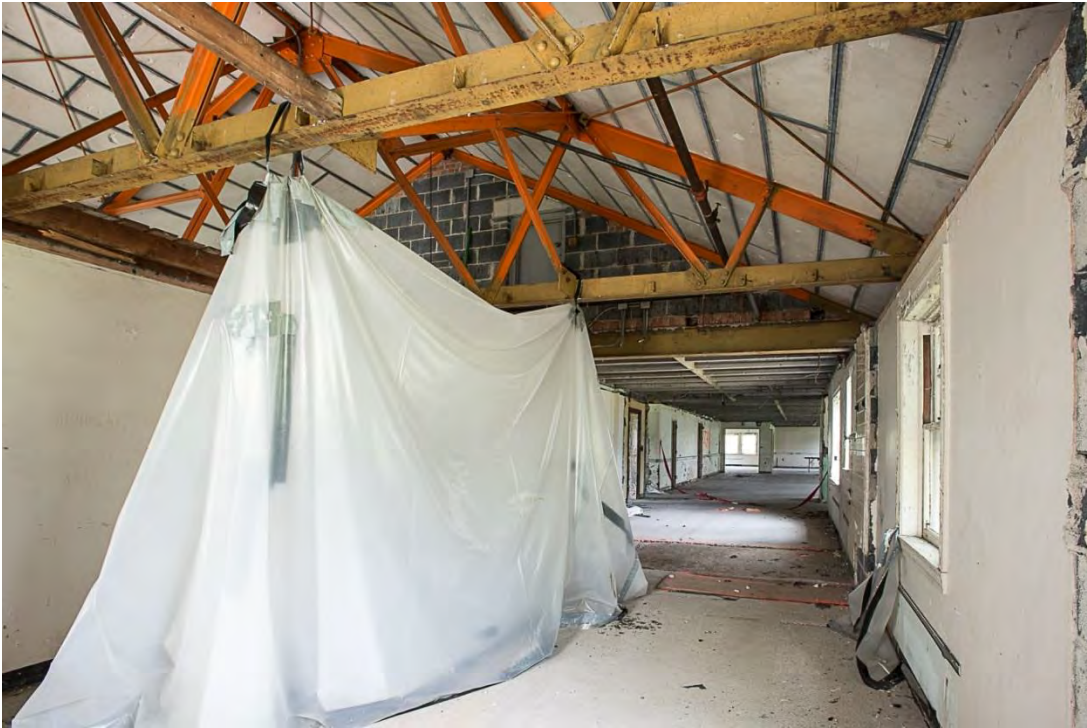
Little architectural integrity remains in the interior. It has been gutted during a remediation process which exposed the steel roof trusses and floor joists. Demising walls have been removed on both floors and only bearing walls remain. Some tile walls in former shower room and bathroom remain, but others were removed during remediation. Steel staircases at the east and west ends of the building remain. Demising walls in the basement have also been removed.

Photo 6. Building 1, first floor interior view northwest showing exposed trusses for east wing.

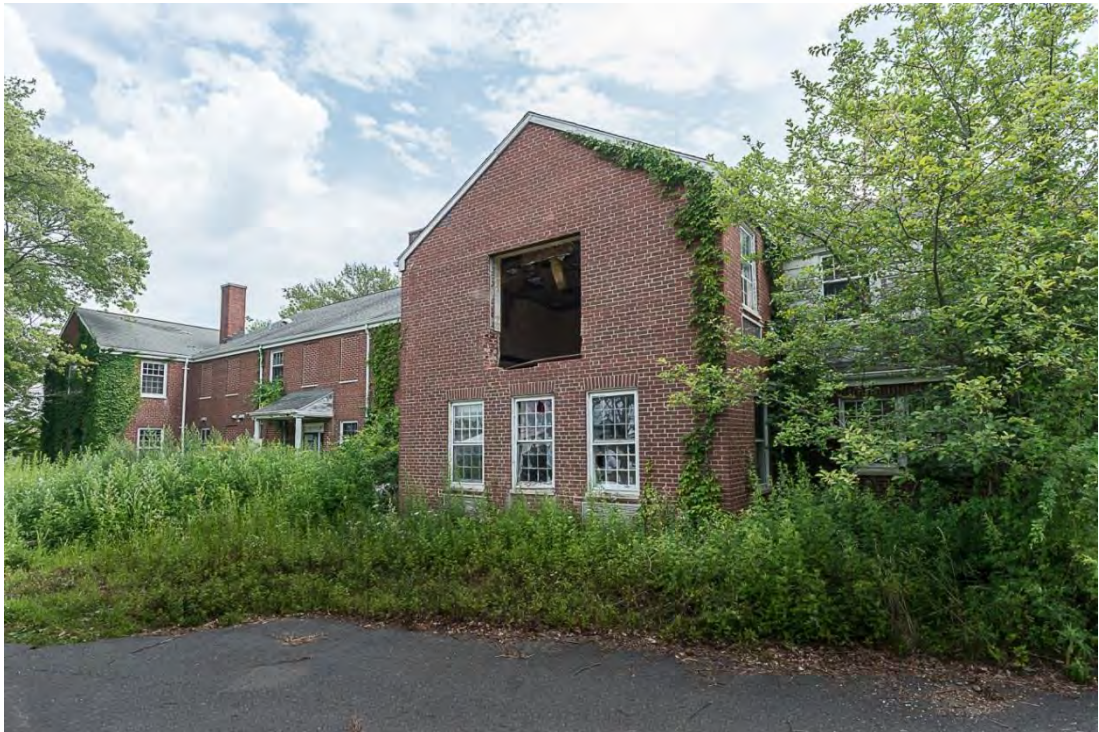
Photo 24. Building 4, view east showing north elevation with hole on second floor.

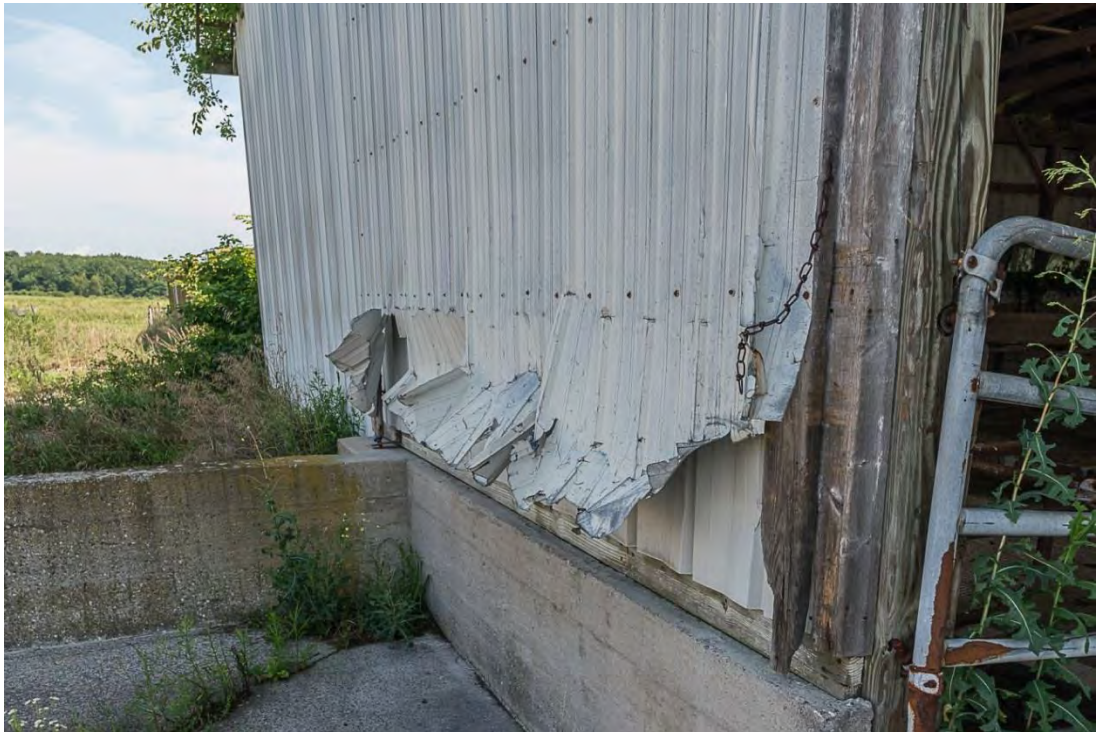
Photo 46. Building 10 view north of west elevation showing damage to siding.

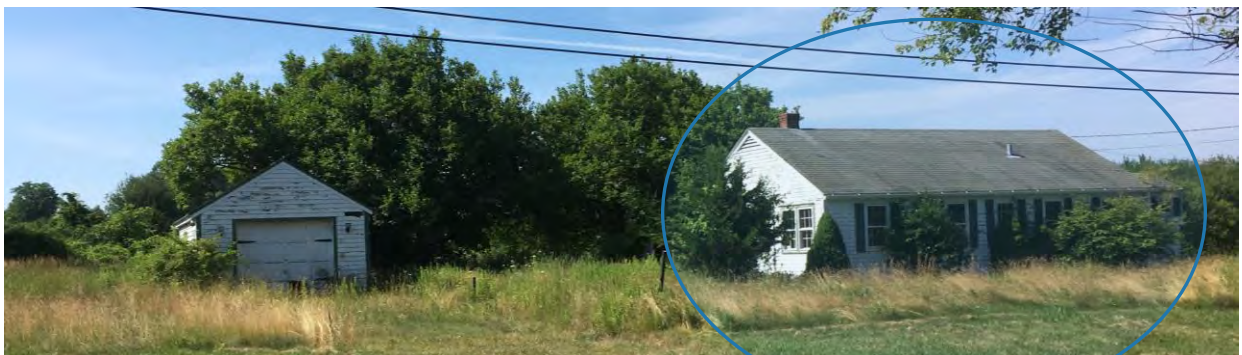
North Elevation Showing Building #2 FOREMAN'S HOUSE and Building #3 DETACHED GARAGE

Item	Description	Comments
1	Building Name	Foreman's House
2	Former Use	Single Family One Level Two Bedroom Ranch House
3	Year Built	1940+/-
4	Gross Building Area	873 SF Single Level
5	Hazmat	Unknown
6	Exterior Envelope	
7	Foundation	Concrete foundation in good condition with no signs of cracking or settlement. Crawl space.
8	Walls	Wood frame stud wall with exterior wood plank sheathing, wood siding & interior gypsum wallboard. Fair to good condition. Recommend gut renovation to replace building systems and upgrade to current code. Recommend prep, prime & paint exterior wood siding & trim.
9	Windows	Existing wood double hung and fixed have exceeded design life and require replacement.
10	Roof	Asphalt shingles at end of design life. Replacement required. To be insulated to code.
11	Structure	Wood frame, plumb level & square without signs of fracture or settlement. The house is a single story structure with a gable roof. Observation of the roof structure was limited to an opening in the ceiling where an attic stair was removed. The roof sheathing is 1x6 tongue and groove decking supported by 2x6 rafters spaced approximately 16 inches on center. The exterior walls are load bearing. It appears the house was framed over a concrete slab on grade. Although majority of the structure was concealed by wall and ceiling finishes, the structure appeared to be in good condition. The roof decking and framing observed was in good condition. There are no visible signs of sag in the roof ridge from street level. The overall structure is plumb, level and square. There are no indications of settlement.

12	Building Systems	
13	Plumbing	Existing original copper water and steel pipe waste.
14	Heating	Oil fired furnace with forced hot air. New mini-split heat pump required.
15	Air Conditioning	None
16	Power	Existing original with 100A service. New 200A service required.
17	Fire Life Safety	None. New mini-split heat pump required.
18	Security	None
19	Tele-data	None. New required.
20	Building Utilities	
21	Sanitary	Septic original to building.
22	Storm	None
23	Power	Original overhead service to building.
24	Water	Existing well.
25	Propane or Oil	Above ground oil tank. Removal required upon conversion to mini-split HVAC system.
26	Other	
27	Accessibility	No accessible entry
28	Record Photos	See Photos No. 13 - 19 in Section IV of this report
29	Historic Status	The building was constructed in 1940 and was listed as CONTRIBUTING to the National Register of Historic place nomination because it was built within the 1940 period of significance.

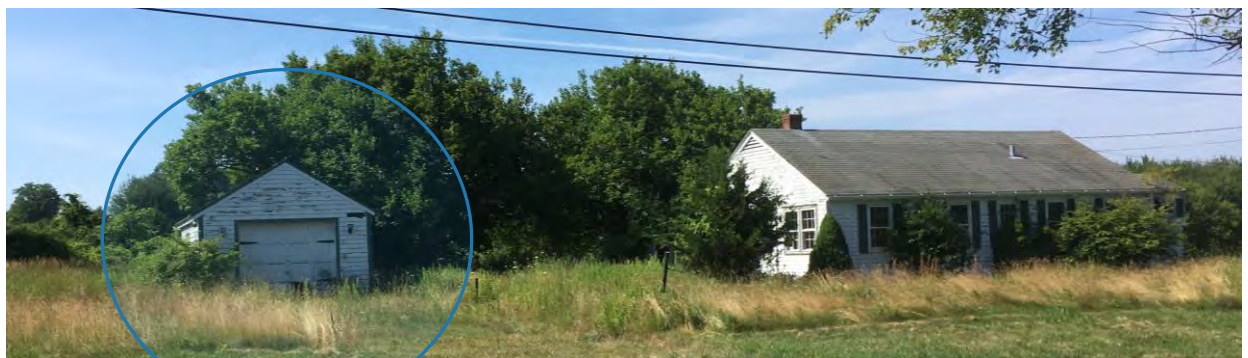
North Elevation Showing Building #2 FOREMAN'S HOUSE and Building #3 DETACHED GARAGE

Item	Description	Comments
1	Building Name	Detached Garage @ Foreman's House
2	Former Use	One bay garage
3	Year Built	1950+/-
4	Gross Building Area	273 SF Single Level
5	Hazmat	Unknown
6	Exterior Envelope	
7	Foundation	Concrete foundation with slab on grade in fair condition.
8	Walls	Wood frame stud wall with exterior wood plank sheathing & wood siding & no interior finishes. Recommend prep, prime & paint exterior wood siding & trim.
9	Windows	Existing wood double hung and fixed have exceeded design life and require replacement.
10	Roof	Asphalt shingle. Approaching end of design life. Replacement required.
11	Structure	Wood frame, plumb level & square without signs of fracture or settlement. The garage is a single story structure with a gable roof. The sheathing consists of 1x6 tongue and groove decking supported by 2x6 rafters spaced approximately 24 inches on center. The roof framing is supported by load bearing 2x6 stud walls, spaced at 24 inches on center. A portion of the roof framing was concealed by a wood framed ceiling. From the outside of the structure there appears to be a localized area, located above the framed ceiling area, where the roof and decking has been damaged and will need to be replaced. Otherwise the wood structure appears to be in good condition. Overall the structure is plumb, level and square. There are no indications of settlement.

12	Building Systems	None
13	Building Utilities	None. An underground power feed/circuit for lights and a GFI duplex receptacle should be refed from the service panel in the house.
14	Other	
15	Accessibility	N/A
16	Record Photos	See Photos No. 20 in Section IV of this report
17	Historic Status	The building was constructed in 1950 and was listed as NON-CONTRIBUTING to the National Register of Historic place nomination because it was built after the end of the 1940 period of significance.

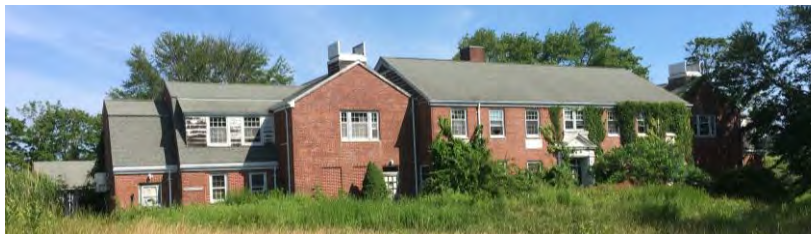
Reference Photo: East Elevation

Item	Description	Comments
1	Building Name	Farm Cottage #1
2	Former Use	Residential Care Facility
3	Year Built	1940+/-
4	Gross Building Area	12,450 SF
5	Basement	4,150 SF – Note standing water was observed in basement after heavy rains
6	First Floor	4,150 SF
7	Second Floor	4,150 SF
8	Hazmat	Asbestos abatement previously by State. Interior lead paint. 100 SF hole was made in exterior wall to remove bulk material debris from selective demolition. Paint assumed to contain lead given date of construction of building.
9	Exterior Envelope	
10	Foundation	Concrete foundation in good condition with no signs of cracking or settlement.
11	Walls	Brick veneer on CMU in good condition with no signs of cracking or settlement.
12	Windows	Existing wood double hung and fixed have exceeded design life and require replacement.
13	Roof	Fiberglass asphalt shingle on wood sheathing and stick framing.
14	Structure	CMU with brick walls with brick veneer and wood framed gable roof. The building is a two story structure with a full walk out basement level. The gable style roof consists of 1x6 tongue and groove wood decking and 2x10 rafters spaced approximately 16 inches on center. The rafters bear on the exterior 12- inch thick brick walls. The ceiling joists at the roof level vary from 2x10 to 2x8 framing. The first and second floors consist of a concrete slab, approximately 3-inch thick, supported by steel open web bar joists. The steel joists are 10 inches deep and are spaced approximately 2'-0" on center. The basement foundation walls were concrete in areas where the earth was back filled against the structure. Water was present on the basement floor at the time of our site visit. Observations of the floor and roof structures were limited to areas where ceilings have been removed. The roof decking and rafters appeared in good condition in the exposed areas. There are no visible signs of sag in the roof ridges from street level. There is an opening cut into the second floor slab, no slab reinforcing was observed. The steel joists appeared to be in good condition in the one area they were exposed. The exterior masonry walls are in good condition except where a large opening was placed in wall at the second floor level. The wall in this area should be replaced. The concrete foundation appeared in good condition, minor cracking was observed. Additional investigation and remediation is required to determine the source of the water infiltration in the basement. Overall the structure is plumb, level and square. There are no indications of settlement. Overall the structure appeared to be in good condition.

15	Building Systems	Interior has been extensively gutted during hazmat remediation
16	Plumbing	None. New required.
17	Heating	None. New required.
18	Air Conditioning	None. New required.
19	Power	None. New required.
20	Fire Life Safety	None. New required.
21	Security	None. New required.
22	Tele-data	None. New required.
23	Building Utilities	
24	Sanitary	Original septic. New required.
25	Storm	None. New stormwater galley system required for roof and parking drainage.
26	Power	Original overhead power service. New required.
27	Water	Original well. New required.
28	Propane or Oil	Unknown. None exists, new required.
29	Other	
30	Accessibility	Accessible entry and has elevator shaft and car. Car is not in operation, is hydraulic and requires ADA upgrade/replacement.
31	Record Photos	See Photos No. 21 – 30 in Section IV of this report
32	Historic Status	The building was constructed in c. 1940 and was listed as CONTRIBUTING to the National Register of Historic place nomination because it was built within the 1940 period of significance.

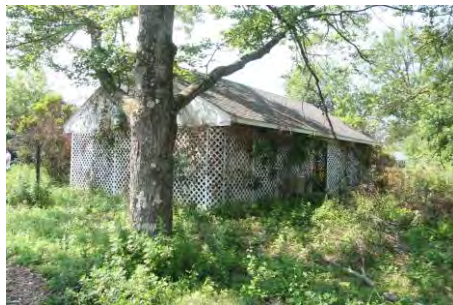
View of Covered Patio Looking North

Item	Description	Comments
1	Building Name	Covered Patio Behind Farm Cottage #1
2	Former Use	Exterior Potting Shed
3	Year Built	1950+/-
4	Gross Building Area	747 SF Single Level
5	Hazmat	Unabated lead paint
6	Exterior Envelope	
7	Foundation	Slab on grade with concrete support piers at columns in good condition with no signs of cracking or settlement. Good condition.
8	Walls	Painted wood lattice. Good condition. Requires repainting. Observe requirements for dealing with lead paint.
9	Windows	None
10	Roof	Fiberglass asphalt shingle on wood sheathing and stick framing. Requires replacement given age.
11	Structure	Wood columns, framing and gable roof profile. The patio is a one story structure with a gable style roof. The roof is timber framed and concealed by a ceiling. The roof is supported by eight steel pipe columns that are exposed. The structure is braced by exposed steel angle (L3x3x1/4) knee braces in both directions. The steel columns are bolted to the foundation. The patio floor is an exposed concrete slab on grade. Although the roof structure was not observed, it appears to be in good condition as the structure is plumb, level and square. There are no visible signs of sag in the roof ridge from street level. The steel superstructure appears to be in good condition. The slab of grade has significant cracking and has been previously patched.

12	Building Systems	None. An underground GFI circuit for power and lighting should be provided from the main building.
13	Building Utilities	None. A water hose bib should be provided from the main building.
14	Other	
15	Accessibility	Yes
16	Record Photos	See Photos No. 31 – 32 in Section IV of this report
17	Historic Status	The building is not mentioned in the National Register of Historic place nomination and is therefore NON-CONTRIBUTING because it was built after the end of the 1940 period of significance.

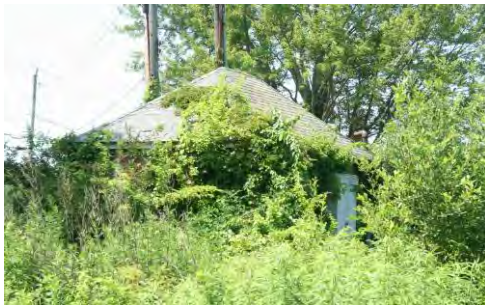
View Looking North from Road

Item	Description	Comments
1	Building Name	Transformer House
2	Former Use	Power transformer
3	Year Built	1940+/-
4	Gross Building Area	210 SF Single Level
5	Hazmat	Unknown, hazmat assessment and remediation being conducted by State
6	Exterior Envelope	
7	Foundation	Assumed concrete foundation wall with spread footings.
8	Walls	Exterior brick on CMU (block). Requires repointing.
9	Windows	None
10	Roof	Fiberglass asphalt shingle on wood sheathing and stick framing. Requires replacement.
11	Structure	Load bearing masonry, wood roof framing and sheathing with asphalt shingle roof. The building is a one story structure with a hip style roof. The building appears to have a wood framed roof supported by masonry bearing walls. Observations were limited to the exterior of the building as the interior was inaccessible. There are no visible signs of sag in the roof ridge from street level. The brick exterior walls are in good condition, there are no signs of settlement.

12	Building Systems	None operable. New required.
13	Building Utilities	None operable. New required.
14	Other	
15	Accessibility	Not required.
16	Record Photos	See Photo No. 33 in Section IV of this report
17	Historic Status	The building was constructed in 1940 and was listed as CONTRIBUTING to the National Register of Historic place nomination because it was built within the 1940 period of significance.

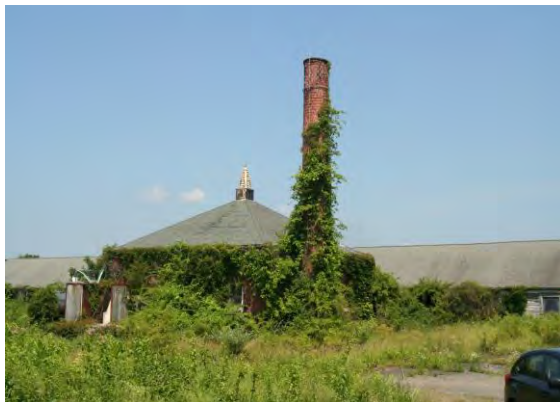
Reference Photo: South Elevation

Item	Description	Comments
1	Building Name	Milk House
2	Former Use	Milk Storage and Distribution Building
3	Year Built	1940+/-
4	Gross Building Area	1,045 SF Single Level
5	Hazmat	Asbestos abatement previously by State. Interior paint lead.
6	Exterior Envelope	
7	Foundation	Concrete foundation in good condition with no signs of cracking or settlement.
8	Walls	Brick veneer on CMU in good condition with no signs of cracking or settlement. Requires repointing. Interior wall finishes are glazed block and tile.
9	Windows	Existing wood double hung and fixed have exceeded design life and require replacement.
10	Roof	Fiberglass asphalt shingle on wood sheathing and stick framing. Roof requires replacement.
11	Structure	CMU with brick walls with brick veneer and wood framed gable roof. The building is a one story structure with a hip style roof and a basement. The roof sheathing is wood decking supported by wood trusses. The roof is supported by load bearing masonry walls. The sub-surface basement walls are concrete. During the observations, the basement was flooded with several feet of water. Although the majority of the structure is concealed by wall and ceiling finishes, the structure appeared to be in good condition. The roof decking and framing that was observed through an opening in the ceiling appeared to be in good condition. There are no visible signs of sag in the roof ridge from street level. The masonry walls are also in good condition; no cracking was observed. The masonry steel lintels are deteriorated and should be replaced. The overall structure is plumb, level and square. There are no indications of settlement. Additional investigation and remediation is required to determine the source of the water infiltration in the basement.

12	Building Systems	Obsolete and non-functioning.
13	Plumbing	None. New required.
14	Heating	None. New required.
15	Air Conditioning	None. New required.
16	Power	None. New required.
17	Fire Life Safety	None. New required.
18	Security	None. New required.
19	Tele-data	None. New required.
20	Building Utilities	
21	Sanitary	Original septic. New required.
22	Storm	None. New required for building and parking.
23	Power	Original overhead power service. New required.
24	Water	Original well. New required.
25	Propane or Oil	Unknown. None. New source required.
26	Other	
27	Accessibility	None.
28	Record Photos	See Figure 2 & Photos No. 34 - 37 in Section IV of this report
29	Historic Status	The building was constructed c. 1940 and was listed as CONTRIBUTING to the National Register of Historic place nomination because it was built within the 1940 period of significance.

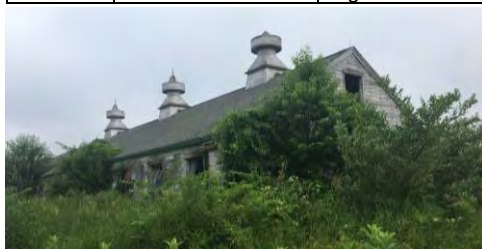
Reference Photo: West End of Dairy Barn Looking Southeast

Item	Description	Comments
1	Building Name	Dairy Barn #2
2	Former Use	Dairy Barn
3	Year Built	1960+/-
4	Gross Building Area	9,827 Single Level
5	Hazmat	Asbestos abatement previously by State. Interior lead paint requires abatement or encapsulation.
6	Exterior Envelope	
7	Foundation	Concrete foundation in fair condition with limited signs of cracking or settlement.
8	Walls	Concrete 24" AFF with wood frame and clapboard inside and out on East Wing and wood frame with exterior clapboard and interior plaster on West Wing. Requires reconditioning and repainting. Existing lead paint can be encapsulated with new.
9	Windows	Existing wood double hung and fixed have exceeded design life and require replacement.
10	Ceilings/Roof	West wing has plywood ceiling. East wing has beadboard ceiling. Roof is fiberglass asphalt shingle on wood sheathing and stick framing with metal ventilators. Lead paint requires abatement or encapsulation.

11	Structure	The building is a one story structure with a gable roof style. The building roof consists of 1x6 wood decking and wood trusses spaced approximately at 2'-0" on center. The trusses are supported at four locations, at the perimeter walls and two interior beam support locations, approximately at third points of the width of the building. The perimeter walls are timber framed and bear on a concrete foundation knee wall. The knee wall extends approximately 32 inches above the floor slab. The two interior beam lines are supported by steel pipe columns filled with concrete spaced approximately 10'-0" on center at the east side of the building and by 6x6 timber posts on the west side of the building. At the center of the building there is a lower one-story wood framed connector that links Building 8 with the north side of Building 7. The connector link is wood framed and has major moisture damage. Although majority of the structure is concealed by a wood ceiling, the overall structure appeared to be in good condition. The roof decking and framing that was observed through a small opening in the ceiling appeared to be in good condition. There are no visible signs of sag in the roof ridge from street level and the walls appear to be plumb. The steel pipe column bases are completely deteriorated and the concrete fill is exposed at most of the pipe column locations. These columns should be replaced. Towards the west end of the building, the interior bearing supports were removed and replaced with two shoring jacks. The 6x6 timber posts appear to be in good condition. The concrete floors are in good condition; minor cracking was observed. The wood framing for the connector link to Building 7 has been exposed to moisture and is deteriorated. The connector link should be demolished and replaced.

12	Building Systems	Existing steel animal stanchion system remains in place. Parts of existing pneumatic milk pumping system/piping remains in place.
13	Plumbing	Automatic animal water distribution system piping and drink basins remain but are obsolete and not functional.
14	Heating	None. Requires replacement.
15	Air Conditioning	None. Requires replacement.
16	Power	None. Requires replacement.
17	Fire Life Safety	None. Requires replacement.
18	Security	None. Requires replacement.
19	IT	None. Requires replacement.
20	Other Systems	Manure removal concrete trench remains but conveyor has been removed.
21	Building Utilities	
22	Sanitary	None
23	Storm	None
24	Power	Original overhead power service.
25	Water	Original well. No longer functional.
26	Propane or Oil	None
28	Accessibility	Main aisle only full accessible.
29	Record Photos	See Figure 2 & Photos No. 38 - 39 in Section IV of this report
30	Historic Status	The building was constructed in c.1960 and was listed as NON-CONTRIBUTING to the National Register of Historic place nomination because it was built after the end of the 1940 period of significance to replace the original barn which burned down.

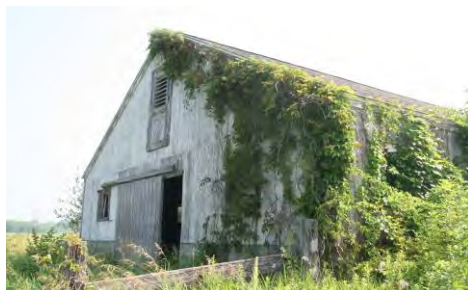
Reference View of North Elevation

Item	Description	Comments
1	Building Name	Hay Barn
2	Former Use	Hay Storage
3	Year Built	1960+/-
4	Gross Building Area	3,927 SF Single Level
5	Hazmat	N/A
6	Exterior Envelope	
7	Foundation	Concrete foundation in good condition with no signs of cracking or settlement.
8	Floor	Broken, frost heaved concrete requires replacement
9	Walls	Conventional wood framing with Texture 111 exterior sheathing. Requires painting.
10	Windows	None
11	Doors	3'-0" x 6'-8" exterior door. Rolling barn door on North End.
12	Roof	Fiberglas asphalt shingle on wood sheathing and manufactured wood trusses. Requires replacement.
13	Structure	Concrete foundation with wood frame walls and manufactured wood trusses. The building is a one story structure with a gable roof style. The building roof consists of plywood sheathing supported by pre-fabricated metal plate wood trusses spaced approximately at 2'-0" on center. The trusses are supported by the exterior wall that consist of 1/2 inch thick plywood sheathing and 2x6 studs spaced at 2'-0" on center. The wood framed walls bear on a concrete foundation knee wall which extends approximately 32 inches above the floor slab. At the south end of the building there is a connector link to Building 8. The connector roof is made up of two elevations, the higher roof construction consists of a tectum deck supported by 6x12 wood beams spaced approximately 8'-0" on center. The lower roof consists of wood decking supported by timber framing. The structure was fully exposed to view. There are localized areas of the roof and wall sheathing that have water damage. In those areas the sheathing should be replaced. The sill plate and double top plate appears to be in good condition except at localized areas where the sheathing is missing. Minor cracking in the concrete knee wall was observed. The bottom sill plate is anchored to the knee wall with 1/2-inch diameter bolts spaced approximately 8'-0" on center however nuts are missing at each anchor location. The concrete floor slab is in poor condition. The connector link has suffered from water infiltration causing it to deteriorate and partially collapse. The remaining structure of the connector link is in poor condition and should be demolished.

14	Building Systems	Interior has been extensively gutted during hazmat remediation.
15	Plumbing	None.
16	Heating	None
17	Air Conditioning	None
18	Power	None. New lighting required.
19	Fire Life Safety	None
20	Security	None
21	Tele-data	None
22	Building Utilities	
23	Sanitary	None
24	Storm	None
25	Power	None. New service required.
26	Water	None
27	Propane or Oil	None
29	Accessibility	Accessible from side or rear yard except for broken concrete floor which blocks passage.
30	Record Photos	See Figure 2 & Photos No. 40 - 43 in Section IV of this report
31	Historic Status	The building is not mentioned individually in the National Register of Historic Places nomination but may have been included as part of the dairy barn. The building was constructed in c.1960 and is most likely NON-CONTRIBUTING to the National Register of Historic place nomination because it was built after the end of the 1940 period of significance.

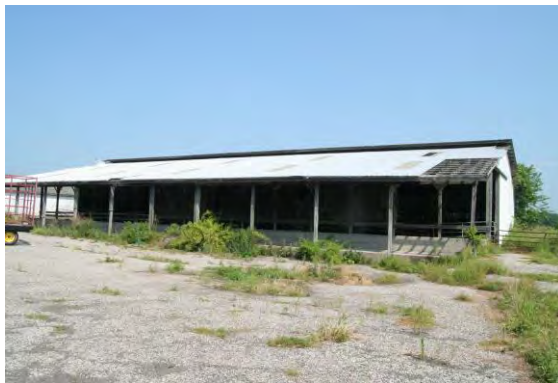
South Elevation of Heifer Barn Looking North from Barn Yard

Item	Description	Comments
1	Building Name	Heifer Barn
2	Former Use	Heifer Barn
3	Year Built	1960+/-
4	Gross Building Area	4,592 SF Single Level
5	Hazmat	None
6	Exterior Envelope	
7	Foundation	Concrete foundation in good condition with no signs of cracking or settlement.
8	Walls	Heavy timber posts with diagonal bracing and beams and aluminum vertical siding on wood frame.
9	Windows	None, but open horizontal band in wall area on North Elevation for daylight.
10	Roof	Metal on manufactured wood trusses. Portions of metal roof blown off during Spring 2018 tornado and require repair.
11	Structure	Concrete foundations and slab with heavy timber wall and manufactured wood trusses.
12	Building Systems	
13	Plumbing	None
14	Heating	None
15	Air Conditioning	None
16	Power	None
17	Fire Life Safety	None
18	Security	None
19	IT	None
20	Building Utilities	
21	Sanitary	None
22	Storm	None
23	Power	None
24	Water	None
25	Propane or Oil	None.

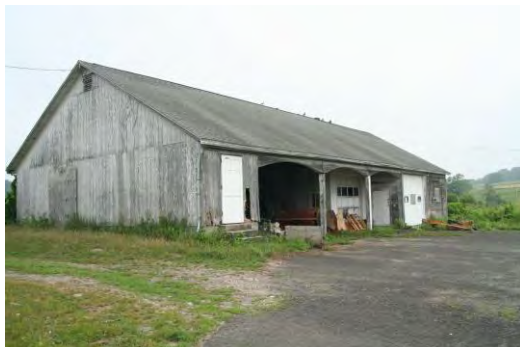
View Looking Northwest

Item	Description	Comments
1	Building Name	Equipment Storage Barn
2	Former Use	Equipment Storage Barn
3	Year Built	1960+/-
4	Gross Building Area	5,076 SF
5	Level 1	4,020 SF
6	Partial Level 2	1,056 SF (Attic)
7	Hazmat	None
8	Exterior Envelope	
9	Foundation	Concrete foundation in good condition with no signs of cracking or settlement.
10	Walls	2x6 wood framing 24" O.C.(H) with Texture 111 sheathing.
11	Windows	Some covered with wood sheathing, others double hung and non-operable.
12	Doors	Wood 3'-0" x 6'-8" half-light, wood garage doors, wood slider barn door.
13	Roof	Field built 2x6 wood trusses with 3/4" wood sheathing and fiberglass asphalt roofing.
14	Structure	Concrete foundations and slab steel pipe support columns with wood frame exterior walls and 2x10 carrying beams supporting a field built wood truss system. Deformation of structural bay at southwestern corner of building consisting of uplift caused by hydraulic equipment is being repaired under a separate initiative by the State with completion anticipated in December of 2018.

15	Building Systems	
16	Plumbing	None
17	Heating	None
18	Air Conditioning	None
19	Power	None evident. Lighting and power should be installed in all interior spaces & attic. Exterior power outlets should be installed in the open equipment bays.
20	Fire Life Safety	None
21	Security	None
22	IT	None
23	Building Utilities	
24	Sanitary	None
25	Storm	None
26	Power	None. A new 200 amp service should be installed to the building.
27	Water	None
28	Propane or Oil	None.
29	Other	
30	Accessibility	Accessible entry from barn yard driveway. Second floor attic not accessible.
31	Historic Status	The building is not mentioned individually in the National Register of Historic Places nomination. The building was constructed in c.1960 and is most likely NON-CONTRIBUTING to the National Register of Historic place nomination because it was built after the end of the 1940 period of significance.
