# **NEPA ENVIRONMENTAL REVIEW REPORT**

**Community Development Block Grant – Disaster Recovery  
Owner Occupied Rehabilitation and Rebuilding Program**

**Site ID No. 1313  
1 Yost Street  
Norwalk, Connecticut**

**February 2017**

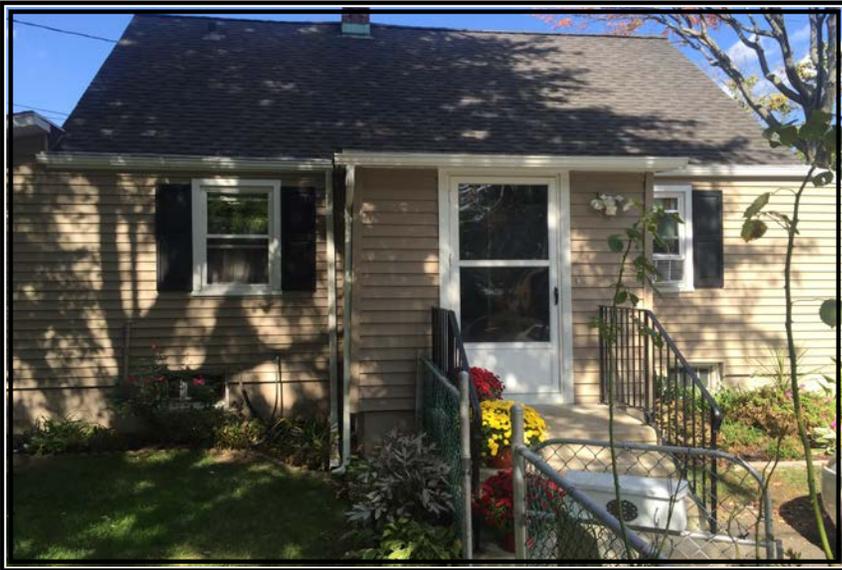
**Photograph 1**  
**Front of 1 Yost Street, Norwalk**

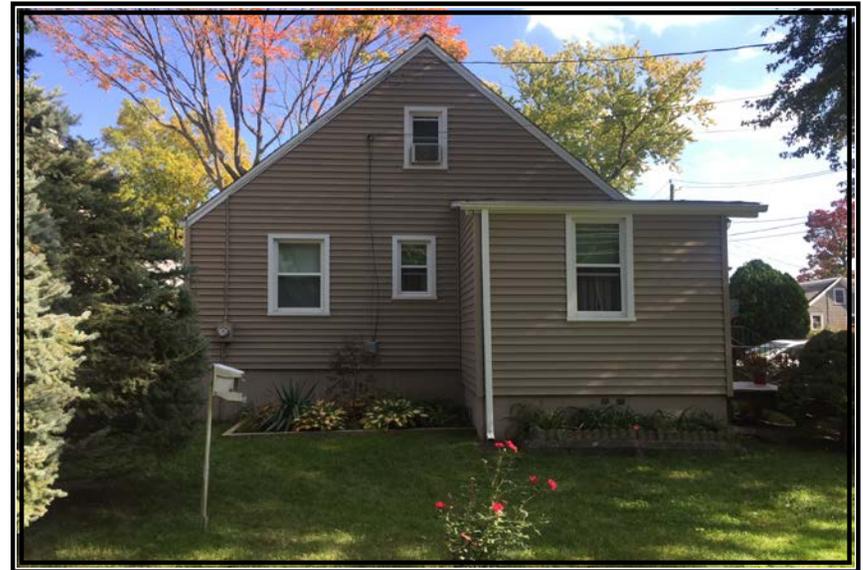
**Photograph 2**  
**Rear of 1 Yost Street, Norwalk**

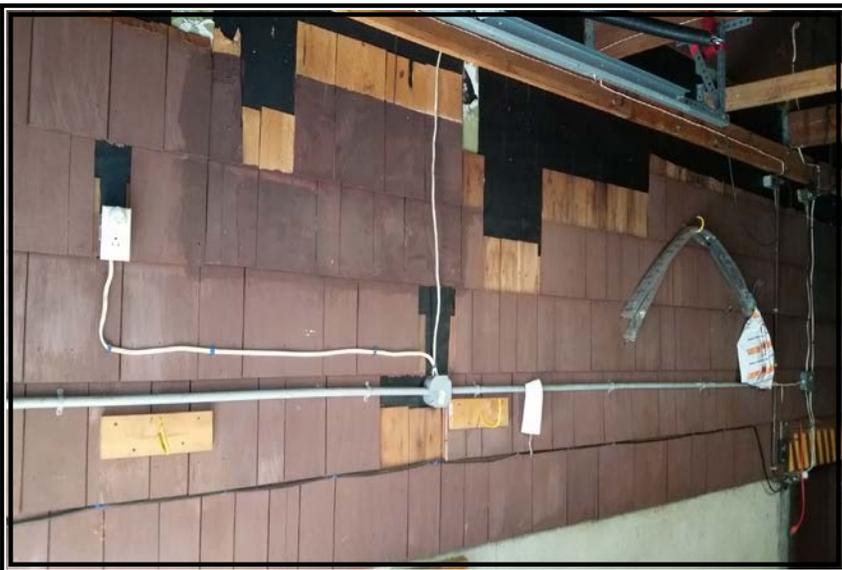
<b>Material</b>	<b>Location</b>	<b>Approx. Quantity</b>	<b>Condition</b>	<b>% Chrysotile</b>
Black tar	Garage floor	400 SF	Poor	2%
Grey transite	B side garage wall	150 SF	Poor	20%

**Photograph 3**  
**Transite on B side wall of garage**

Approximately 400 square feet of asbestos-containing black tar material was identified on the garage floor and approximately 150 square feet of asbestos-containing grey transite was identified on the B side wall of the garage. Both of these areas are within the work zone. To be protective of the health of occupants, any ACM to be disturbed during construction will be required to be removed by a licensed asbestos abatement contractor. All abatement activities must be conducted in accordance with local, state, and federal regulations including, but not limited to, project design, containment structures, air monitoring, and clearance sampling by a licensed project monitor. Waste materials must also be properly disposed of at an appropriately permitted disposal facility. The abatement contractor must provide credentials/adequate qualification documentation and a work plan for abatement with their bid for review by Merritt and Triton.

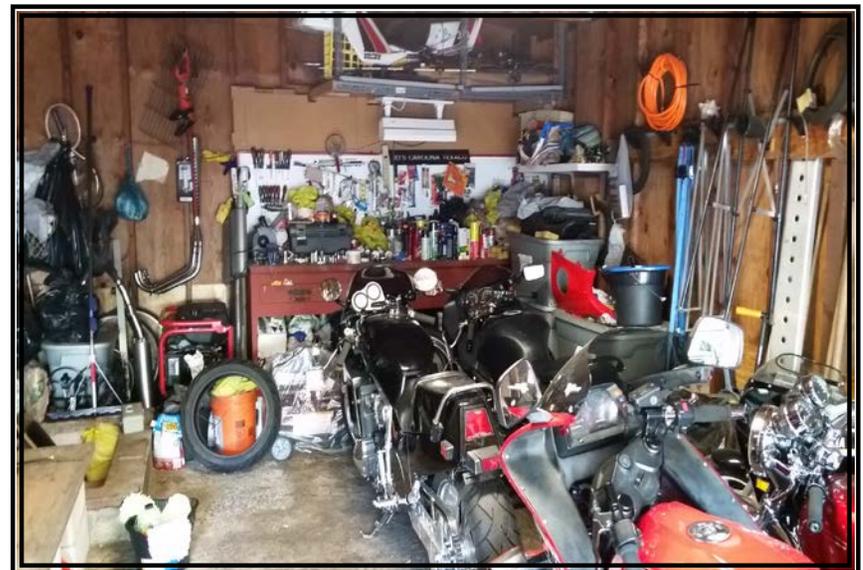
**Photograph 4**  
**Black tar material underneath bike in garage**
