RE: Applicant 5061, 758 East Broadway, Milford, CT

This letter is to provide a summary description of the Statutory Checklist for CDBG-DR Applicant – 5061 – Damian Pasqua.

Hazardous Materials
Inspection Report

**LEAD BASED PAINT INSPECTION
REPORT OF FINDINGS
OF:**

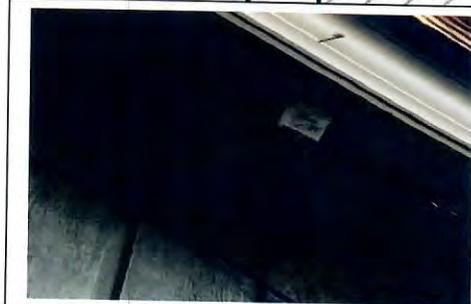
121	Exterior	Door	Casing	Wood	C	Deteriorated	-0.1	Negative
122	Exterior	Door	Header	Wood	C	Deteriorated	-0.1	Negative
123	Exterior	Room	Wall	Wood	D	Deteriorated	-0.1	Negative
124	Exterior	Window	Casing	Wood	D	Deteriorated	-0.1	Negative
125	Exterior	Window	Casing	Wood	D	Deteriorated	-0.1	Negative
126	Exterior	Room	Wall	Wood	A	Deteriorated	0.1	Negative
127	Exterior	Window	Sill	Wood	A	Deteriorated	0.1	Negative
128	Exterior	Window	Casing	Wood	A	Deteriorated	0	Negative
129	Exterior	Window	Casing	Wood	A	Deteriorated	0	Negative
130	Exterior		Green overhang	Wood	A	Deteriorated	10.3	Positive

Green positive testing soffit is highlighted in yellow
