June 23, 2017
File No. 05.0045937.00

Re: Letter Condition Survey Report for the Shaw's Cove Bulkhead
Shaw's Cove, New London, CT

SHAW'S COVE BULKHEAD INSPECTION
410 BANK STREET
NEW LONDON, CONNECTICUT

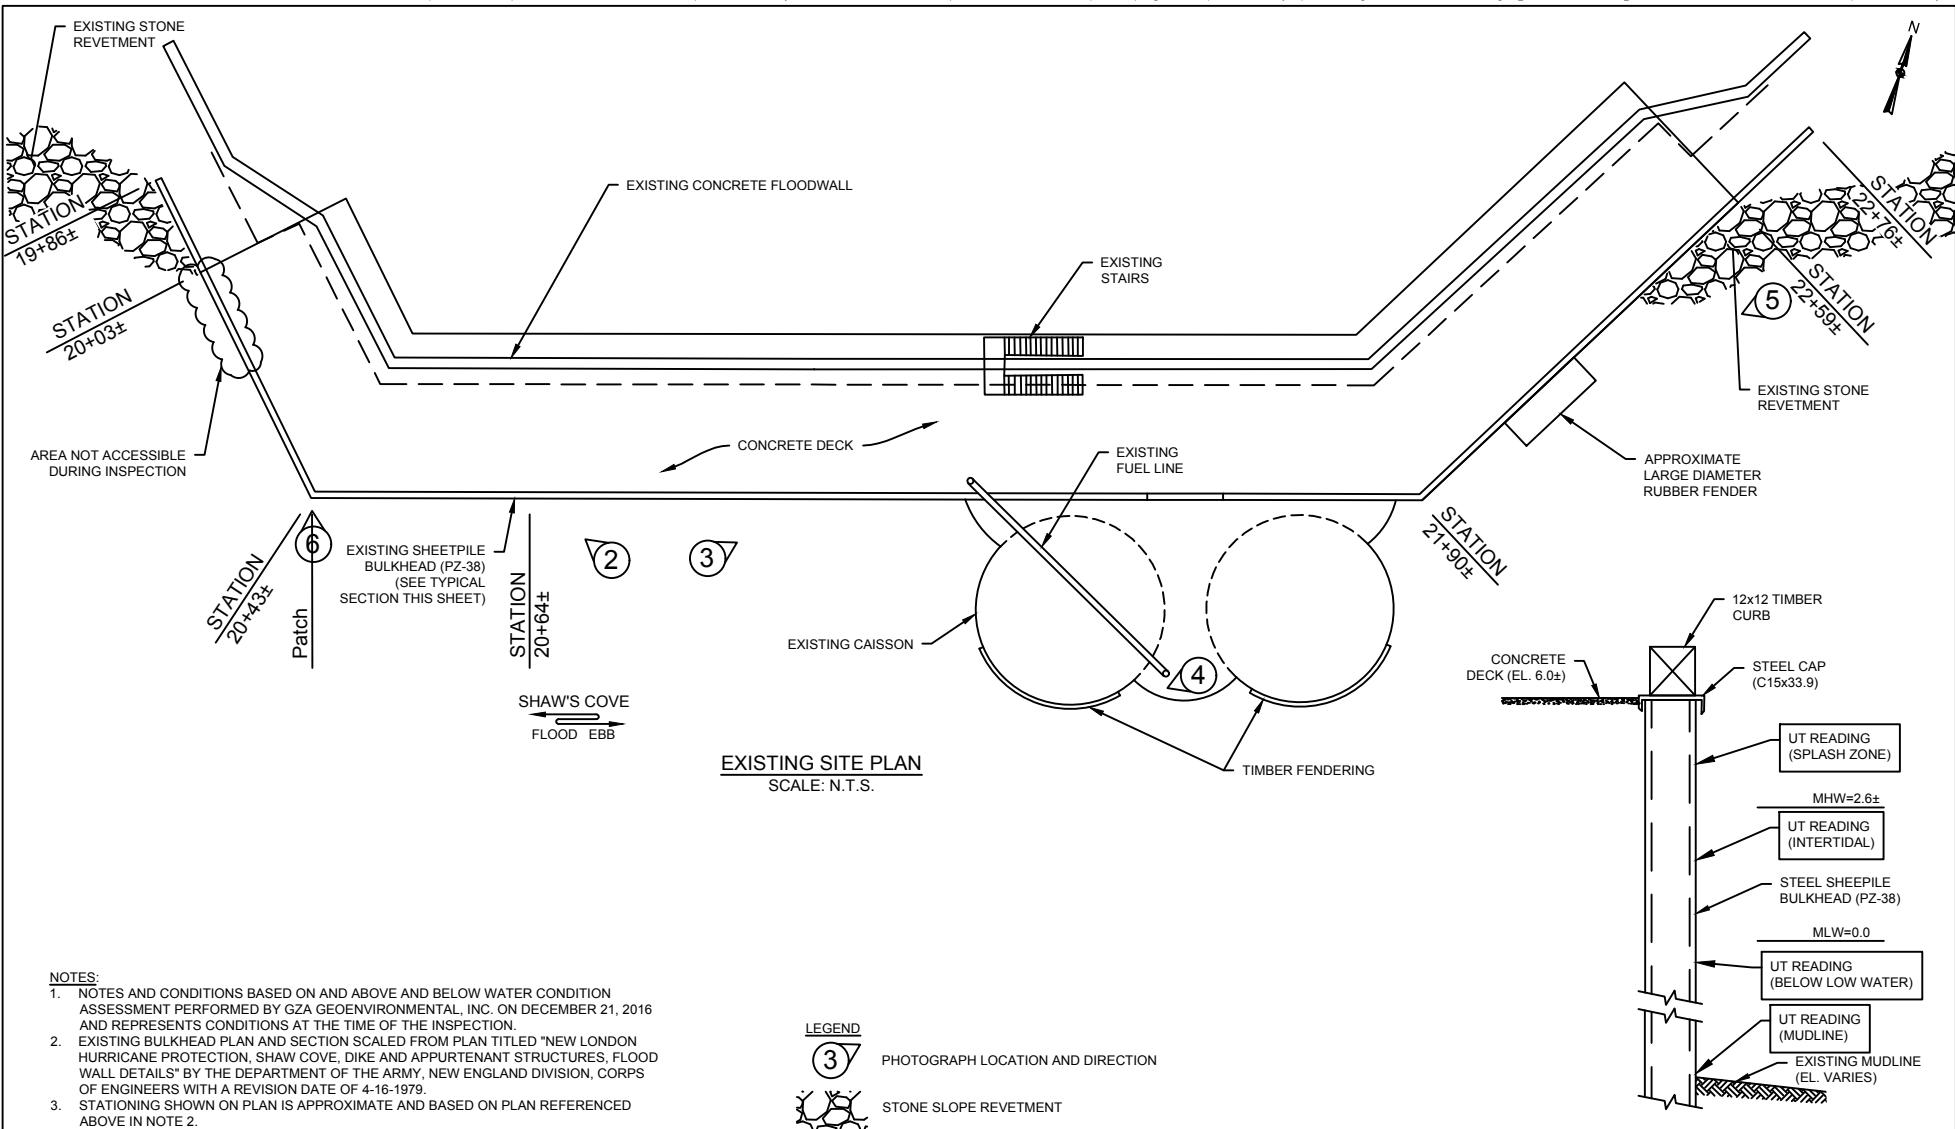
EXISTING SITE PLAN & TYPICAL SECTION

The observations below are based on above-water and underwater inspection on the steel sheetpile bulkhead. Refer to Figure No. 1 for stationing and photograph locations.

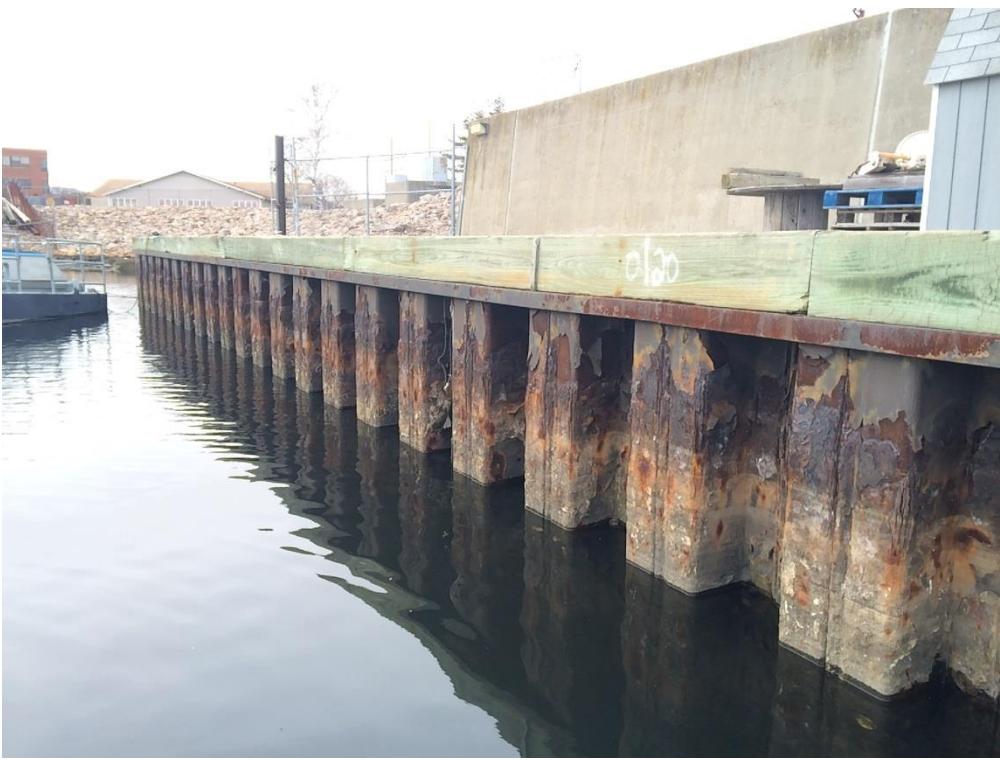
Photo No. 2	Date: 12-21-16	Direction Photo Taken: Looking West

Description: Existing conditions of bulkhead splash zone west of the caissons.

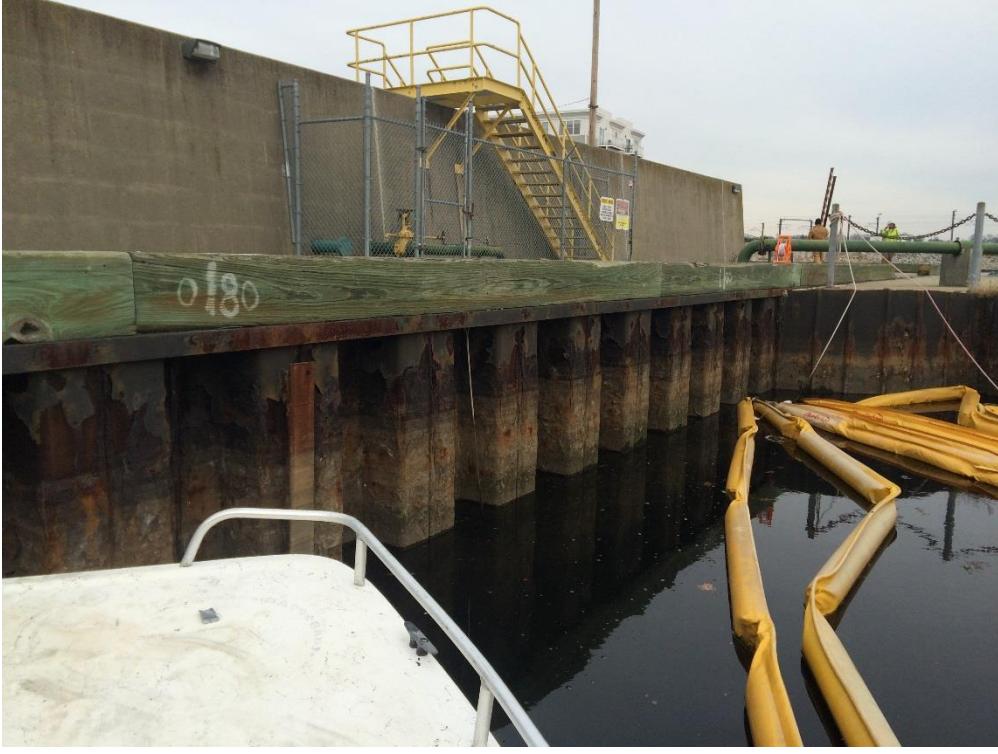
Client Name: City of New London		Site Location: Shaw's Cove, New London, CT	Project No. 05.0045937.00
Photo No. 3	Date: 12-21-16	Direction Photo Taken: Looking Northeast	
Description: Existing conditions of bulkhead splash zone west of the caissons. Note beginning of caissons.

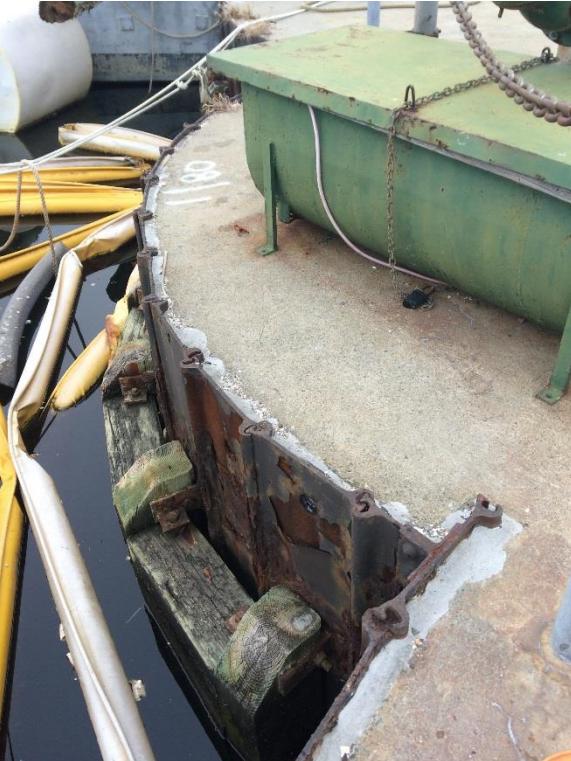
Photo No. 4	Date: 12-21-16	Direction Photo Taken: Looking Southwest	
Description: Typical condition at top of caisson.

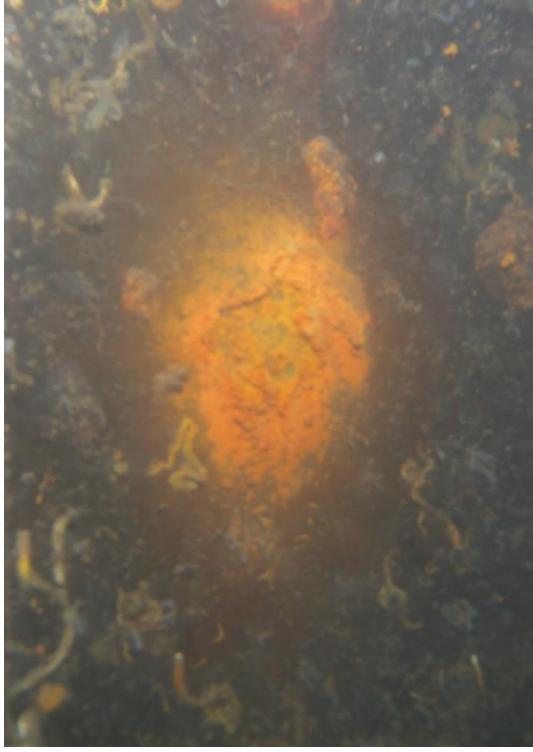
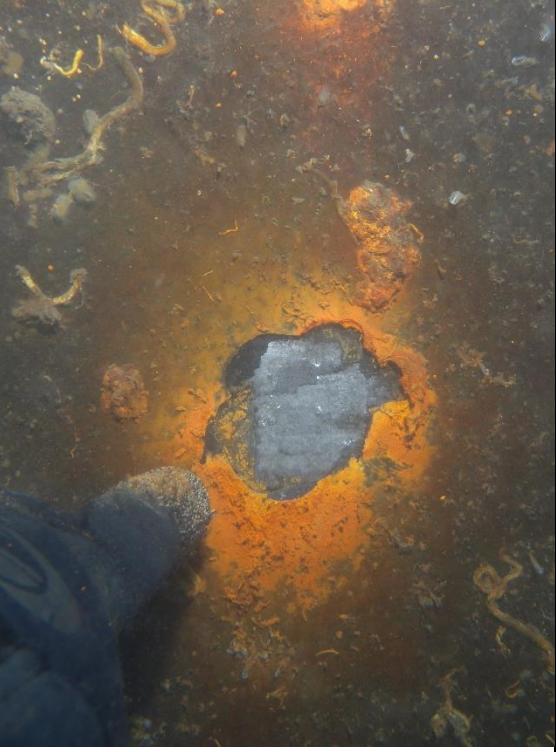
Client Name: City of New London		Site Location: Shaw's Cove, New London, CT	Project No. 05.0045937.00
Photo No. 7	Date: 12-21-16

Iron oxide was observed along the face of the steel sheetpiles between the mudline and approximate Mean Low Water elevation (subtidal). In general, scraping at the iron oxide locations revealed smooth steel with minor pitting (See Photograph 7 through 9). Minor marine growth was observed in the subtidal zone along the bulkhead. The tidal and splash zones were observed to be corroded with loss of coating and delamination and corrosion of steel. It should be noted that readings and observations along the western end of the bulkhead was limited along the length due to shallow water.

Description: Observed iron oxide along bulkhead west of caissons and exposed steel. Photographs taken before and after cleaning.

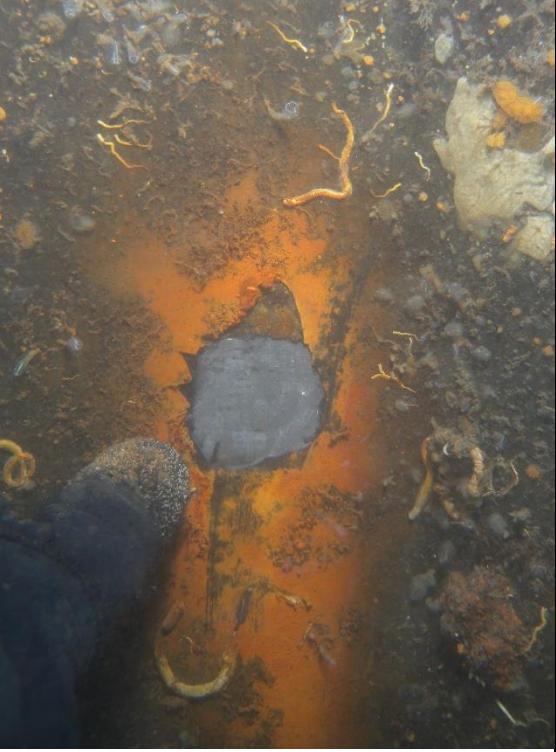
Photo No. 8	Date: 12-21-16

Direction Photo Taken: Looking North			
Description: Observed iron oxide along bulkhead west of caissons and exposed steel. Photographs taken before and after cleaning.
