RE: Applicant 1183, 9 East Avenue, Milford, CT

This letter is to provide a summary description of the Statutory Checklist for CDBG-DR Applicant – 1183, Spencer Hoyt.

**Figure E-10 Statutory Checklist**

**Project Name and Identification No. CDBG-DR Project 1183 – 9 East Avenue**

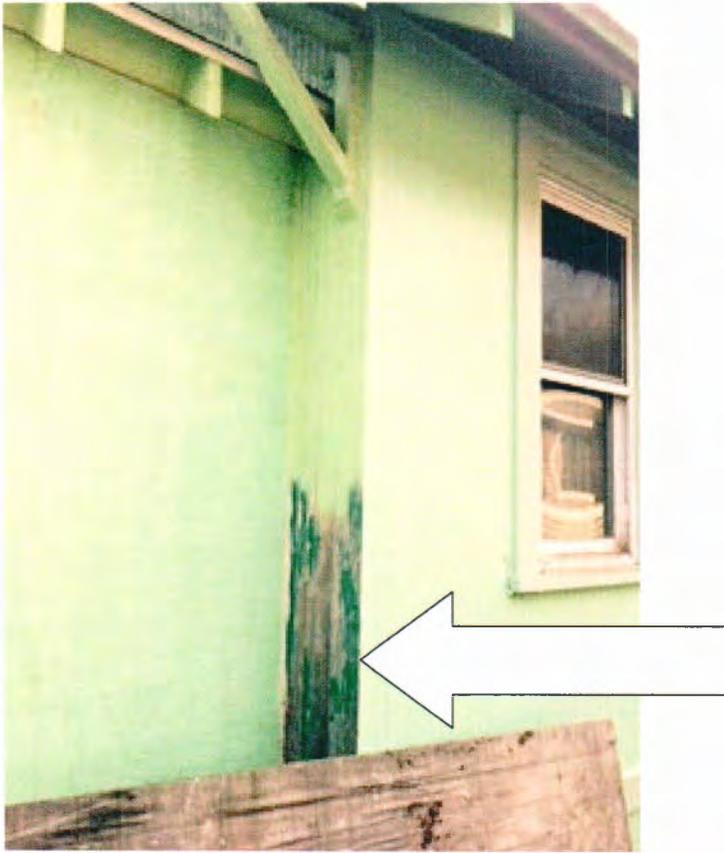
Exterior Wall , wall 3 (rear)

* see picture				
<b>98</b>	<b>8</b>	<b>Exterior</b>	<b>2</b>	<b>Overhang-purple</b>	<b>Intact</b>	<b>Wood</b>	<b>9.9</b>	<b>Positive</b>
<b>99</b>	<b>8</b>	<b>Exterior</b>	<b>2</b>	<b>Window Trim</b>	<b>Intact</b>	<b>Wood</b>	<b>9.3</b>	<b>Positive</b>
<b>100</b>	<b>8</b>	<b>Exterior</b>	<b>2</b>	<b>Window Sill</b>	<b>Intact</b>	<b>Wood</b>	<b>5.1</b>	<b>Positive</b>
<b>101</b>	<b>8</b>	<b>Exterior</b>	<b>2</b>	<b>Wall -upper</b>	<b>Intact</b>	<b>Wood</b>	<b>3.9</b>	<b>Positive</b>
102	8	Exterior	2	Wall-foundation	Intact	Wood	0.3	Negative
103	999	Calibration					0.8	okay
