NEPA ENVIRONMENTAL REVIEW REPORT

**Community Development Block Grant – Disaster Recovery
Owner Occupied Rehabilitation and Rebuilding Program**

**Site ID No. 1260
35 Harbor View Avenue
Norwalk, Connecticut**

April 2015

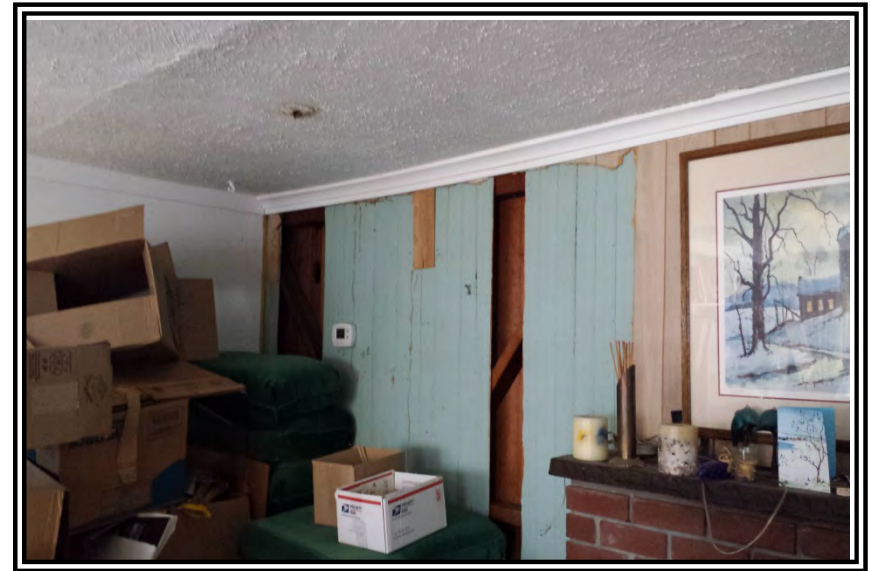
Photograph 2
Lead-containing blue paint behind wood paneling

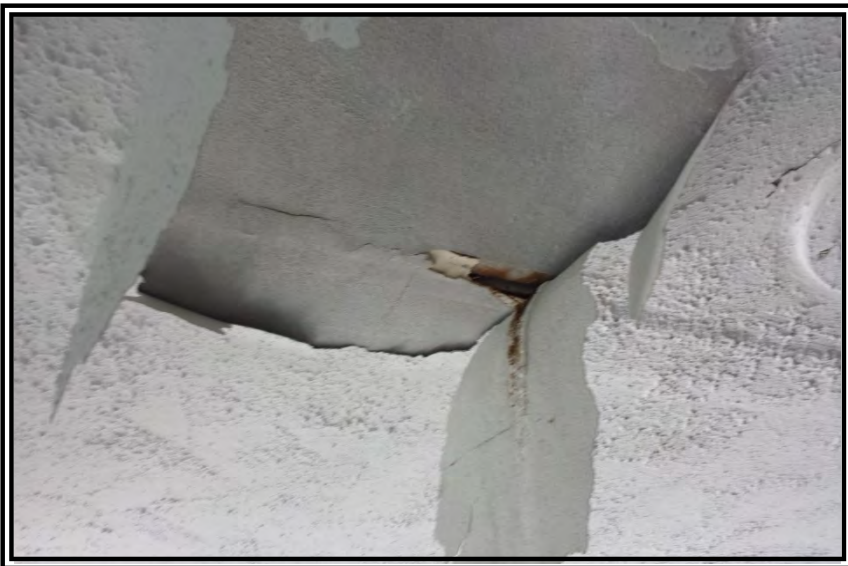
Material	Location	Approx. Quantity	Condition	% Chrysotile
Sheetrock walls and ceiling	Living Room	1,800 SF	Poor	2
Front window glazing	2 nd floor	8	Poor	3

Photograph 3
Textured ceiling containing ACM

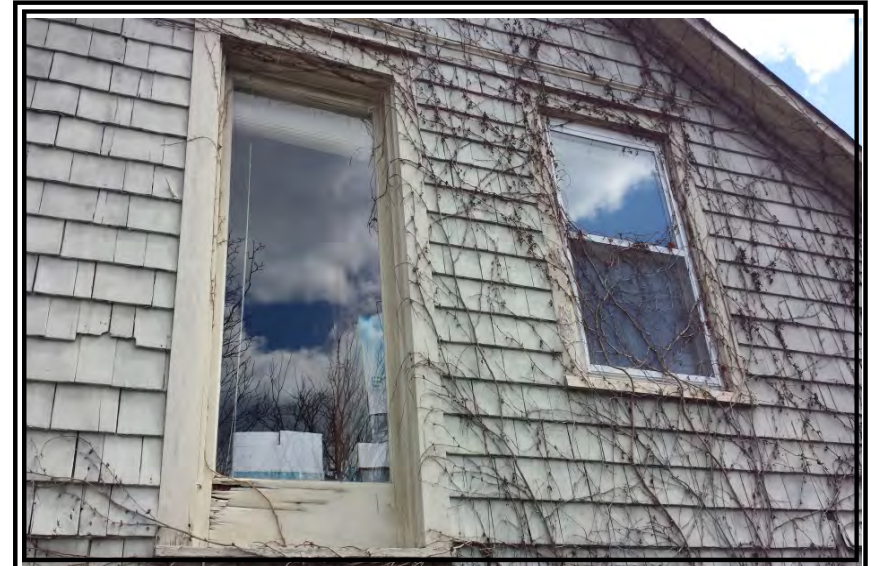
Photograph 4
Window with ACM glazing

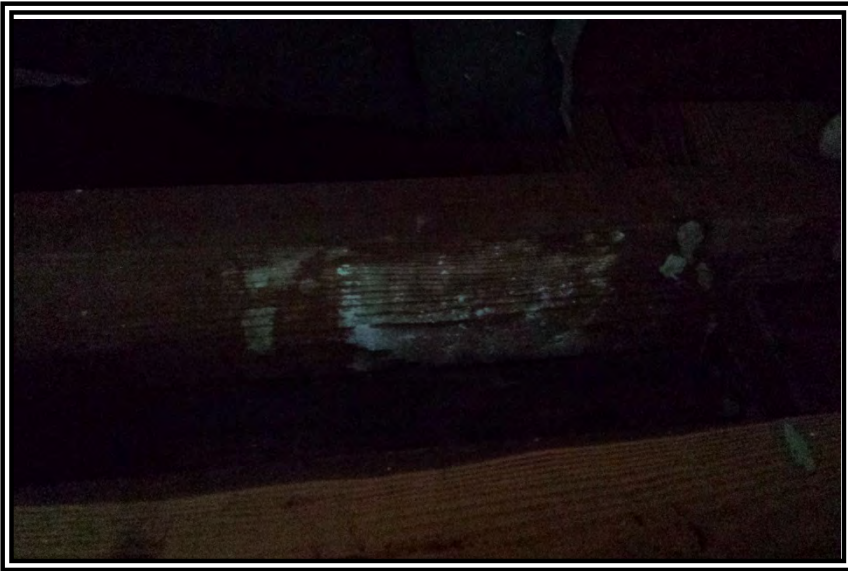
Triton completed a visual mold inspection of the work area on May 1, 2014. Mold was observed on several interior surfaces including on the exposed wooden framing beneath the kitchen window, on the wooden framing adjacent to the furnace, on the wooden framing of the closet opposite the stairs, and on the sheetrock behind the front door trim. Photographs of the apparent mold are provided in Appendix B. The house was filled with personal effects that limited Triton's ability to visually inspect all interior areas. It is assumed that mold is present behind all walls on the wooden framing and insulation throughout the entire work zone.

Photograph 5
Mold on wood closet frame opposite stairs

the wooden framing of the closet opposite the stairs, and on the sheetrock behind the front door trim. Mold is presumed to be present behind all interior walls. Additional mold impacted surfaces may be encountered during renovation in spaces that were inaccessible or not apparent during the inspection. To protect occupant and worker health, the mold must be abated by a qualified contractor. Pre-abatement air testing will be completed by Triton to establish a baseline. Triton recommends that a competent person be present during the renovation work who is capable of identifying potential additional suspect materials. General precautions should be taken during the renovation process to avoid the potential spread of mold spores and to mitigate health and safety concerns. Clearance testing will be completed (and compared against the baseline) to evaluate the efficacy of the abatement.

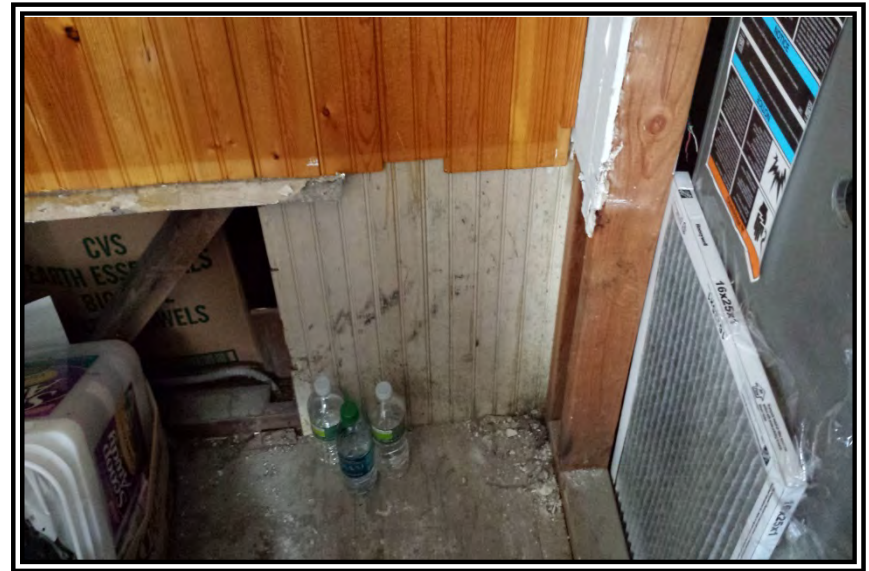
Photograph 6
Mold on wood paneling adjacent to furnace

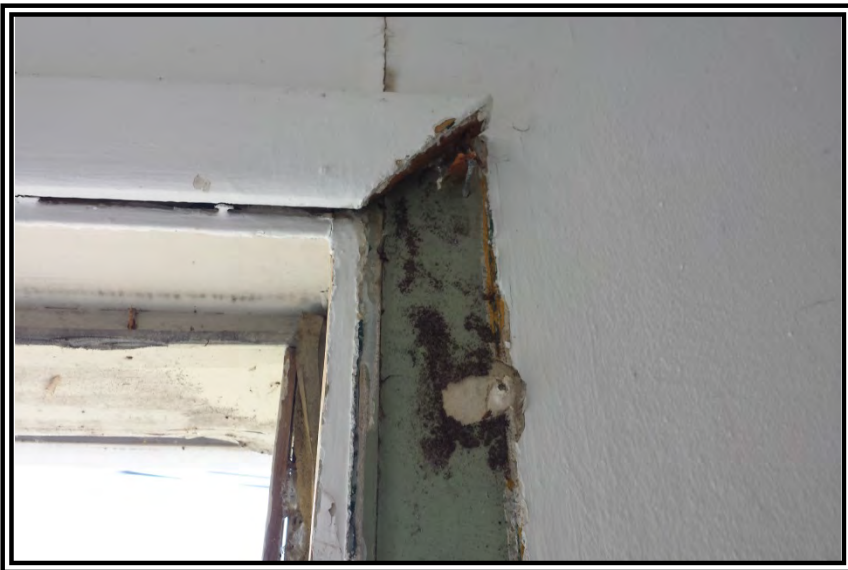
Photograph 7
Mold behind entryway trim

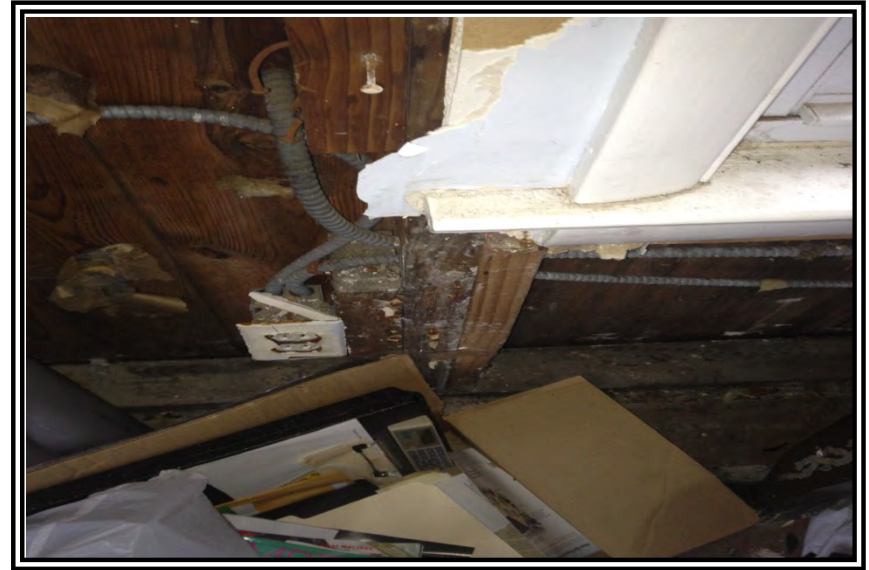
Photograph 8
Mold on wooden frame in kitchen
