**ENVIRONMENTAL REVIEW REPORT**

**Community Development Block Grant – Disaster Recovery  
Owner Occupied Rehabilitation and Rebuilding Program**

**9 Parker Street, Preston, CT**

**Limited Hazardous Materials Building  
Inspection Report**  
Storm Sandy Residential Rehabilitation Project  
9 Parker Street  
Preston, Connecticut

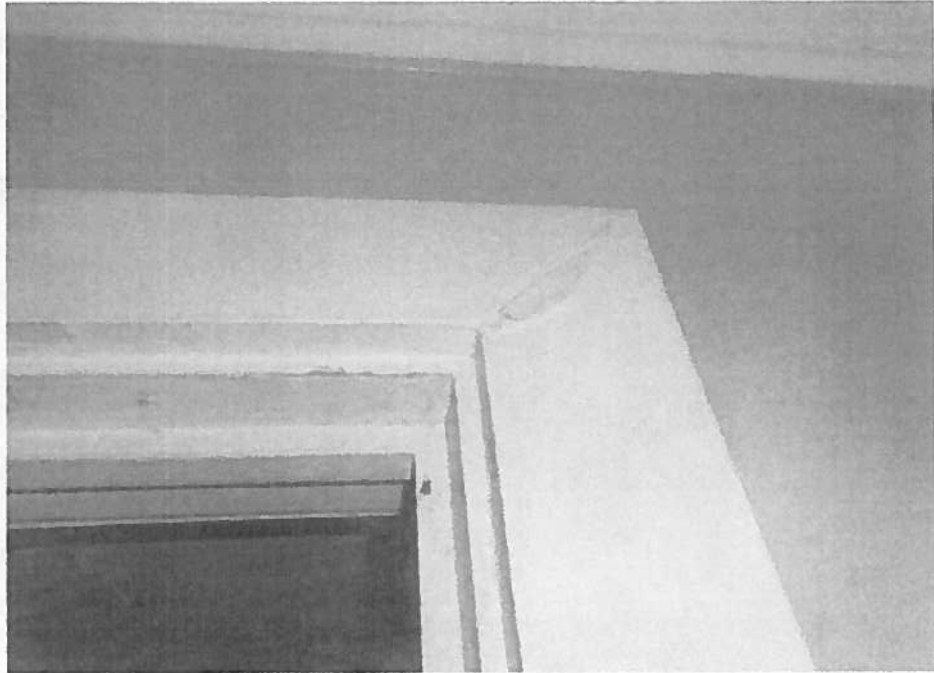
Interior defective LBP identified on the living room door jamb and bedroom door casing must be completely abated of LBP. Exterior defective LBP identified on the exterior window sill on the A side of the residence can be managed with interim controls that consist of scrapping defective LBP and encapsulating the painted surface with a State of Connecticut-approved encapsulant.

**Defective Lead-Based Paint on Door Casing**

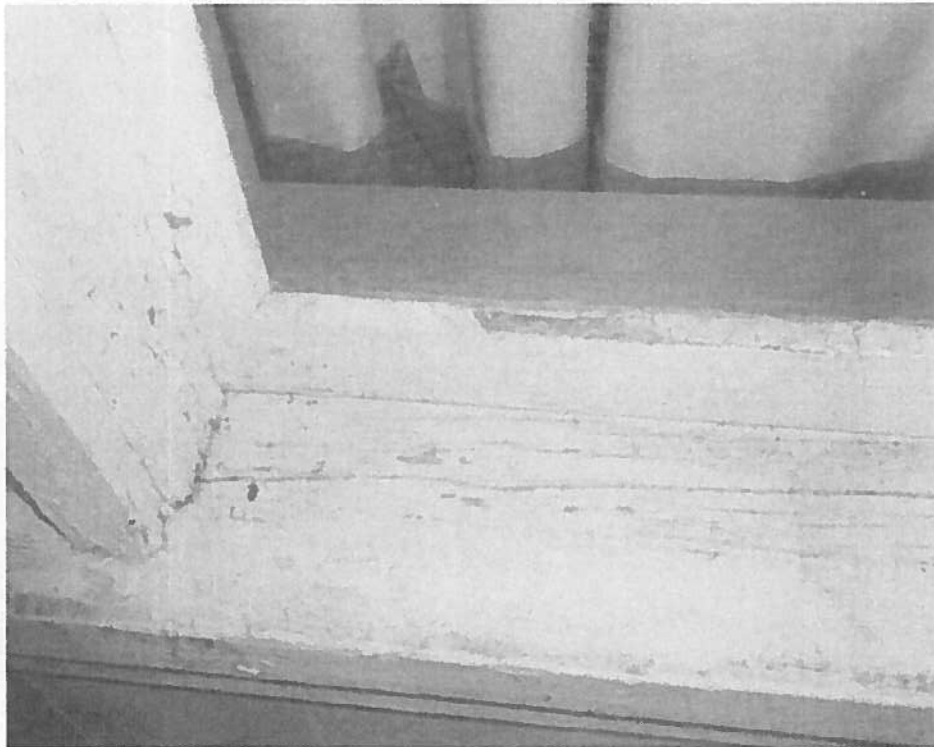
**Defective Lead-Based Paint on Window Sill**

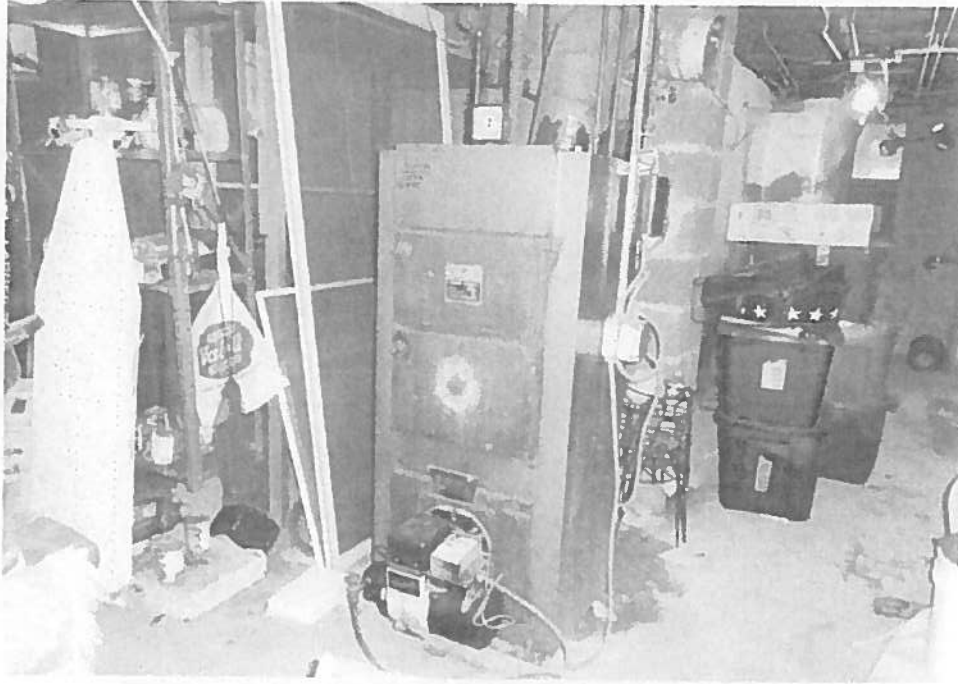
**Inaccessible Furnace: Interior Materials Presumed to be ACM**

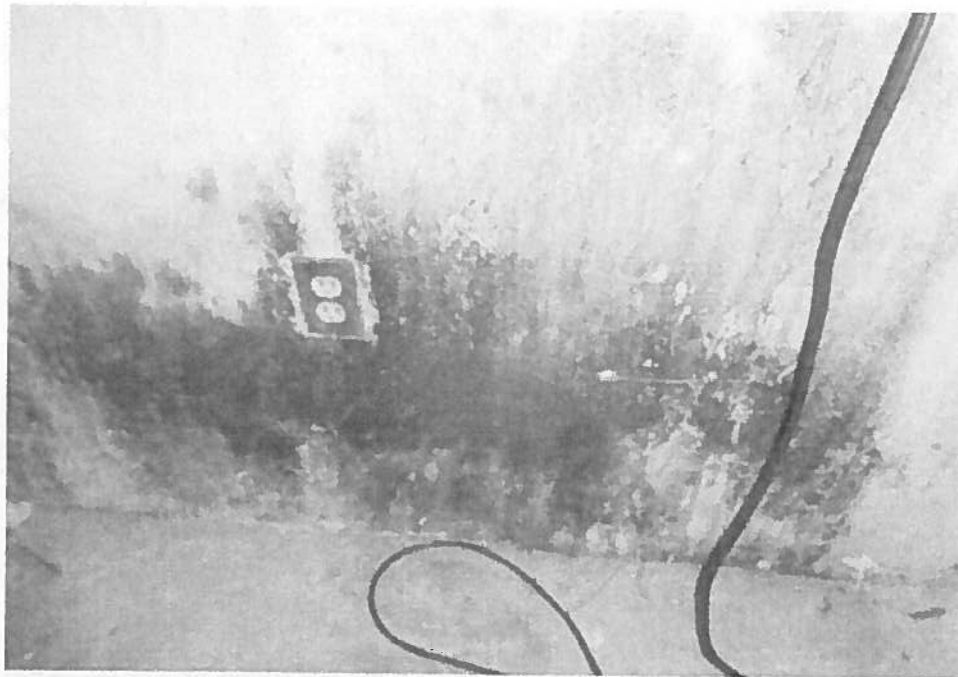
**Visible Suspect Mold on Basement Sheetrock Wall**
