BRIDGEPORT ROAD SAFETY AUDIT

ROUTE 1: SHERIDAN STREET TO BRUCE AVENUE

JANUARY 2022

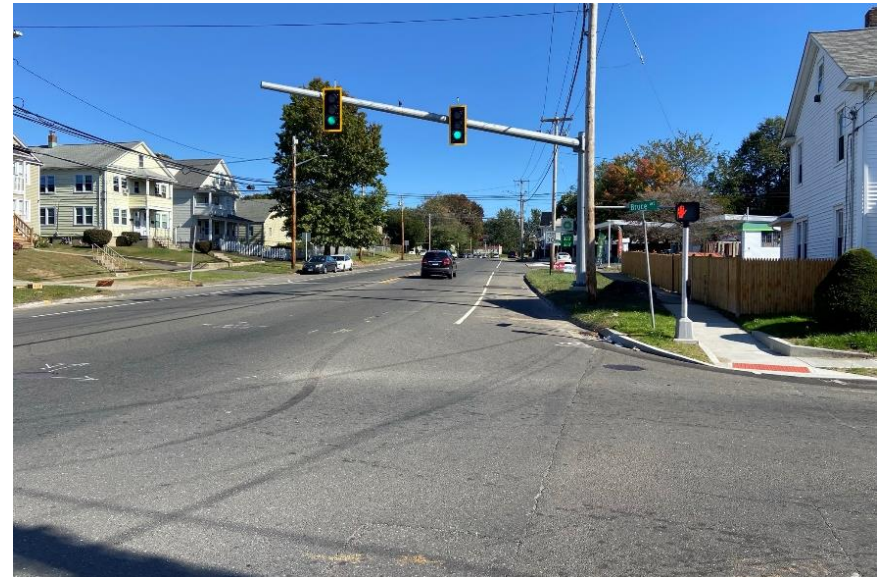
Exhibit 16: New Signal at Route 1 at Bruce Avenue

- CTDOT noted that the signal at this location is newly replaced including new curb ramps, and crosswalks. The signal at this location includes an audible pedestrian signal (APS). See Exhibit 16.
- The pedestrian phase at this signal is an exclusive pedestrian phase.

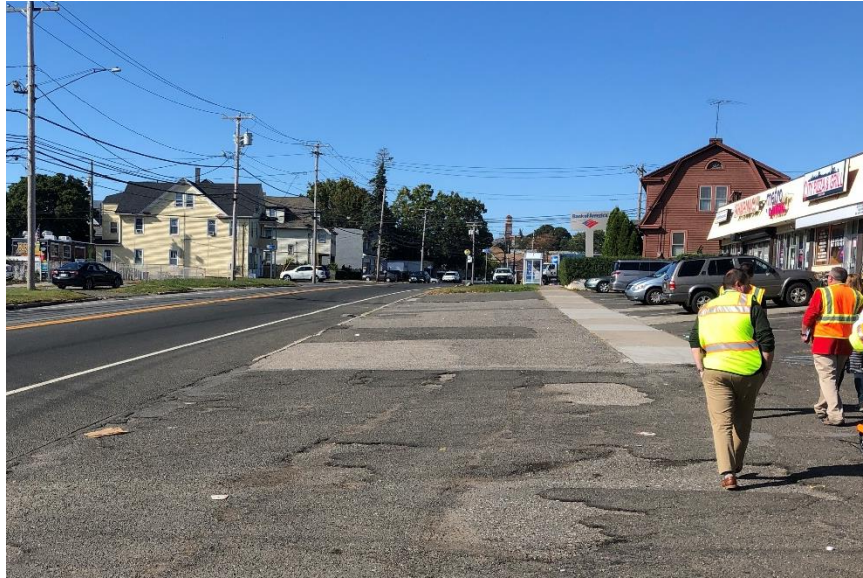
Exhibit 17: Sidewalk setback away from roadway, behind parked cars in the ROW adjacent to 2115-2135 Boston Avenue (Insurance – Laundromat)

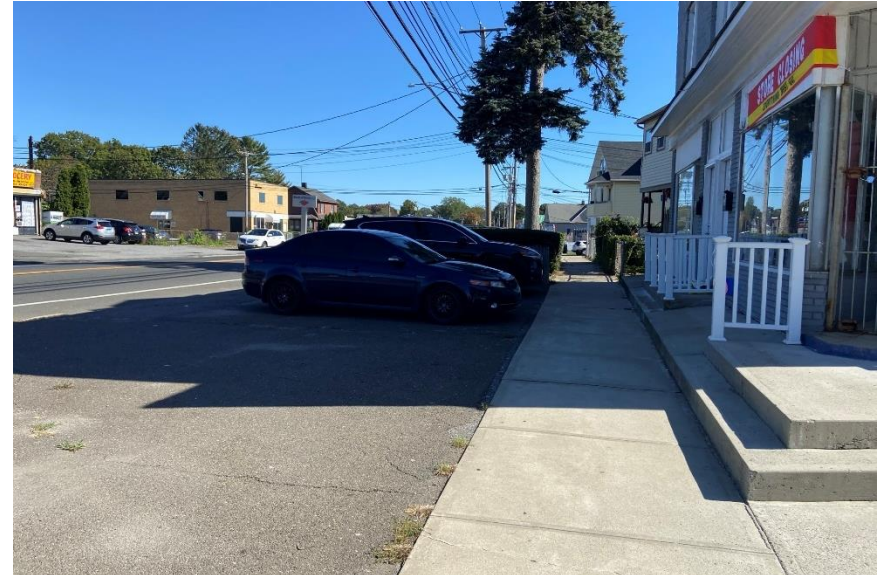
Exhibit 18: Cars parked in ROW between roadway and sidewalk (buffer zone) at 2044 Boston Avenue

- The intersection does not have a sidewalk on the northern side of Route 1. There may be sufficient space within the ROW to install one.
- No crosswalks are present at this intersection.
- Curb ramps are located behind stop bars.
- Parking in the ROW between the roadway and the sidewalk (the buffer zone) is frequently observed in many of the properties to the south of Route 1. Many properties here have limited or no parking. Participants noted that no-parking signage is frequently removed by area residents and businesses. See Exhibit 18.

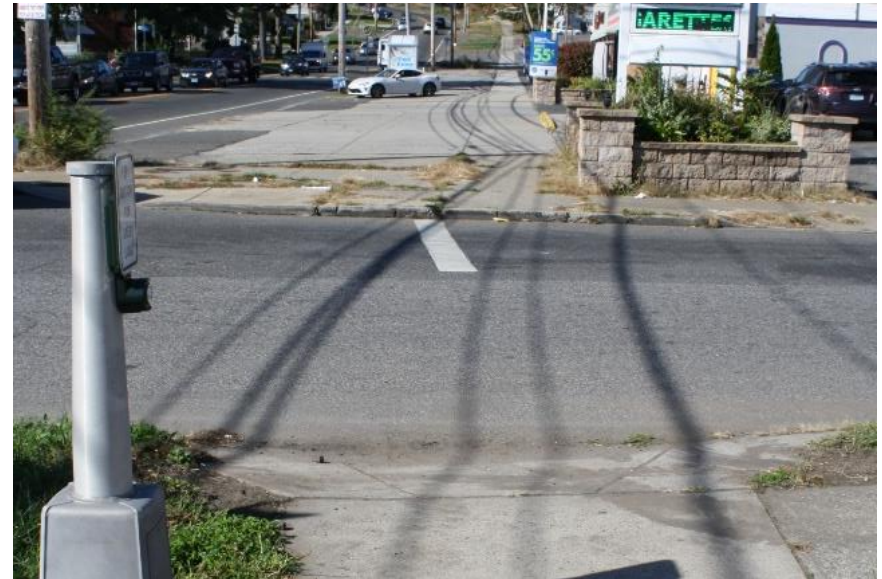
- The signals at Success Avenue and Bishop Avenue are not coordinated, leading to unnecessary congestion due to the lack of coordination between signals (one will be green, while the other red).
- Traffic signal does not include pedestrian signal heads.
- Intersection does not have crosswalks across Route 1 or the southbound approach (Success Avenue). See Exhibit 19.
- Parking in sidewalk area at 1917 Boston Avenue (Shell Gas Station) observed.

Exhibit 19: Missing crosswalk and confusing crossing environment at the intersection of Route 1 and Success Avenue

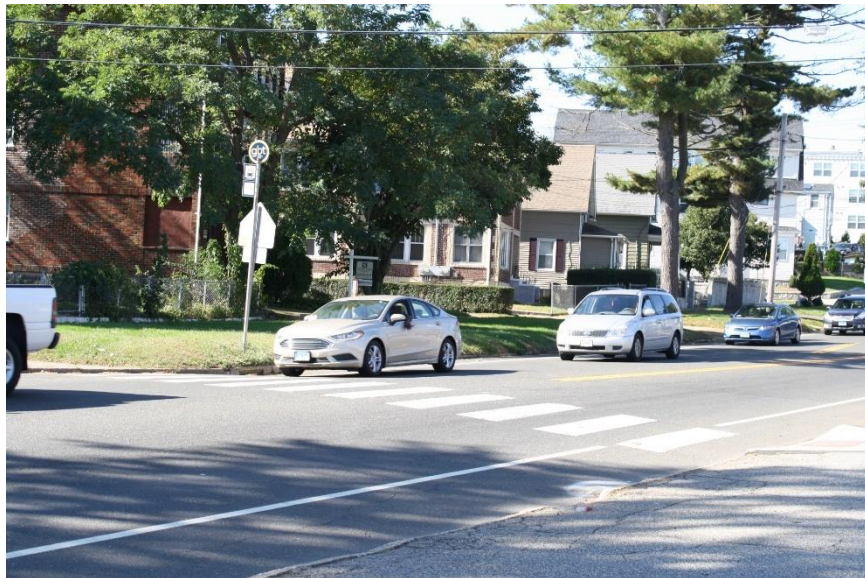
Exhibit 20: Crosswalk at Willow Street

- Missing pedestrian sign in the Route 1 southbound direction (was knocked down at time of RSA).
- Curb ramp missing at southern curb.
- Damaged bus shelter at the westbound bus stop.
- Crossing was observed to be very difficult during RSA assessment period. There are many dead trees and hanging limbs near the intersection. See Exhibit 20.

- 1) Consider striping new crosswalks across all side streets in study area. Prioritize crosswalks across side streets with significant traffic and/or crash history. This could include new side street crossings at Kent Avenue, Sage Avenue, Weber Street, and Bruce Avenue.
- 2) Install and/or replace all curb ramps in study area not up to ADA standards (if present). See Exhibit 28 for an example an ADA compliant curb ramp.
- 3) Coordinate traffic signals at East Avenue and Bishop Avenue.
- 4) Restripe roadway to include (refer to Exhibit 29 for a similar roadway configuration):
 - a) 2 x 11-foot travel lanes
 - b) 12-foot center turn lane
 - c) 2-foot shoulders
- 5) Repair damaged bus shelter at Route 1 and Willow Street in the southbound direction

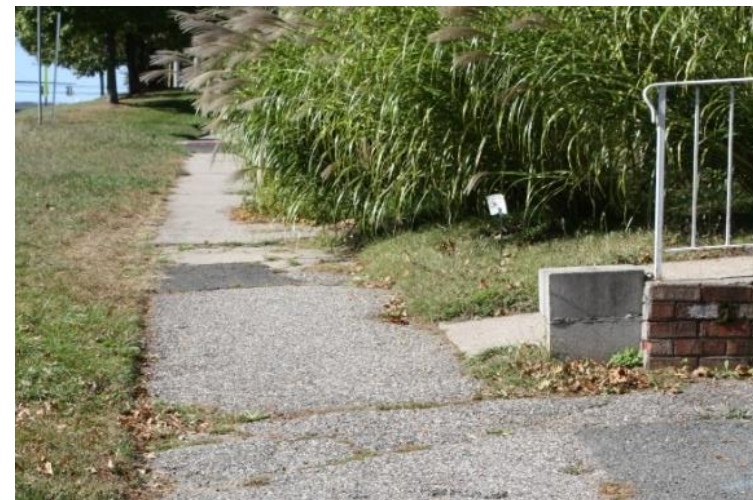
- Missing curb ramp on southwest corner.
- No crosswalks on any approach.
- Bus stops are separated from sidewalk without any clear accessible pathway. Riders were observed waiting for the bus in the grass buffer between the roadway and the sidewalk.
- Sidewalk on the northern side of Route 1 was observed to be in poor condition in some areas. See Exhibit 21.

Exhibit 21: Sidewalk in poor condition on the north side of Route 1

- 2) Rehabilitate all deteriorated sidewalk in study area. Coordinate rehabilitation of sidewalk with roadway reconstruction efforts.
- 3) Install pedestrian signal heads and crosswalks on all approaches at Bishop and East Avenue signals. Coordinate work on traffic signal equipment with roadway reconstruction efforts.

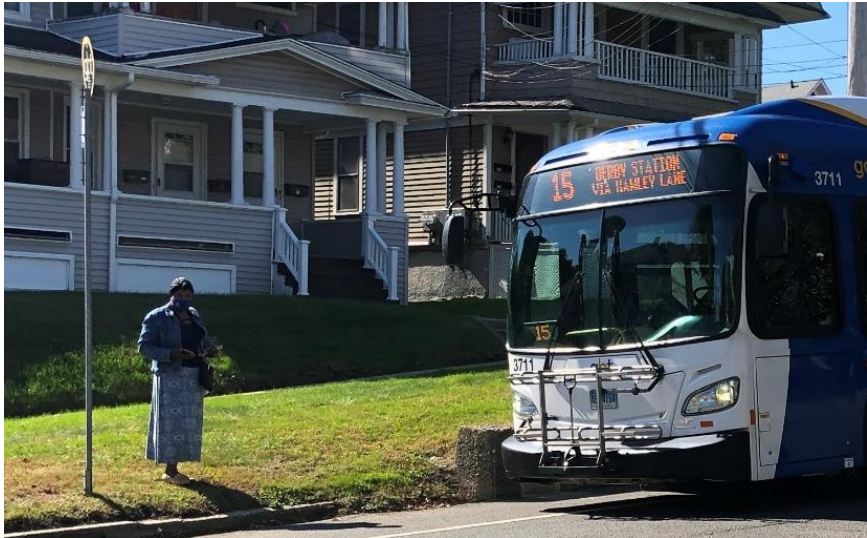
- No crosswalks on any approach.
- Stop bar at Boston Terrace is poorly located, drivers often roll past where pedestrians cross.
- Bus stops are separated from sidewalk without any clear accessible pathway. Riders were observed waiting for the bus in the grass buffer between the roadway and the sidewalk. See Exhibit 22.
- Sidewalk on the northern side of Route 1 was observed to be in poor condition in some areas.
- When buses stop, cars often try and pass by getting partially in the opposing travel lane.
- Stop bars are inconsistently placed relative to crosswalk.

Exhibit 22: Transit rider waiting for Greater Bridgeport Transit (GBT) Route 15 bus at Route 1 and Judson Place. Note the limited accessibility at the bus boarding location and the lack of connection to the sidewalk

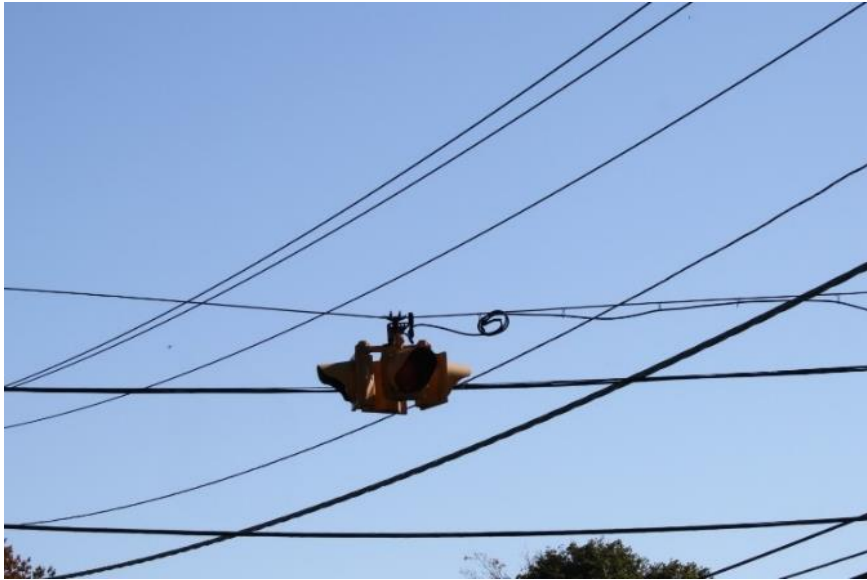
Exhibit 23: Inoperable flashing beacon at Ridgefield Avenue

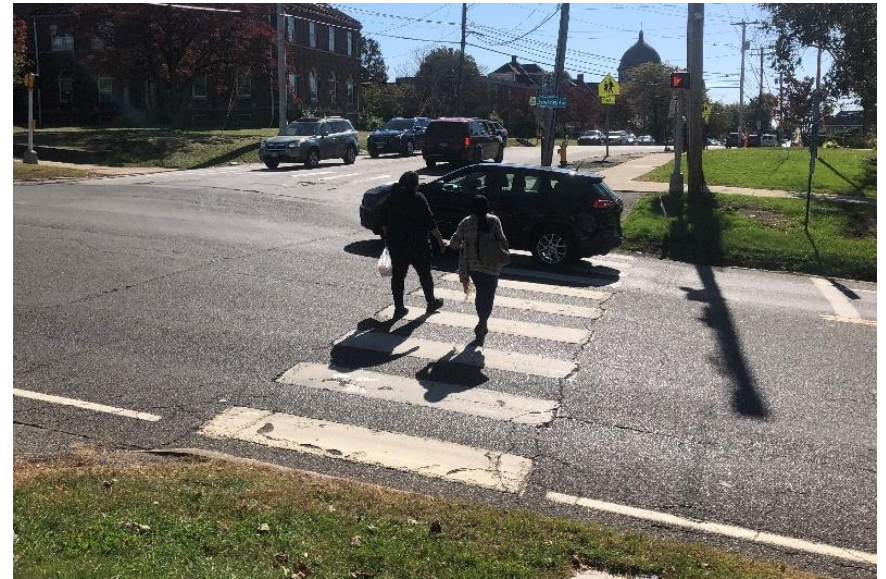
Exhibit 24: Crosswalk at Mill Hill Avenue

- Crosswalk across Route 1 (eastbound approach) does not have a curb ramp on northern curb and does not have an accessible curb ramp on the southern curb. See Exhibit 24.
- Pedestrian push button on the southwest corner is broken.
- Pedestrian signals not clearly illuminated on the eastbound approach. Sun glare makes it difficult to tell which indication is illuminated. CTDOT representatives stated these signal heads will get transitioned to light emitting diode (LED) signal heads in the future.
- Bus stops are separated from sidewalk without any clear accessible pathway. Riders were observed waiting for the bus in the grass buffer between the roadway and the sidewalk.
- Drivers were observed to turn right-on-red without stopping or yielding.
- RSA participants from the city noted that school pick up in this area frequently occurs on Route 1.

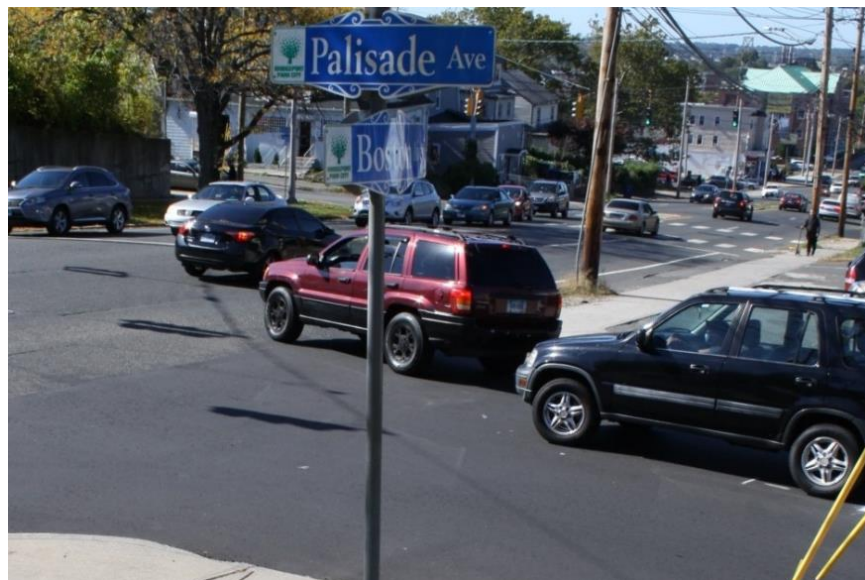
- The sidewalk on the northeast corner has a very steep incline to the intersection.
- No crosswalks on any approach.
- No pedestrian signal heads are provided at this intersection.
- Stop bar on the Route 1 southbound approach is set far back.
- The intersection works with the Central Avenue intersection as an offset intersection. There are high turning volumes. Participants of the RSA generally agreed it was difficult to tell when it was safe to cross the side streets at this intersection. See Exhibit 25.
- Higher traffic speeds were observed going downhill (Route 1 southbound).

Exhibit 25: Turning traffic at Palisade Avenue

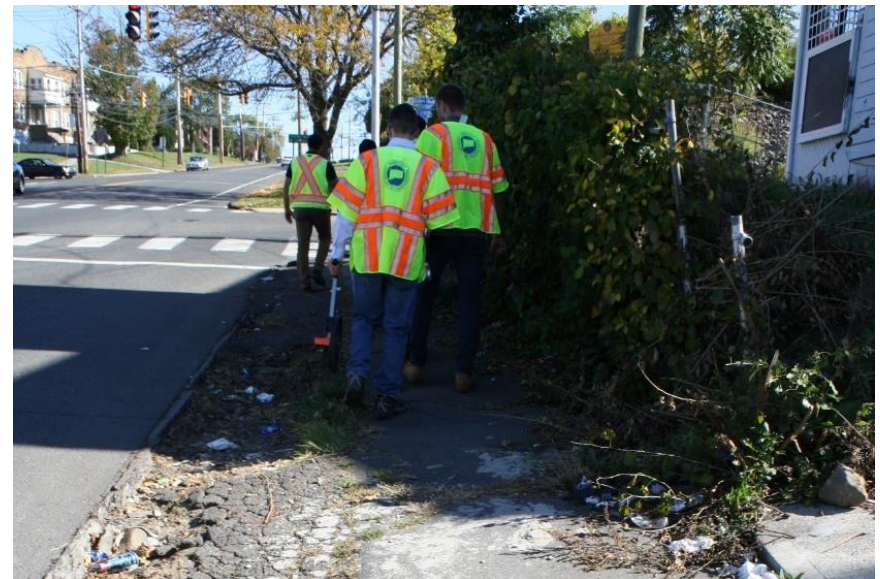
- Parking for 1439-1455 Boston Avenue is adjacent to sidewalk on northern side of Route 1. Vehicles must back out onto the sidewalk when leaving the property.
- Difficult to determine where curb cuts are located.
- No pedestrian signal heads are provided at this intersection.
- No crosswalk across Central Avenue.
- Poor sidewalk conditions located throughout this area. See Exhibit 26.
- Stop bar set too far back at intersection and sidewalk is offset.

Exhibit 26: Sidewalks in poor condition in the vicinity of Central Avenue

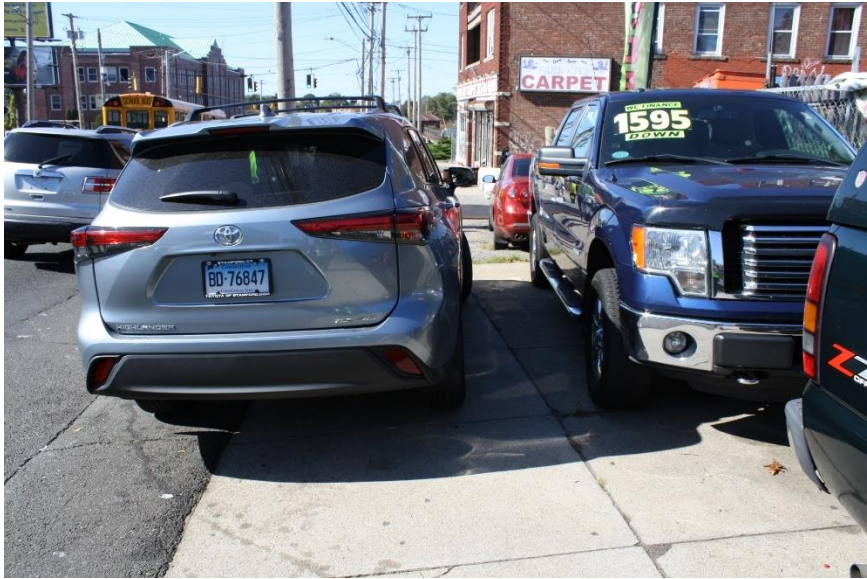
- Some properties in this area have parking that requires drivers to back up into Boston Road when leaving front-in parking spaces.
- Cars were observed utilizing sidewalk and ROW area to park cars. See Exhibit 27.
- U-turns common on Route 1 at Sheridan Street due to median.
- Missing crosswalks across all side streets in this area.

Exhibit 27: Parked vehicles on-sidewalk in the vicinity of Dover Street
