Bridgeport

Main Street on the east and west sides of Route 8 – Road
Safety Audit

September 9, 2016

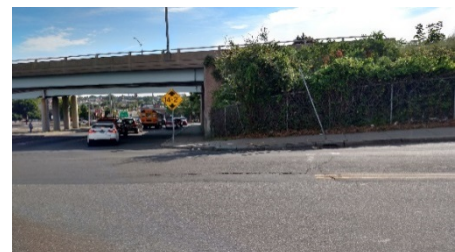
Figure 5. Intersection of Washington Avenue and Catherine Street

- There are no crosswalks at the Washington Avenue and Catherine Street intersection. (Figure 5)
- The sight lines for traffic heading south on Washington Avenue is restricted for right turning vehicles due to the highway overpass.

- The turning radius heading south on Washington Avenue and making a right hand turn onto Catherine Street is insufficient for commercial trucks and buses.

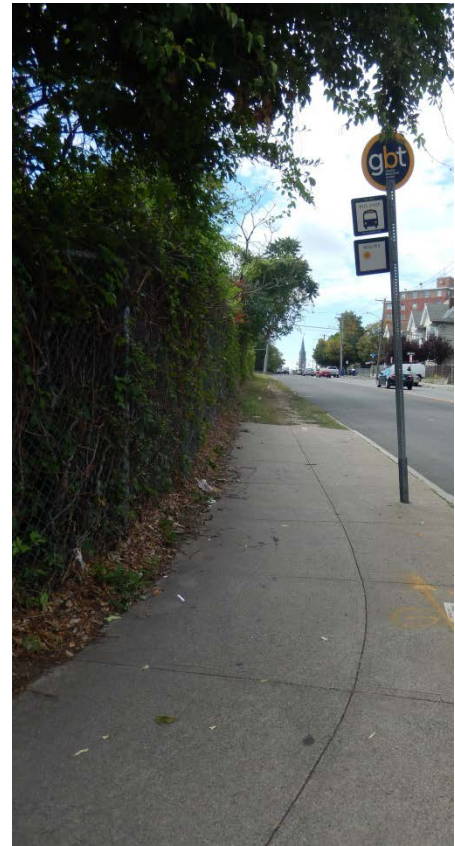
Figure 6. Bus Stop Waiting Area With No Amenities and Overgrown Vegetation

- There is virtually no bicycle infrastructure, bike lanes or shoulder striping. On the southeast corner of Catherine Street and Washington Avenue there is a public school bus stop that residents noted was extremely dangerous due to traffic, tight turning radius, and lack of buffer separating the road and sidewalk.

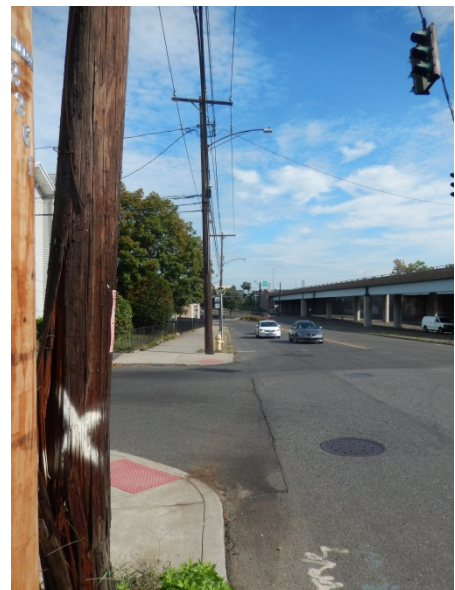
Figure 7. ADA Compliant Ramps on the West Side of Washington Avenue

- There are ADA compliant ramps at the northwest and southwest corners of Washington Avenue and Catherine Street but not the northeast and southeast corners. There are no pedestrian signals or push buttons to cross. (Figure 7)

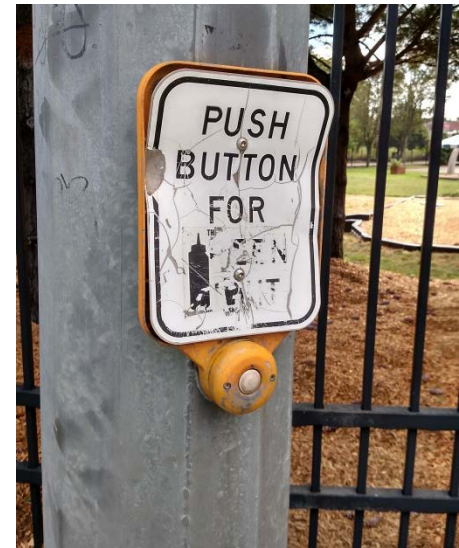
Figure 9. Broken Pedestrian Push Button

- There is only one pedestrian push button at this intersection (south-east corner) and it was broken. (Figure 9)
- There are no pedestrian signal heads.

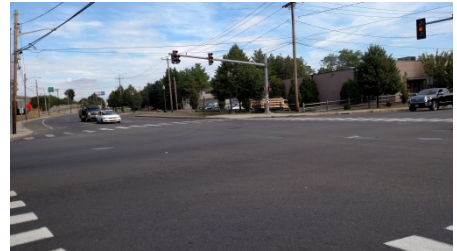
Figure 11. East Washington and Housatonic Avenue

- Housatonic Avenue and East Washington is a four way signalized intersection with marked crosswalks. The ramps lack tactile warning strips. (Figure 11)
- The pedestrian push buttons are tactile but not audible.
- There are pedestrian signals, but they are not countdown.
- The sidewalk between Housatonic Avenue and Main Street is in poor condition.

6. Replace the Pedestrian signal heads at Housatonic Avenue and East Washington Avenue with countdown ones. (Figure 27)
7. Install tactile warning strips where missing. (Figure 28)

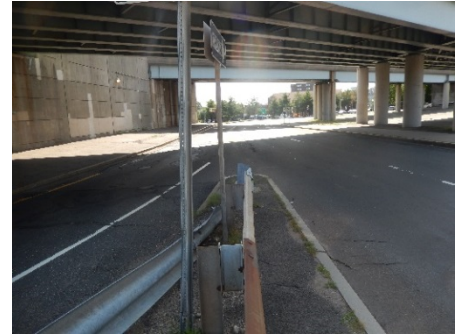
Figure 13. Route 8 Off-ramp and Main Street Merge

- Installing speed humps or tables was discussed. Speed tables with long approaches are favored over speed humps.
- The lack of signage where southbound Main Street merges with the Route 8 off-ramp causes confusion.

12. Install proper signage for southbound Main Street traffic that merges with Route 8 off-ramp, directing one of the flows of traffic to yield.
13. Repair broken sidewalk.

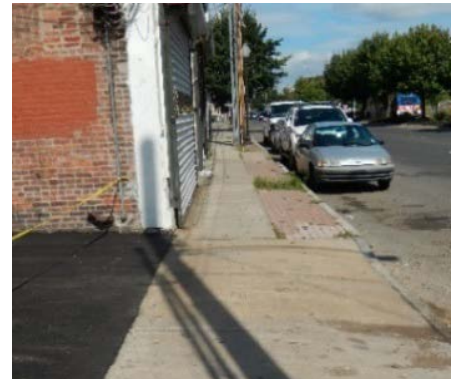
Figure 14. Main Street

- Main Street has sidewalks with some buffers on both sides of the street, no shoulder lines, intermittent on street parking, and faded pavement markings. (Figure 14)

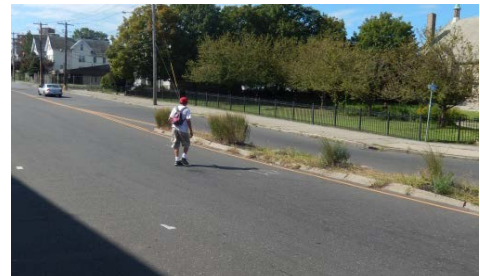
Figure 16. Individual Jaywalking Just South of Madison Avenue

- The Team noted that the majority of pedestrians in this corridor jaywalk and cross haphazardly, endangering the walkers themselves and drivers, primarily from the triangle area below the highway and across Main Street and the Route 8 on-ramp. Barriers need to be installed to limit/reduce this. Installing a crosswalk across the northern edge of Main Street is not advised due to the free flow movements.

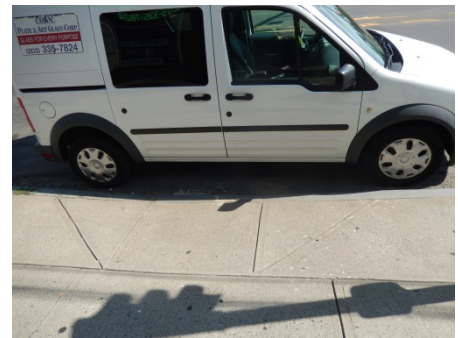
Figure 18. Vehicle Parked in Front of Ramp

- Parking is allowed on the west side of the street in the intersection. One vehicle was observed parking in front of the crossing ramp. (Figure 18)

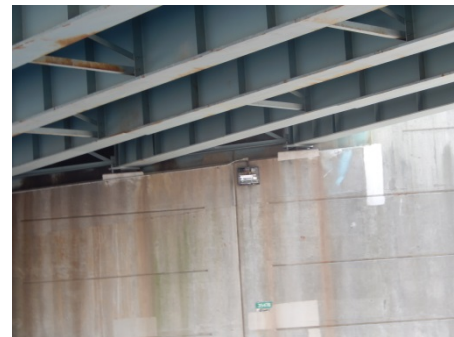
Figure 21. Light Out Under Bridge

- Several of the lights under the Route 8 bridge appear to be inoperative. (Figure 21)

14. Fix broken lighting under bridge.
