COMMUNITY
connectivity program

Danbury

Mill Plain Road and Saw Mill Road

July 12, 2016

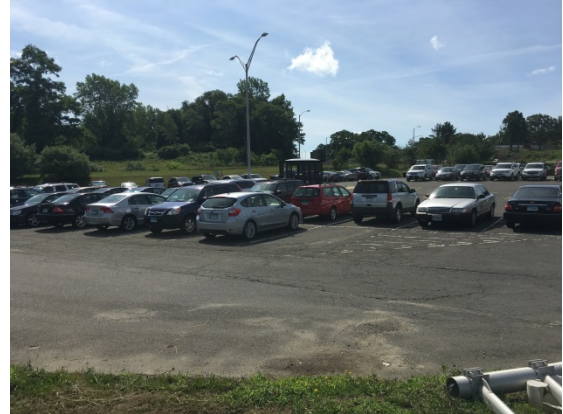
- On the southeast corner of this intersection, there is a commuter parking lot that is served by HART (#3 and Brewster Shuttle) (Figure 9).
- There are only sidewalks on the north side of Mill Plain Road between the shopping plaza and the hotel. There are sections with overgrown vegetation that block the pathway (Figure 10).

Figure 9. Commuter parking lot with bus stop

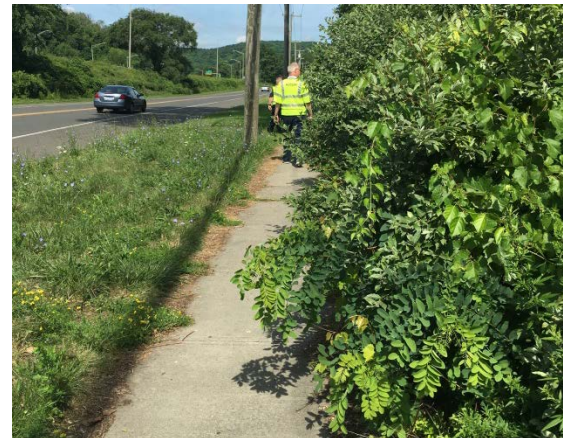
Figure 10. Overgrown vegetation

- 1) Trim overgrown vegetation on sidewalks along Mill Plain Road (Figure 17).
- 2) The City should request that when CTDOT upgrades the signals at the ramps for I-84 at exits 1 & 2 (project # 174-376), that the project be expanded to the adjacent intersections on Mill Plain Rd. near the shopping plaza at Saw Mill Road to include:
 - a) ADA compliant ramps with detectable warning strips (Figure 18).
 - b) ADA compliant signal heads with countdown (Figure 19).
 - c) ADA compliant pushbuttons in accessible locations (Figure 20).
 - d) Painted crosswalks across Mill Pond Road.

Figure 17. Trim areas with overgrown vegetation

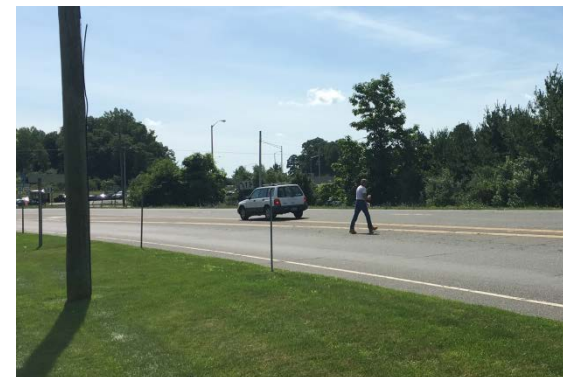
- A pedestrian was observed crossing Mill Plain Road mid-block (Figure 11).
- The sidewalks end west of the hotel property. Past this point, there is a steep drop-off in the area's topography north of the westbound lane. The HRRC rail line is located in this area and generally runs parallel with Mill Plain Road throughout the RSA area.

Figure 11. Pedestrian crossing Mill Plain Road

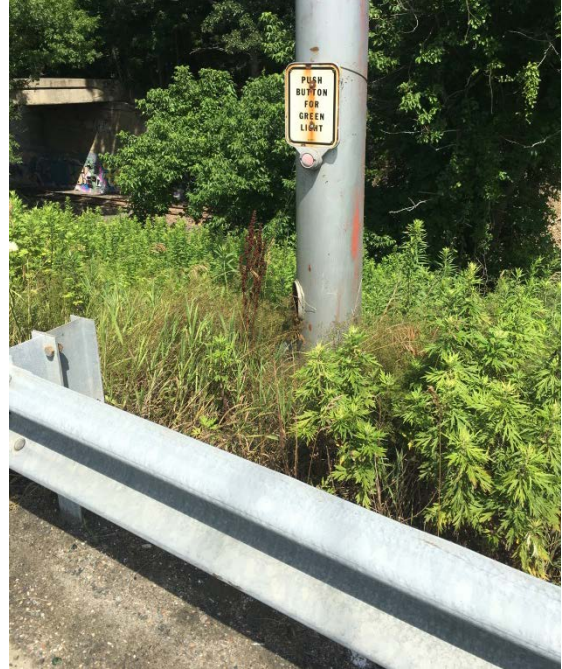
- At the Mill Plain Road and Saw Mill Road intersection, the pedestrian pushbuttons are located in inaccessible locations. On the westbound side, the pushbutton is located behind the guardrail (Figure 12). Pedestrians must cross four lanes of traffic at this point.

Figure 12. Inaccessible pushbutton

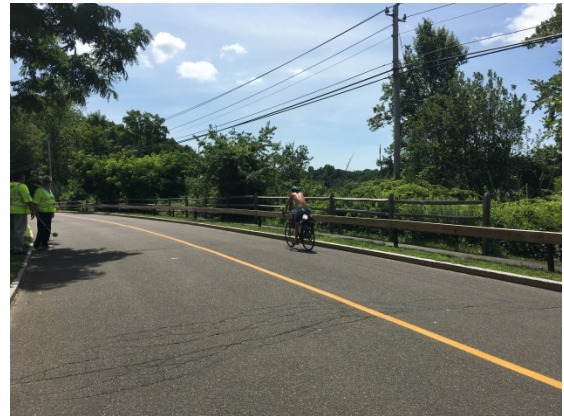
- Heading southbound on Saw Mill Road, the roadway narrows and is constrained by the I-84 bridge. Three travel lanes run under the bridge, with shoulders approximately 1 foot wide. Concrete barriers line the bridge walls taking up potential shoulder room.
- Further south on Saw Mill Road are multiple housing complexes and large businesses. The residential developments along Woodland Road and Reserve Road have thousands of residents.
- There is sidewalk along the west side of Saw Mill Road between Reserve Road and Turner Road. It turns west on the north side of Turner Road as far as Barnum Place.
- On the south side of Turner Road there is an asphalt bike path between McKeon Place and Barnum Place (Figure 13).

Figure 13. Turner Road

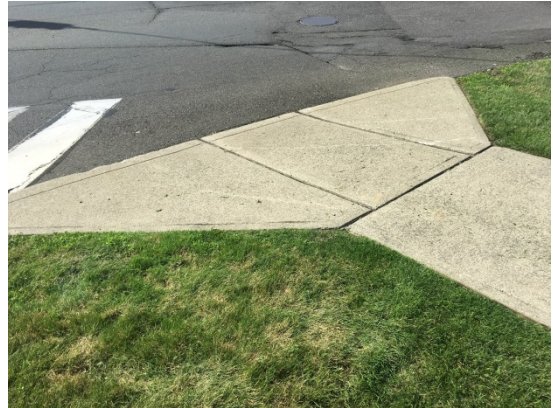
3. Some crosswalks are not ADA compliant. Upgrades to the crosswalks throughout the corridor are inconsistent. Some pushbuttons are located in areas that are inaccessible to pedestrians with disabilities. This may result in a challenging environment for pedestrians to navigate.

Figure 14. Ramp without detectable warning strip

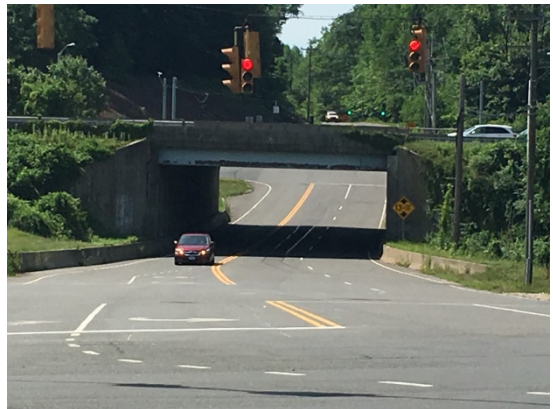
4. While the shoulder width on Mill Plain Road is wide enough for bike lanes, there are more constraints on Saw Mill Road, particularly under the I-84 Bridge.

Figure 15. Bridge over Saw Mill Road

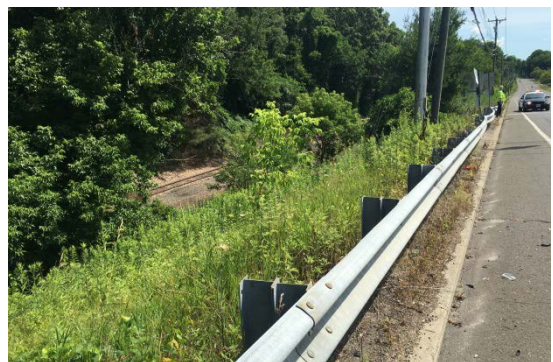
5. There are topography challenges along the corridor. Primarily there is a steep grade between Mill Plain Road and the HRRC rail line (Figure 16) that would make it difficult to construct a sidewalk. However, the roadway is wide in this section and could be narrowed to provide space for a sidewalk.

Figure 16. Steep grade between Mill Plain Road and rail line
