# New Fairfield

Route 37 – Road Safety Audit

April 24, 2017

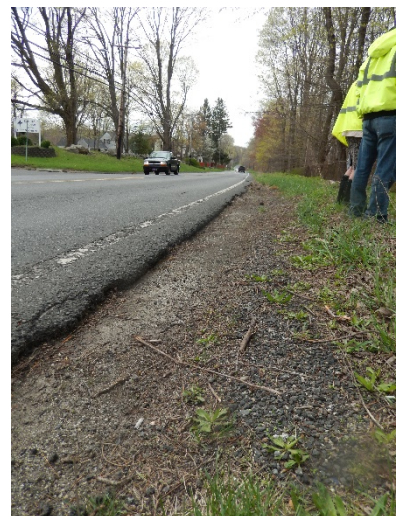
Figure 8: Pavement conditions along Route 37

- In general, Route 37 needs improvement and better accessibility.
- Sections of the corridor have drainage issues, pavement edge drop-off issues, and areas of crumbling asphalt (Figure 8).

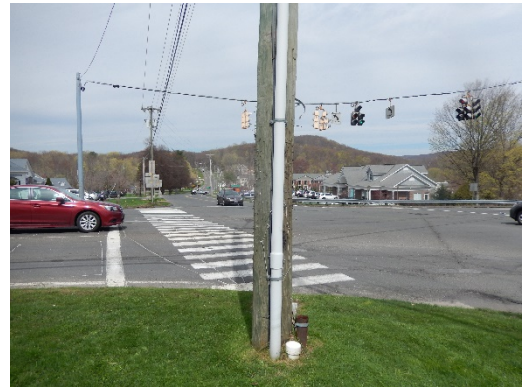
Figure 9: Route 37/ Brush Hill Road

- Four-way signalized intersection (Figure 9).
- Crosswalks and green light activated buttons.
- Minimal shoulder along the northbound travel lane is at the southern side of junction.
- Intersection will be upgraded per Projects 0174-0405 and 0174-0418.

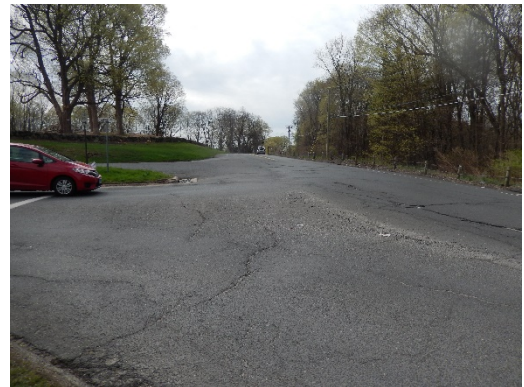
Figure 10: Saw Mill Road and Route 37

- Stop controlled intersection (Figure 10).
- Vertical and horizontal curvature along both approaches.
- Town wants to provide a safe crossing to connect to Saw Mill Road.
- Utility poles and grading issues along west side (Figure 11).
- Adequate sight distance for northbound crossing looking south, crosswalk is feasible at this site with adequate advanced crossing

warnings.

- Heavy traffic noted at this intersection.
- Cable and wood guardrail system on the west side southbound side along this section of Route 37.

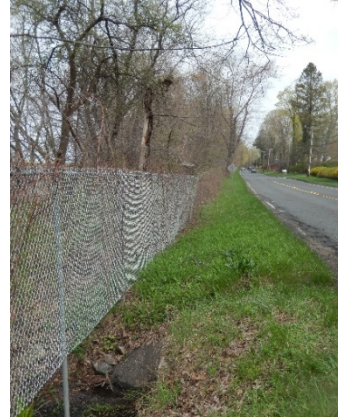
**Figure 12: west side of Route 37 north at Reservoir View Drive**

- Stop controlled intersection.
- Utility poles on northbound side.
- Northbound shoulder measures 5' and the south bound measures 2'.
- Distance varies from 4' to 11' from the edge of the road to the fence (Figure 12).

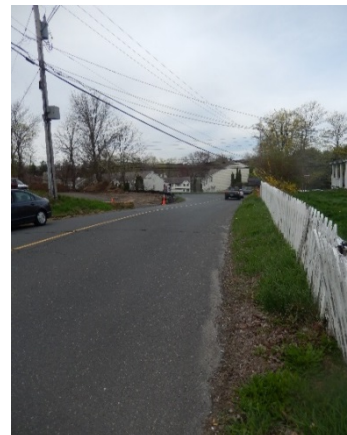
**Figure 13: Bear Mountain Road**

- Stop controlled intersection.
- Bear Mountain Road leads to Bear Mountain Park; there are no sidewalks (Figure 13).
- Shoulders measure 4' in northbound lanes, and 3' in southbound lanes.
- Empty grassy lot owned by the Town of Danbury on the western corner; possible site for a trail parking lot.
- Sidewalk begins on the southbound side of this intersection (Figure 14).

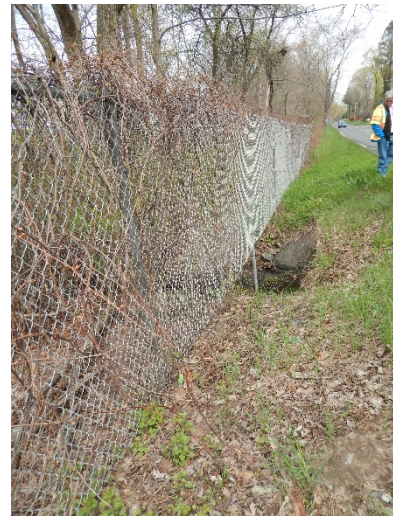
Figure 15: Culverts along Route 37

- textured crosswalk or stamped concrete.
- Culverts would have to be considered in the design of trails (Figure 15).
- Environmental impact study may be warranted due to proximity to Margerie Lake Reservoir.
