# STAMFORD ROAD SAFETY AUDIT

ROUTE 137 (WASHINGTON BOULEVARD)

NOVEMBER 2023

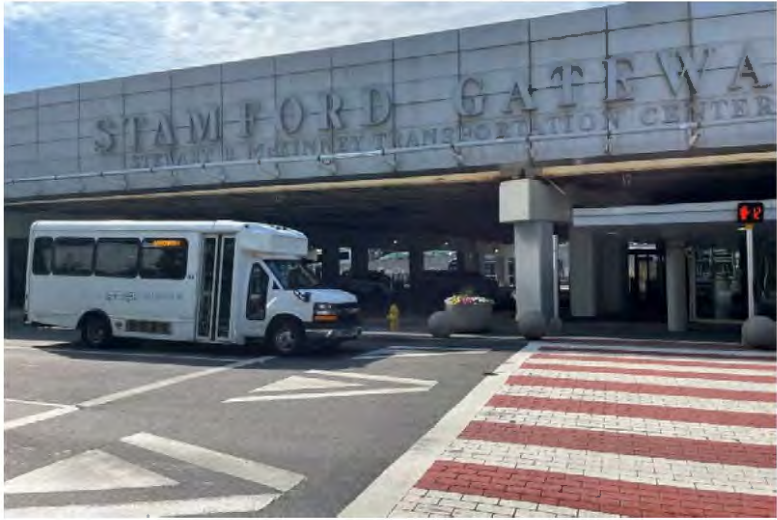
- This intersection is near to the mid-block crosswalk of North State Street between the Transportation Center and a private pathway to points further north along the property of 677 Washington Boulevard. This is a very busy and most common walking route for people going to or from the Transportation Center and Downtown Stamford. This crossing features a raised crosswalk and an automated pedestrian detection system. RSA participants from the city noted that these features have greatly improved pedestrian safety at this location. Exhibit 30 displays a photo of this location.

*Exhibit 30: Crosswalk with an automated pedestrian detection system at Stamford Transportation Center entrance on North State Street*

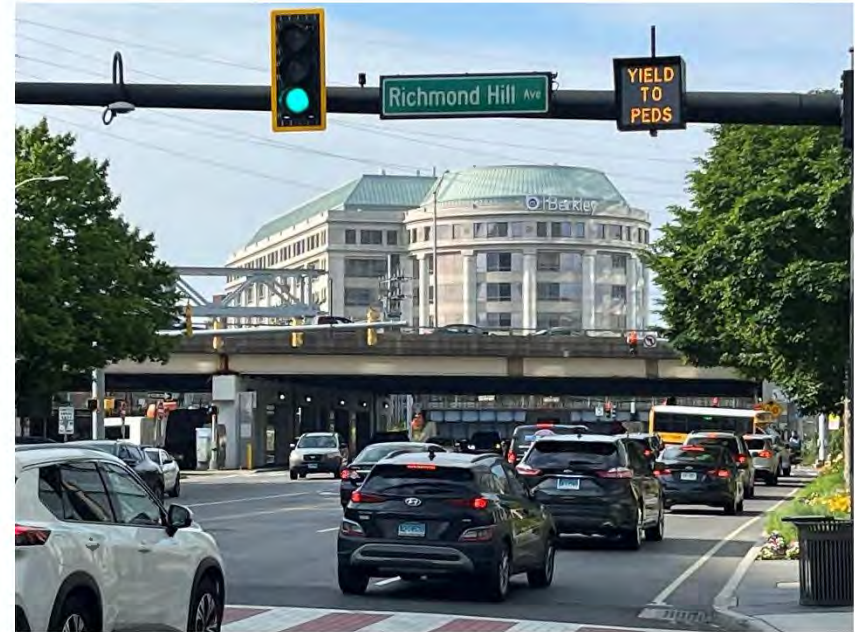
Exhibit 31: Pedestrian detection crosswalk at Stamford Station entrance on North State Street

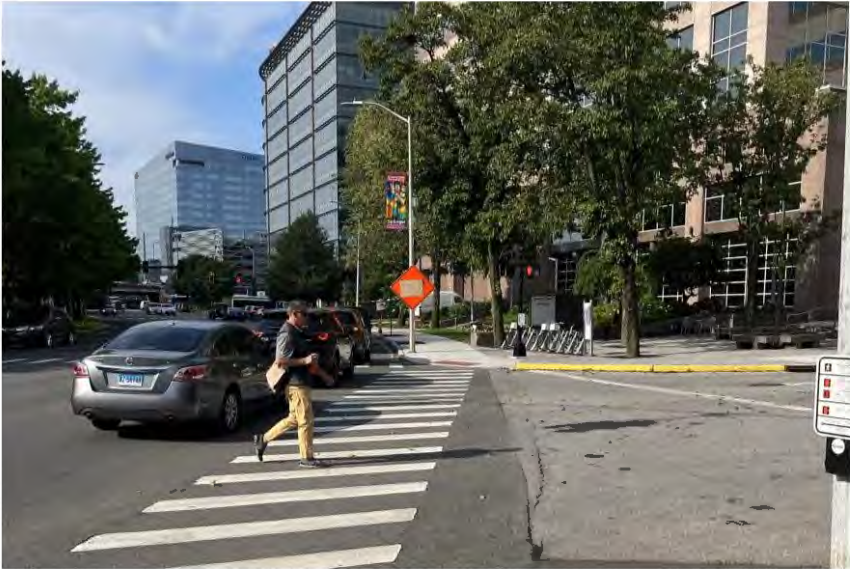
- RSA participants suggested removing the option to turn left from Washington Boulevard to Division Street. Exhibit 32 displays the view south at the Division Street intersection.
- Traffic often backs up past Richmond Hill Avenue past this intersection.
- Traffic signal equipment at this intersection is older than other intersections. The intersection does not feature any dynamic “No Turn on Red” signs as found in other intersections.

*Exhibit 32: Washington Boulevard looking south through the intersection of Division Street.*

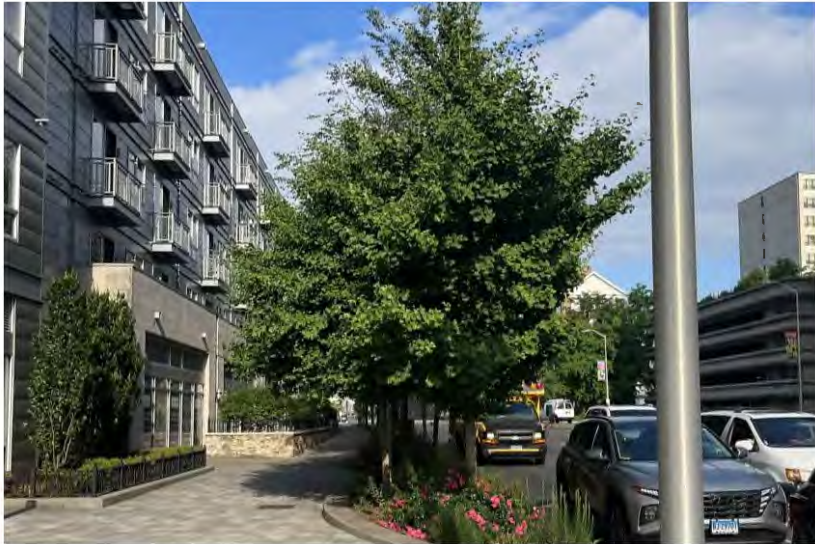
*Exhibit 33: Separation and landscaping near 75 Tresser Boulevard*

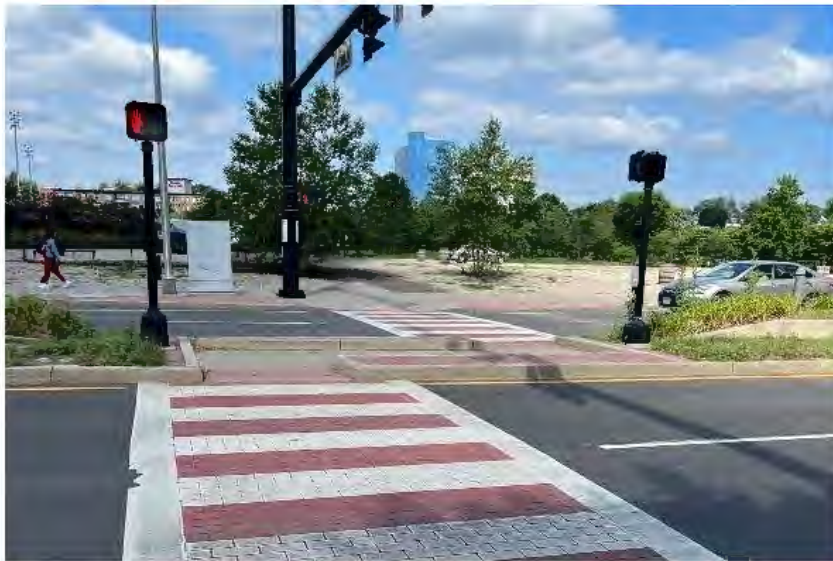
- RSA participants noted that while the staggered crosswalk protects pedestrians, it is not very accessible for all pedestrians. Residents with physical impediments and wheelchairs have trouble maneuvering the crosswalk. Exhibit 37 displays an example of this crosswalk.
- The landscaped median needs to be trimmed in this area to allow for better pedestrian visibility.
- RSA participants also suggested that the connection between Mill River Park and the rest of the parks system should be considered.
- Some driveways are not constructed at sidewalk grade. These should be located at sidewalk grade in the future to preserve the pedestrian space.

*Exhibit 37: The Pedestrian Hybrid Beacon (or "HAWK") in front of Mill River Park*

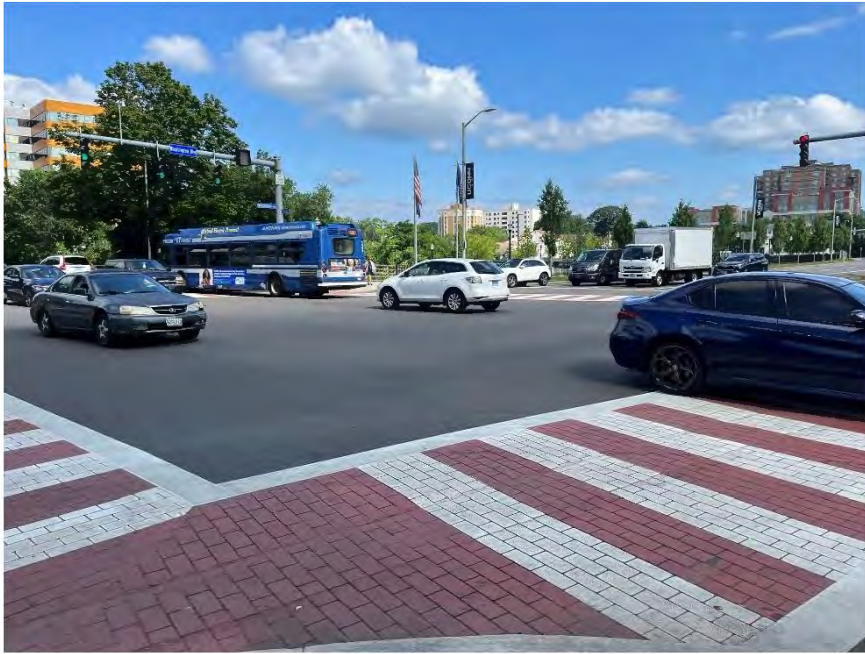
- Right turns are problematic at this intersection as well. All approaches, to this intersection except the eastbound approach, have a dedicated right-turn lane. Vehicles frequently fail to yield to pedestrians in this configuration.

Exhibit 38: Broad Street and Washington Boulevard intersection, view north

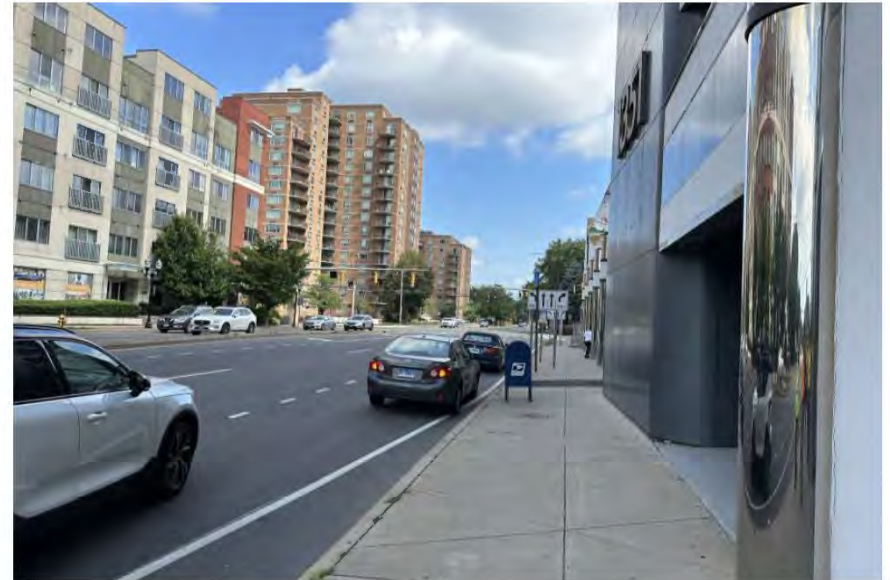
Exhibit 39: Washington Boulevard looking north towards North Street

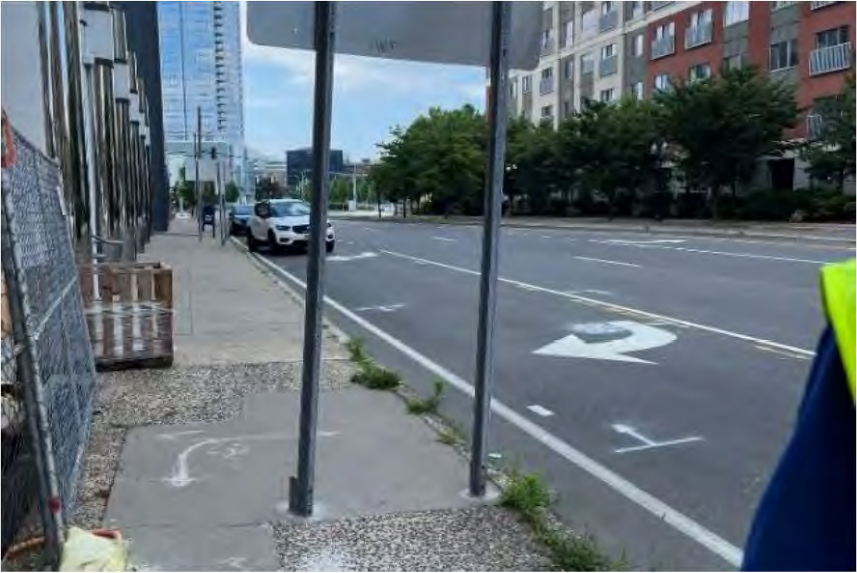
- RSA participants noted that there needs to be consideration of left turn signals for North Street.
- Some areas along the sidewalk network need to be updated, including those shown in Exhibit 40.

Exhibit 40: Sidewalk near the North Street intersection

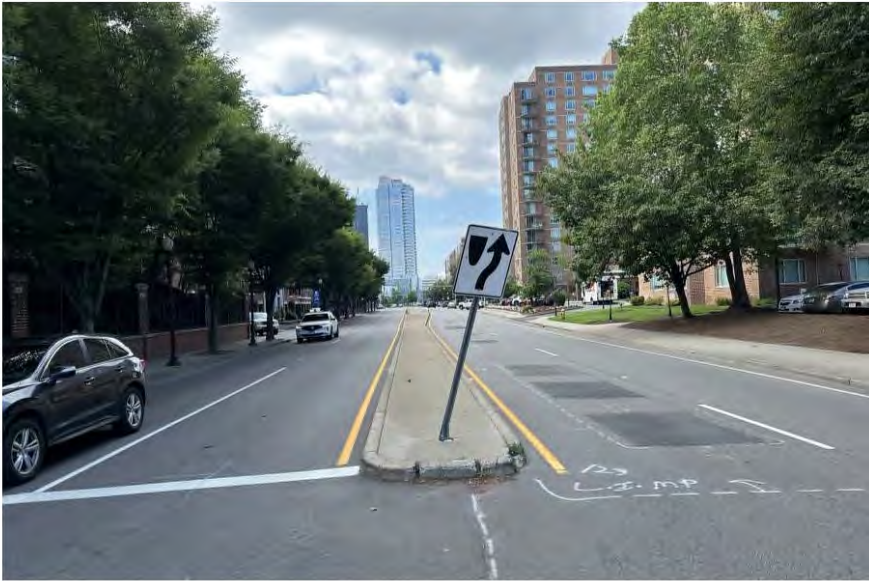
- RSA participants discussed the median island in this section. While this is visually unappealing, participants noted that this does help with eliminating some left-turn movements from the apartment drop off areas. Exhibit 41 displays this median.
- This area is among the narrowest sections of Washington Boulevard in our study area.
- Sidewalks in this area are narrow and adjacent to traffic.

Exhibit 41: Washington Boulevard, view south, from the intersection of Hoyt Street

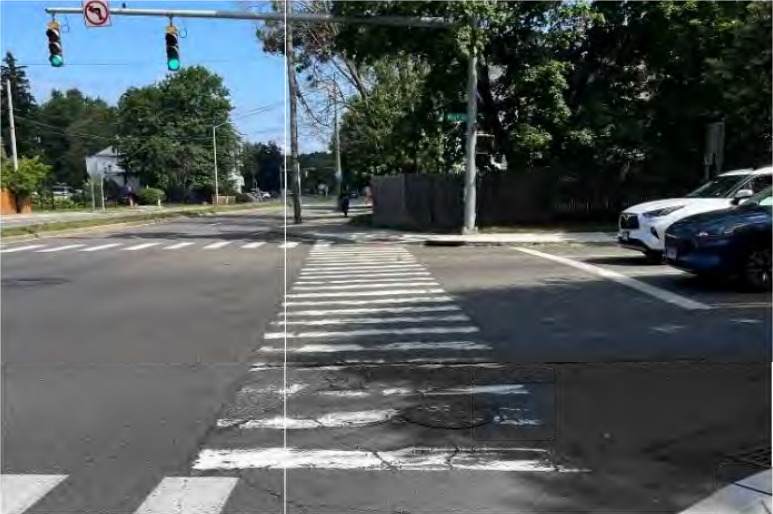
Exhibit 42: Hoyt Street Intersection with the no left turn sign onto Linden Place
