COMMUNITY
connectivity program

Stonington

Route 27 – Road Safety Audit

September 28, 2016

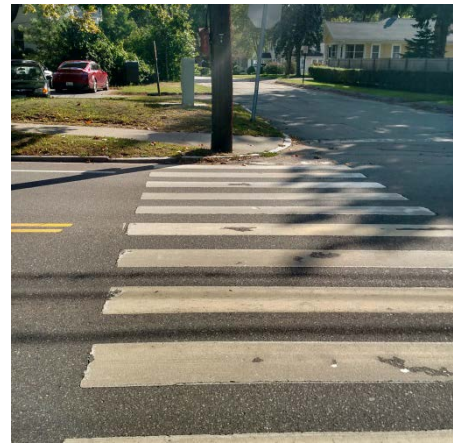
Figure 6. Crosswalk at Rossie Street Ending at Utility Pole

- At Rossie Street there is a crosswalk. On the east side the crosswalk ends at a utility pole (Figure 6). The ramps are not ADA compliant, are oriented incorrectly, and lack detectable warning strips. There is an advanced warning sign for this crosswalk northbound but it is blocked by the tree canopy. There is not a crosswalk across Rossie Street, although there is a non-compliant ramp on the south corner.

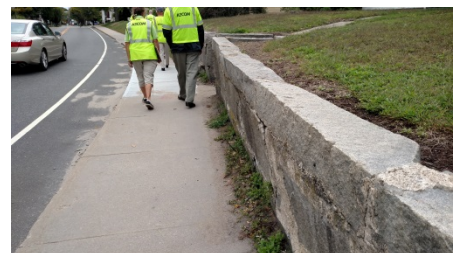
Figure 7. Retaining Wall Against Sidewalk

- The snow shelf on the west side of Route 27 ends at Bruggeman Place and begins again at Isham Street.
- South of The Seaport, on the west side the sidewalk width becomes five feet with concrete curbing. Between the Seaport and Isham Street there is no room to widen the sidewalk due to the side slope and retaining walls (Figure 7).

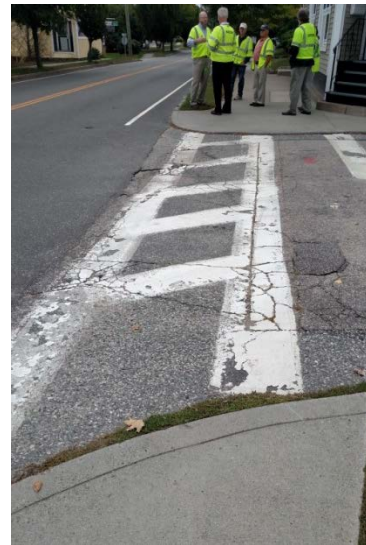
Figure 8. Crosswalk Across Isham Street

- The crosswalks across Isham Street and Oak Street are narrow and the road is in poor condition, resulting in uneven pavement. There are no tactile warning strips. (Figure 8).

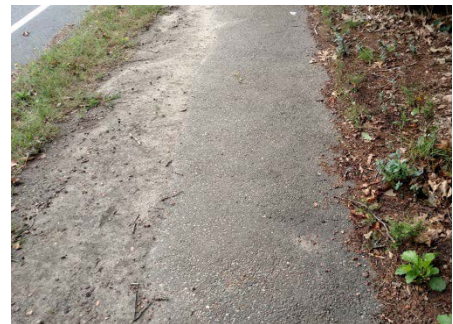
Figure 10. Clearing and Grubbing Needed on Sidewalk

sidewalk is in poor condition and dirt/grass encroaches on it. (Figure 10).

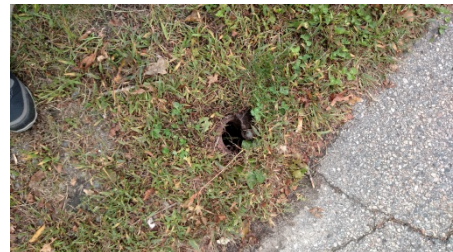
Figure 14. Old Water Valve

- There is an old water valve which is missing its cover and has been filled in with dirt (Figure 14).
- At Church Street the sidewalk becomes concrete and is five feet wide.

29. Remove the unused telephone pole in the northeast corner of Isham Street and Route 27.
30. Contact the water company to repair the water valve with a missing cover.

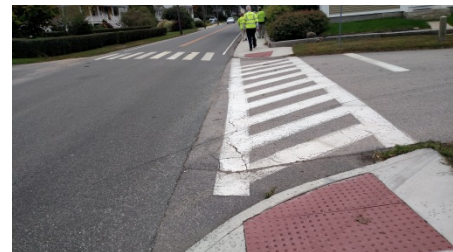
Figure 15. Church Street Intersection

- There is a crosswalk across Church Street with ramps and tactile warning strips (Figure 15).
- There is a crosswalk across the south leg of Route 27 at Church Street. It has a poorly aligned ramp on the west side and no ramp or sidewalk on the east side.

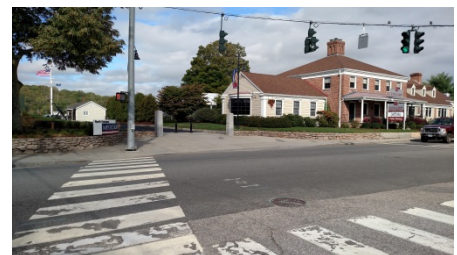
Figure 17. Route 27 and Rossie Pentway Intersection

- This signal has an exclusive pedestrian phase. There are crosswalks across Rossie Pentway and the southern leg of Route 27.
- The pedestrian signal heads are not count down, the pushbuttons are not tactile and the landing ramps do not have tactile warning strips.

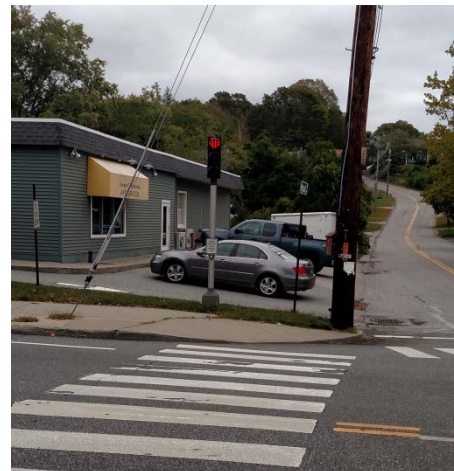
Figure 23. Lack of Pedestrian signal Heads

- There are crosswalks across Mistuxet Avenue, Willow Street and the northern leg of Route 27.
- The pedestrian push buttons are the older "Push Button for Green Light" style. There are no pedestrian signal heads. (Figure 23).

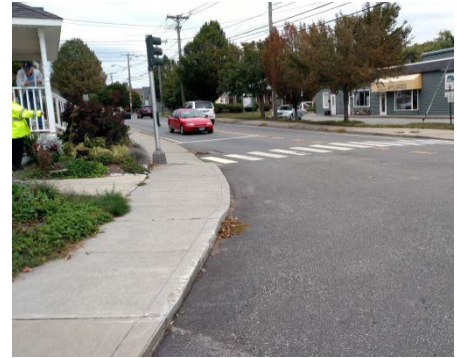
Figure 24. Driveway in Intersection

- The northwest corner has a very large turning radius.
- The ramps lack tactile warning strips.
- There are cat tracks through the intersection.
- There is a driveway within the intersection at the northwest corner. Vehicles back out of the property into the intersection from this driveway. (Figure 24).

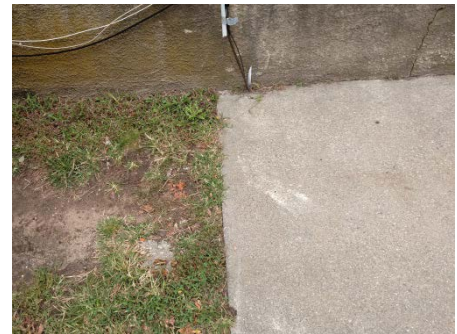
Figure 25. End of Sidewalk

- The sidewalk on the west side ends 50 feet before the intersection (Figure 25).
- This signal has an exclusive pedestrian phase. There is a long crosswalk across Route 27. It is faded, and lacks ADA compliant ramps on either side. The crosswalk across Route 1 is on the western leg. The southern side of the crosswalk does not connect to a sidewalk and has no ramp.
- The pedestrian signal to cross has 7 seconds of walk time, followed by 16 seconds after the warning hand appears. This does not appear to be enough time to cross. The crosswalk across Route 27 is 84 feet and across Route 1 is 35 feet.
- The pedestrian signal heads are not count down and the push buttons are not tactile.
- The push button in the northwest corner is far from the crosswalk.
- The pedestrian phase is not called quickly upon pushing.
- The sidewalk location is not well defined on the northwest corner.

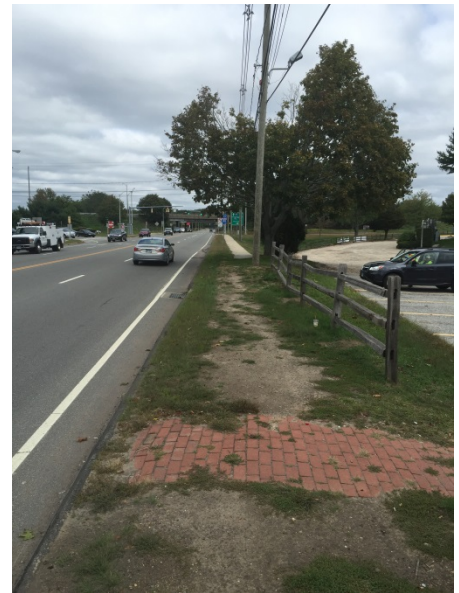
Figure 27. Goat Path to Sidewalk

- There is a worn path along the east side of Route 27 that connects the crosswalk with the sidewalk, which ends 200 feet to the north (Figure 27).
- The channelizing island does not provide a sense of refuge for pedestrians, it is unwelcoming. It does have a pedestrian signal head and push button. It is unclear which crossing the button is for. (Figure 28).
