Windham

Main Street (Route 66) – Road Safety Audit May 3, 2016

OFFICE OF INTERMODAL PLANNING BUREAU OF POLICY AND PLANNING CONNECTICUT DEPARTMENT OF TRANSPORTATION

With assistance from AECOM Transportation Planning Group

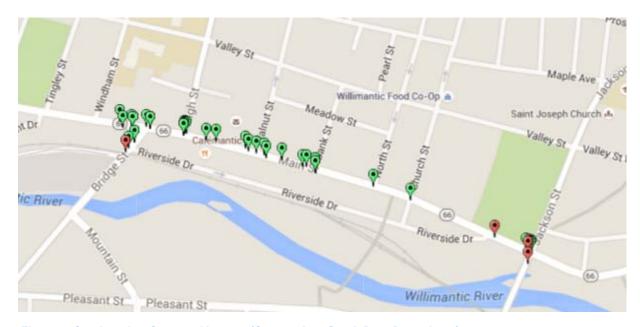
Figure 3. Crashes that Occurred in 2015 (Connecticut Crash Data Repository)

As noted previously, traffic volumes are significant at this location. Crash history shows that the most frequent crashes are rear-end collisions (32%) and they are generally clustered around the intersections along Main Street (Figure 3). Approximately two-thirds of accidents occurred between 9:00 AM and 4:00 PM; this may be attributed to commuting, commercial truck traffic, shopping, and school activities. While the majority of crashes resulted in property damage only, 14 crashes did cause injuries to involved parties (Table 1). Although the largest number of crashes involved rear-end collisions (Table 2), it should be noted that there were a considerable number of crashes that involved parking (10 crashes), backing (9 crashes), and vehicles sideswiping in the same direction (19 crashes).

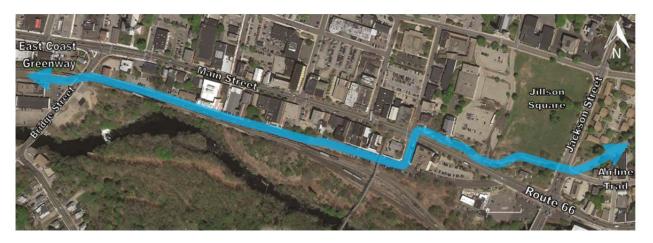
Figure 15. Proposed Trail Connection

- 6. There is an alleyway connecting Riverside Drive to the intersection of Main Street and North Street; however, the slope is steep and is not currently conducive to use as a trail connection.
- 7. The main issue Windham faces is identifying a logical and safe connection between the East Coast Greenway (ECG) and the Airline Trail. The following alignment was discussed and it was agreed this could provide the safest connection between the two trails:
 - ECG trail cross Bridge Street onto Riverside Drive (Figure 14) – head north onto Church Street Extension – cross Main Street – head east towards Jackson Street traveling on existing pathways in Jillson Square – cross Jackson Street – connect to Airline Trail on Union Street (Figure 15).

- 1. Establish trail connection between East Coast Greenway and Airline Trail. From the terminus of the East Coast Greenway, trail users will cross Bridge Street onto Riverside Drive. Pedestrians and cyclists will travel on Riverside Drive and turn north on Church Street (Figure 26) towards Main Street. At this point, pedestrians and cyclists could use the pedestrian crossing signal to cross northbound on Main Street and then head east towards Jillson Square. Pedestrians and cyclists can use the existing pathways in Jillson Square (Figure 27) to continue east towards Jackson Street. From here, trail users can cross Jackson Street to connect to the start of the Airline Trail.
