CONNECTICUT  
DEPARTMENT  
OF  
TRANSPORTATION

CONDITION INSPECTION  
CANNONDALE STATION

**CONN. DEPT OF TRANSPORTATION  
STATION INSPECTION**

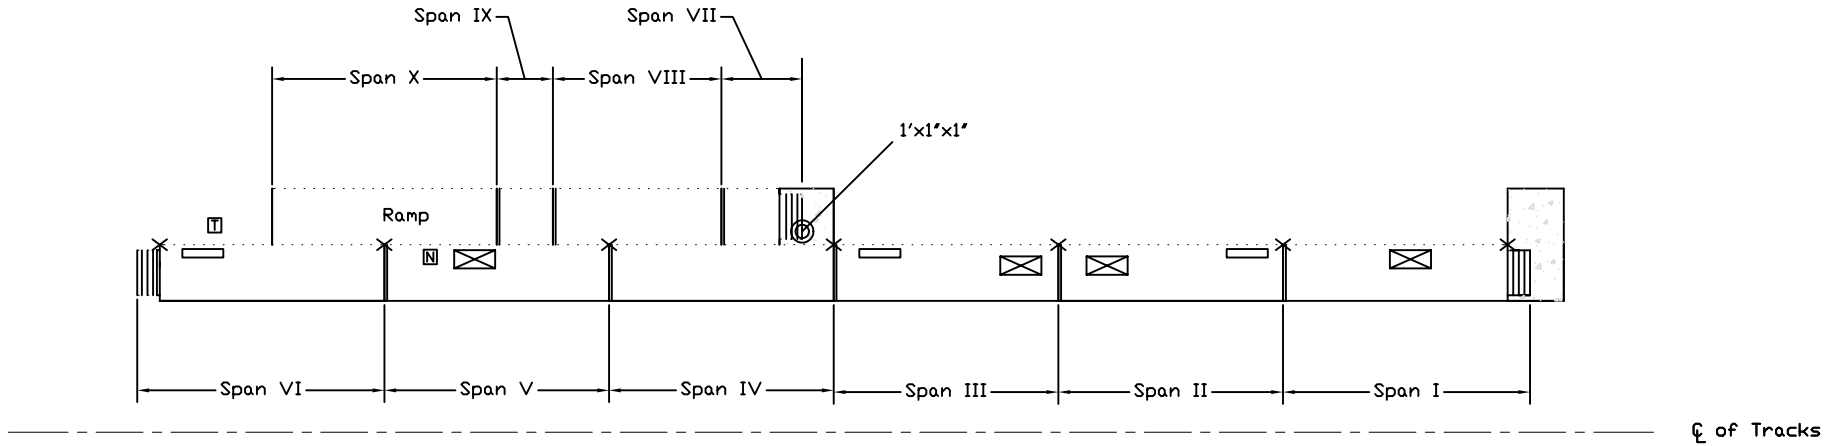
Cannondale Station  
Platform Plan

1. Every joint is damaged. It is either uplifted or sunken in.

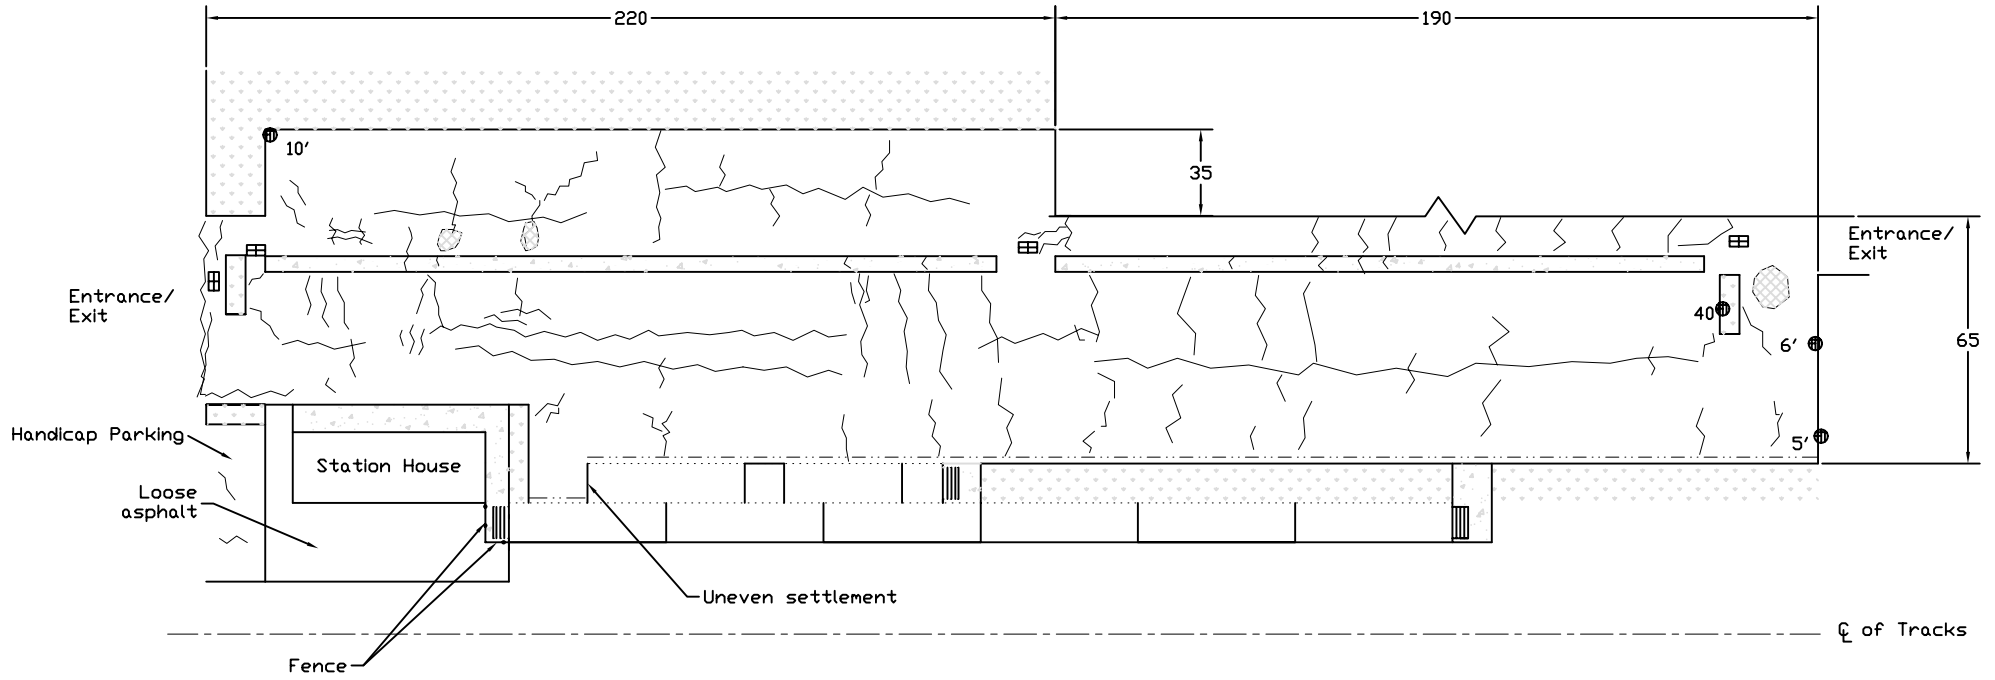
Cannondale Station  
Quadrant I Plan

1. 40% of the asphalt pavement exhibits cracks

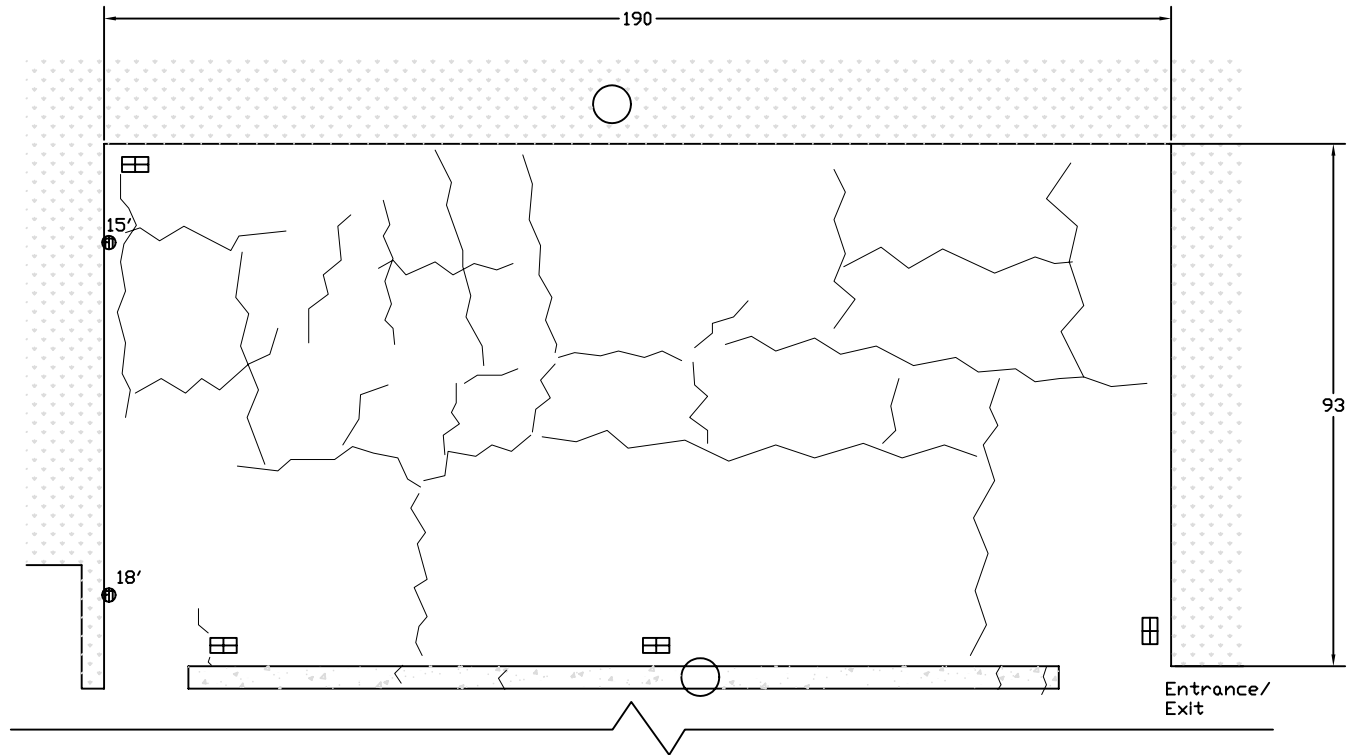
Cannondale Station  
Quadrant II Plan

1. 30% of the asphalt pavement exhibits cracks

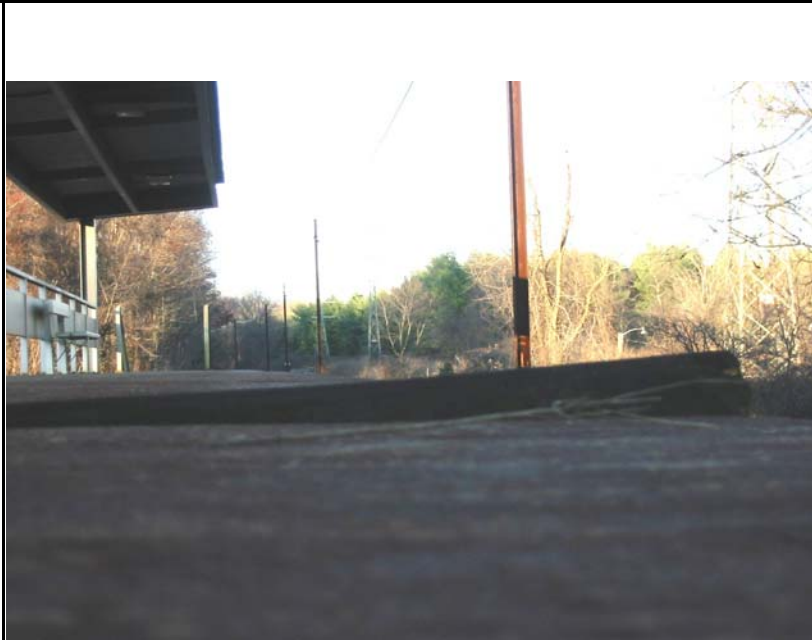
PHOTO NO. 9

Description: \_\_\_\_\_  
The joint in Span III is  
uplifted and can be  
physically moved out of  
its location

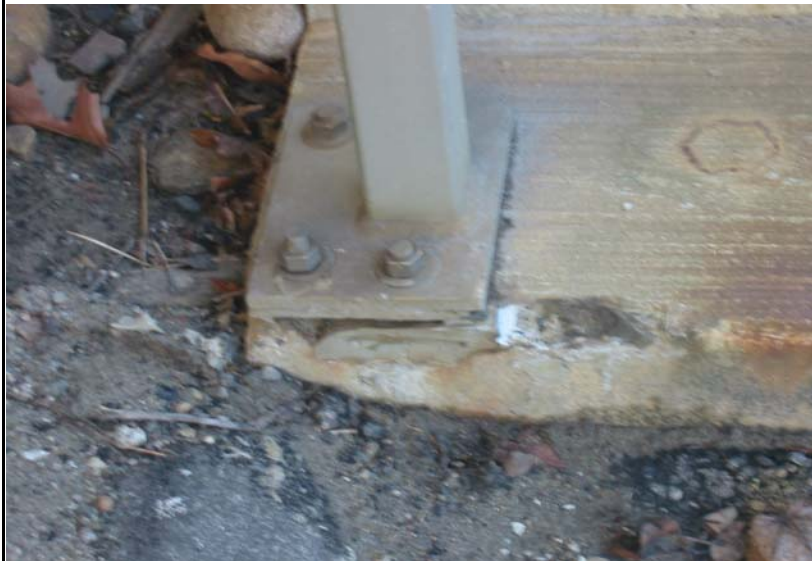
PHOTO NO. 10

Description: \_\_\_\_\_  
Spalled concrete  
(1'x1"x1") located at the  
at the stairs. The base  
plate of the railing is not  
fully supported

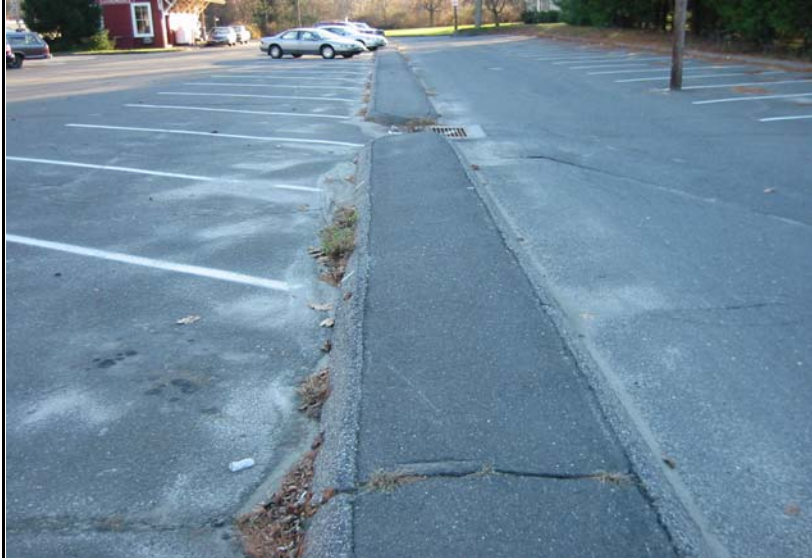
PHOTO NO. 15

Description: \_\_\_\_\_  
Typical crack with  
vegetation growth in the  
asphalt sidewalk / median

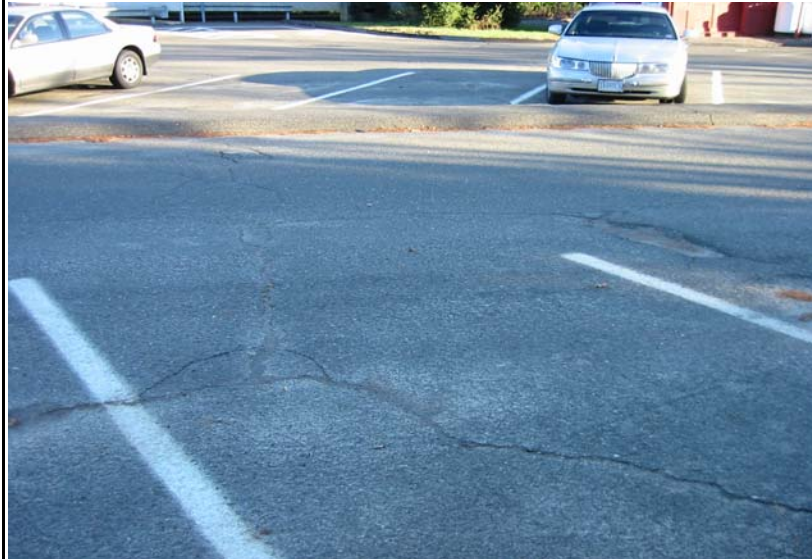
PHOTO NO. 12

Description: \_\_\_\_\_  
Pothole 4'x1'x2" and  
typical cracks throughout  
Quad I

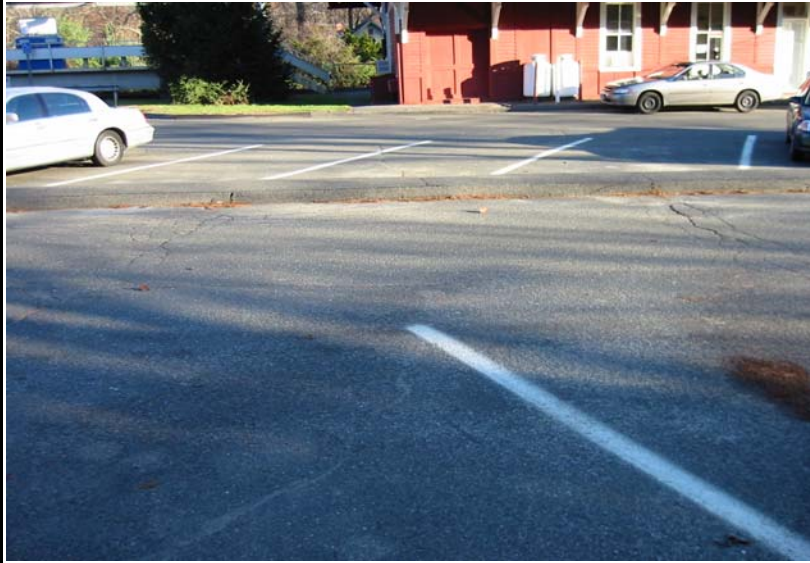
PHOTO NO. 13

Description: \_\_\_\_\_  
Typical map cracking in  
Quad I. Note that  
similar cracking exists  
in Quad II

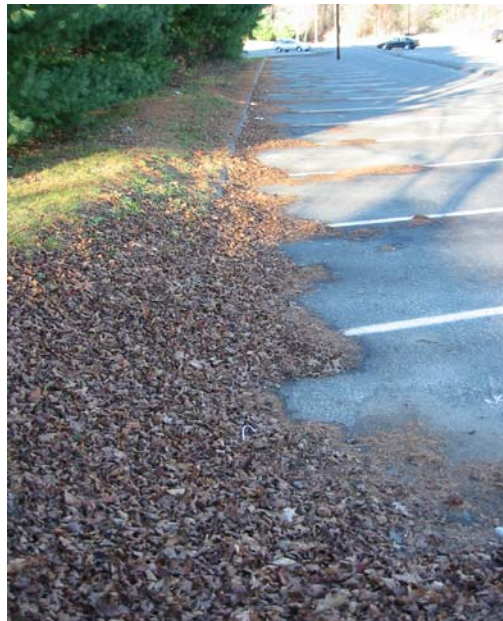
PHOTO NO. 14

Description: \_\_\_\_\_  
Typical overflow of  
leaves into Quad I

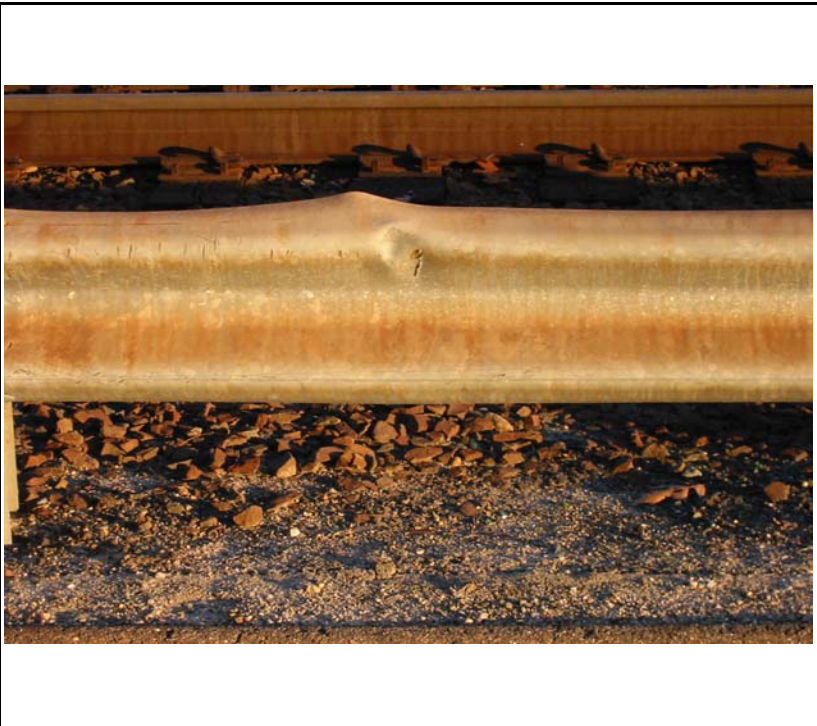
PHOTO NO. 15

Description: Typical rust and random dents in the guardrail

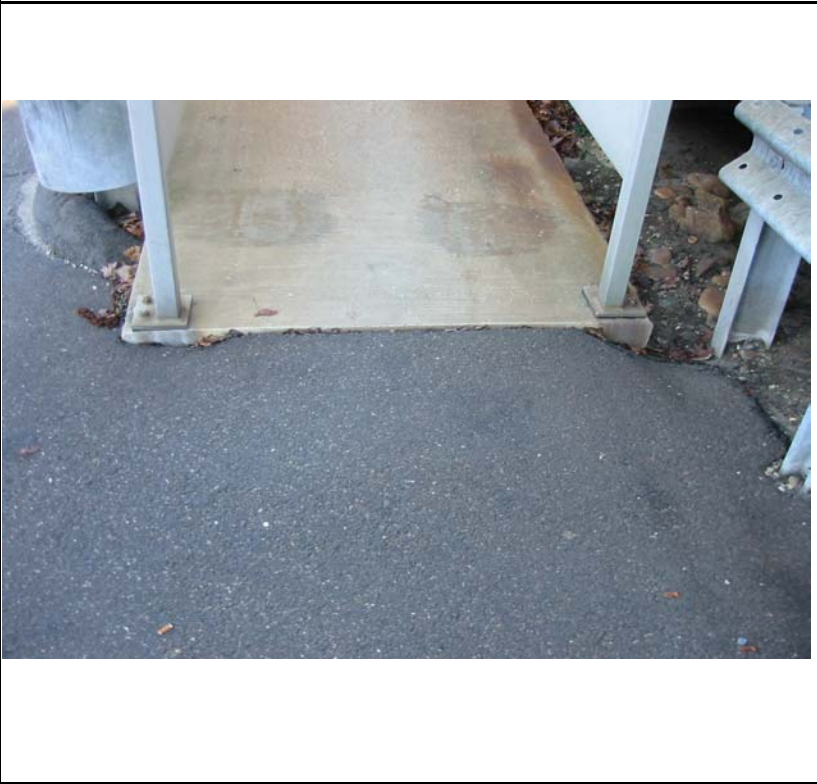
PHOTO NO. 16

Description: The asphalt contains uneven walking surface where the platform ramp intersects the asphalt pavement

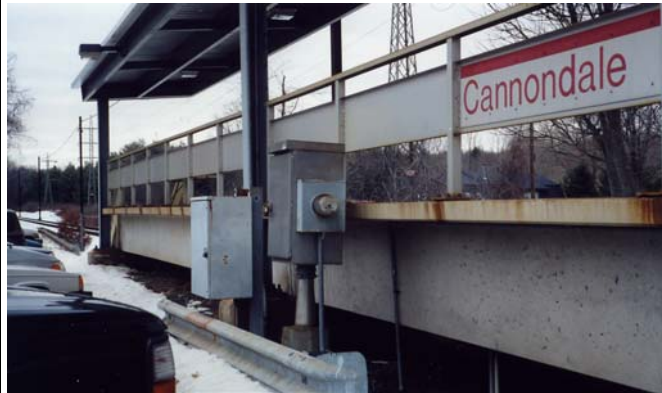
PHOTO NO. 18

The electrical service to the platform terminates in a pedestal type enclosure. We were unable to verify the size and condition of the main panel because the enclosure was locked. However, the enclosure was well sealed and appeared to be protecting the panel inside. There were a few non-GFCI receptacles located on the platform that should be replaced with GFCI type. Also, one of the receptacle covers was missing and should be replaced.

Description:  
electrical service  
pedestal enclosure

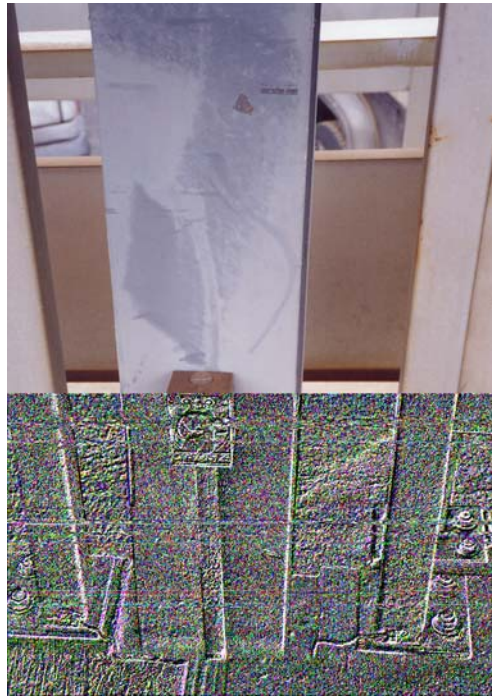
PHOTO NO. 19

Remarks: One receptacle is missing its' cover.

Description:  
damaged a  
platform receptacle

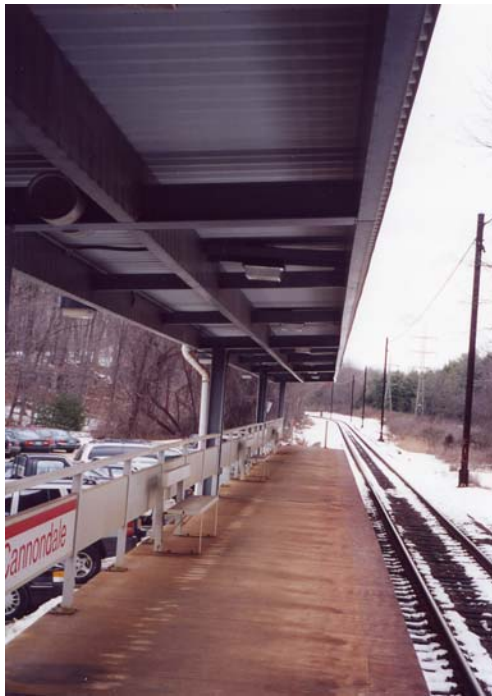
PHOTO NO. 20

The platform luminaires are mounted beneath the canopy with an average lighting output of 5.33 foot-candles. Inside many of the lenses were insects and dirt, which indicate that the luminaires are no longer sealed. We suggest that the luminaires be cleaned and sealed with new gaskets to restore the designed performance of the fixtures.

Description:  
platform lighting  
& speakers

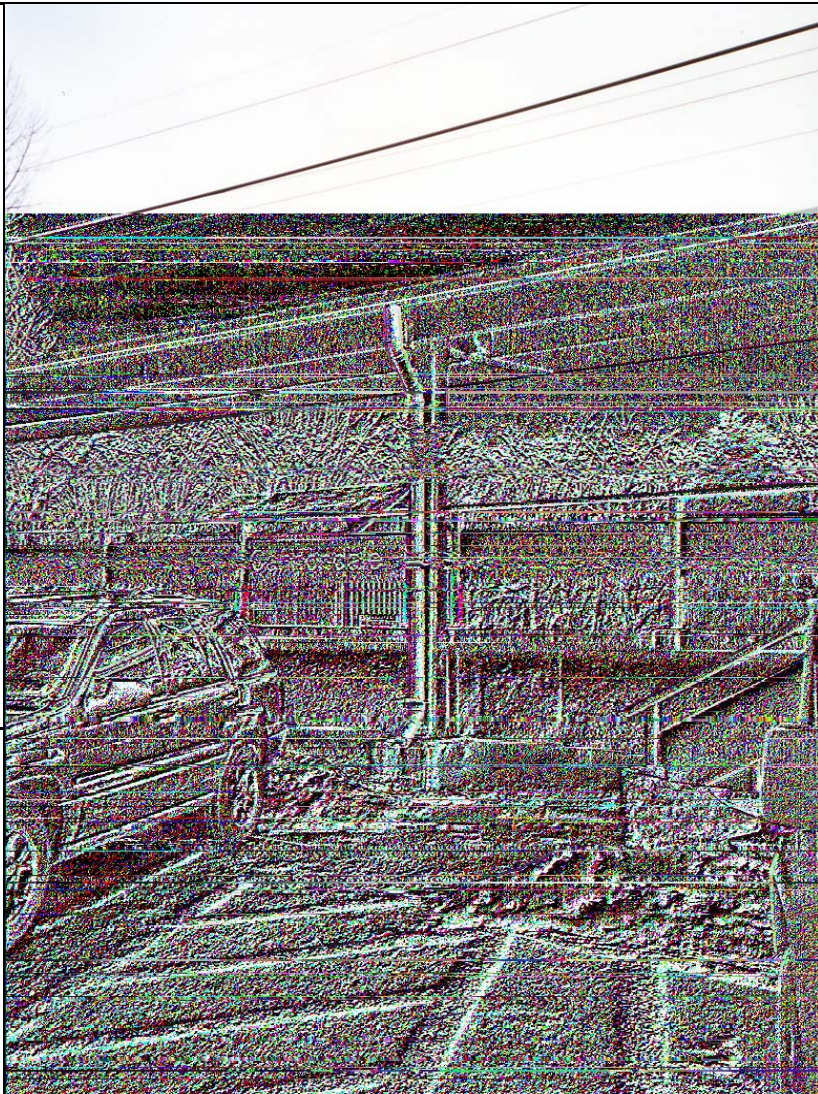
PHOTO NO. 21

The rain canopy is in good repair, aluminum gutters in good condition. The plastic pipe downspouts are in good repair. No maintenance is required.

Description: Platform with  
gutters and  
downspouts  
(Typical)
