CONNECTICUT
DEPARTMENT
OF
TRANSPORTATION

CONDITION INSPECTION
FOR THE
EAST NORWALK STATION

CONN. DEPT OF TRANSPORTATION
 STATION INSPECTION REPORT
 SHEET 1 OF 34

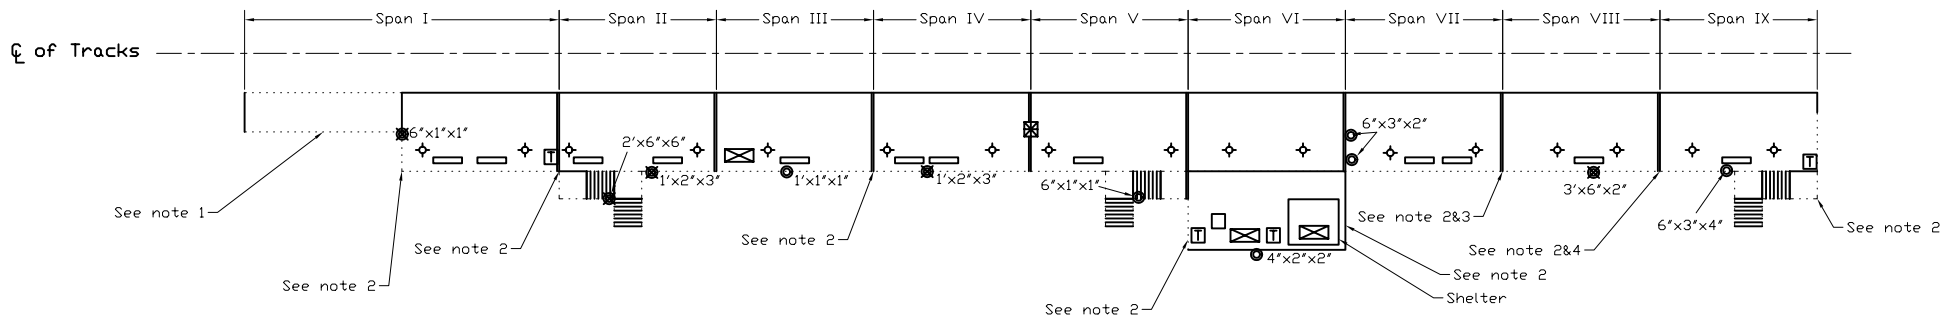
| East Norwalk Station South Platform Plan |

1. 12 of the railing base plates are rusted and deteriorating and there are 4 areas where the concrete is spalled (1'x3"x3") adjacent to the plates.
2. The base plate located at the top of the pier is rusted and deteriorated.
3. Cracked concrete pier which is about to spall (2'x3"x3").
4. Spalled concrete pier with exposed rebar (2 1/2'x2"x3").

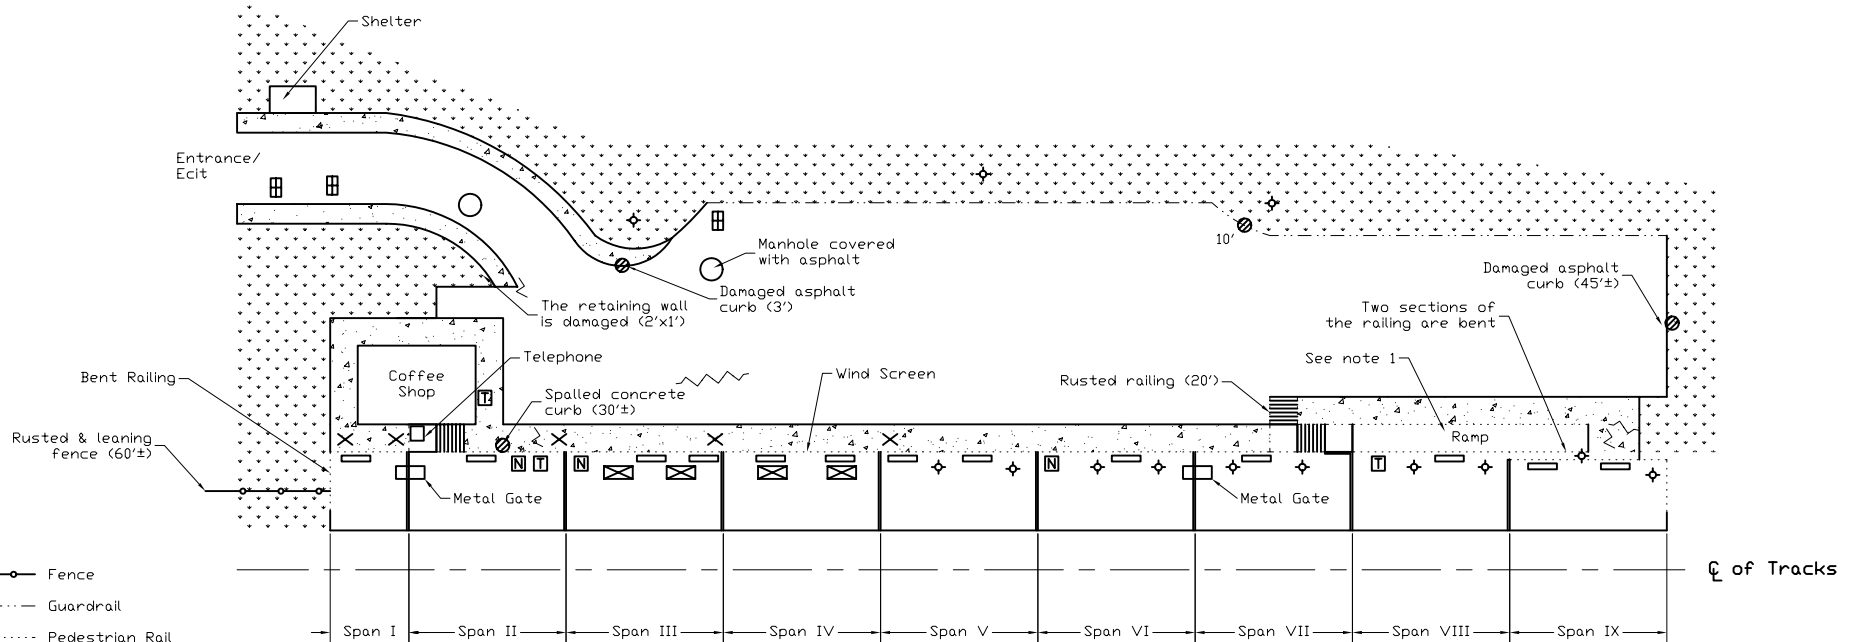
| East Norwalk Station North Platform & Quadrant I Plan |

1. 12 of the railing base plates are rusted and deteriorated and there are 3 areas where the concrete is spalled (1'x3"x3") adjacent to the plates.

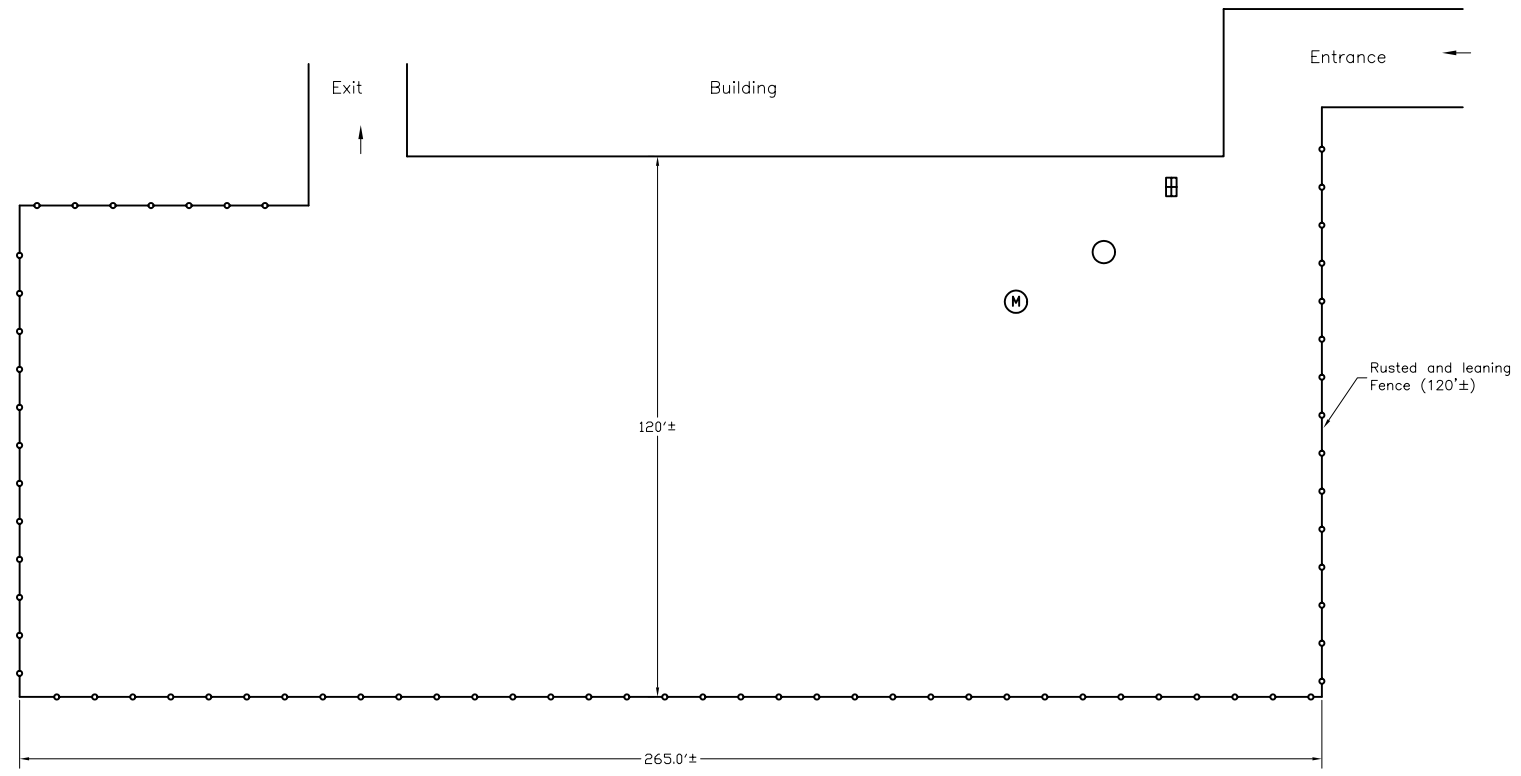
| East Norwalk Station Quadrant III Plan |

NOTES:
 1. The entire surface (265'x120') contains numerous cracks with vegetation growth.

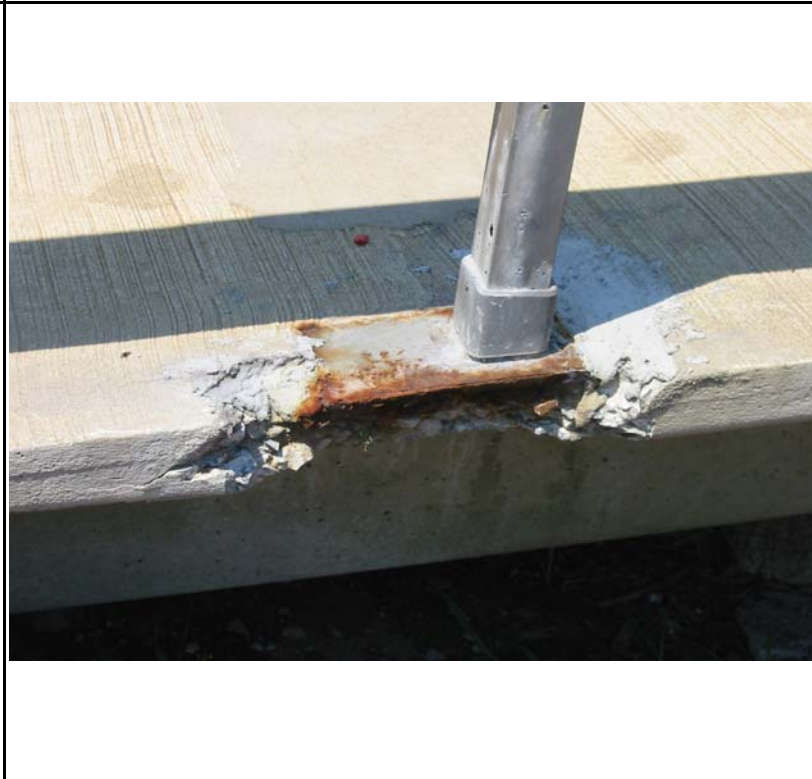
PHOTO NO. 12

| RATINGS | | PHOTO NO. | REMARKS: |
|---|---|---|---|
| 2 | | 12-13 | Span I (S-Platform) 1,2,&5 - Along the ramp there is spalled and cracked concrete adjacent to the rusted railing base plates |

Description: _____
Typical spalled concrete
(1"x3"x2") adjacent to
the rusted base plate
along the ramp; Note
similar occurrence at
the North Platform

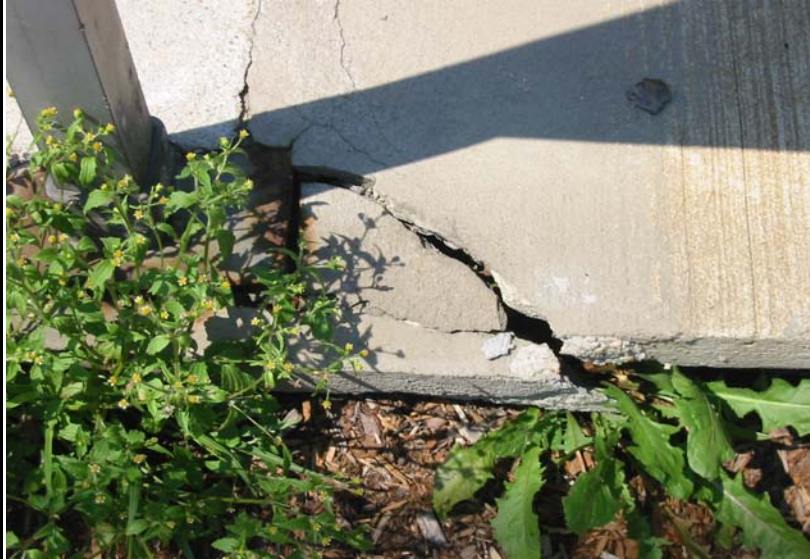
PHOTO NO. 13

Description:
Spalled and cracked
concrete (1"x4"x2")
adjacent to the railing
base plate

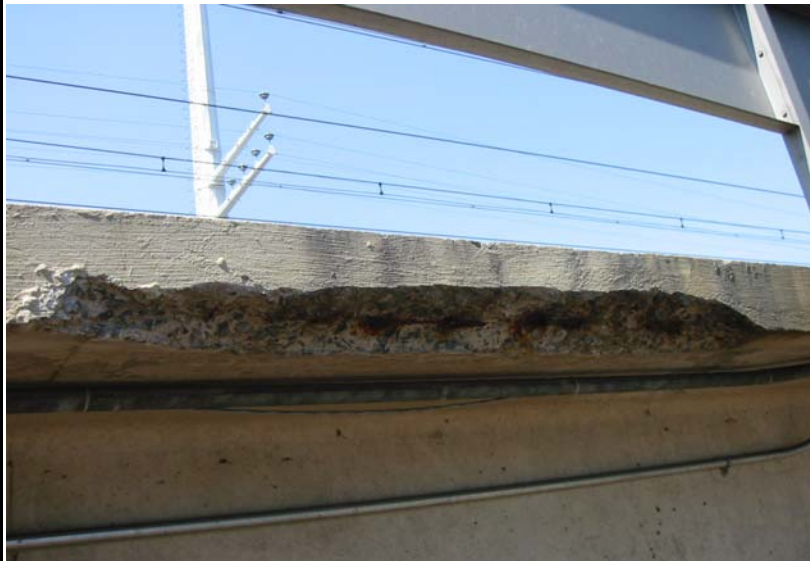
PHOTO NO. 14

| RATINGS | | PHOTO NO. | REMARKS: |
|---|---|---|---|
| 2 | | 14 | Span II-IV, VIII, & IX 15 - There is spalled concrete with exposed rebar along the flange of the double tee |

Description:
Typical spalled concrete
with exposed rebar
(3'x3"x3")

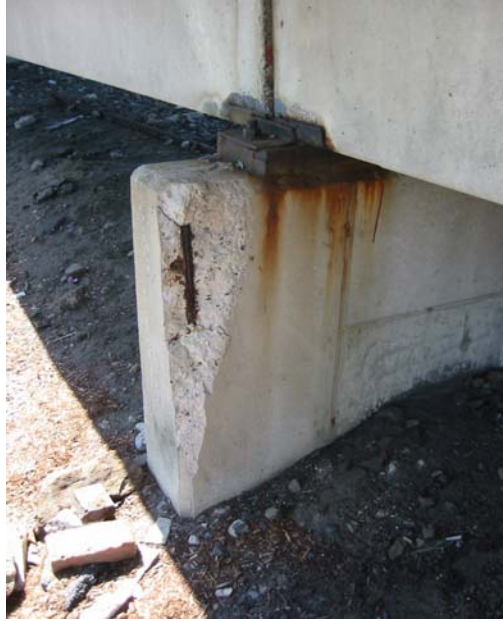
PHOTO NO. 15

| RATINGS | | PHOTO NO. | REMARKS: |
|---|---|---|---|
| 2 | | 15 | Span I, III, & V-IX 16 - The base plates on top of the piers (S-Platform) are rusted and deteriorated |
| 2 | | 15 | Span IX 16 - The concrete pier is spalled (2 1/2'x2"x3") with exposed rebar |

Description: _____
Spalled concrete pier
with exposed rebar
(2 1/2' x2"x3") and
rusted base plate

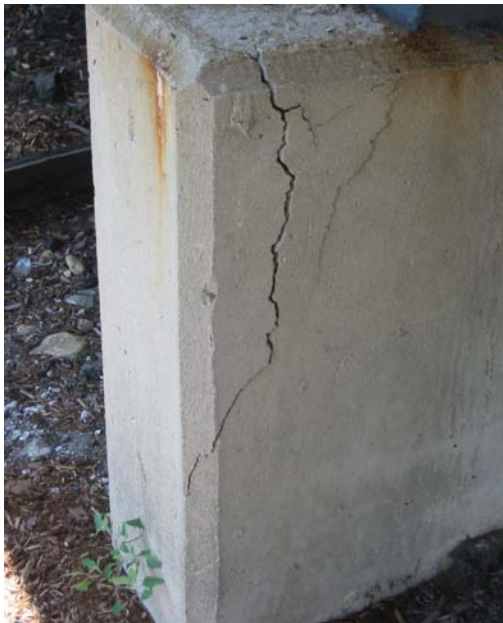
PHOTO NO. 16

| RATINGS | | PHOTO NO. | REMARKS: |
|---|---|---|---|
| 2 | | 16 | Span VIII 16 - The concrete pier is cracked (2'x3"x3") and about to spall |

Description: _____
Cracked concrete pier
about to spall
(2'x3"x3")

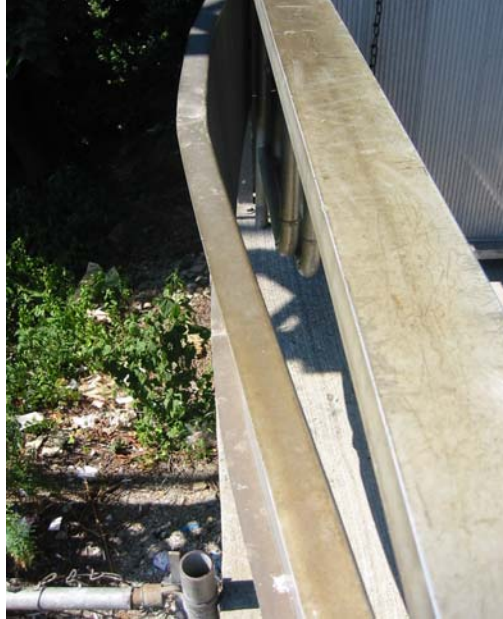
PHOTO NO. 17

| RATINGS | | PHOTO NO. | REMARKS: |
|---|---|---|---|
| 2 | | 17 | Span I 1 - The railing is bent (N-Platform) |

Description:
Typical bent railing

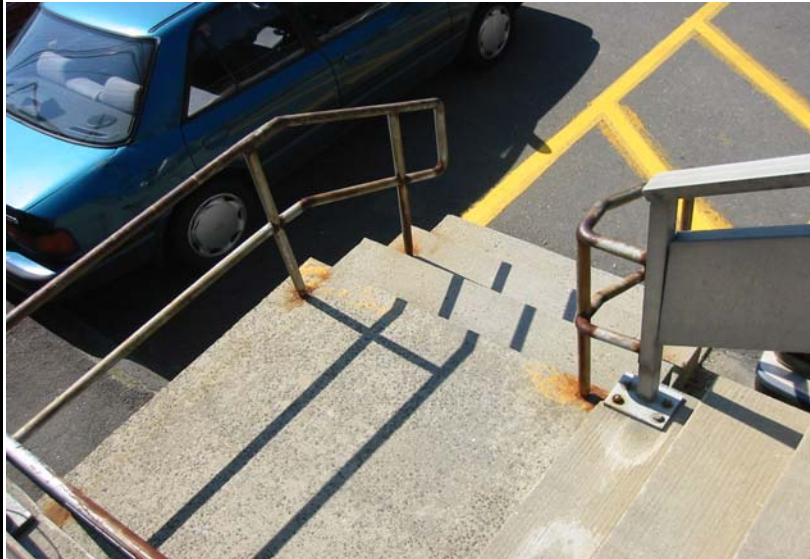
PHOTO NO. 18

| RATINGS | | PHOTO NO. | REMARKS: |
|---|---|---|---|
| 2 | | 18 | Span VII 2 - The railing is rusted (N-Platform) |

Description:
Typical rusted railing

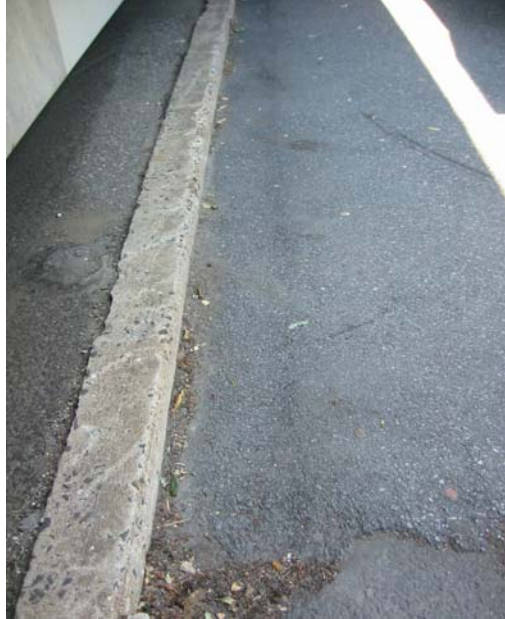
PHOTO NO. 19

| RATINGS | | PHOTO NO. | REMARKS: |
|---|---|---|---|
| 2 | | 19 | Quad I Curb - The concrete curb is spalled |

Description: _____
Typical spalled concrete
curb (30')

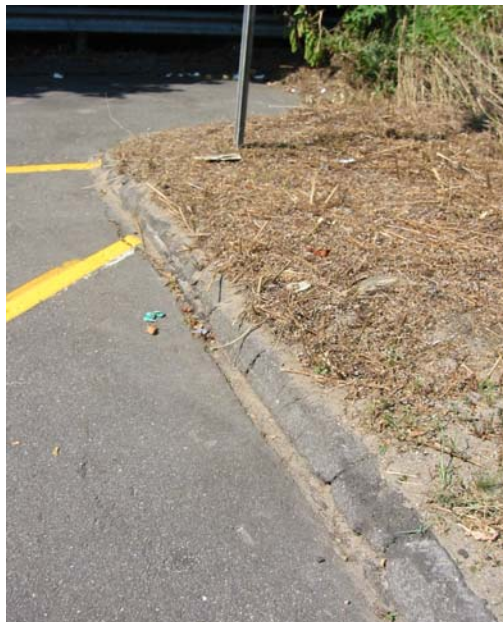
PHOTO NO. 20

| RATINGS | | PHOTO NO. | REMARKS: |
|---|---|---|---|
| 2 | | 20 | Quad I Curb - The asphalt curb is damaged |

Description: _____
Typical damaged
asphalt curb

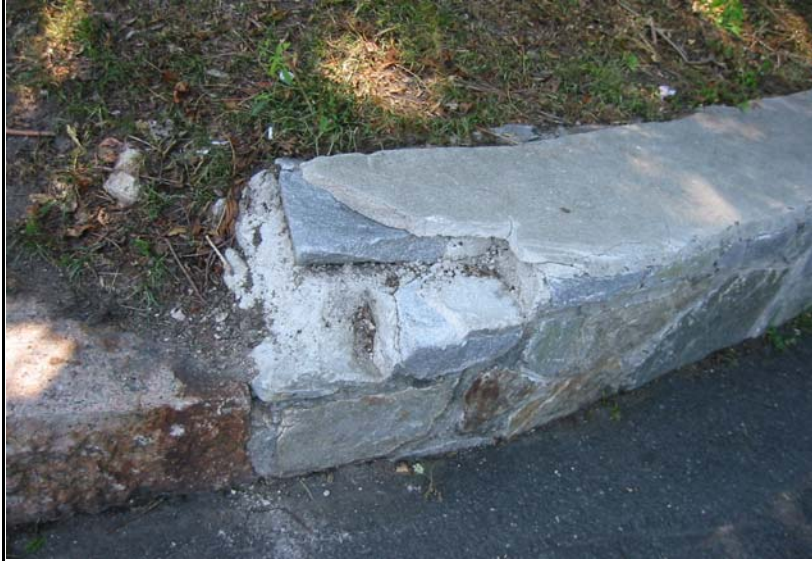
PHOTO NO. 21

| RATINGS | | PHOTO NO. | REMARKS: |
|---|---|---|---|
| NA | | 21 | Quad I Misc - The retaining wall is damaged (2'x1'x1') |

Description: Damaged retaining wall
(2'x1'x1')

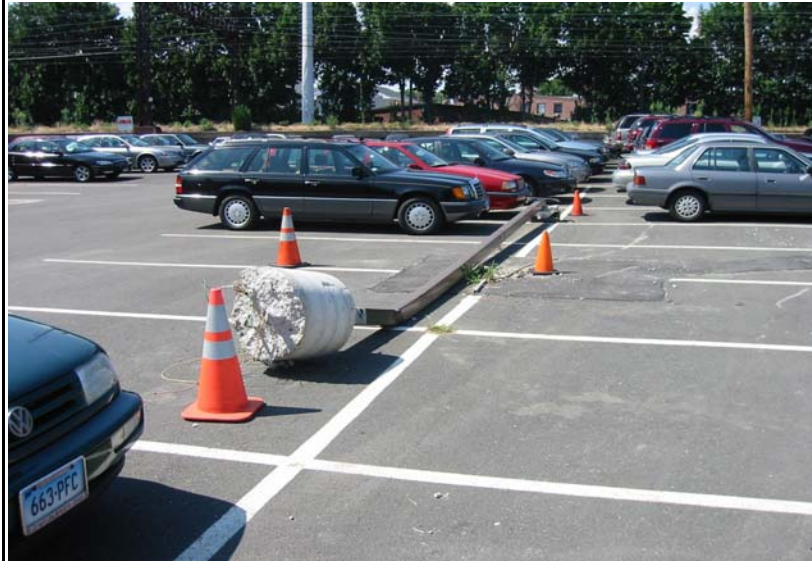
PHOTO NO. 22

Description: Light pole that has
collapsed

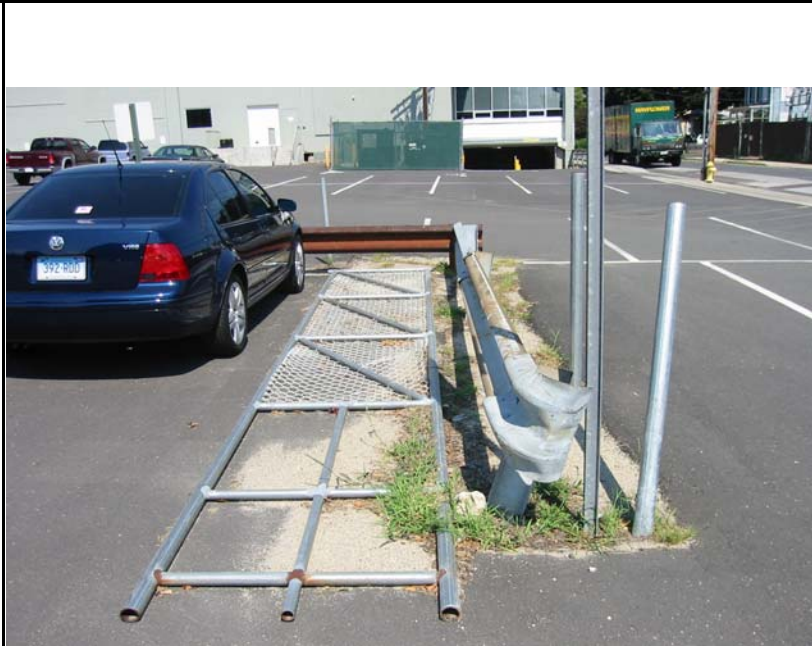
PHOTO NO. 23

| RATINGS | | PHOTO NO. | REMARKS: |
|---|---|---|---|
| 2 | | 23 | Quad II Fence/Guardrail - The guardrail is rusted and the fence is damaged |

Description: Typical damaged fence and rusted guardrail

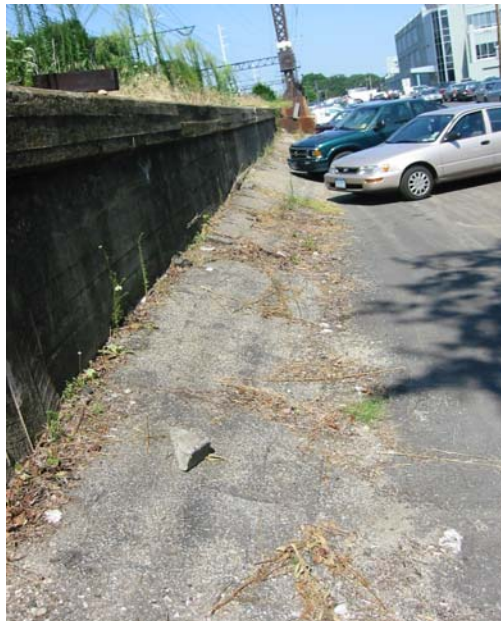
PHOTO NO. 24

Description: Uneven asphalt pavement (5'x90')

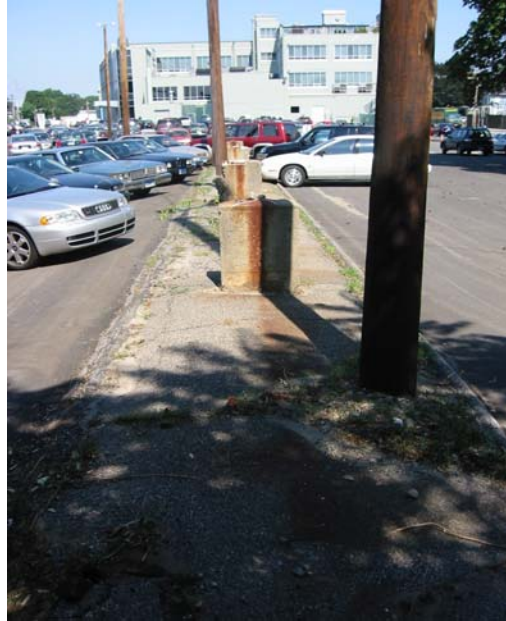
PHOTO NO. 25

| RATINGS | | PHOTO NO. | REMARKS: |
|---|---|---|---|
| 2 | | 25 | Quad II Stripping - The stripping is faded or non-existent |
| 2 | | 25 | Quad II Sidewalk - The concrete sidewalk / median is uneven and cracked (6'x90') |

Description: Uneven and cracked asphalt median (6'x90') with spalled concrete blocks; note that there is no stripping

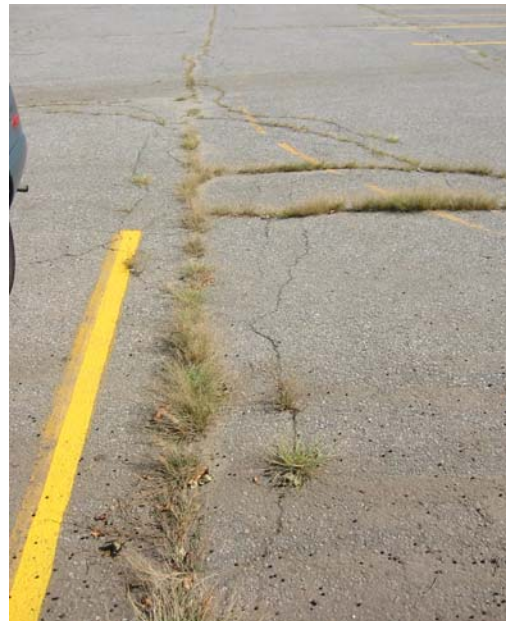
PHOTO NO. 26

Description: Typical asphalt crack with vegetation growth

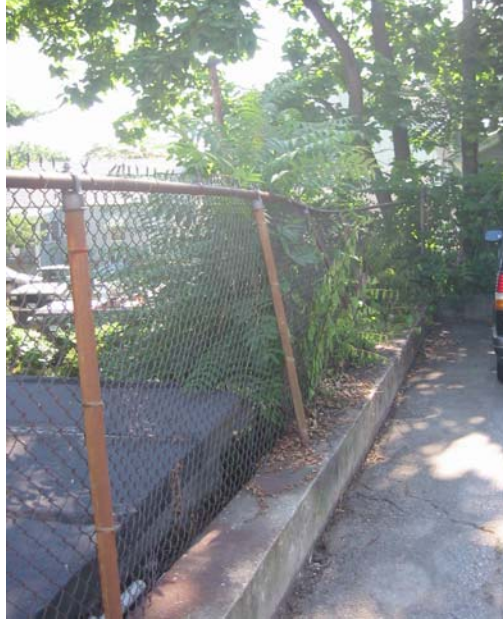
PHOTO NO. 27

Description: Typical rusted and leaning fence

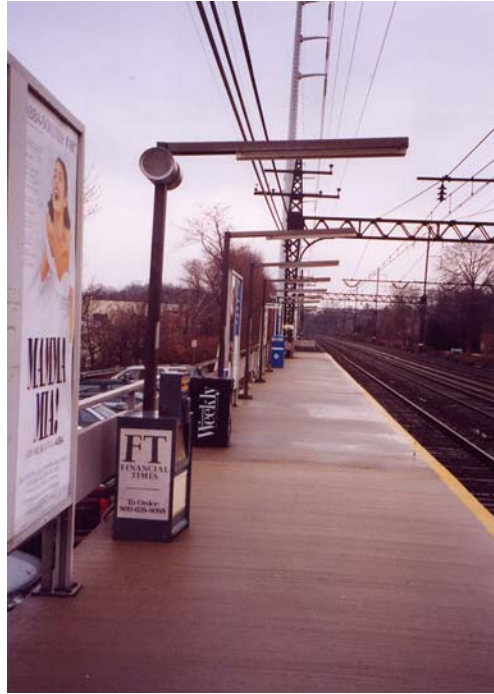
PHOTO NO. 30

The lighting on the southbound platform maintains an average of 5.02 foot-candles and the northbound platform was averaging 5.4 foot-candles. Both platforms exceed the minimum light level recommended by IESNA. Many of the light fixture lenses are either damaged or missing end caps and should be replaced. Much of the conduit for this lighting system is prematurely corroding and will likely fail within the near future.

Description:
platform luminaire
and speakers

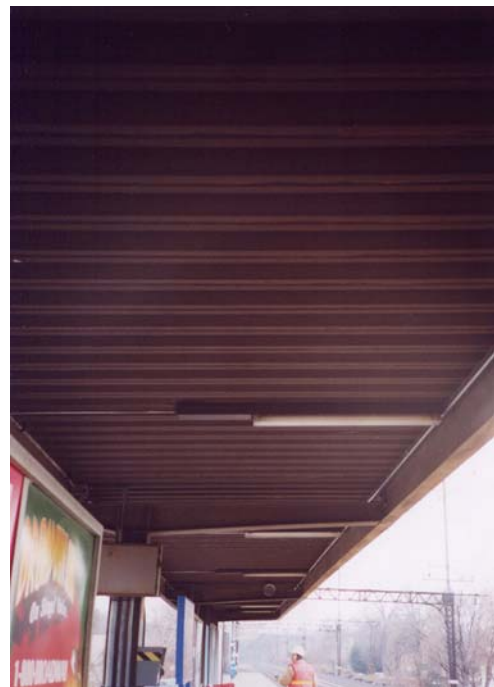
PHOTO NO. 31

Description:
platform canopy
luminaire and
speakers

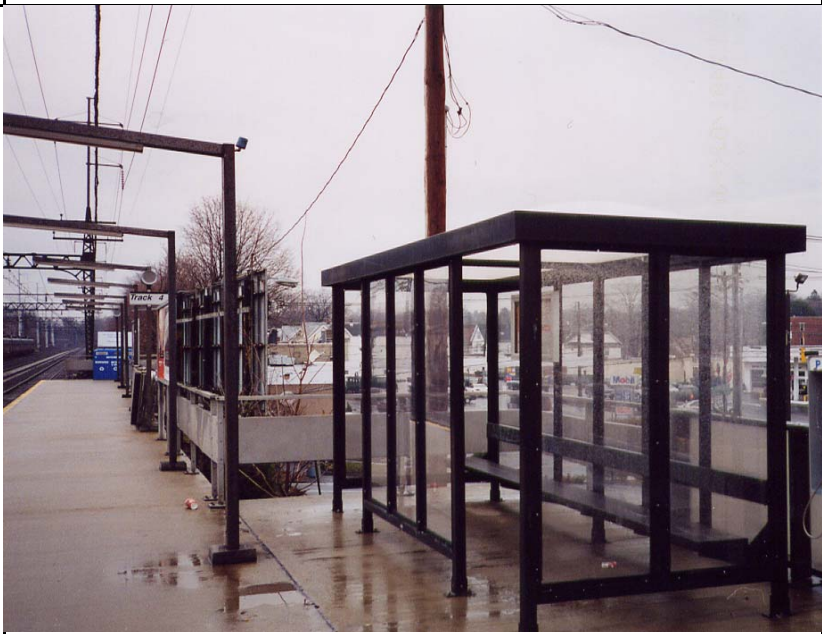
PHOTO NO. 33

On the New Haven bound platform there is a small shelter with a curbed roof. There are no gutters or downspouts.

Description:
Shelter with
curbed roof,
no gutters
or downspouts
