CONNECTICUT
DEPARTMENT
OF
TRANSPORTATION

CONDITION INSPECTION
MERRITT 7 STATION

**CONN. DEPT OF TRANSPORTATION
STATION INSPECTION**

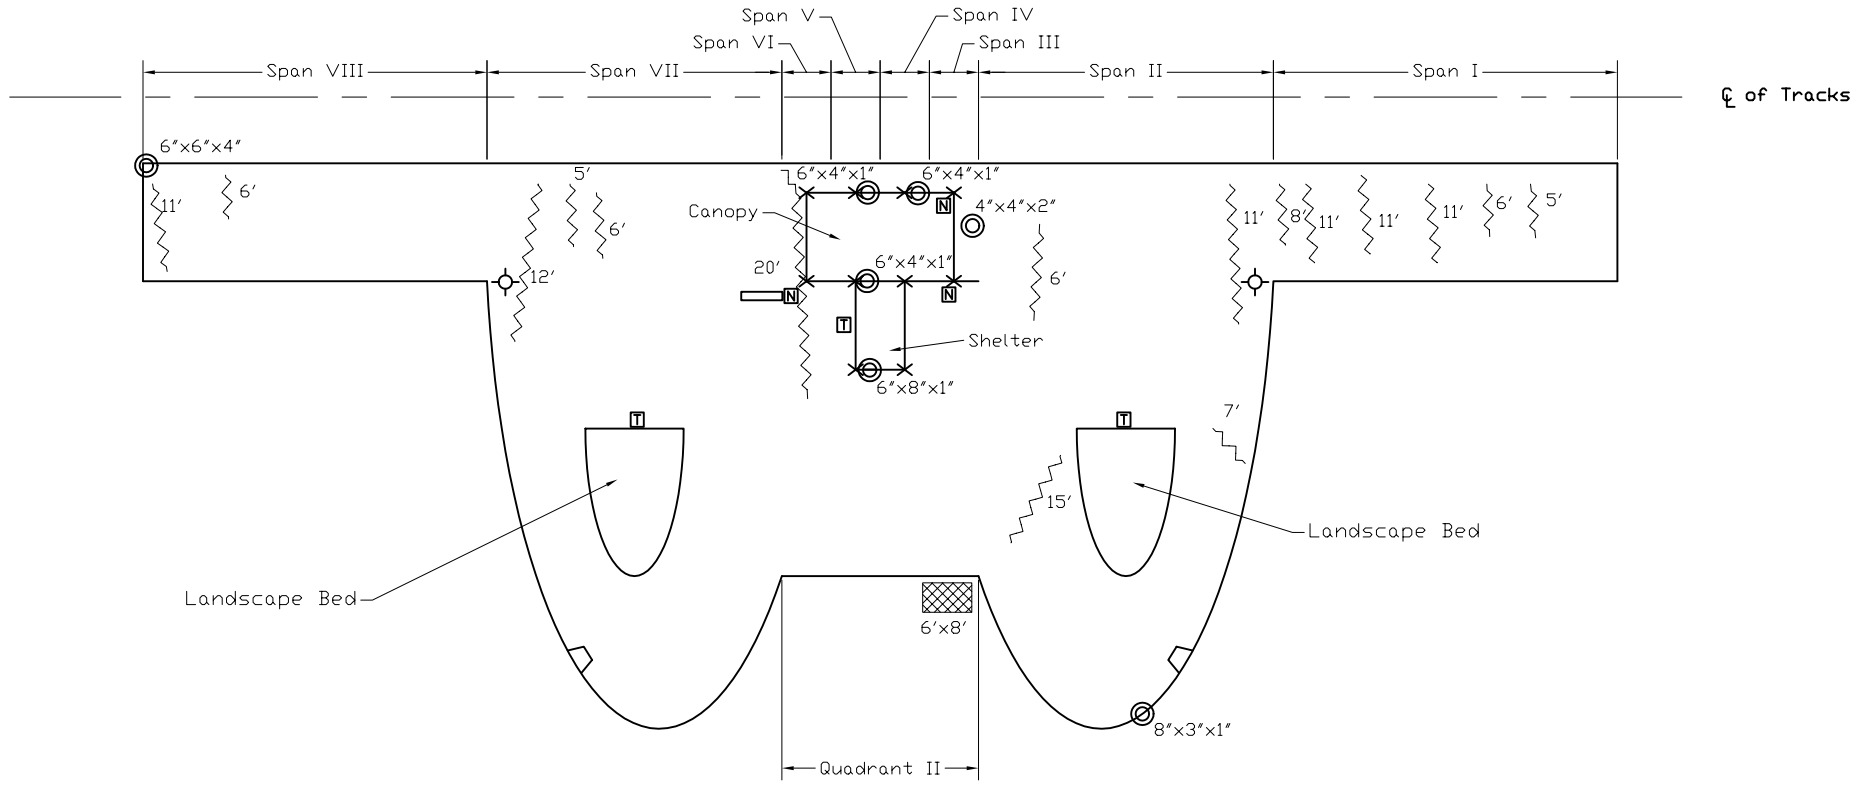
| Merritt 7 Station Platform and Quadrant II Plan |

1. Surface displays minor scaling throughout the entire platform surface.

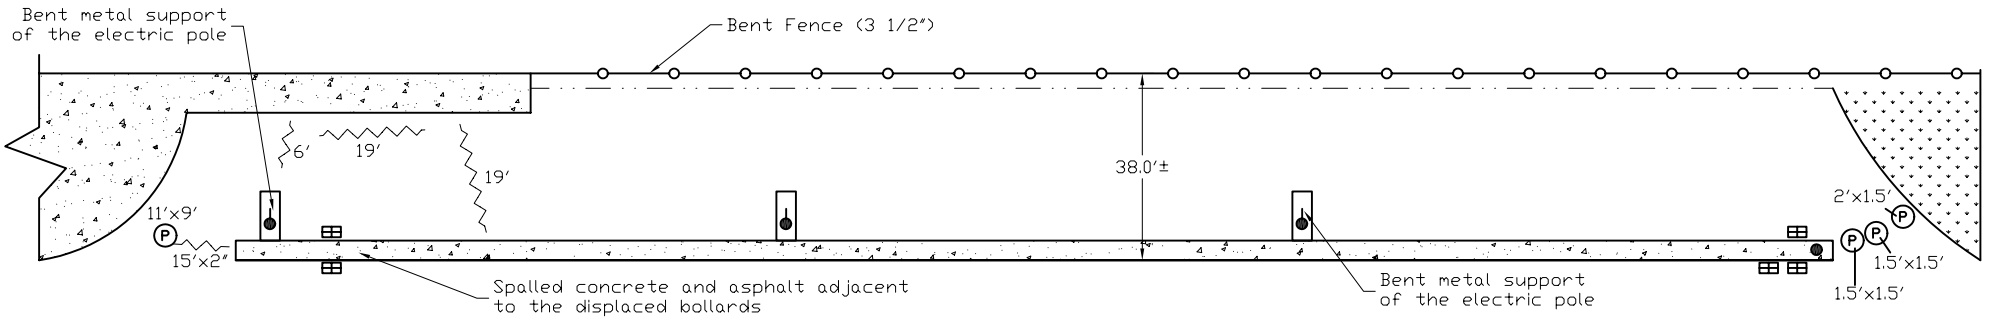
| Merritt 7 Station Quadrant I Plan |

1. There is minor rusting on the fence.

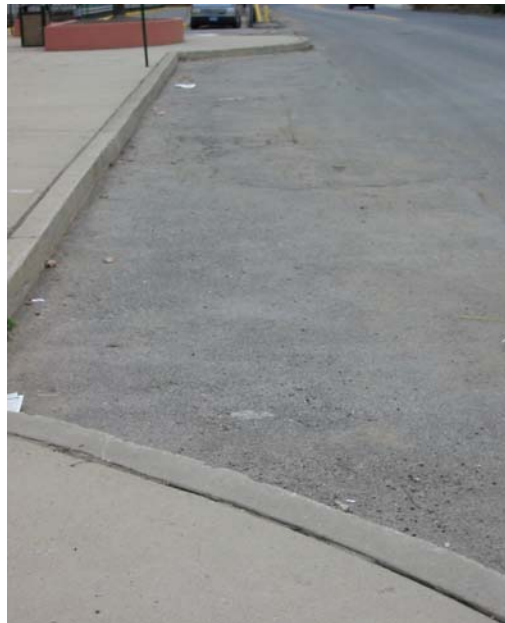
PHOTO NO. 2

Description: _____
General view of Quad II;
Note map cracking
(6'x8')

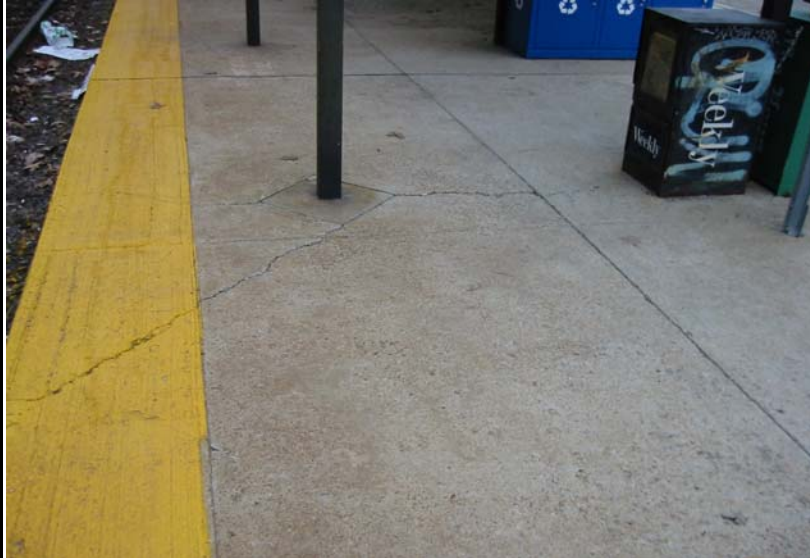
PHOTO NO. 9

Description: _____
Typical cracks along the platform

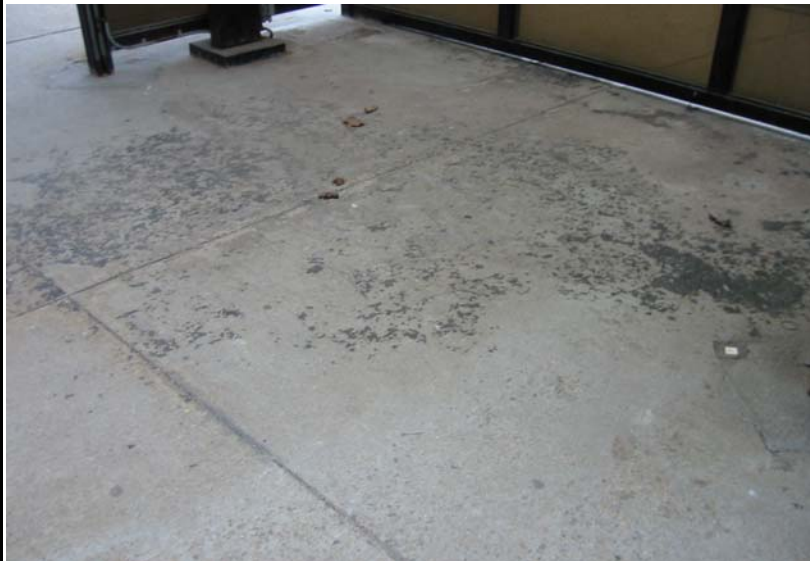
PHOTO NO. 10

Description: _____
Typical concrete scaling along the platform

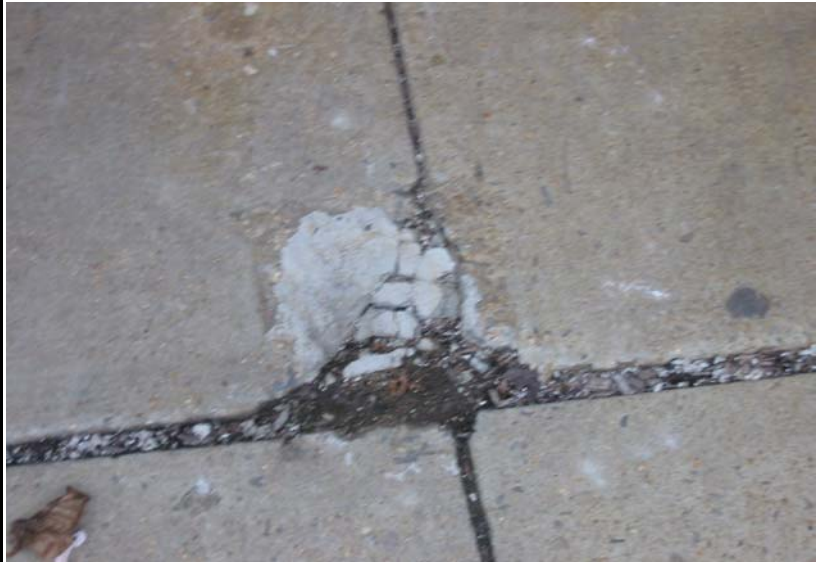
PHOTO NO. 11

Description: _____
Spalled concrete
(4"x4"x2")

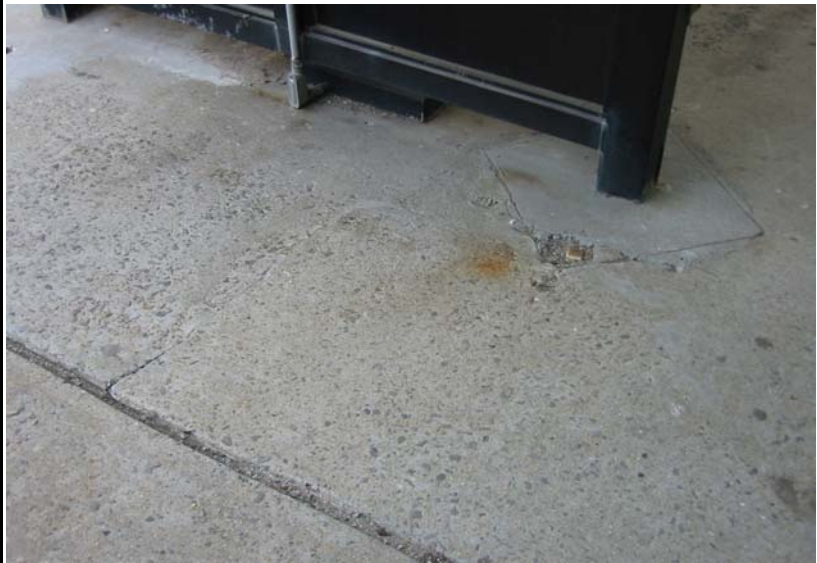
PHOTO NO. 12

Description: _____
Spalled concrete at the
base of the shelter's
column

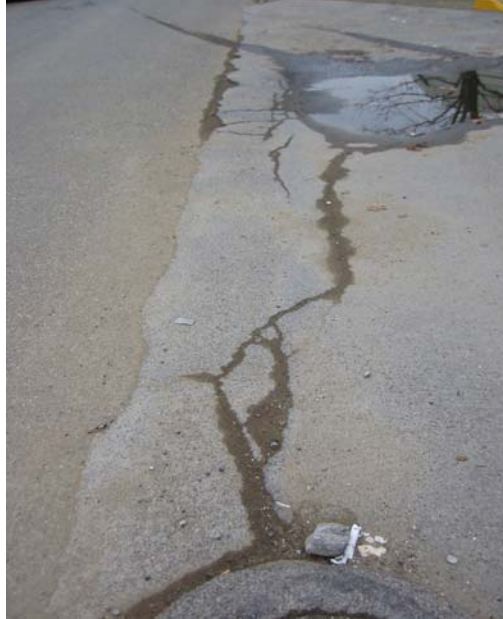
PHOTO NO. 13

Description: Typical crack and ponding of water in Quad I

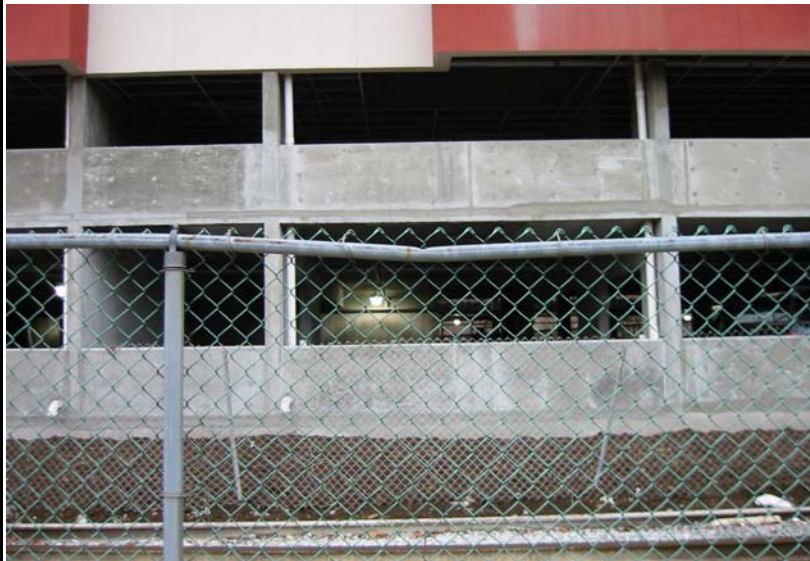
PHOTO NO. 14

Description: Minor rust is present throughout the fence. There is one isolated area where the top rail of the fence is displaced vertically by 4"

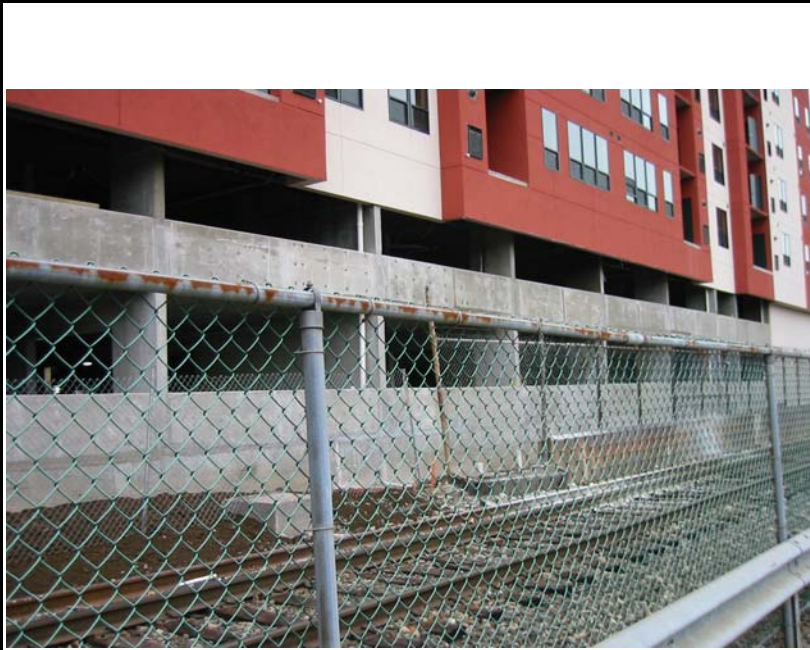
PHOTO NO. 15

Description: Typical rust located on the South fence in Quad I

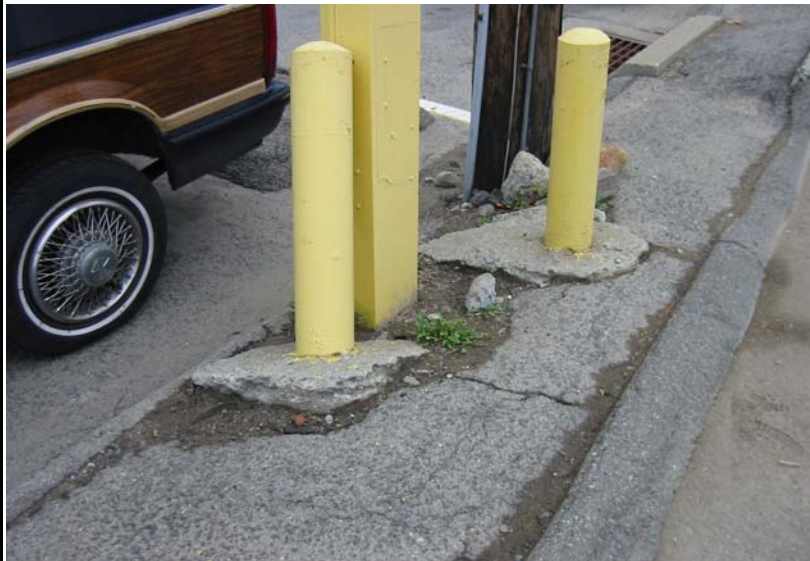
PHOTO NO. 16

Description: Spalled asphalt and concrete adjacent to the displaced bollards

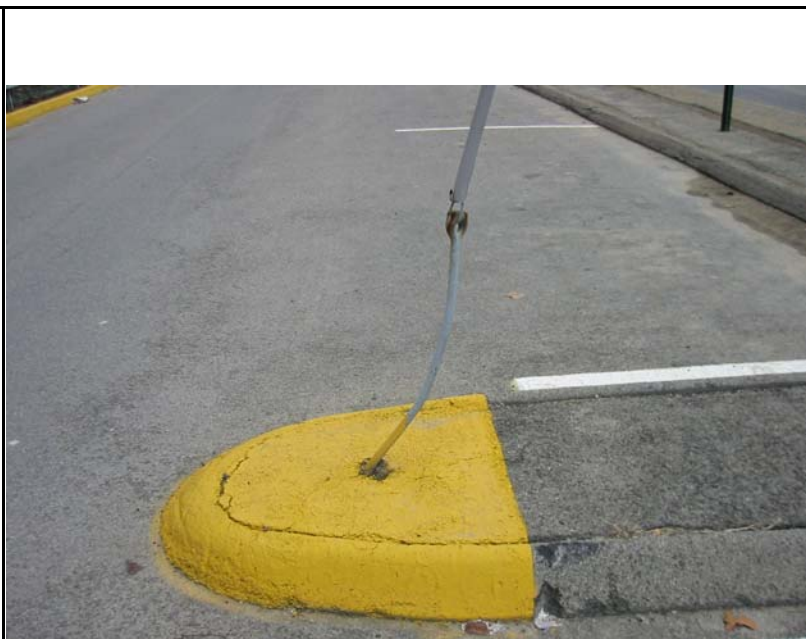
PHOTO NO. 17

Description: Bent cable support for the electrical pole;

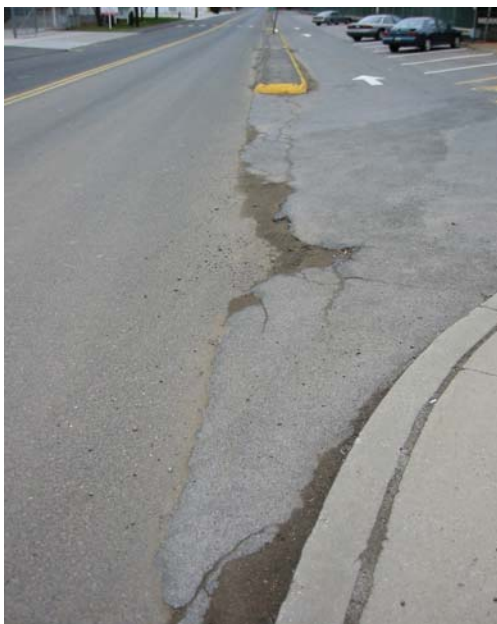
PHOTO NO. 18

Description: The asphalt pavement is cracked, spalled, and there is an uneven alignment between the street and Quad III

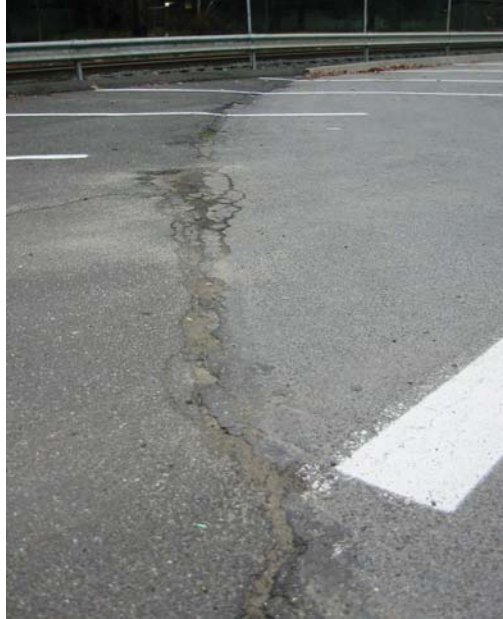
PHOTO NO. 19

Description: _____
The asphalt pavement
exhibits a crack
up to 4" wide and 45'
long

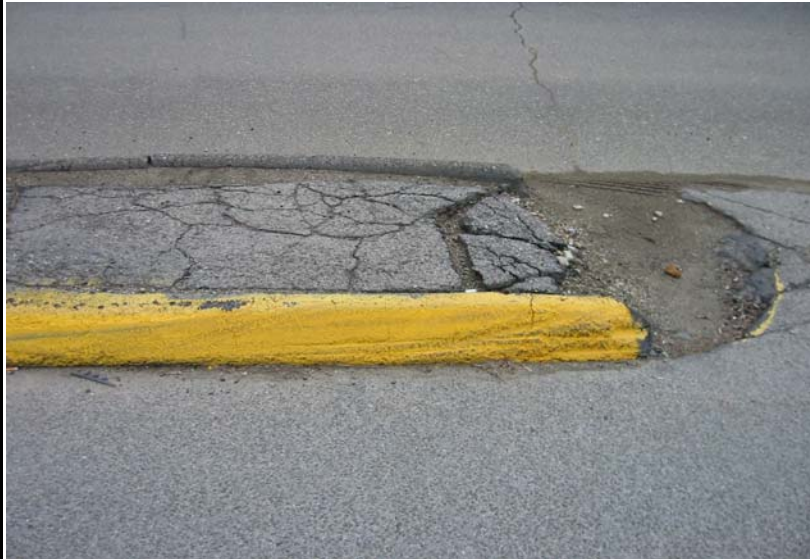
PHOTO NO. 20

Description: _____
The asphalt median
is spalled and cracked
(9'x4')

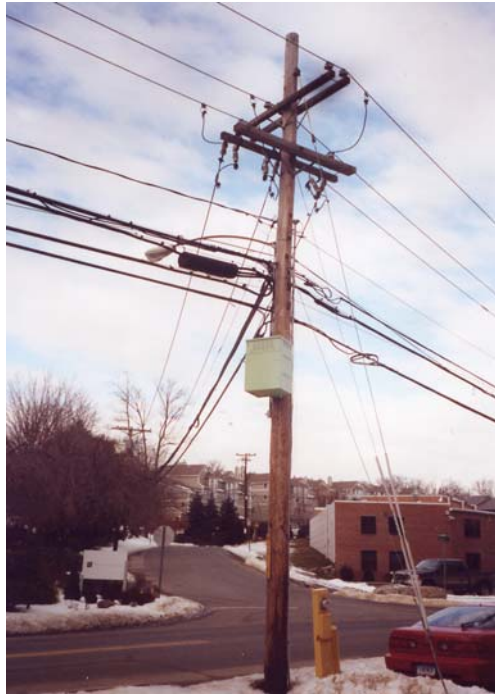
PHOTO NO. 21

Remarks: We were unable to gain access to the electrical service enclosure to verify the exact size and condition of the main panelboard.

Description:
electrical service
pole and pedestal

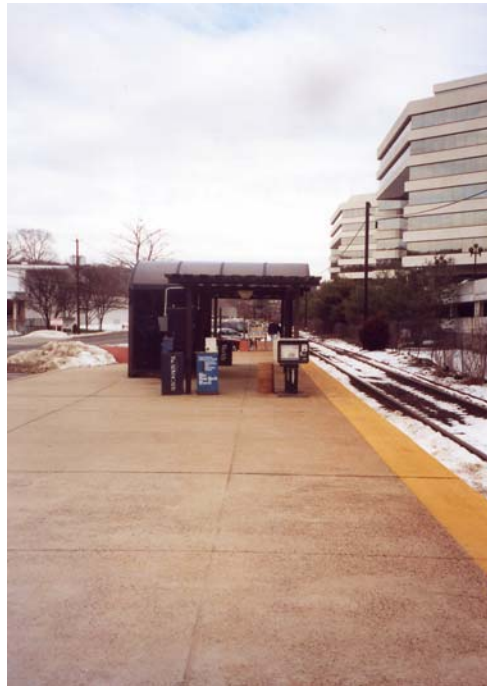
PHOTO NO. 22

The platform luminaries are mounted beneath the canopy with two additional pole mounted luminaires. They provide 14.0 foot-candles near the structure. However, the one light pole mounted at each end of the platform provides less than 1 foot-candle of light. We recommend that several light fixtures be uniformly installed to raise the average light level to the minimal 5 foot-candles recommended by the IESNA.

Description:
platform lighting
with canopy

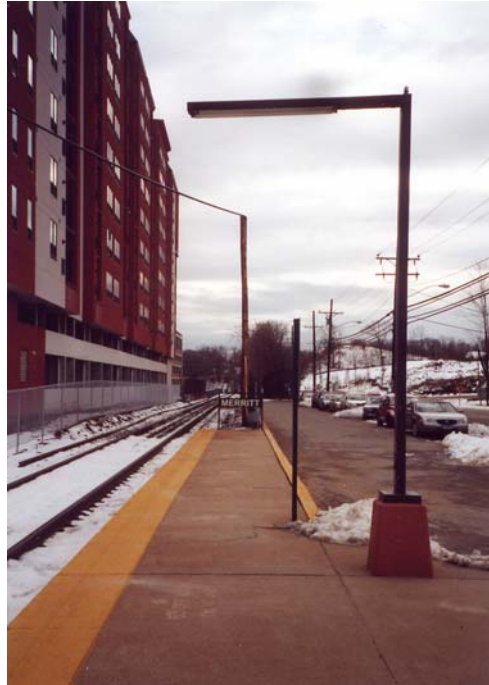
PHOTO NO. 23

Description:
platform pole
lighting

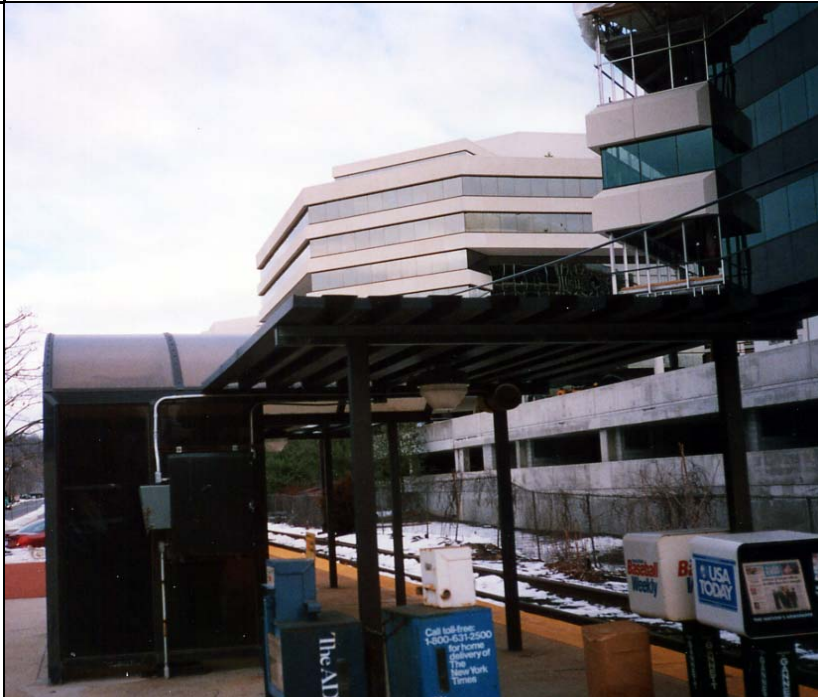
PHOTO NO. 26

Description:
Rain shelter
part with curbed
roof, corrugated
metal wings,
no gutters or
downspouts
