CONNECTICUT  
DEPARTMENT  
OF  
TRANSPORTATION

CONDITION INSPECTION  
FOR THE  
SEYMOUR STATION

**CONN. DEPT OF TRANSPORTATION  
STATION INSPECTION**

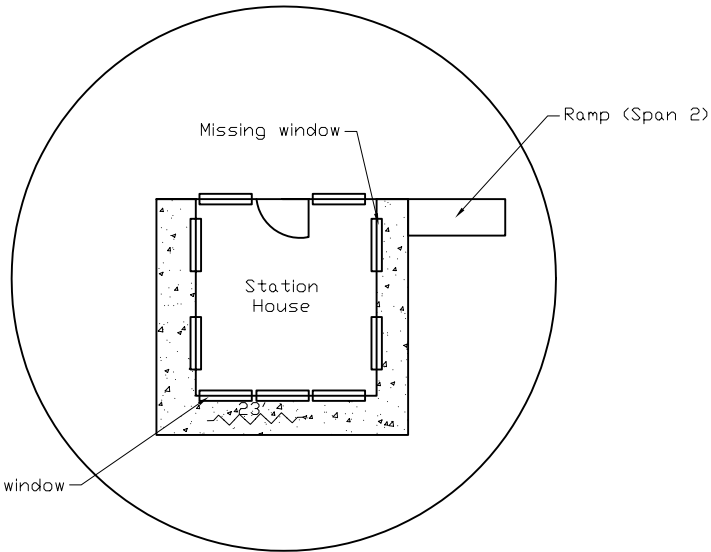
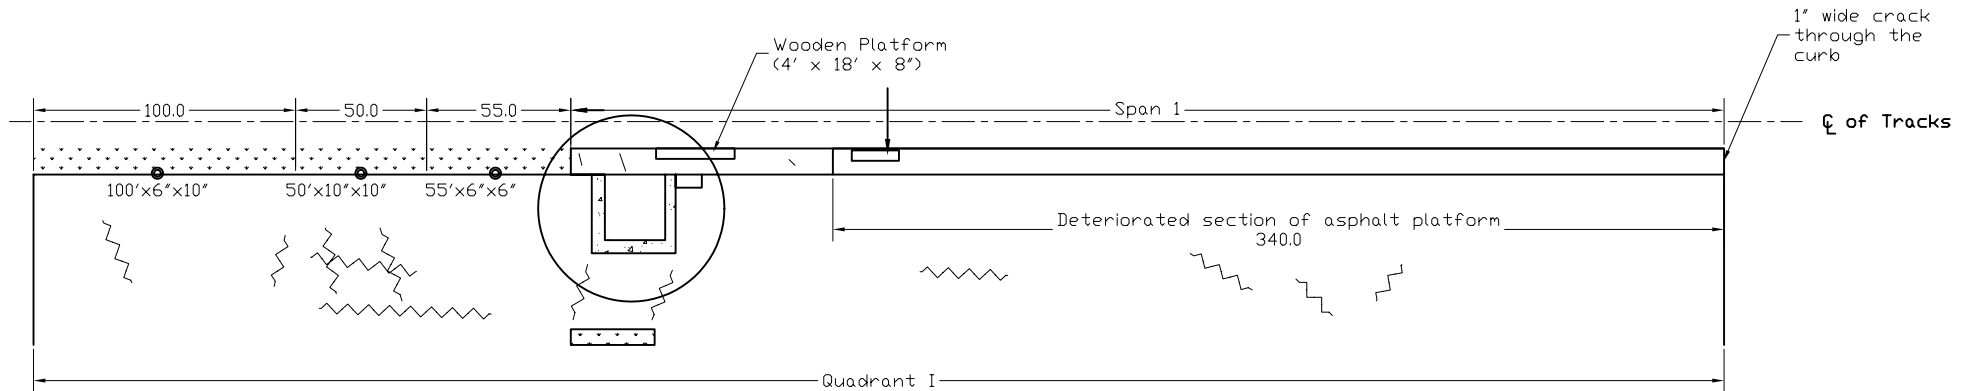
Urbitran Associates, Inc.
Connecticut Dept. of Transportation
Seymour Station General Plan
Date: 11-19-01

- NOTES:
1. The hinge of the door is damaged

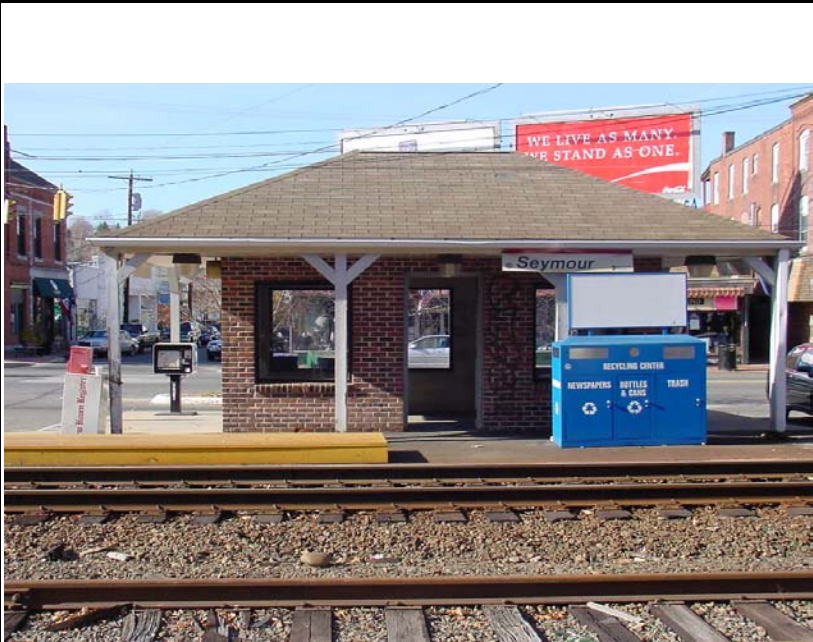
PHOTO NO. 1

Description:  
General view of the station

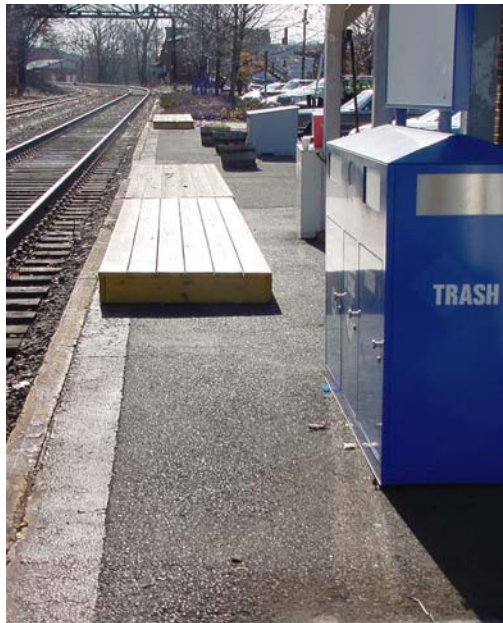
PHOTO NO. 2

Description:  
General view of the platform

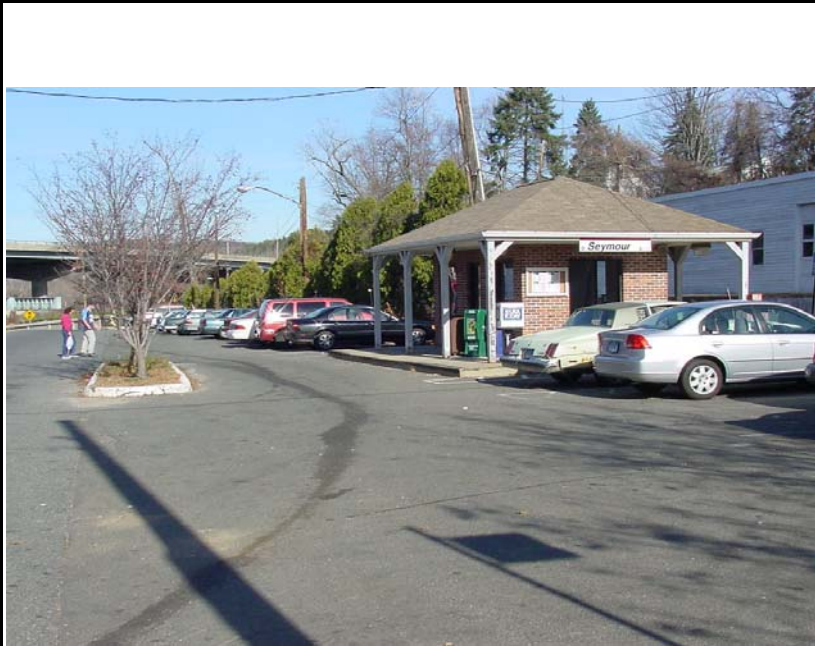
PHOTO NO. 3

Description: General view of Quad I

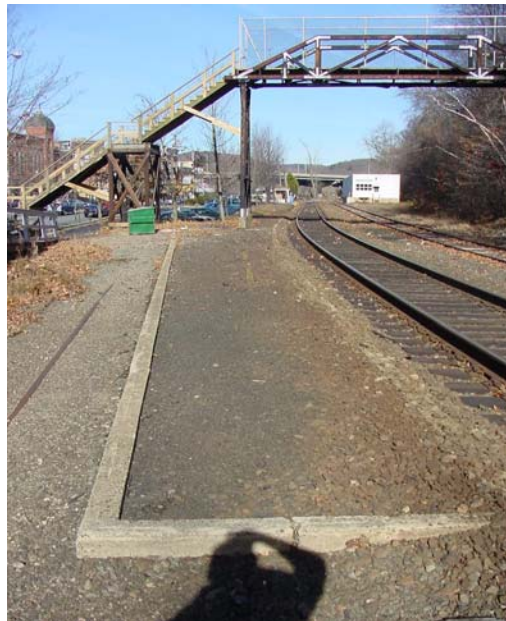
PHOTO NO. 4

Description: The asphalt exhibits deterioration (340'x5')

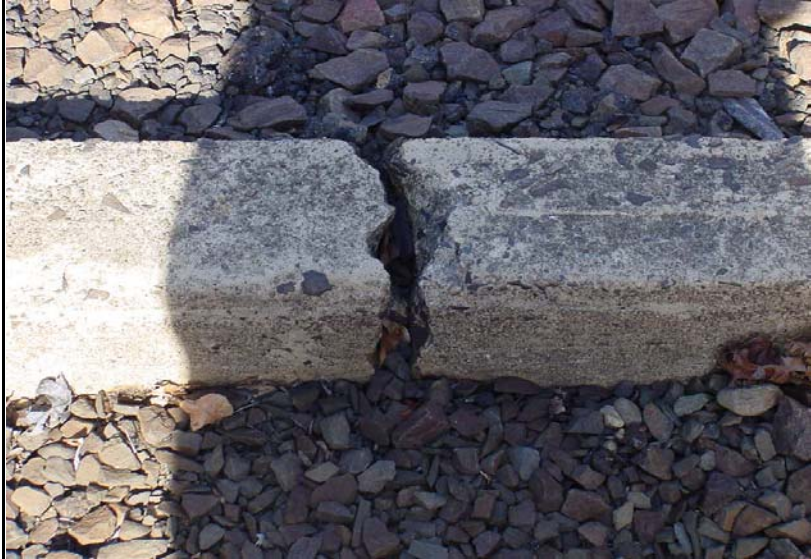
PHOTO NO. 5

Description: \_\_\_\_\_  
The concrete curb  
exhibits an 1" wide  
crack

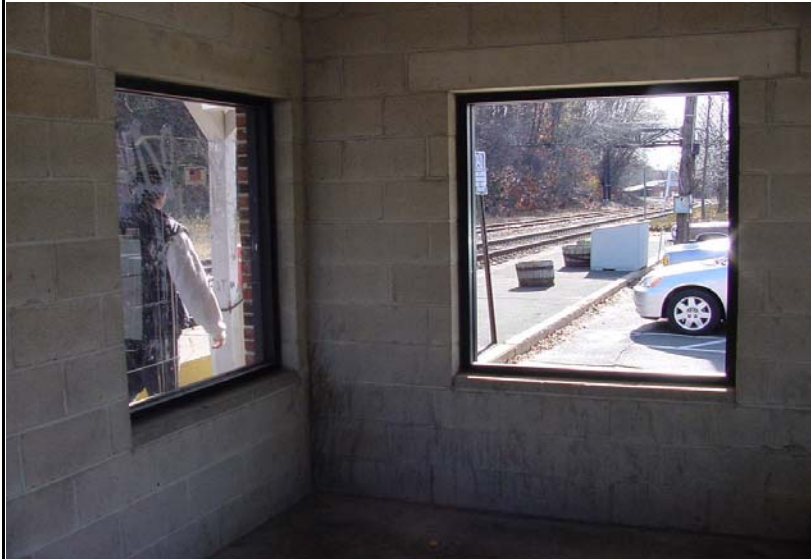
PHOTO NO. 6

Description: \_\_\_\_\_  
The south side window  
is missing

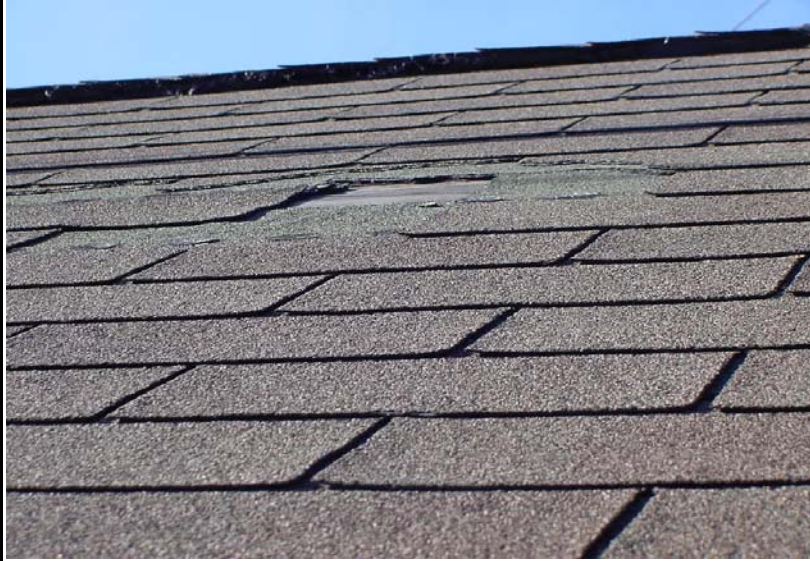
PHOTO NO. 7

Description:  
Missing shingles on the  
roof which exposes  
wood

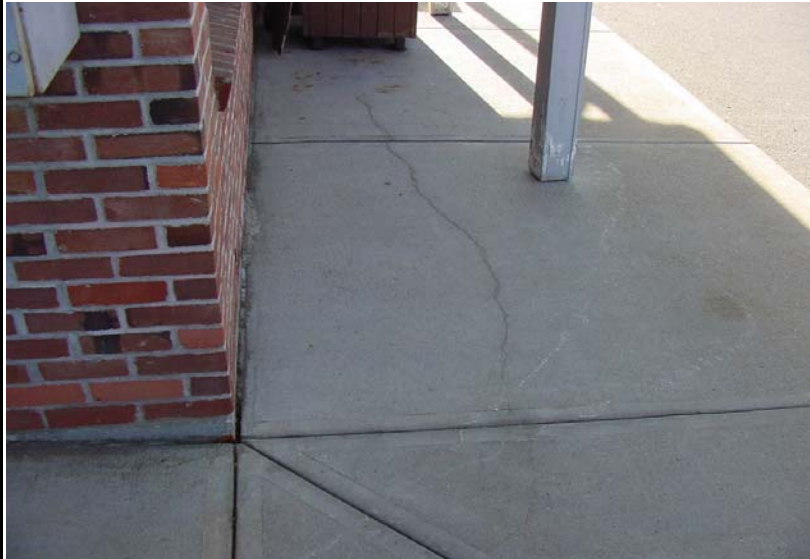
PHOTO NO. 8

Description:  
The concrete sidewalk  
exhibits a 23' crack

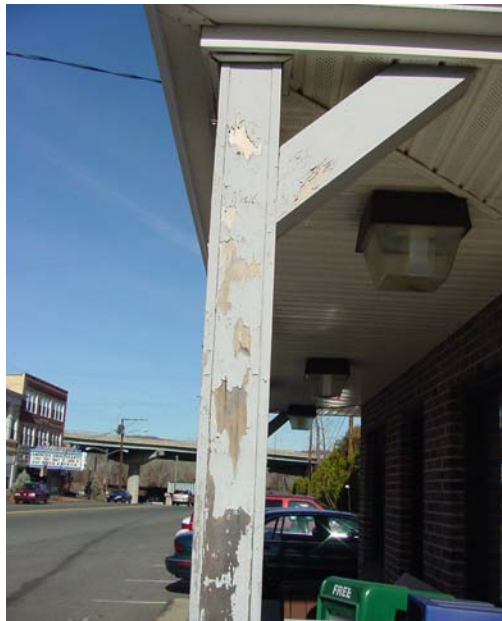
PHOTO NO. 9

Description: The column paint is chipped

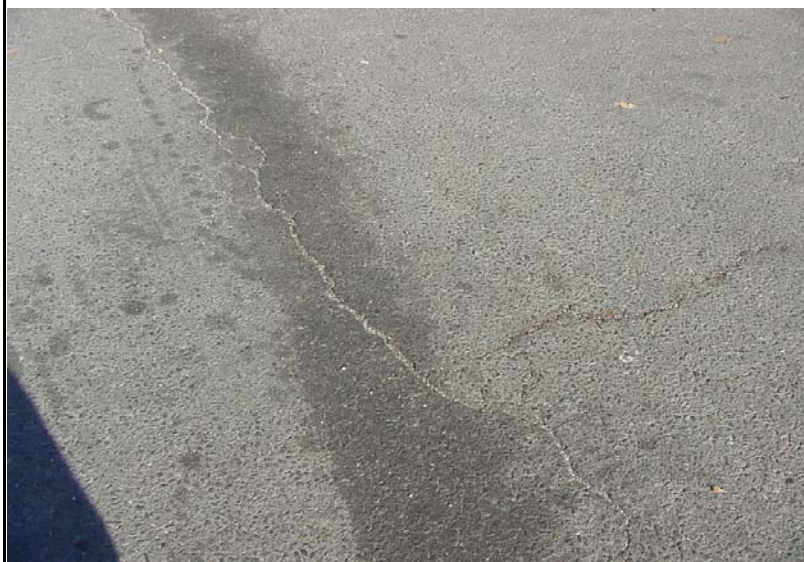
PHOTO NO. 10

Description: Typical crack

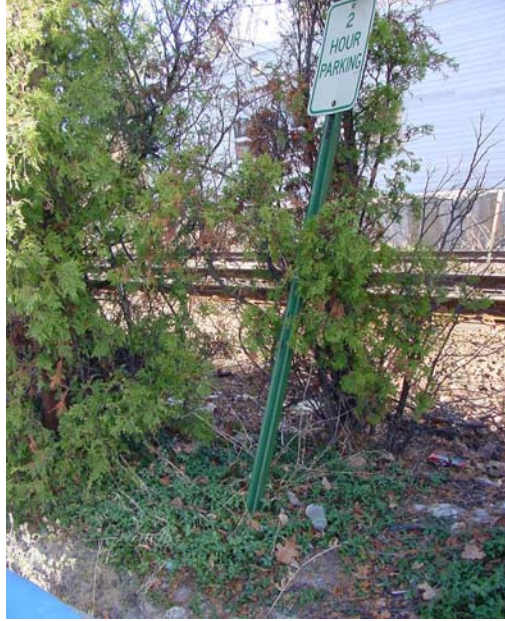
PHOTO NO. 11

SIGNAGE: 2

Description: \_\_\_\_\_  
The sign is leaning

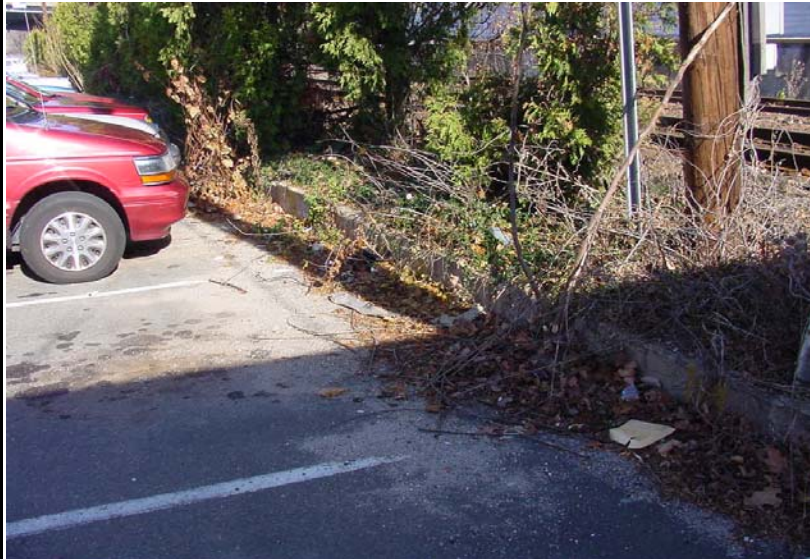
PHOTO NO. 12

LANDSCAPE: 2

Description: \_\_\_\_\_  
Landscape is overflowing into the parking area

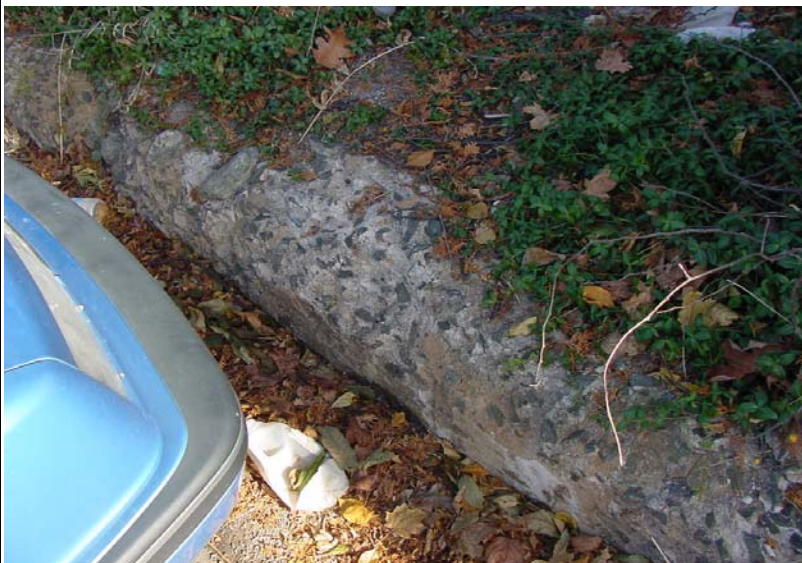
PHOTO NO. 13

CURB: 2

Description: Typical spalled concrete curb along the east side of Quad I

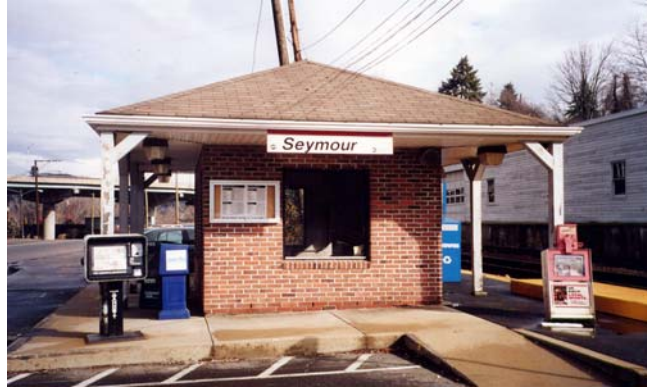
PHOTO NO. 14

Description:  
over all view of the  
building

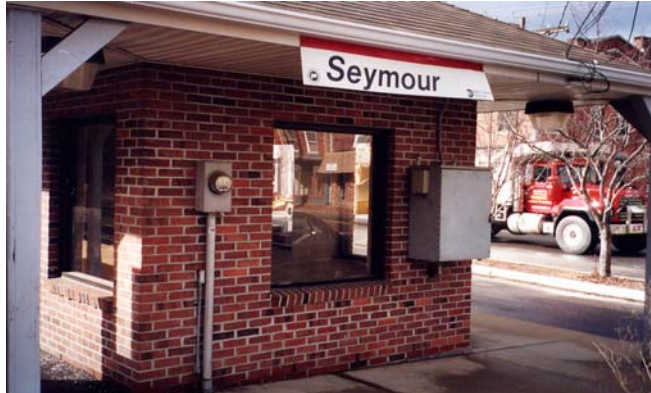
PHOTO NO. 15

Remarks: The electrical service riser conduit adjacent to the north side of the building is dislocated.  
We were unable to gain access to the locked electrical cabinet to verify the exact size and condition of the main panelboard. The pole number was partially missing and incomplete.

Description:  
electrical meter  
enclosure

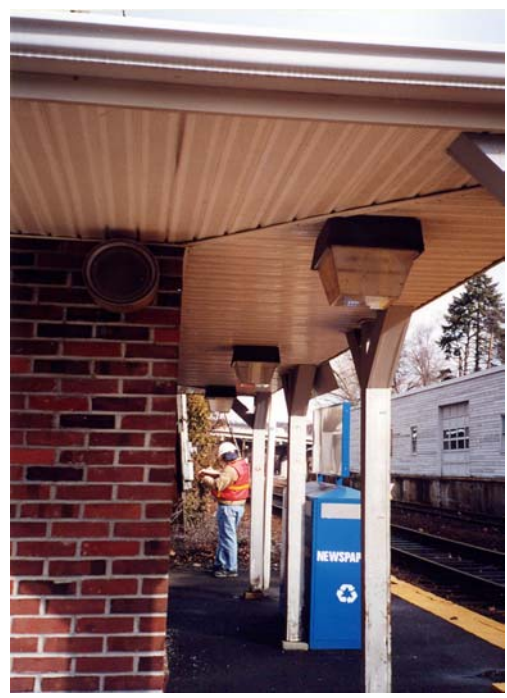
PHOTO NO. 16

Remarks: A typical section of the platform was measured and found to average  
8.01 fc adjacent to the building and 1.1 fc at the south side of the platform.  
The platform luminaires are mounted beneath the building soffit.

The platform luminaries are mounted under the soffit of the small structure. The platform at the shelter exceeds the minimal IESNA light levels of 5 foot-candles by measuring 8.01 foot-candles. However, less platform lighting is provided towards the southern end of the platform and this area measured an average of 1.1 foot-candles. We recommend that additional luminaries be installed at the platform to elevate the light levels to IESNA recommended practice. Two of the canopy luminaires need to be reattached to the canopy soffit.

Description:  
platform lighting  
and speaker

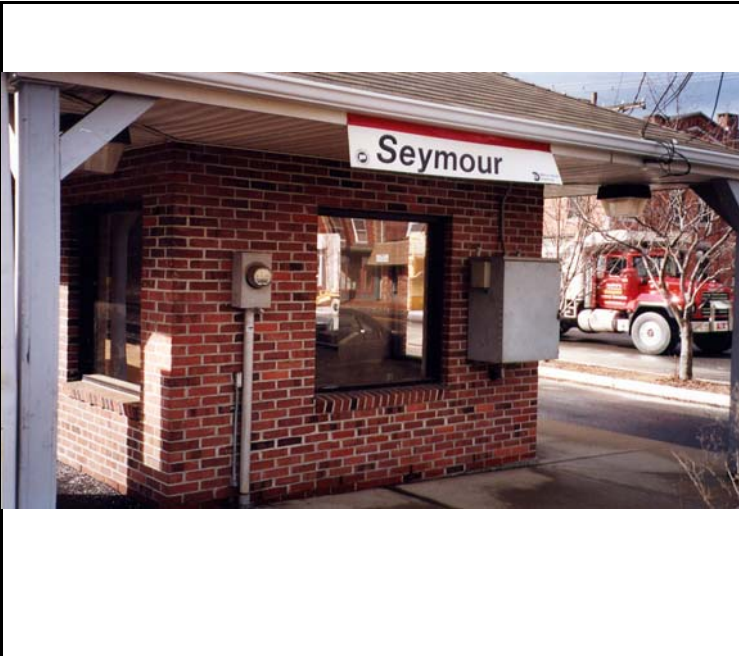
PHOTO NO. 17

Description:  
Station name

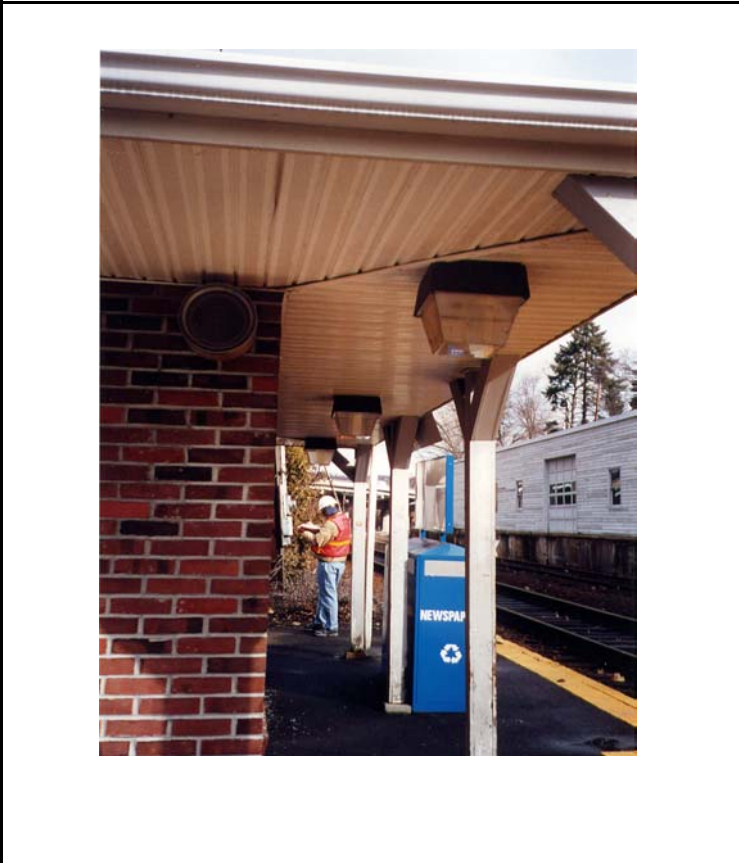
PHOTO NO. 18

Description:  
Platform shelter

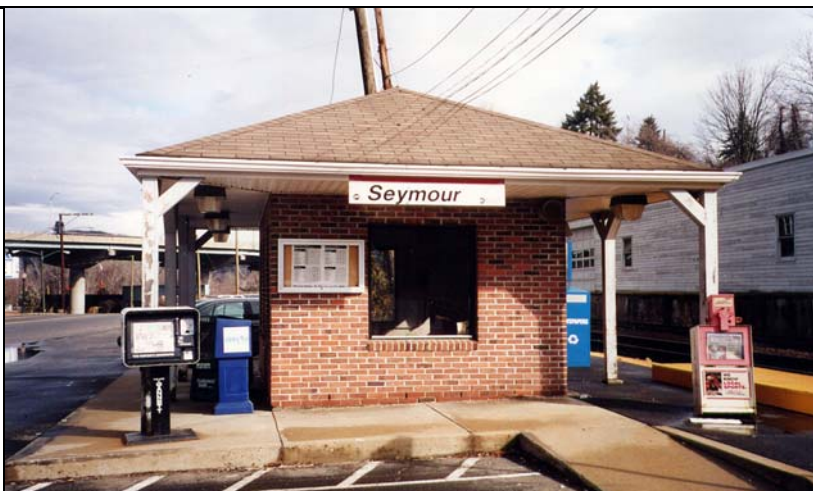
PHOTO NO. 19

Description: Station sheltering  
platform
