# Ansonia

Prepared to Connecticut Department of Transportation

# CONDITION INSPECTION FOR THE ANSONIA STATION

PREPARED BY: URBITRAN ASSOCIATES, INC. DATE: 7/3/02

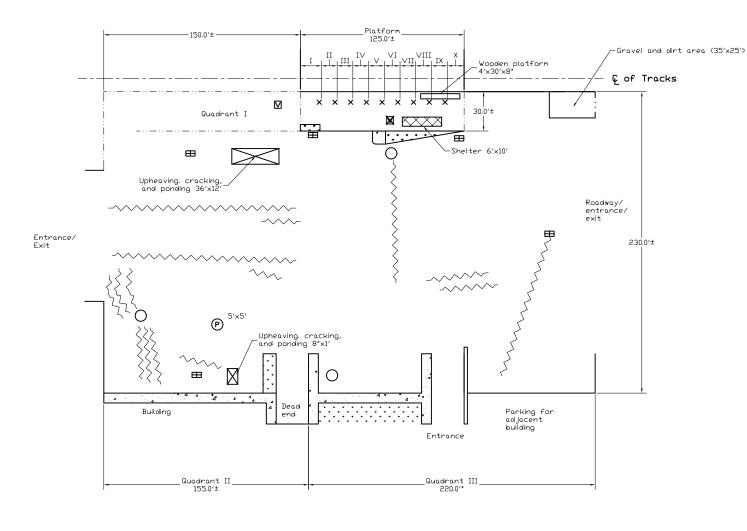
SHEET <u>10</u> DF <u>24</u>

---- Guardrail ···· Crack NDTES •••• Grass 1. The timber columns in Spans I, VII, VIII, and IX are cracked. Sidewalk Urbitran Associates, Inc. 2. The surface of Quadrant I is a mix of gravel and asphalt which contains uneven driving surface, cracks, potholes, and vegetation growth. O Sanitary Manhole Connecticut Dept. of ⊞ Drain P Ponding Transportation Concrete Scaling Ansonia Station 🗙 Canopy Column General Plan Vegetation Dead Vegetation Date: 11-19-01
