Individual Station Report

Beacon Falls

Prepared to Connecticut Department of Transportation

CONDITION INSPECTION FOR THE BEACON FALLS STATION

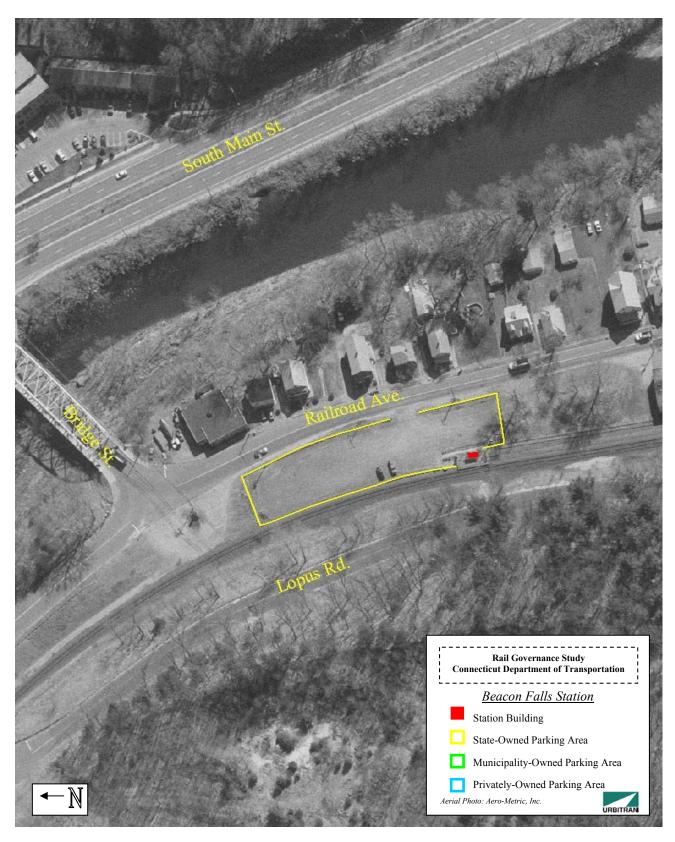
Figure 35: Beacon Falls Rail Station Parking Map

Note: This is a gravel lot with no striped spaces. There is a fenced lot adjacent to the rail station parking area but it does not appear to be available for rail commuter parking.

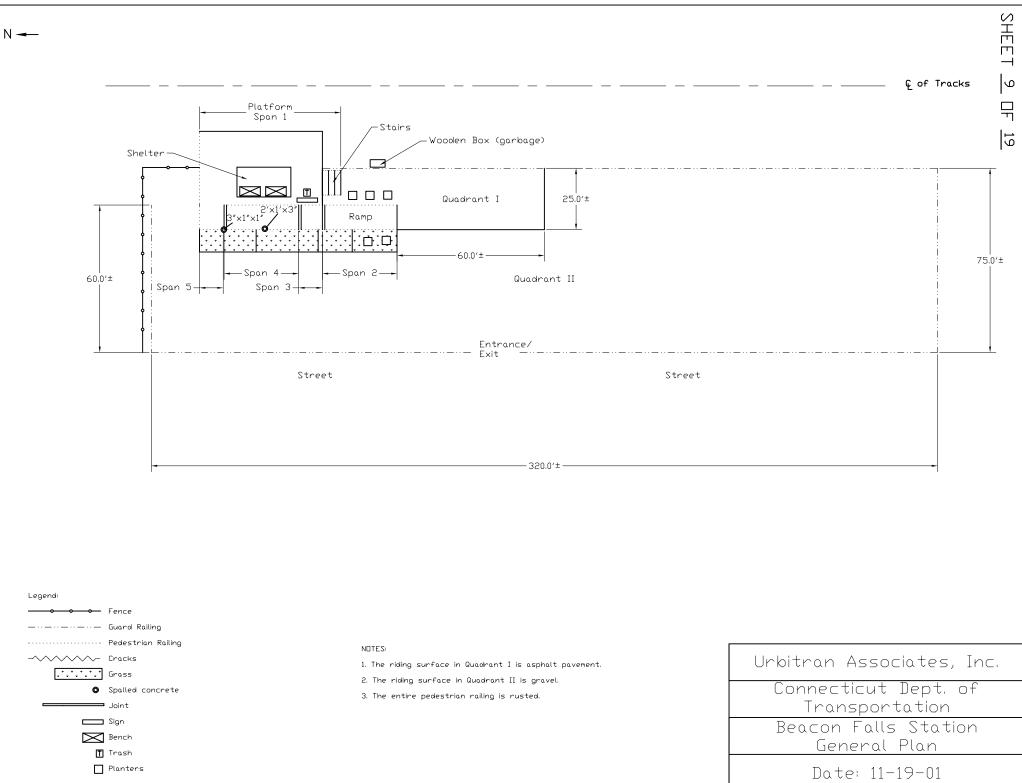
TINGS	РНОТО	REMARKS:							
NEW	PREV	NO.								
2		6	Span I-V 1,2 - The railing paint is rusted and chipped							
1		7	Span IV 4 - The joint is missing and the adjacent concrete							
			is cracked and spalled							
3		8	Span IV 5 - There is spalled concrete on the west side of the							
			ramp.							
2		9	Span I 7 -The sign's lettering is damaged							
2		10	Quad I Surface - There are minor cracks in the surface							
1		5	Quad I Stripping - The striping is faded							
1		5	Quad I Signage - The signs are bent and rusted; one of the							
			handicap signs are missing.							
1		3-4	Quad II Surface - The gravel riding surface is uneven and area							
			are missing with vegetation growing within the							
	_		parking area.							
2		1-4	Quad II Landscape - Generally the vegetation adjacent to							
	-		this area is dead.							
	+									
	+

Beacon Falls Station				
Description	Units	Quantity	Price / Unit	Total Cost
Replace asphalt pavement				
-Remove asphalt	yd ³	61.00	\$30.00	\$1,830.00
-Remove dirt and gravel	yd ³	843.00	\$30.00	\$25,290.00
-6" asphalt top course and binder course	yd ²	2500.00	\$25.00	\$62,500.00
-7" aggregate base	yd ³	904.00	\$20.00	\$18,080.00
Paint Railing	ft	230.00	\$9.00	\$2,070.00
Repair spalled Concrete	ft ²	2.00	\$40.00	\$80.00
Repair expansion joint	ft	15.00	\$9.00	\$135.00
Mobilization / Demobilization (10%)				\$10,998.50
Sub-total				\$120,983.50
Contingency (20%)				\$24,196.70
Grand Total				\$145,180.20
Say				\$146,000.00
