Individual Station Report

Old Greenwich

Connecticut Department of Transportation

Urbitran Associates, Inc.

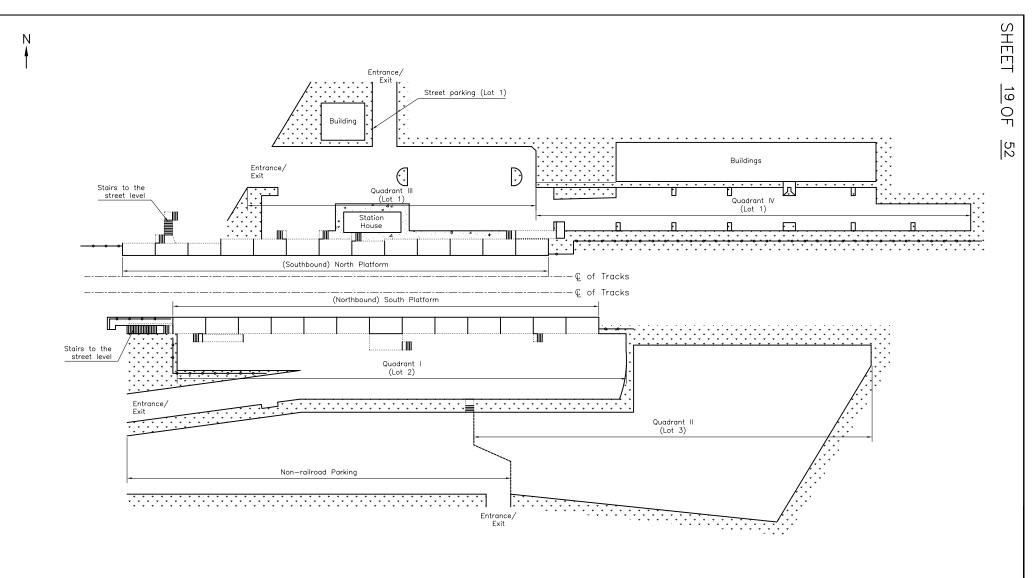
- 1. The base plates for the double tee are rusted and deteriorated throughout the platform.
- 1. The railing base plates are rusted and deteriorated throughout the platform.

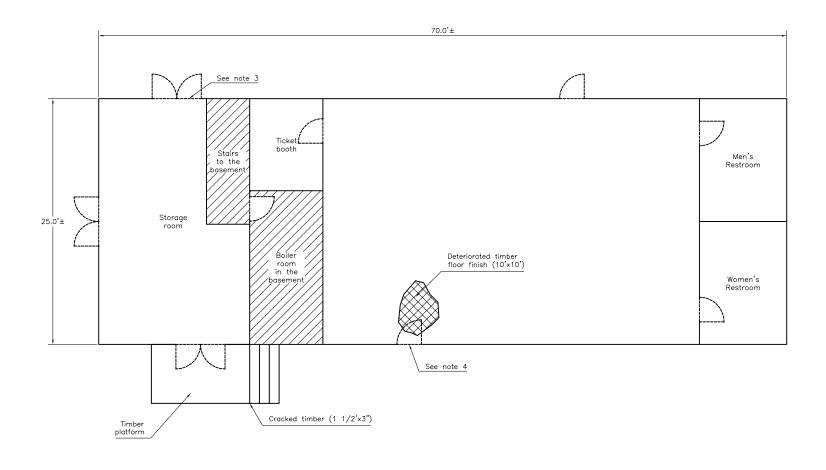
Connecticut Dept. of
Transportation
Old Greenwich Station
Station House Plan

- 1. The roofing shingles are buckling in random locations.
- 2. The exterior paint has started to chip and peel; also there are isolated areas where there are cracks in the timber facade.
- 3. There is a gap between the southeast corner door and the door frame.
- 4. The hinge is not aligned correctly and could not be moved.

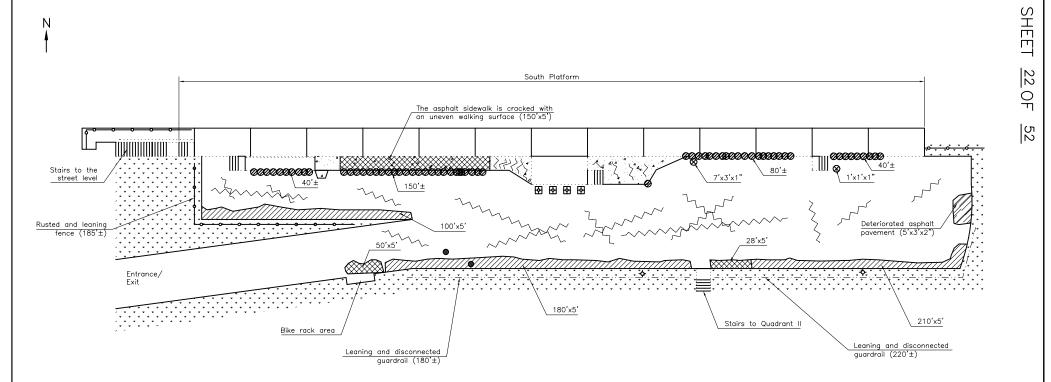
Pole with Missing Sign

- 1. In the parking area there are $2000'\pm$ of asphalt cracks.
- 2. There are $80'\pm$ of asphalt cracks in the sidewalk.

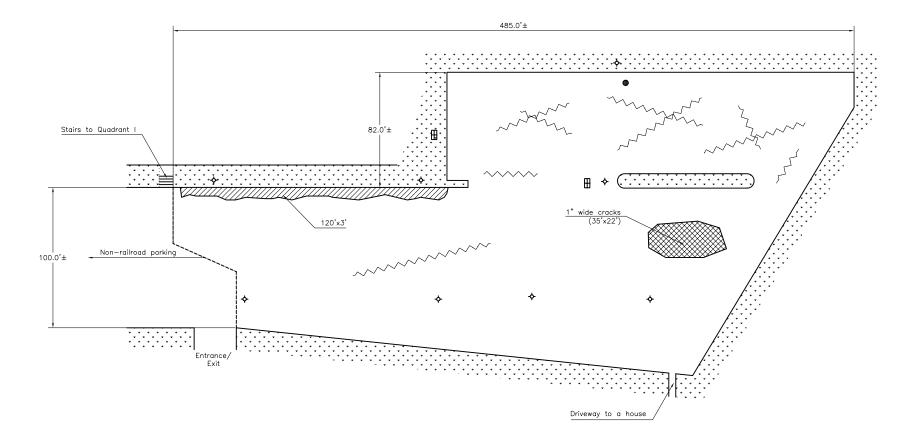
- 1. Most of the curb is missing throughout this Quadrant.
- 2. In the parking area there are $500'\pm$ of asphalt cracks.

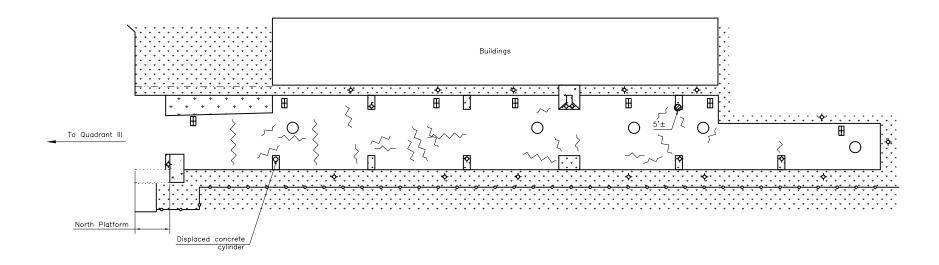
1. In the parking area there are $300'\pm$ of asphalt cracks.
