Individual Station Report

Seymour

Station Condition Inspection

CONDITION INSPECTION FOR THE SEYMOUR STATION

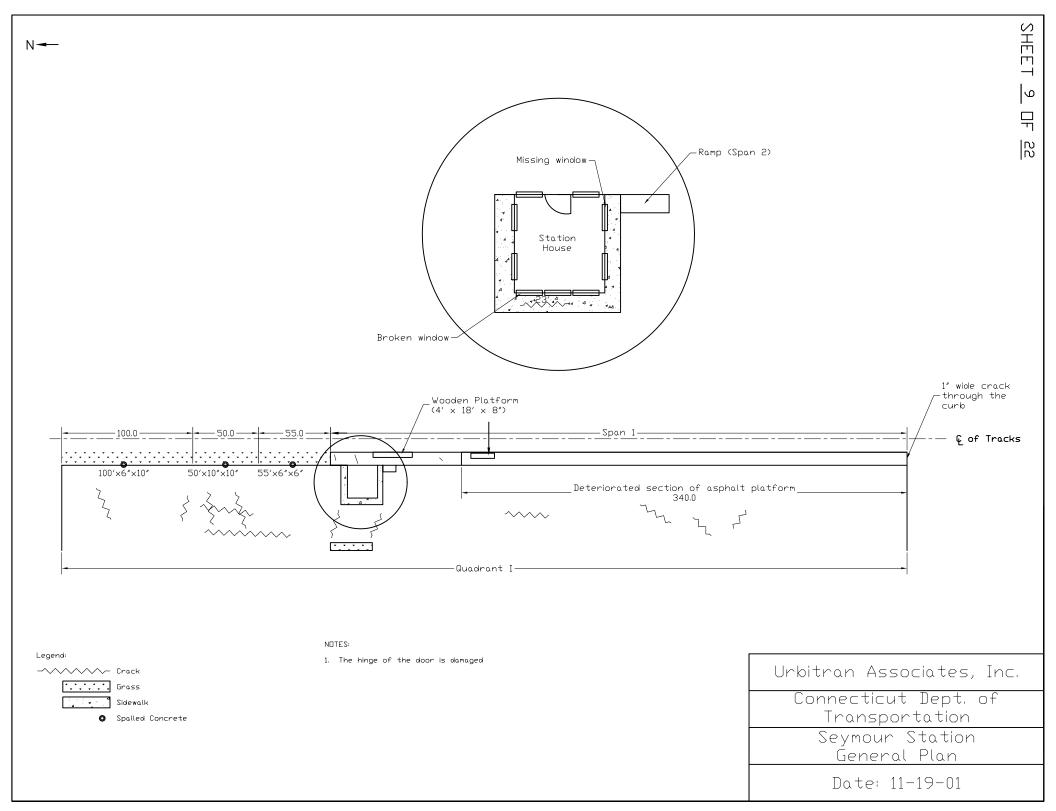
DA:	TINGS	РНОТО	REMARKS:
NEW	PREV	NO.	KEMAKKS.
1	FILV	4	Span I 5 - There is major deterioration along the southside
- '		7	of the asphalt platform
			or the deprior platform
1		5	Span I Other - There is a 1" wide crack at the south end
			of the asphalt platform
1		4	Span I 8 - The warning strip is missing as the top of the
			asphalt platform deteriorates
1		6	Station house 26 - There is a missing window, broken window
			and missing hinge on the door in the shelter
1		7	Station house 30 - There are missing shingles on the top of the
'		'	roof exposing the wood
			Tool exposing the wood
2		8	Station house 32 - There is a hairline crack (23' length) on the
			westside of the sidewalk
2		9	Station house Other - The paint is chipped along the columns
2		10	Quad I Surface - There are random cracks through out the
			surface of the parking area

4.4	
2		11	Quad I Signage - One of the signs post is leaning
2		12	Quad I Landscape - Parts of the landscape are dieing and
		12	overflowing into the parking area
			Overnowing into the parking area
2		13	Quad I Curb - There is spalling along the curb on the
			north side of the parking area
L
