Individual Station Report

Southport

Station Condition Inspection

July 2003

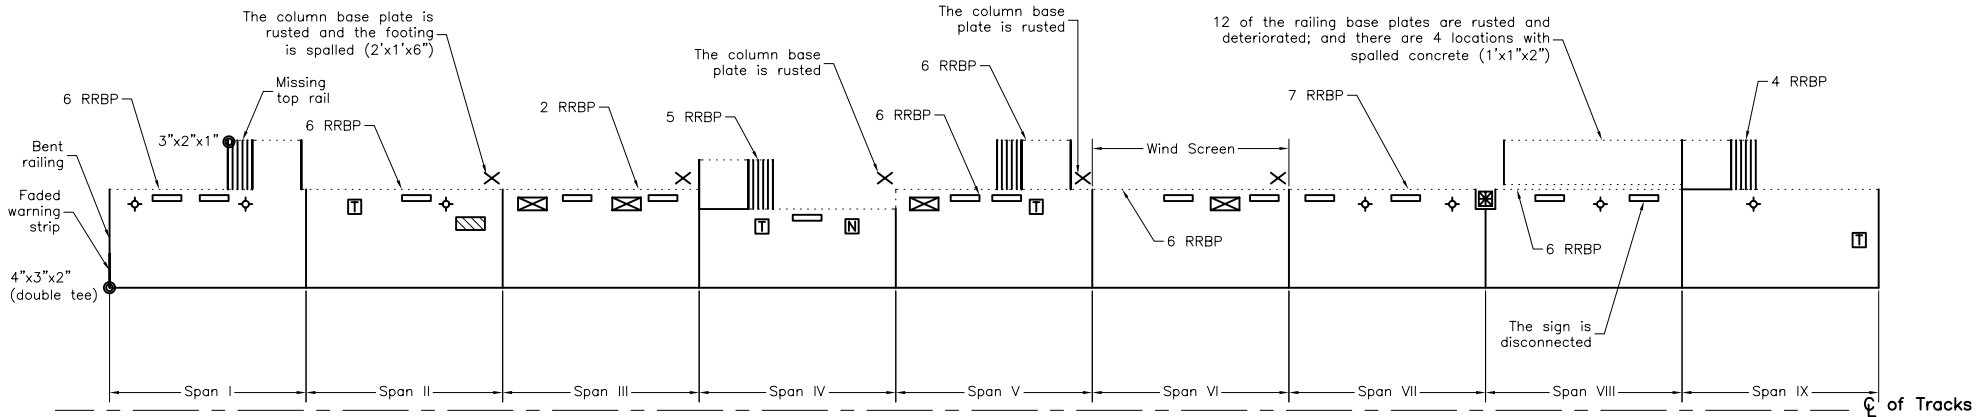
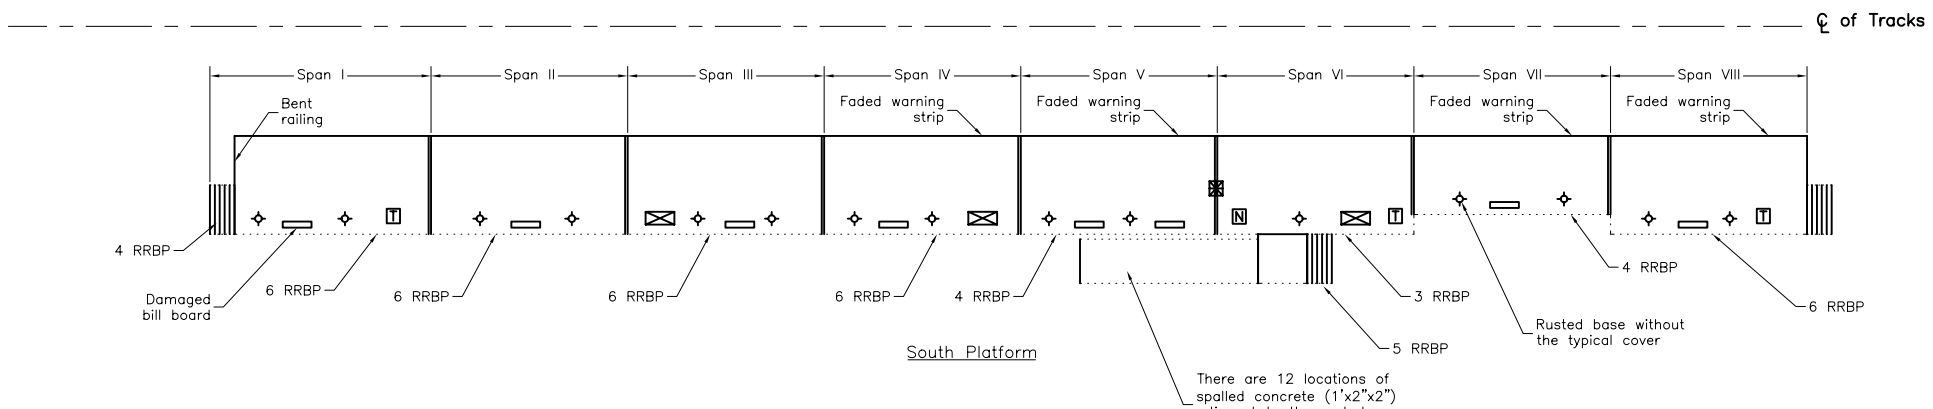
Urbitran Associates, Inc.
Connecticut Dept. of Transportation
Southport Station North and South Platform Plans
Date: 8/3/02

NOTES:
 1. All of the base plates adjacent to the footings and double tees are rusted and deteriorated.

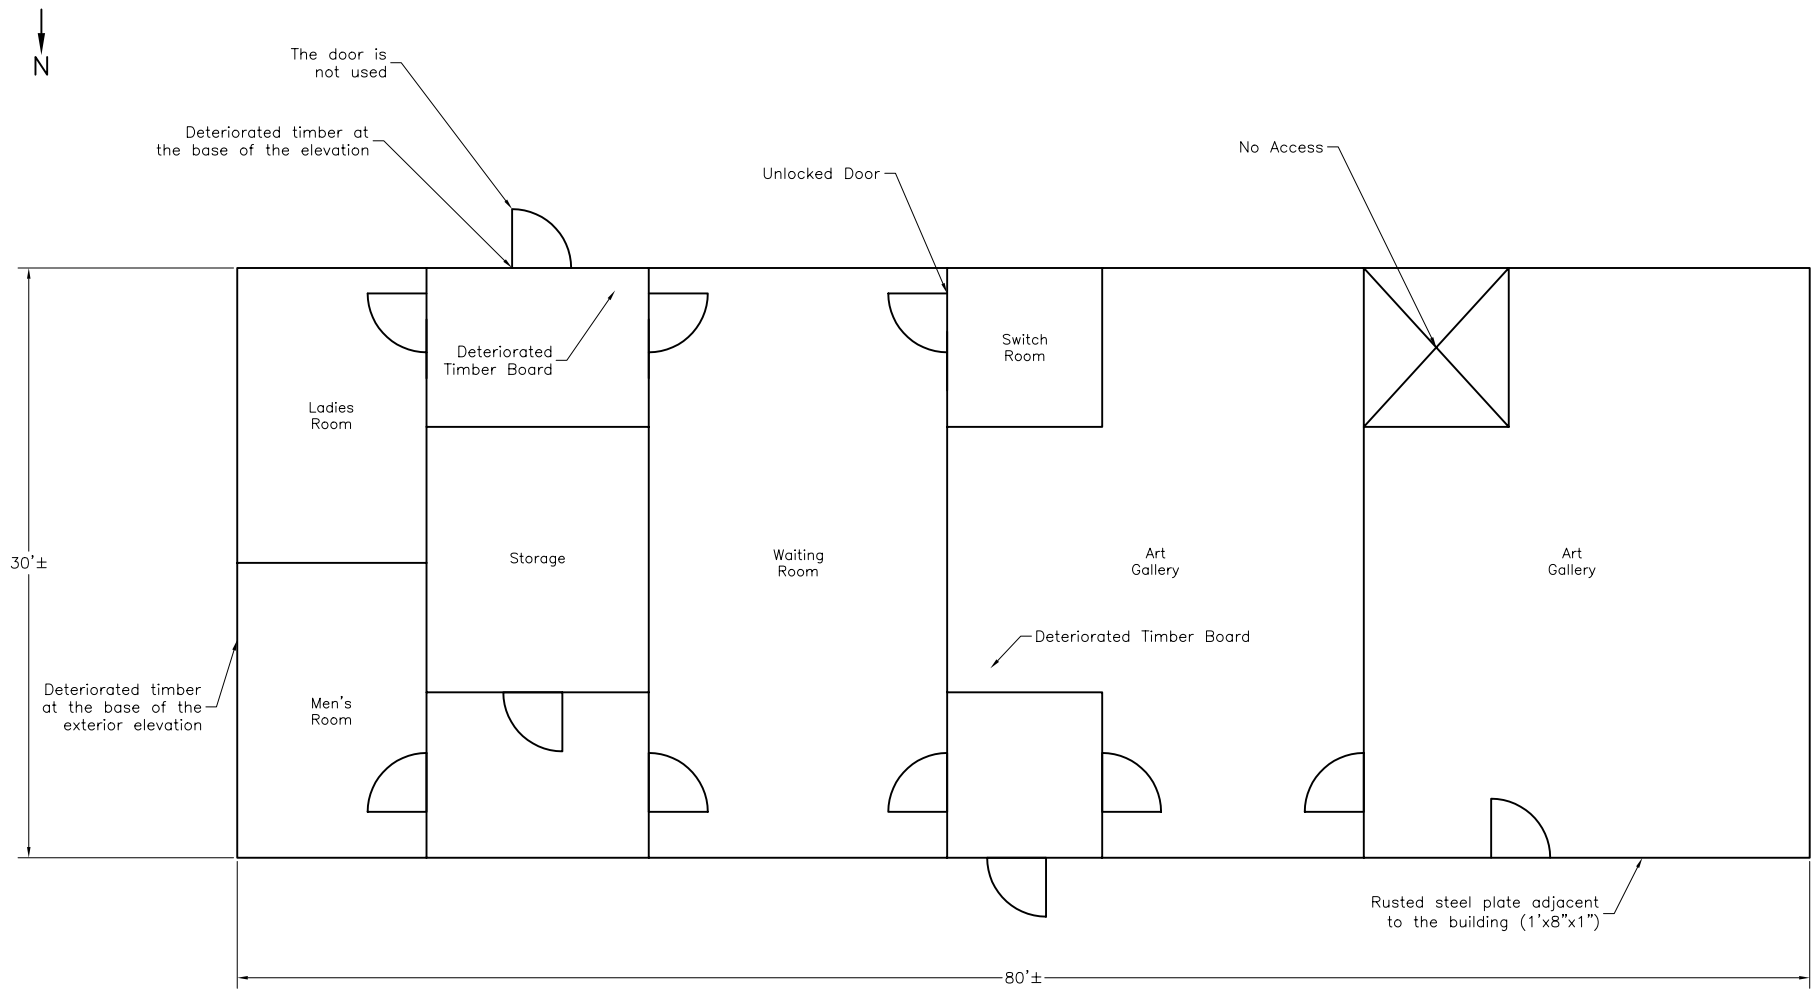
Urbitran Associates, Inc.
Connecticut Dept. of Transportation
Southport Station North Station House
Date: 12-06-01

1. The ceiling paint above the waiting room contains minor map cracking
2. The protective coating floor finish is worn down through out the station house.

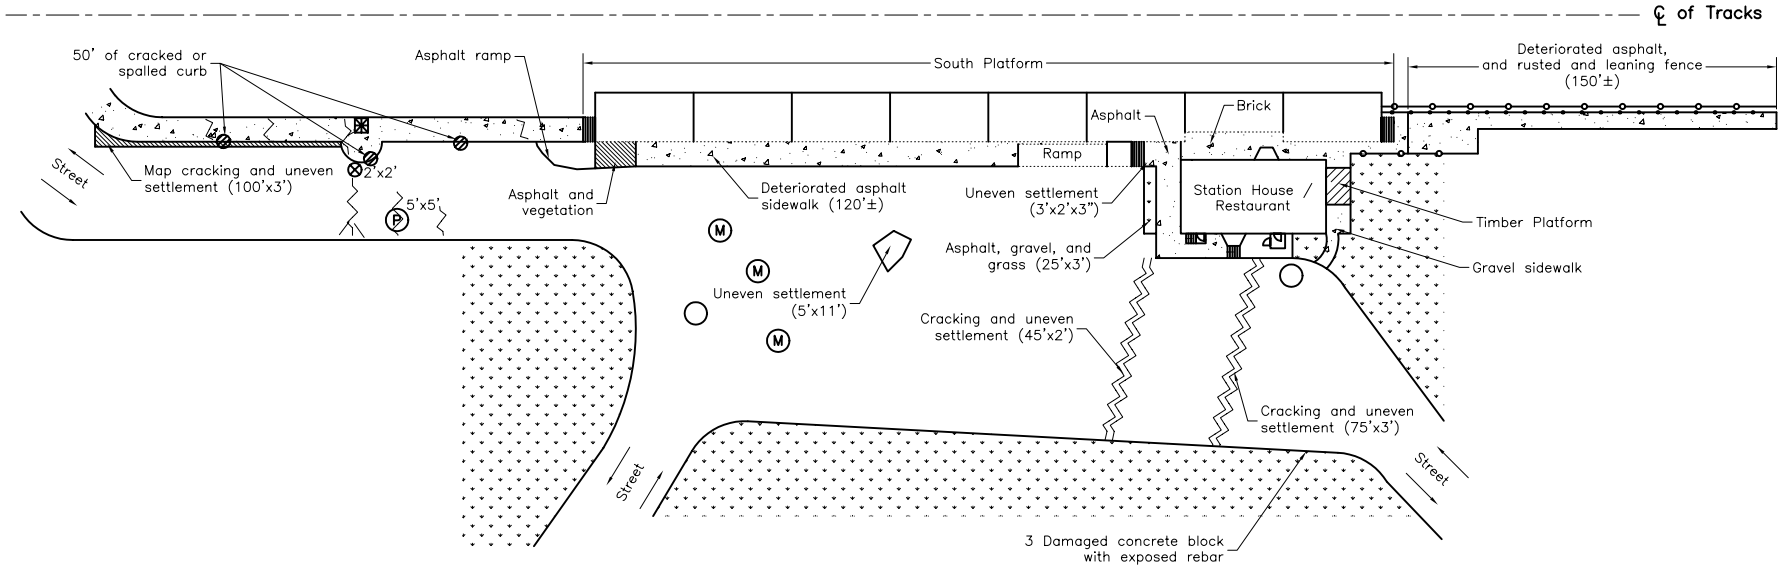
NOTES:
 1. 10% of the asphalt pavement contains additional cracks that are not shown on the drawing for clarity.
