# PROJECT DESCRIPTION

Project No. 0070-0119  
Replacement of Bridge No. 07119 in Lebanon  
Route 616 over Goshen Brook

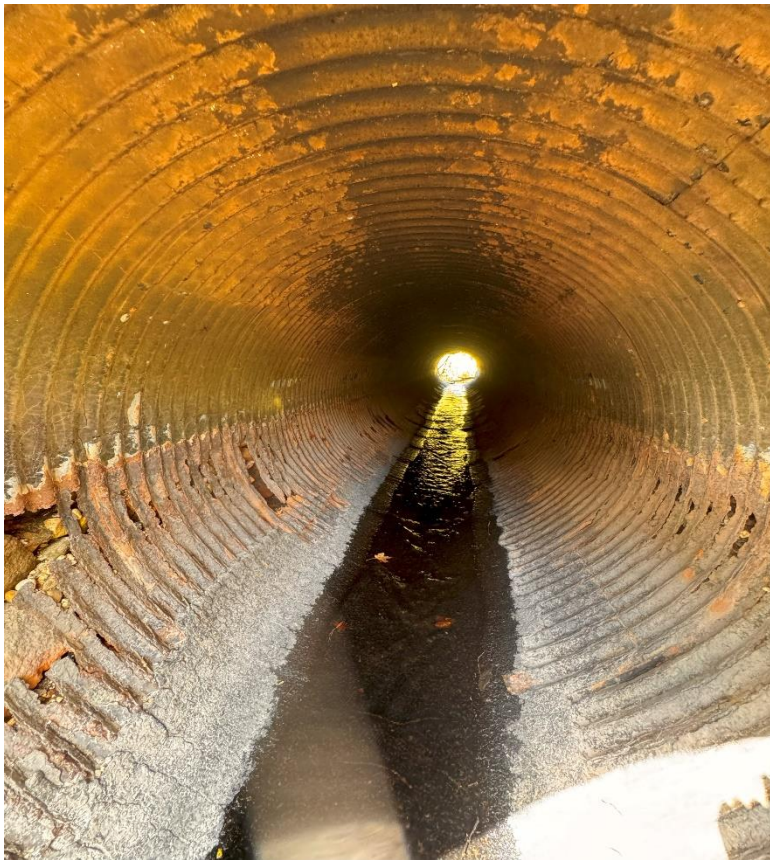
The culverts and retaining walls are rated 4 – poor. It is evident from surrounding conditions that the roadway is overtopped during significant enough storm events, likely due to backflow from the Yantic River, as there is not enough debris in the barrels to block the flow. The corrugated steel barrels show moderate corrosion beginning from the bottom and extending up to 2' high along their length. There is common, localized corrosion resulting in complete section loss of the pipe in those areas, some up to 3.7 feet long by 1.4 feet wide. The joint of barrel 2 is offset 5" vertically at station 0+18. The interior epoxy coating is nearly 100% deteriorated with isolated remnants only. The headwalls exhibit significant mortar loss, up to 25%, with some areas missing blocks entirely (over 3 sf of blocks in some areas). The upstream headwall exhibits several voids around the opening of barrel 1, up to 1.7 feet of penetration into the wall. The upstream headwall of barrel 2 also had severe gaps, up to 6 feet of penetration into the roadway base. On the downstream side there is much less penetration with only about an inch around barrel 2.

Typical Interior View of Barrel (Barrel 1 Shown)

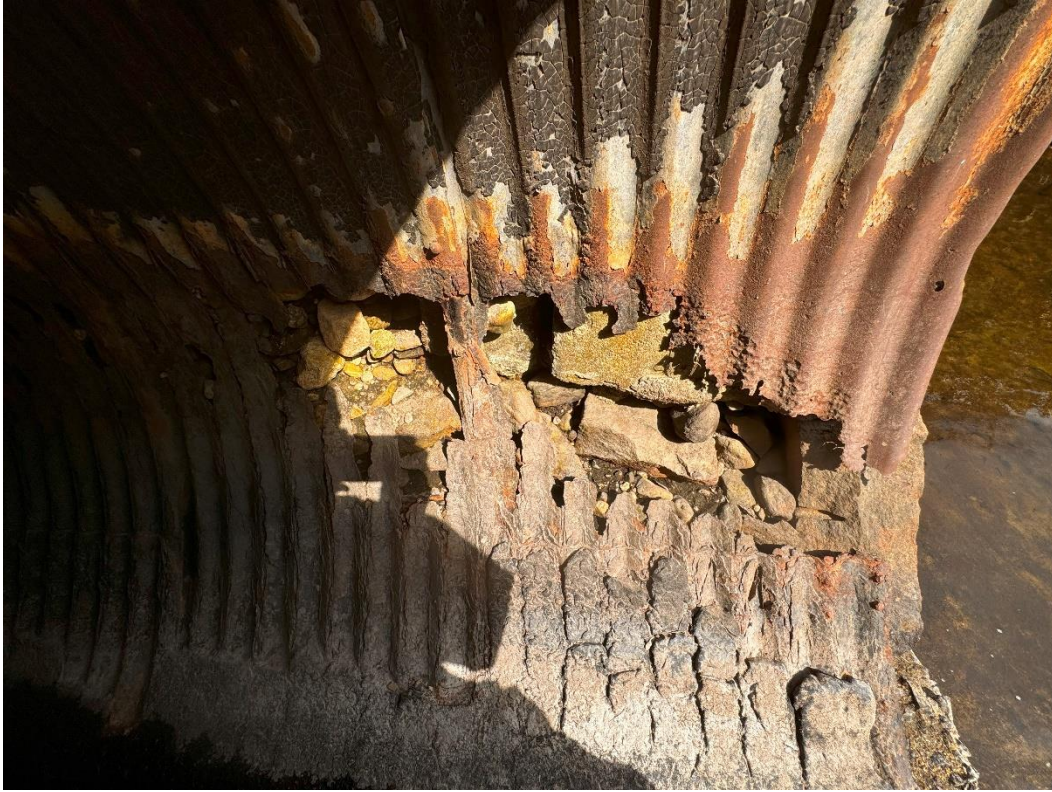
Typical View of Section Loss in Barrel (Barrel 1 Shown)

The purpose of this project is to address the above noted deficiencies and provide a structure that meets both modern load rating requirements and design standards. A full replacement of the culvert with a cast in place concrete slab supported on integral abutments, potential local drainage improvements and approach modifications is likely to meet these goals. The existing opening at the structure will be increased in size and will be a 25' clear span over Goshen Brook. Along with the new bridge structure, there will be full depth roadway reconstruction, roadway embankment construction, channel embankment regrading, and safety improvements for both cyclists and motorists. There are existing overhead utilities which will be moved prior to construction to allow for crane placement and movements associated with installation of steel piles for the bridge foundation. There will be right of way impacts at the south side of the structure associated with removal of the existing culvert & headwall, embankment grading, water handling devices installation and removal, & channel regrading. This project will be constructed using stage construction in two separate stages due to the high average daily traffic and inadequate detour routes available. During stage construction the traffic will cross Goshen Brook in an alternating one-way configuration with stop sign controlled stops at each end of the work zone. There will be advanced warning signs set up according to the latest Manual for Uniform Traffic Control Devices (MUTCD) standards with illumination set up for improved visibility.

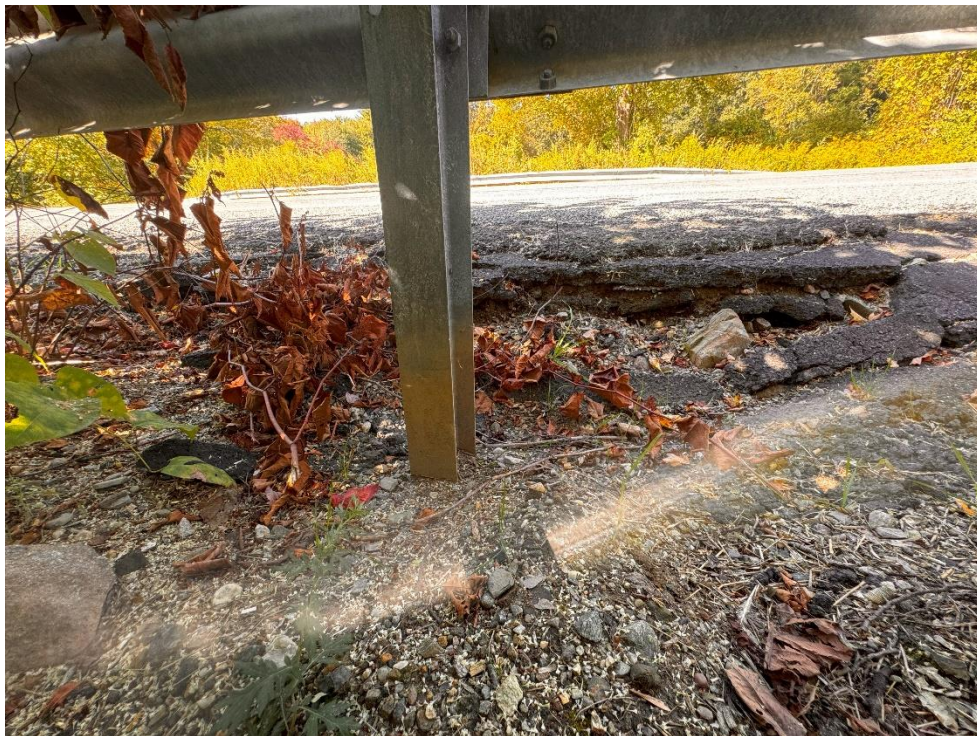
On the topside, there are overhead electrical and communication lines that cross over the south side of the structure. There are currently no sidewalks along route 616 or traffic signals at the intersection of either approach. The road exhibits undermining particularly at the southeast shoulder. There have previously been repairs done for asphalt crack sealing and rip rap installation for erosion prevention.

Typical View of Undermining at Shoulder (South East Corner Shown)
