**Field Strain Monitoring to Evaluate Unexpected Cracking
in a Non-Redundant Steel Plate Girder Bridge**

July 2009

Report No. CT-2251-2-09-4

**Connecticut Department of Transportation
Bureau of Engineering and Construction
Research and Materials**

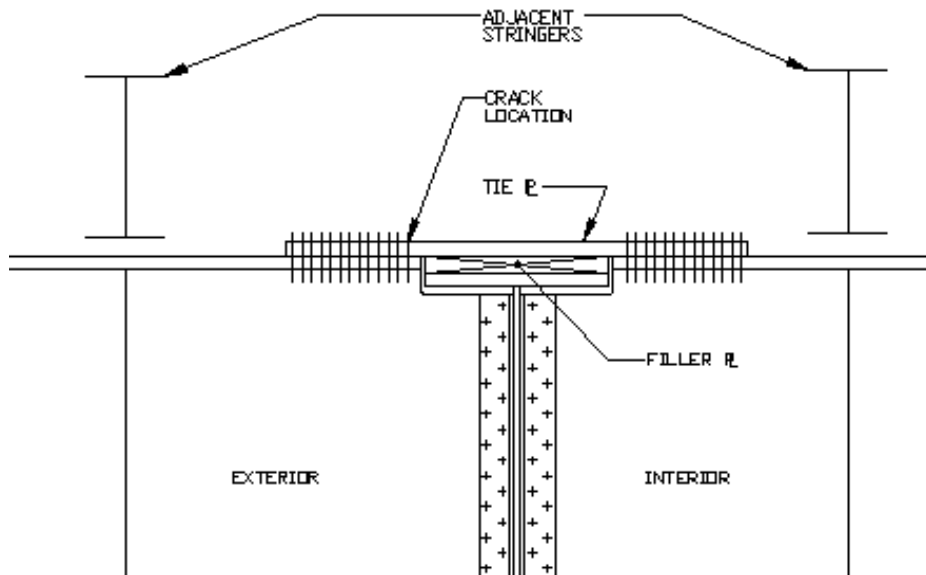
Cracking has occurred in the top plate used to make the interior transverse floor beam continuous with the exterior cantilevered transverse floor beam. The web is made continuous through the longitudinal girder using bolted double-angle connections. The bottom flange of the transverse floor beam is also made continuous through the longitudinal girder using a bolted seat connection. The top flange of the transverse floor beam is not rigidly connected to the top flange of the longitudinal girder. A tie plate is used to make the top flange of the transverse floor beams continuous over the top of the longitudinal girder, as shown in Figure 3. A filler plate exists between the tie plate and the top flange of the longitudinal girder. Significant corrosion is present between the tie plate and the filler plate at the end joints in the concrete deck, located at the ends of the simple spans. The corrosion has caused an upward vertical deformation of the tie plate

with respect to the top of the longitudinal girders, with magnitudes up to approximately $\frac{3}{4}$ inch (1.91 cm).

FIGURE 3 Detail of tie plate connection between interior transverse floor beam and exterior cantilevered transverse floor beam.

Prior to this study, eight tie plates on the transverse floor beams at the ends of each simply supported span exhibited fatigue cracks. The cracks occurred on the edge of the tie plate, on the interior side of the longitudinal girders. All cracks were on the interior side of the tie plate. Each crack developed adjacent to the first bolt of the bolted connection to the top flange nearest the longitudinal girder. The cracks have occurred in similar locations on each tie plate, but only on the southern side of the bridge, towards

The first set of cracked tie plates were repaired two years prior to this study. The repair design consisted of removing the cracked tie plate and filler plate, and replacing only the tie plate. The filler plate was not replaced because it was believed that the rust between the filler plate and the original tie plate was a major contributor to the cause of the crack. The new tie plate had the same dimensions as the one it replaced, but it was made using steel with a yield stress of 50 ksi, whereas the original tie plates had a yield stress of 36 ksi. A recent inspection revealed a crack on a tie plate that was not previously replaced. This is what prompted the strain monitoring reported in this study. This report presents the findings of two sets of strain gage monitoring. Monitoring was first conducted to collect strain data from two original tie plates, one with a crack and one without a crack. Additional monitoring was carried out to collect data from a recently repaired tie plate.

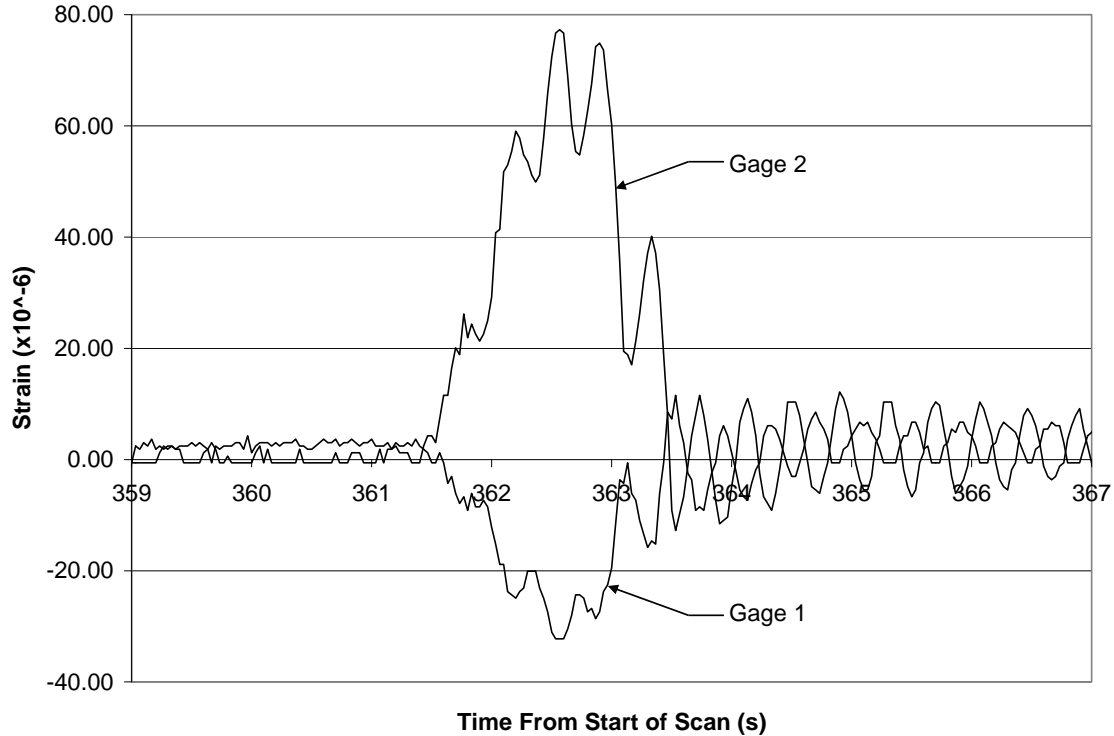
Figure 6 shows a truck event recorded during the initial set of tests. Gage 2 is on the leading edge, i.e. it is located on the same side of the tie plate as the approaching vehicle. This side is the interior side with respect to the end support. Gage 1 is on the trailing edge of the tie plate, i.e. on the side opposite to the leading edge. Gages were placed on both sides of the tie plate because the cracks always seemed to be aligned on one side with respect to the direction of traffic crossing, even though the tie plates were expected to be in uniform axial tension resulting from the continuity of the transverse floor beams. The tests demonstrated that there is significant bending in the horizontal plane.

FIGURE 6 Strain data from a truck event on a cracked tie plate.

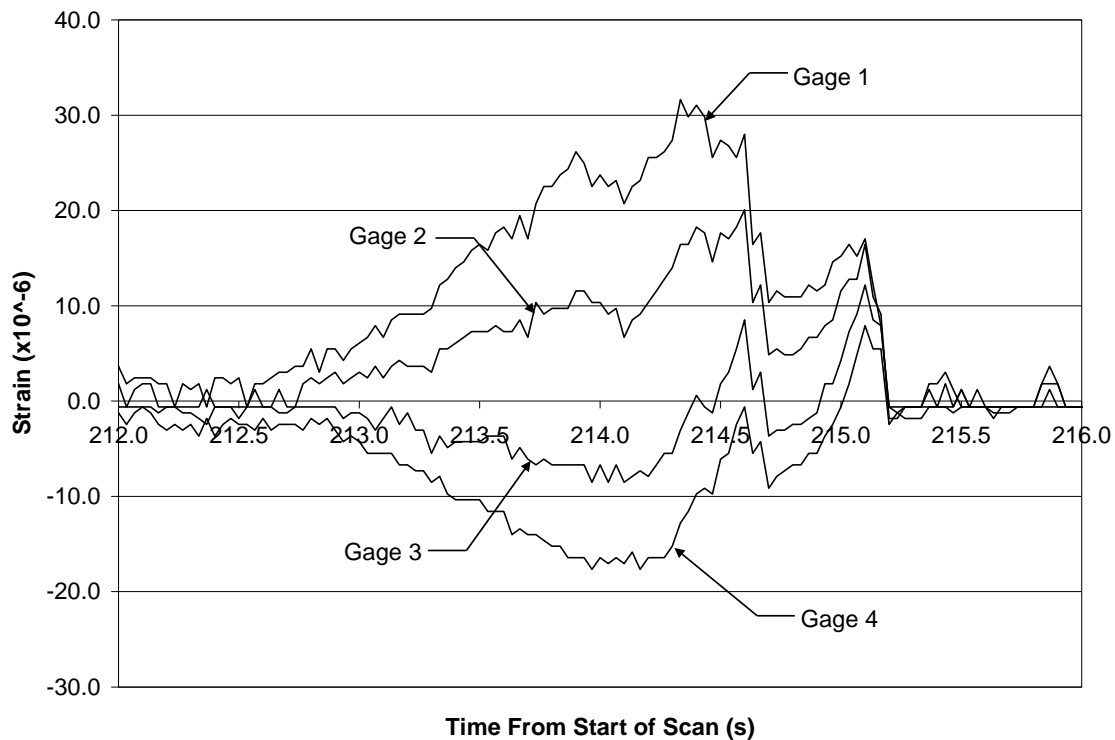
A typical set of strain data collected for a truck in the second set of tests is shown in Fig. 7. The strain data was collected in the second set of testing on a repaired plate, which, as noted before, no longer had a filler plate. As shown, the strains increased approximately linearly during the initial loading stage, i.e. in the first half of the event. Strain gages 1 and 2 are on the leading edge. Strain gages 3 and 4 are located on the trailing edge. As shown, strain gages 1 and 2 recorded linearly increasing tensile strains while strain gages 3 and 4 recorded linearly increasing compressive strains. All strains

were approximately at their respective peaks at the same time during the event. Based on the time period for the full event, it is clear that the vehicle is approximately in the middle of the span when the strains are at their highest peaks. The magnitude of the strains then decreases as the truck approaches the monitored girder, at the end of the span.

FIGURE 7 Strain data from truck event on a repaired tie plate.

Fig. 7 also shows that the magnitude of the tensile strains at the end of the event are not as large as the peak strains that occur when the truck is approximately in the center of the longitudinal span. This suggests that the cantilever action that is expected to control the loading on the tie plate is not the worst case loading. The worst case for the tie plate is, in fact, while the truck is in the center of the longitudinal girder span.

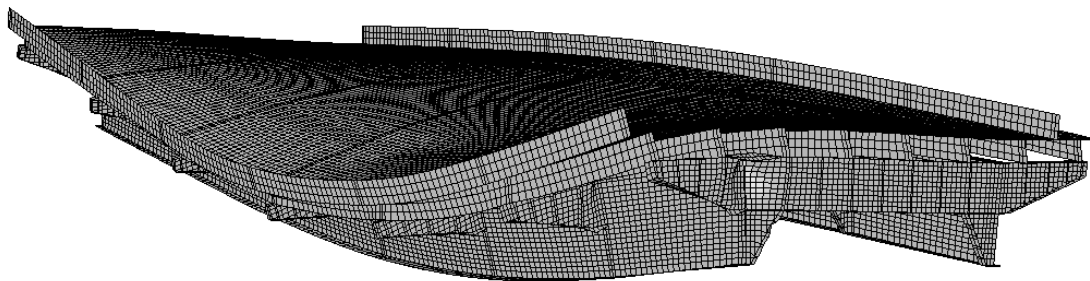
FIGURE 9 Three-dimensional finite element model in deformed shape.

A study of the deformations shown in this deflected shape confirms qualitatively that the tie plate is bending in the horizontal plane, and that these deformations are consistent with the field strain data. Figure 9 shows that the longitudinal girder deflects in simple bending when the load is in the center of the simple span. This deflection causes the end of the girder to rotate toward the center of the span, about the bearing located at the bottom flange of the girder. As the longitudinal girder rotates inward, the top of the transverse floor beam's web, which is connected via bolted double angles to the longitudinal girder, is pulled toward the center of the span. The stringers, which are connected to the top flange of the transverse floor beam, provide lateral bracing restraint and resist the inward movement of the transverse floor beam. This forces the tie plate to bend in the horizontal plane, creating tension on the leading edge of the tie plate and compression on the trailing edge of the tie plate.

The behavior is described in more detail in the M.S. thesis of the first author (13). As shown, the deflection of the longitudinal girder decreases as the load is stepped across the last transverse floor beam and away from the center of the span. Thus, the end rotation of the longitudinal girder is lessened, reducing the horizontal bending of the tie plate. When the load is directly over the last transverse floor beam of the span, the girder is subjected to simple cantilever action that causes near uniform tension in the tie plate. The tension caused in the tie plate from the cantilever action is much lower than the tension caused by the bending forces in the tie plate when the load is in the center of the simple span. This behavior reinforces the fact that the first, and highest, peak of the strain data collected occurs when the truck is in the center of the span, which is where the longitudinal girder is at its largest deflection, and therefore, its largest end rotation.
