STATE OF CONNECTICUT  
DEPARTMENT OF TRANSPORTATION

**Form: Asset Photos**

**Inspection type:** Fracture Critical,Routine

**Bridge No:** 01524

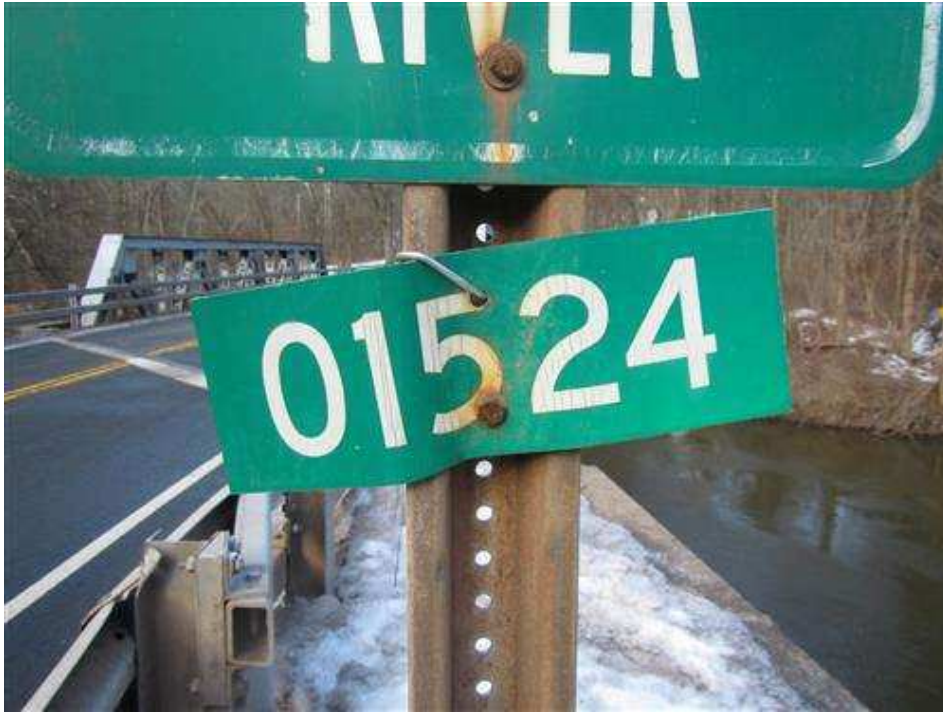
Photo Number: 1

Bridge ID.

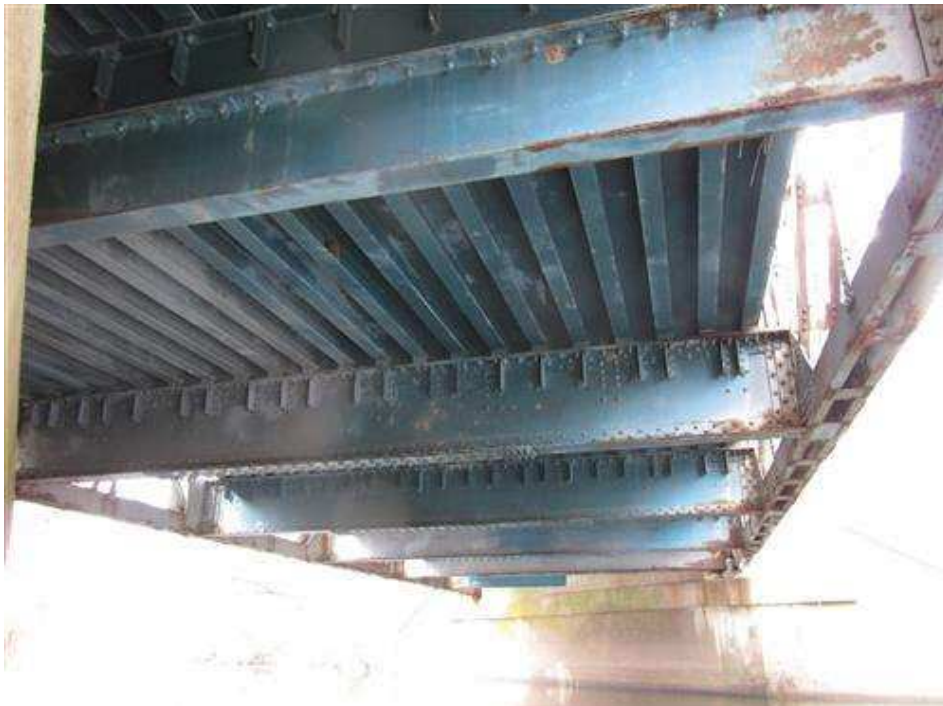
Photo Number: 2

Typical underside, looking west.

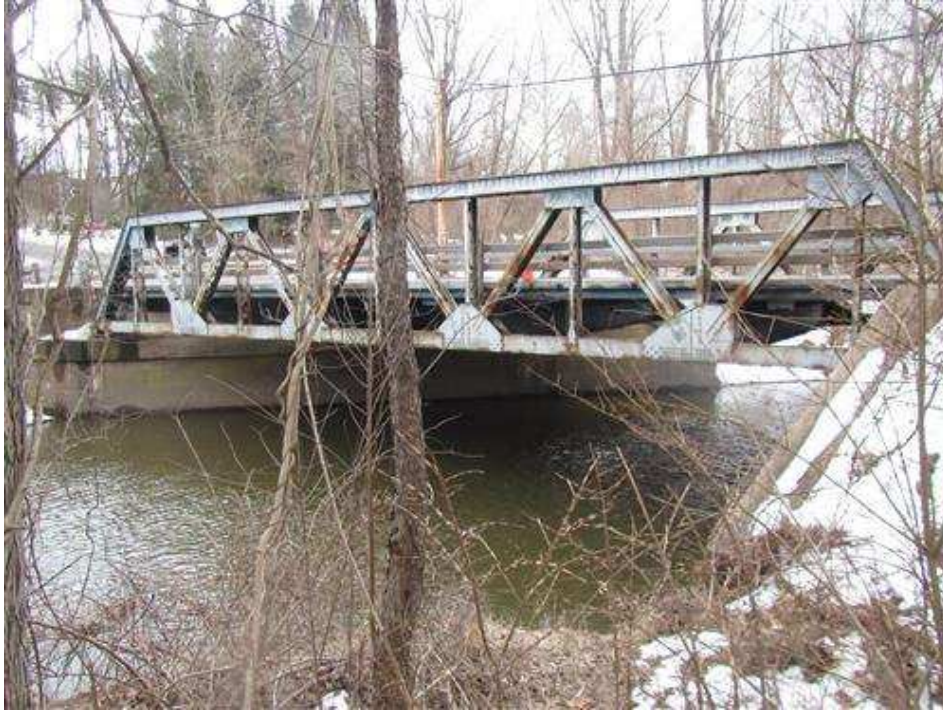
Photo Number: 3

North elevation.

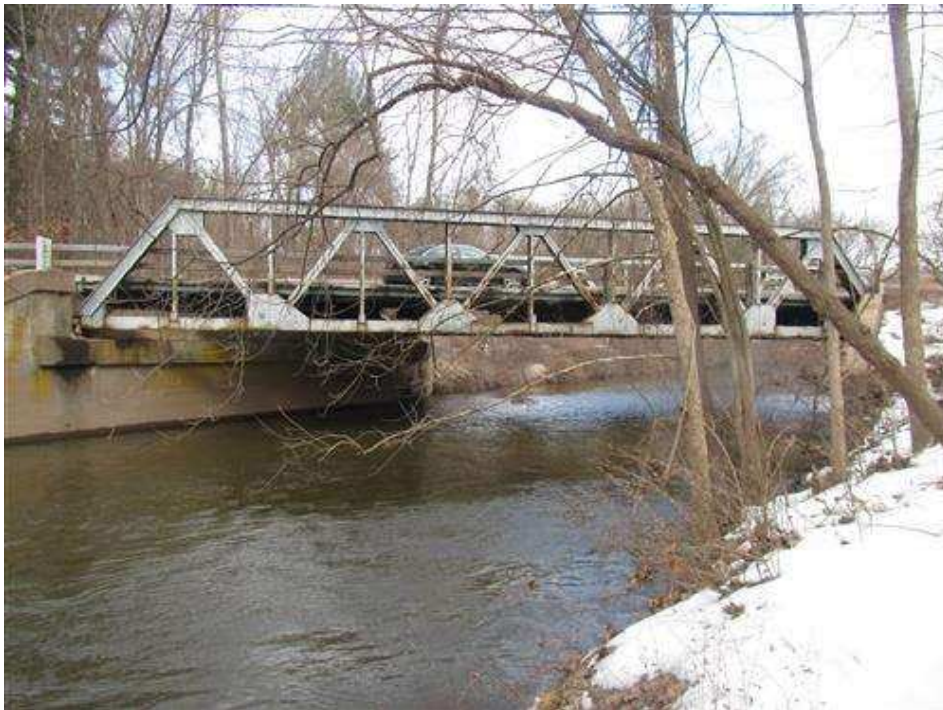
Photo Number: 4

South elevation.

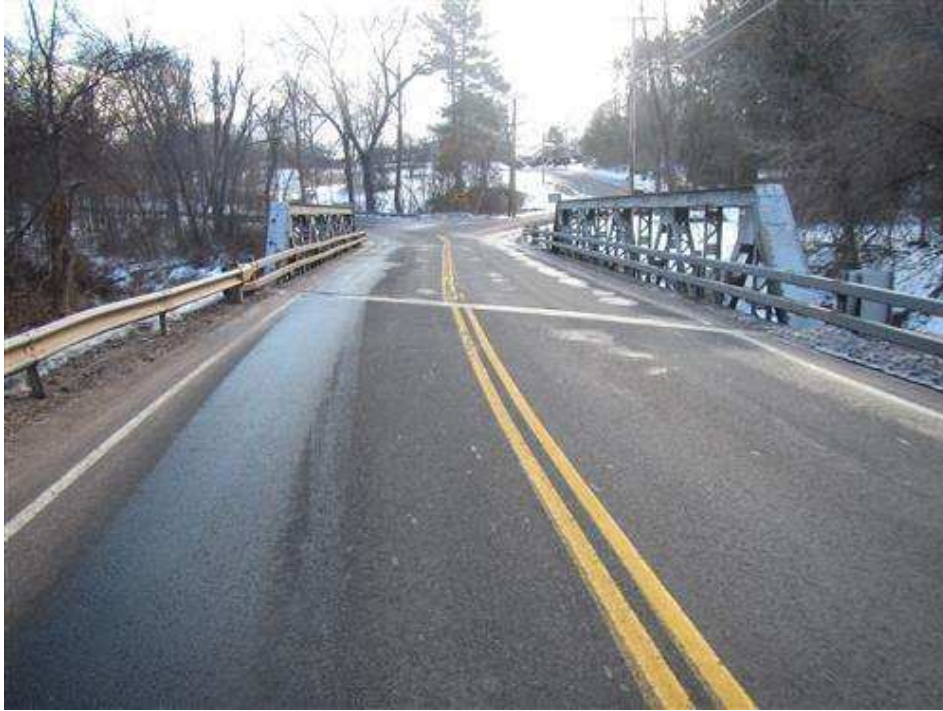
Photo Number: 5

Bridge from the west approach.

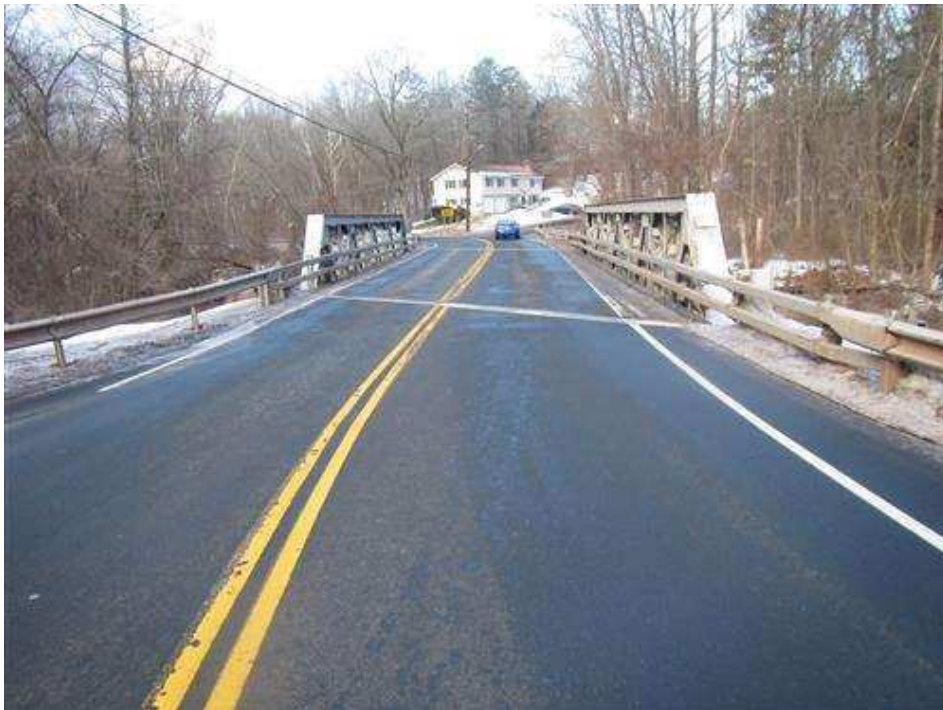
Photo Number: 6

Bridge from the east approach.

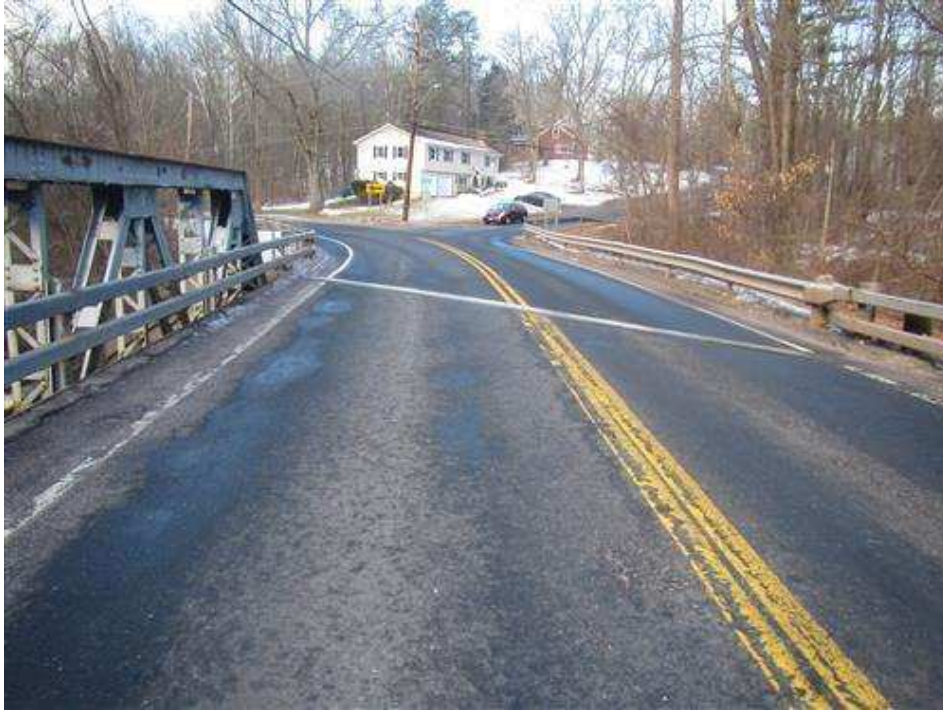
Photo Number: 7

West approach from the bridge.

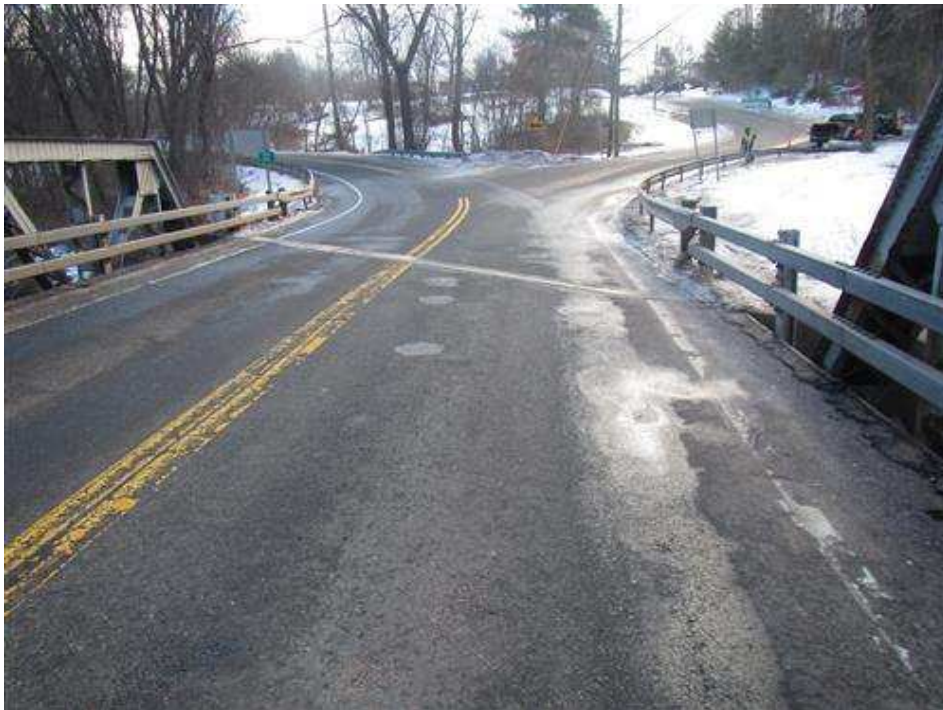
Photo Number: 8

East approach from the bridge.

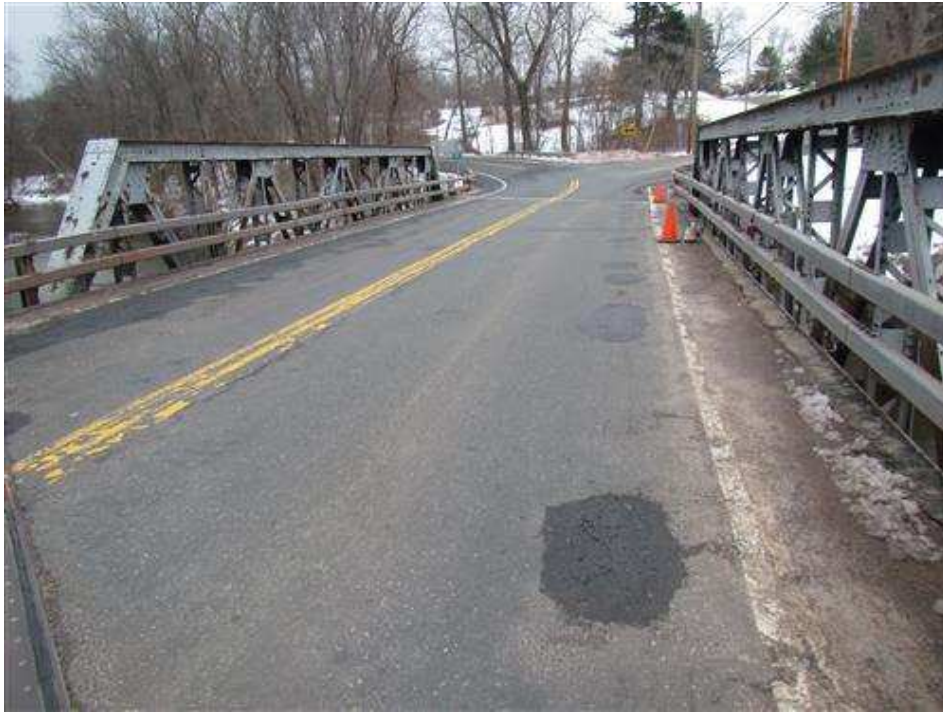
Photo Number: 9

Typical top of deck, looking east.

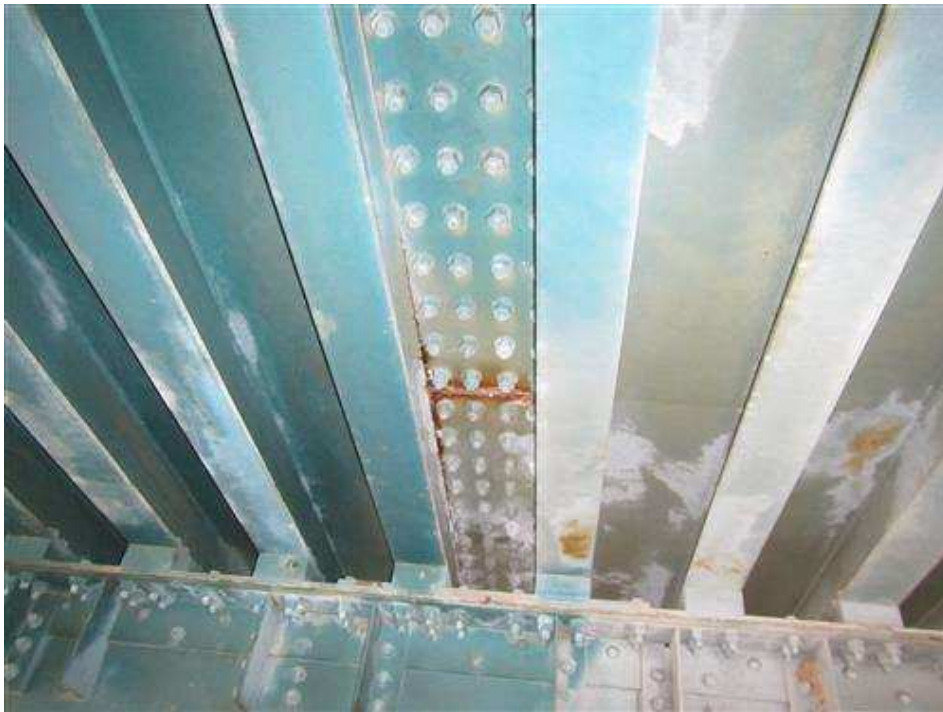
Photo Number: 10

Panel 4, bay 11, deck splices near floorbeam 5, note the laminated rust at the ends of the splice plates.

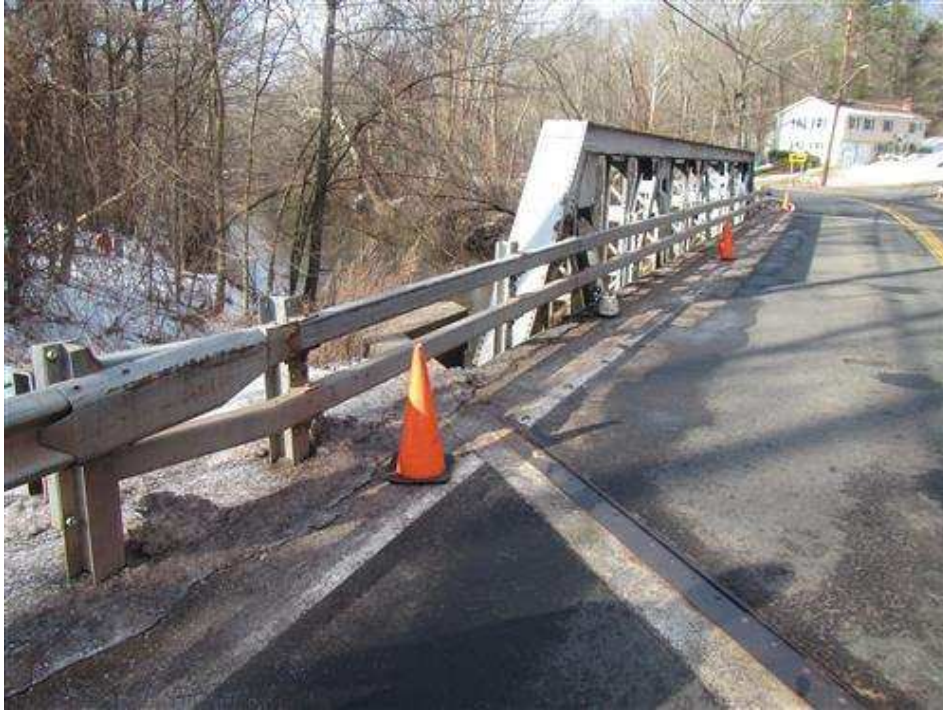
Photo Number: 15

Southeast metal beam rail transition to the bridge rail. Note the tear at the metal beam rail at the connection.

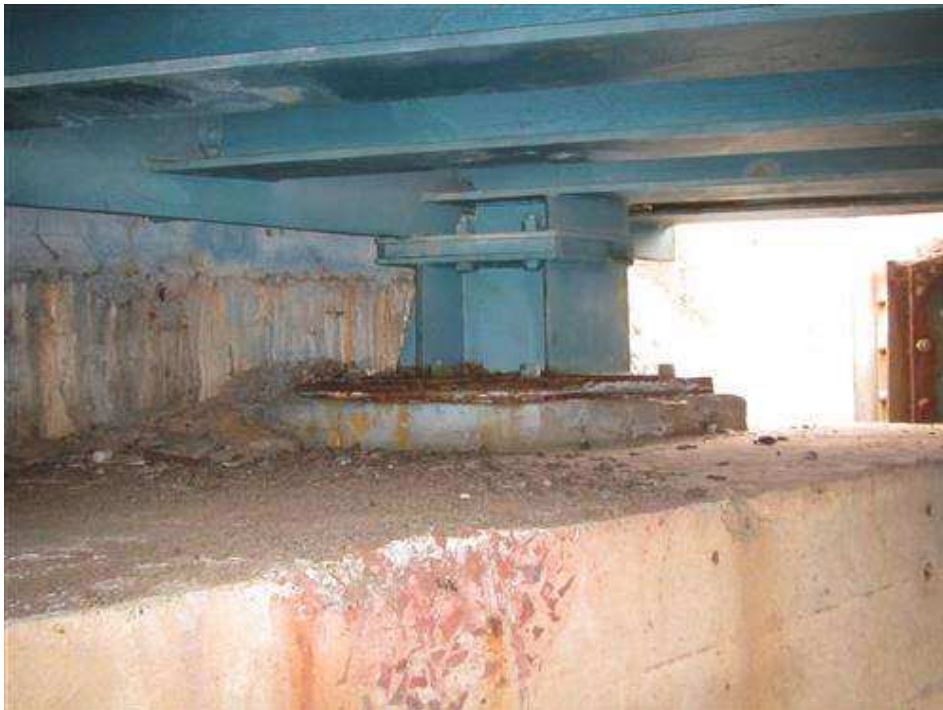
Photo Number: 16

Deck rib 2 sliding expansion bearing at abutment 1. Note the impact rust between the sliding plate and masonry plate.

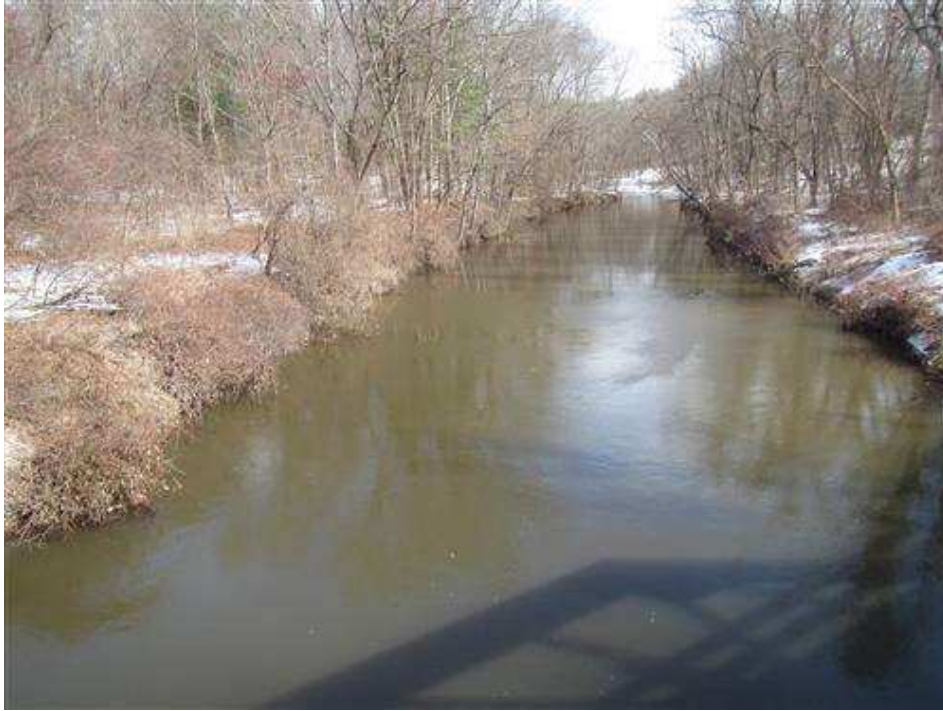
Photo Number: 43

Upstream, north channel.

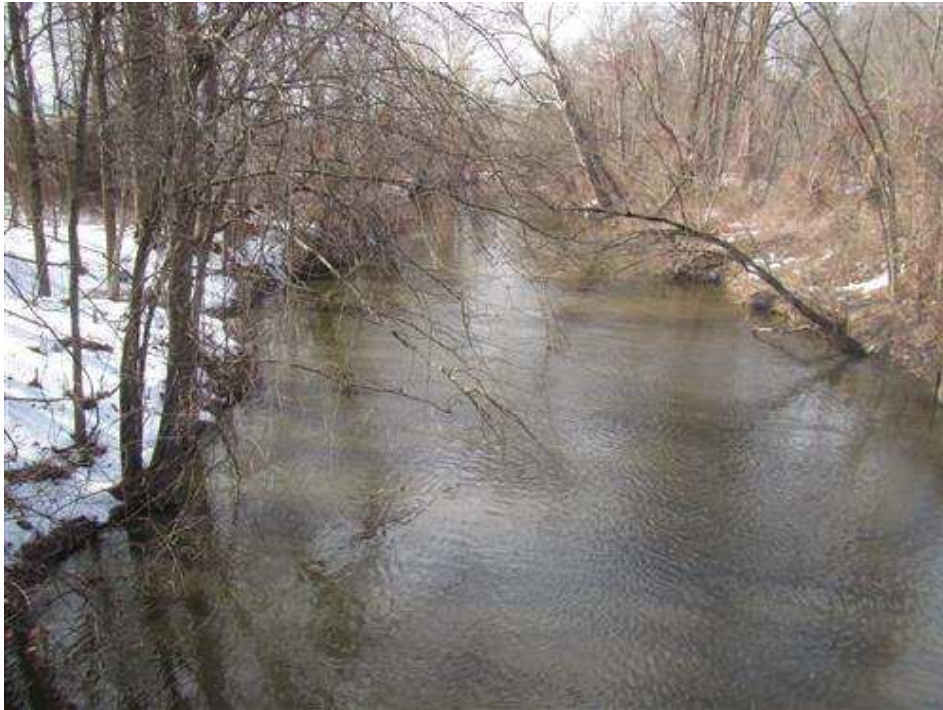
Photo Number: 44

Downstream, south channel.
