State of Connecticut DAS

CDECCA Due Diligence Final Report

**Veolia North America
Waldron Engineering**

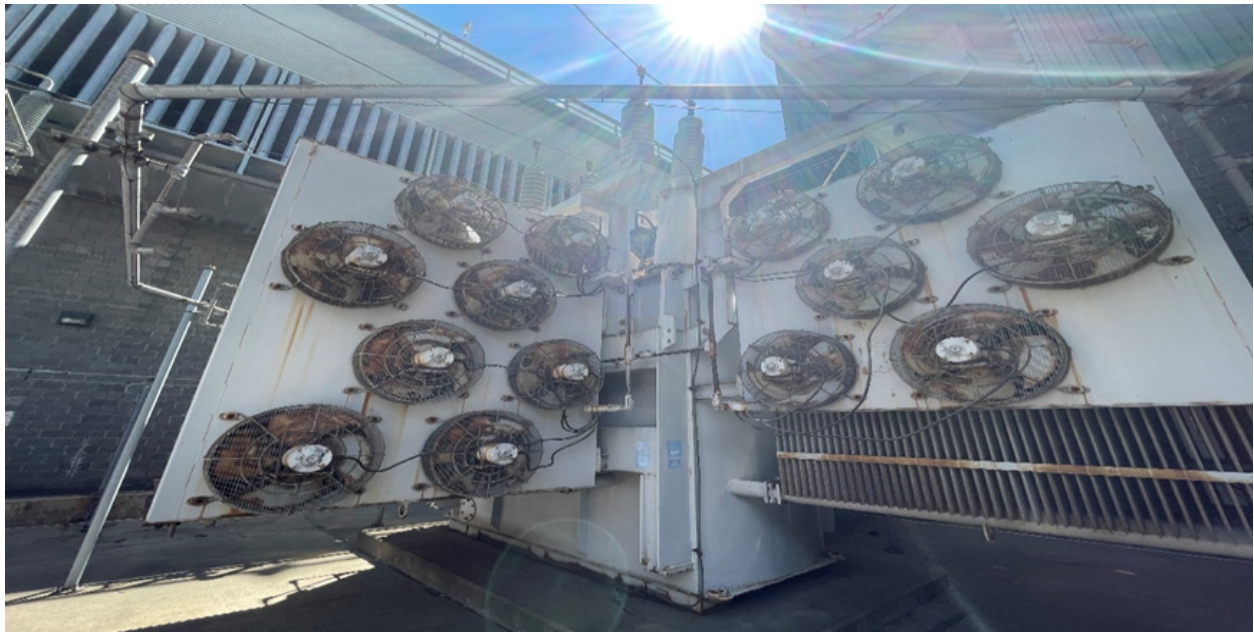
Visual inspection of the transformer shows the unit is in good condition given that it's been in service for more than 35 years.

The results of oil testing and auxiliary protection equipment testing performed in 2016 by 3C Electrical Company did not show any major issues and are satisfactory considering the equipment age. The infrared testing of the transformer performed in 2016 by 3C Electrical Company shows minor overheating in the lightning arresters.

Figure 1: 115kV main utility transformer

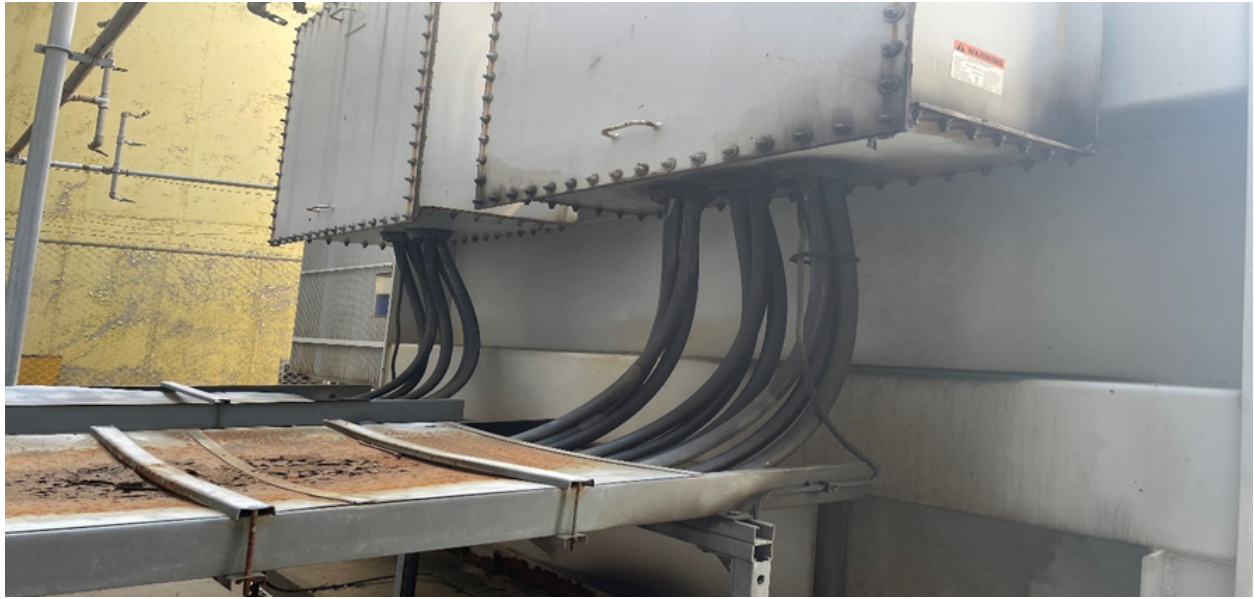
Figure 2: 13.2kV cables on Transformer 51L-1X secondary

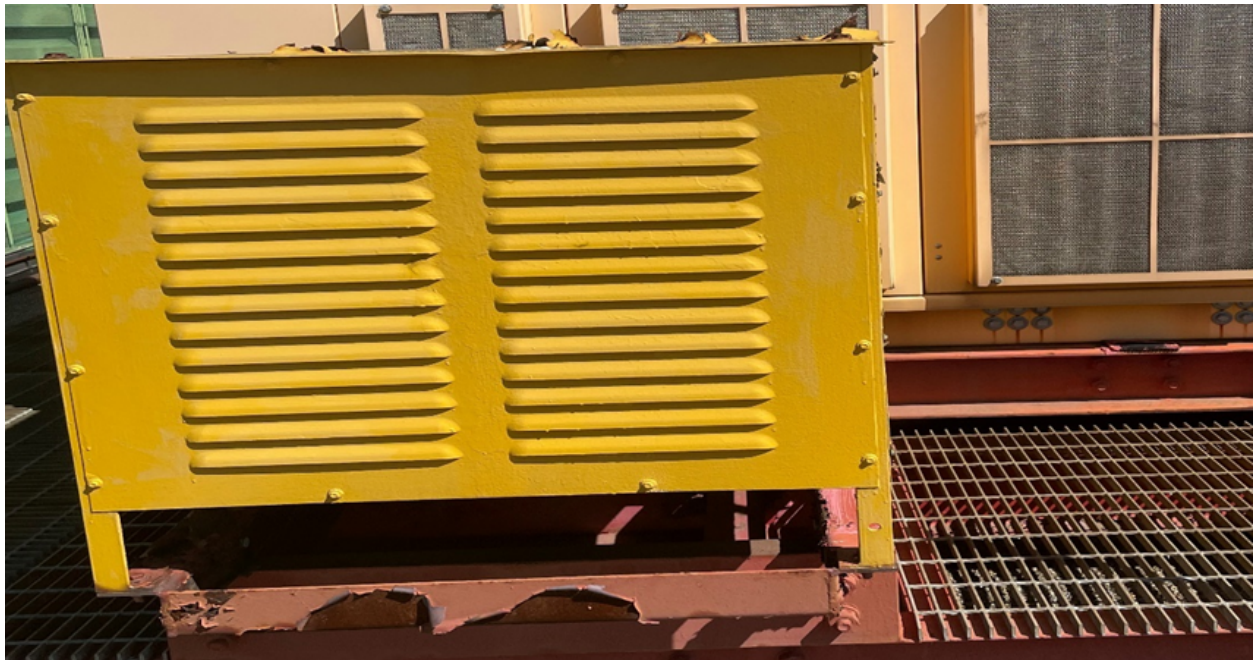
Figure 3: Neutral Grounding Resistor NGR

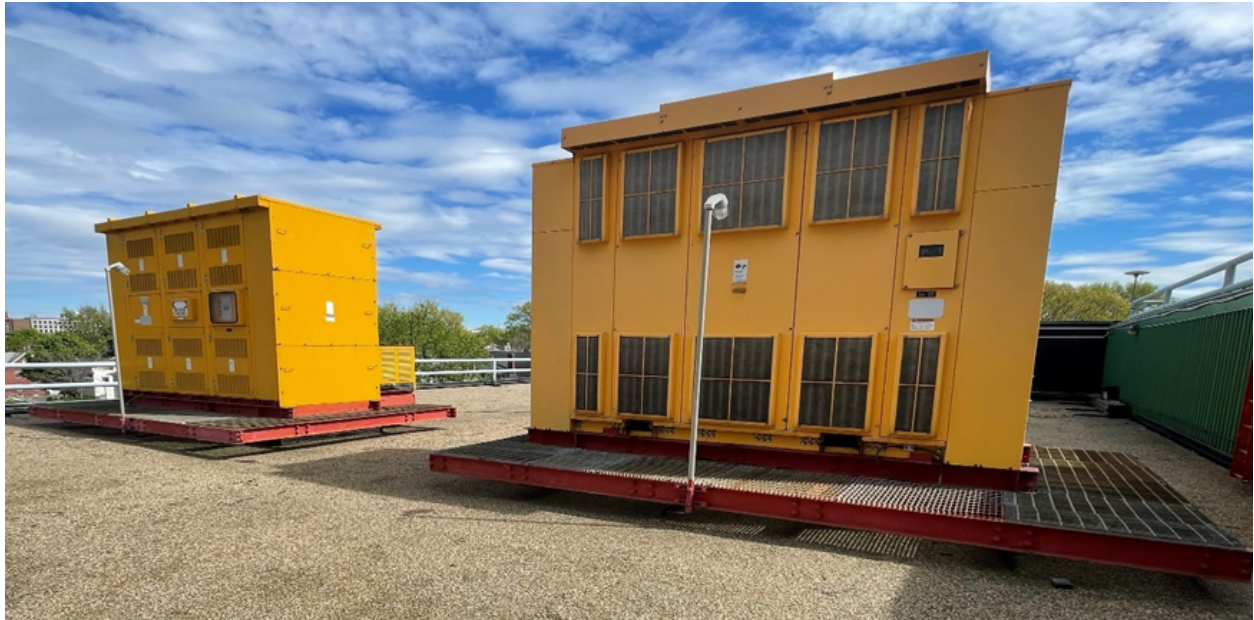
Visual inspection of the transformers shows the two units are in good condition despite the service time of 29 years.

The transformer infrared testing wasn't performed on the two transformers as part of the 2016 Thermographic testing by 3C Electrical Company.

Figure 4: Transformers 51L-1S & 51L-2S

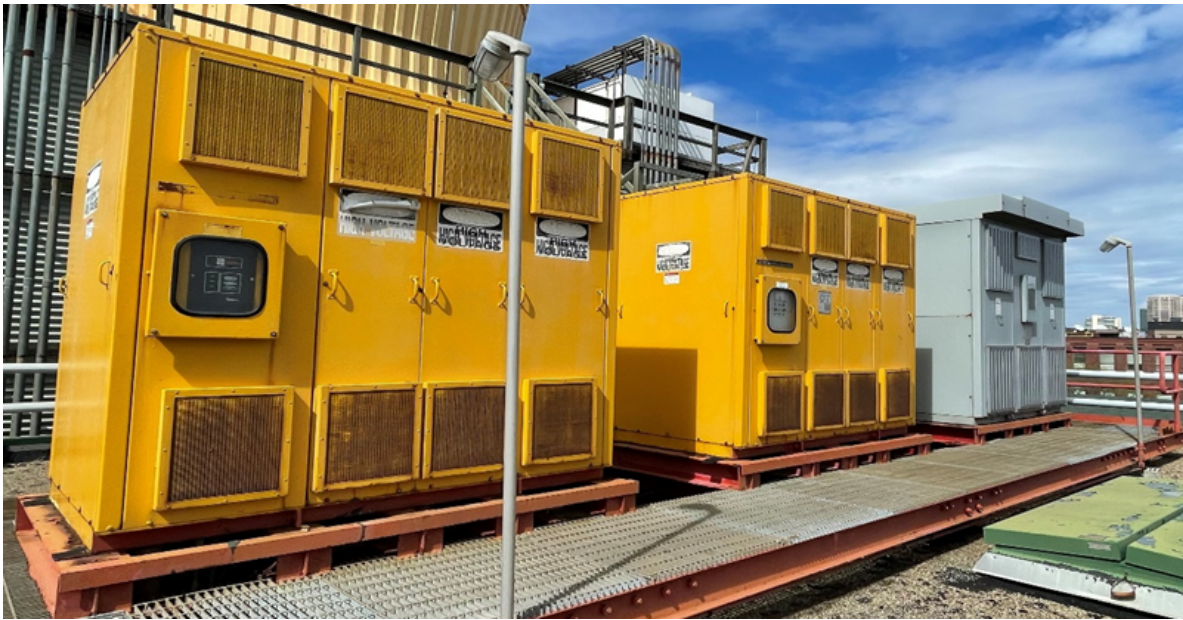
Figure 5: Transformer T4, T5 and T6

Visual inspection of the transformers T4 and T5 shows the two units are in good condition despite the service time of 35+ years. Transformer T6 is relatively new and was installed in 2012.

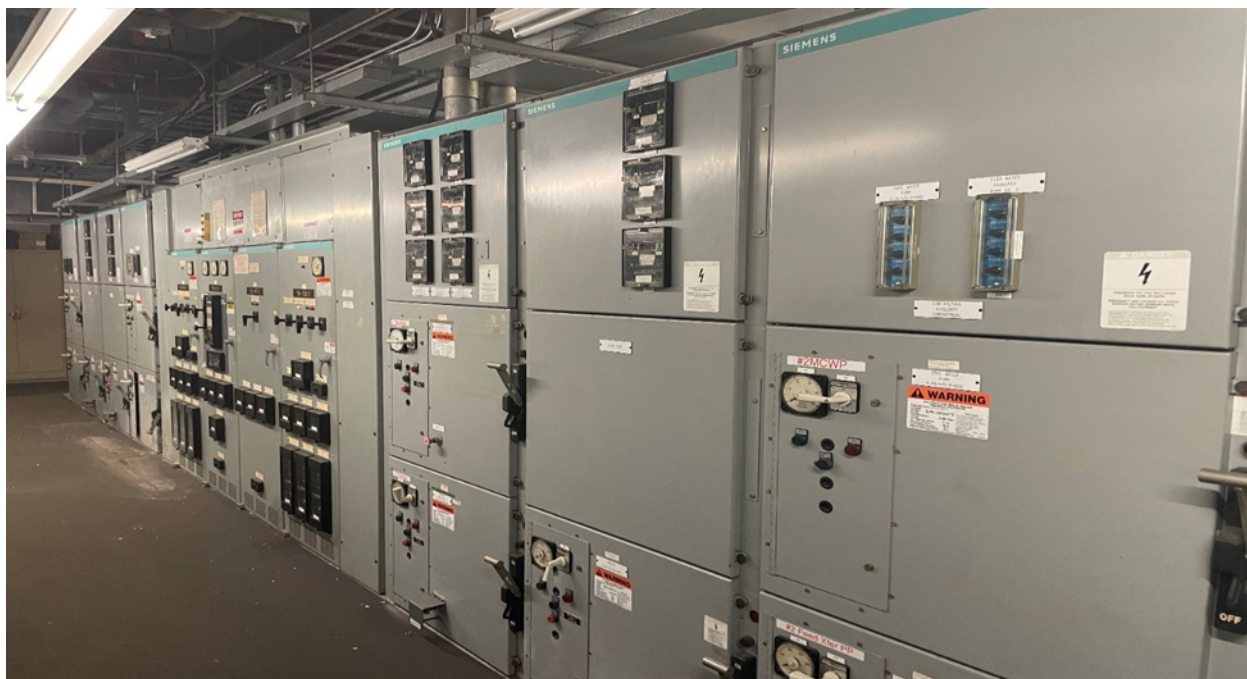
Figure 10: Existing electromechanical relays

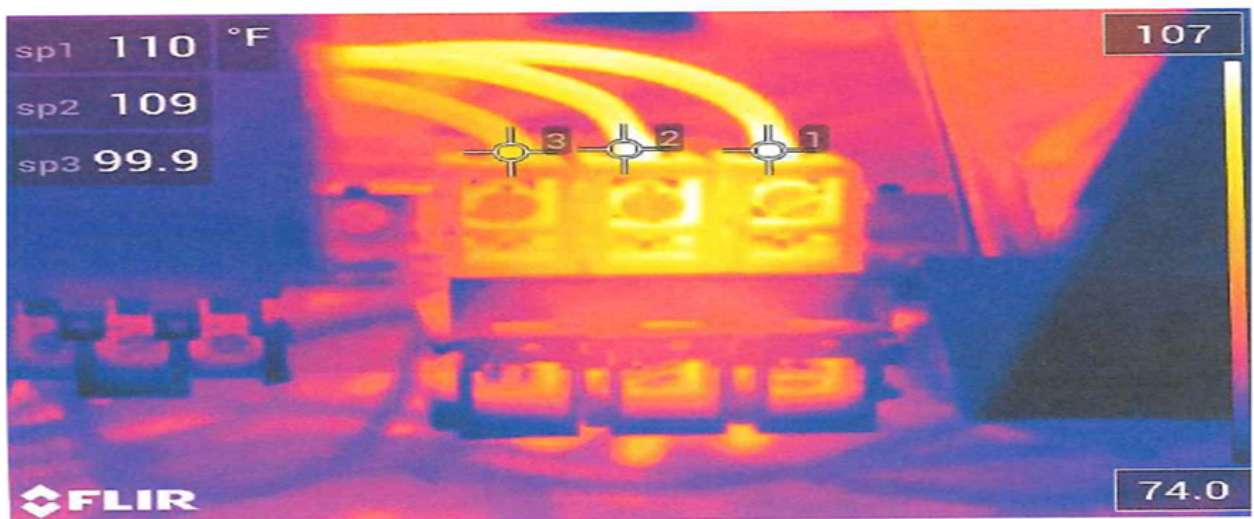
Figure 16: Example of overheating issue in MCC-D

The MCCs have shown, through thermal imaging in 2020, various hot spots (refer to Traver IDC Infrared Inspection Report, Appendix E). The photos below are examples of some of the overheating issues that were revealed by the report.

The MCCs have shown, through thermal imaging in 2020, various hot spots (refer to Traver IDC Infrared Inspection Report, Appendix E). It is recommended to determine whether or not CDECCA has made any repairs to alleviate this condition or not, as continued service with elevated temperatures will lead to fires and faults on an unpredictable and short timeline. If CDECCA has not made the repairs recommended by the previous assessment, the State could use this for negotiation, but also, it is important to validate the condition and be sure these issues have been resolved. As of the date of this report, CDECCA has not provided documentation of recommended repairs.

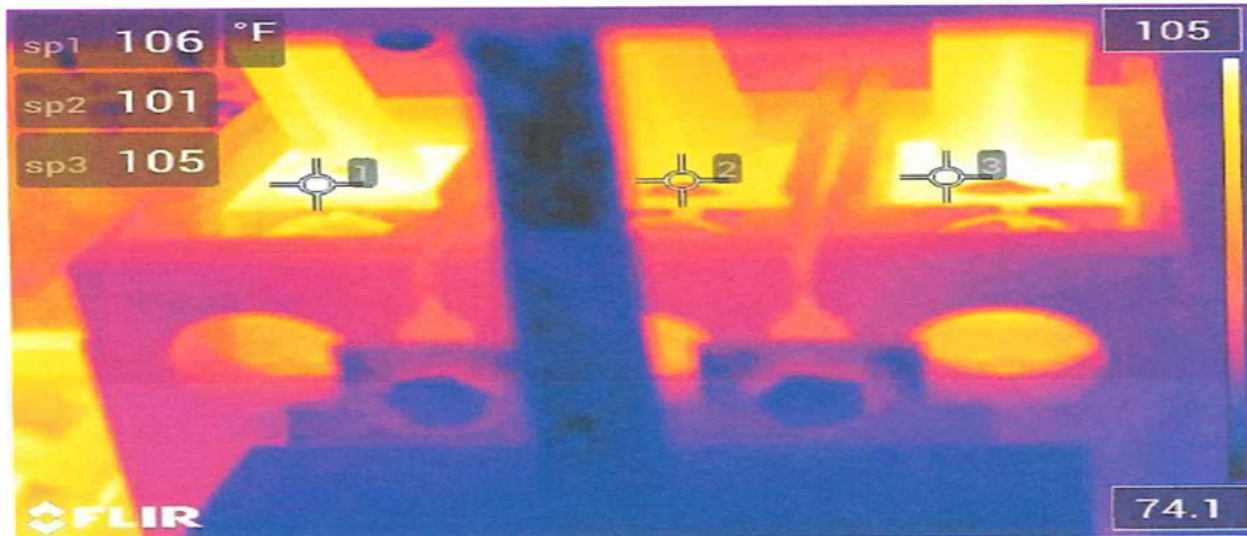
Figure 17: Example of overheating issue in MCC-C

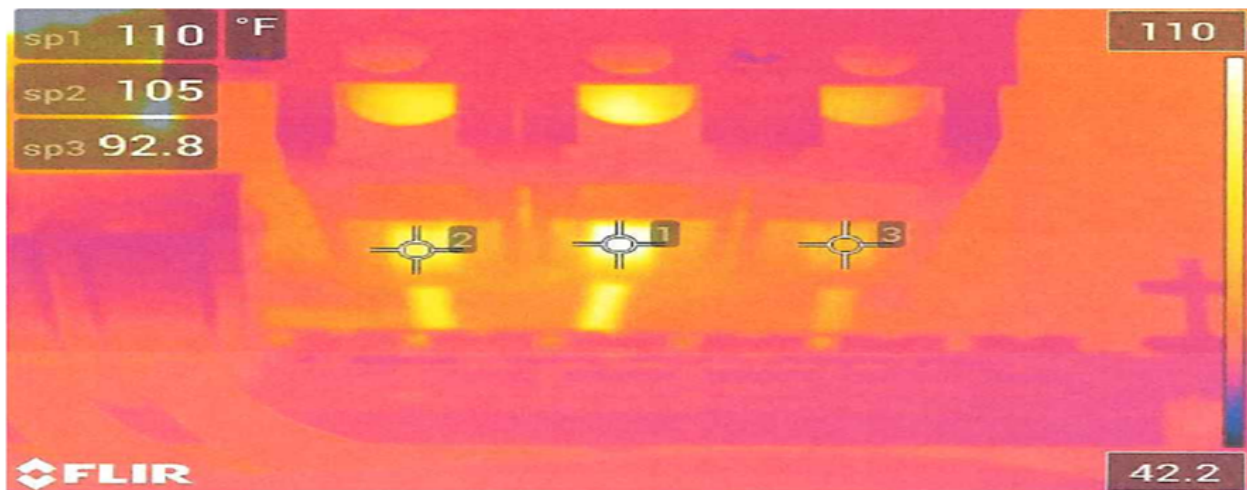
Figure 18: Example of overheating issue in MCC-E

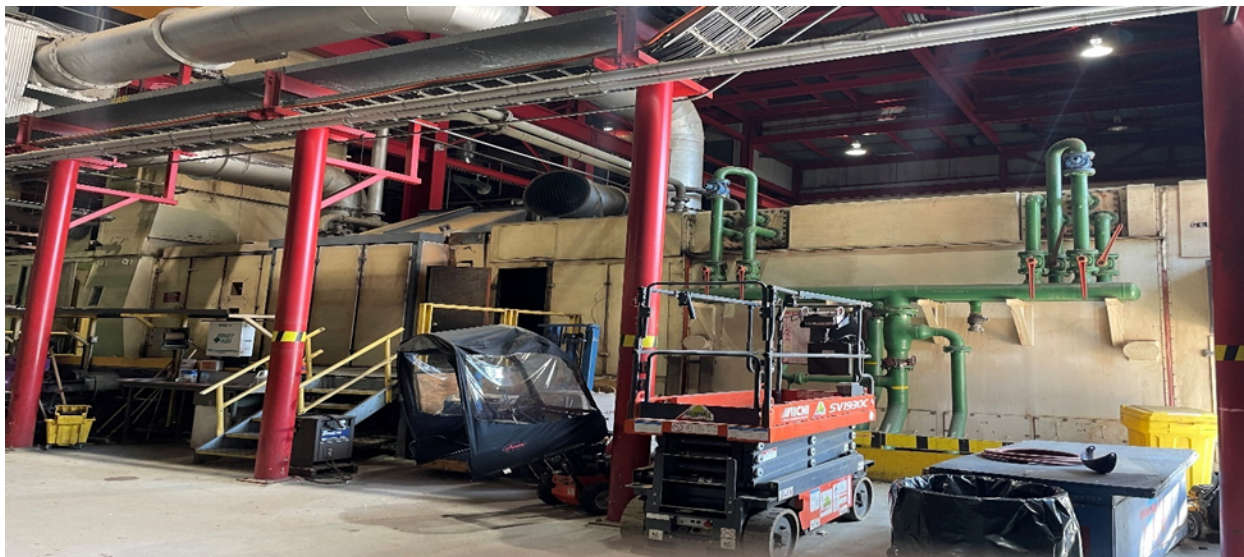
The steam turbine is de-commissioned and is currently offline.

Figure 19: Existing Steam turbine generator
