Introduction

As part of the Safe Routes to School non-infrastructure grant program administered by the Connecticut Department of Transportation, staff from Fitzgerald & Halliday, Inc. (FHI) provided a general Safe Routes to School program overview presentation to members of the Haddam Elementary School (HES) Parent Teacher Association in Haddam, CT on April 11, 2011. In addition, after speaking with the members of the school and community, FHI conducted a site audit of the school on the afternoon of May 5, 2011 to observe the dismissal activities.

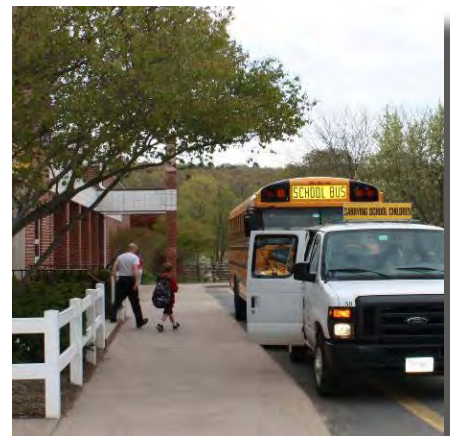
Students boarding the van and bus outside the all-purpose room doors.

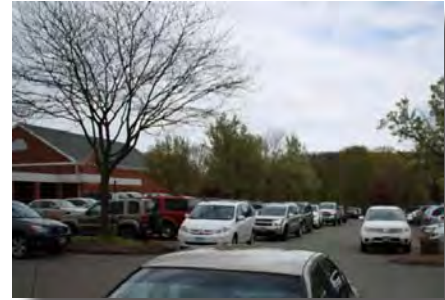
All students exit the school through the all-purpose room doors. Those students that are picked up by parents must be signed out by those parents in the all-purpose room. Because the school lot is small, parents typically parallel park (essentially double park) behind the second row of parked cars in the lot. These short-term parked cars block the cars parked in the formal spaces for a brief period. Because of the relatively small number of vehicles, however, this does not appear to cause a large congestion problem in the parking lot.

Parents double park in the parking lot when there enter the school to sign out their children.

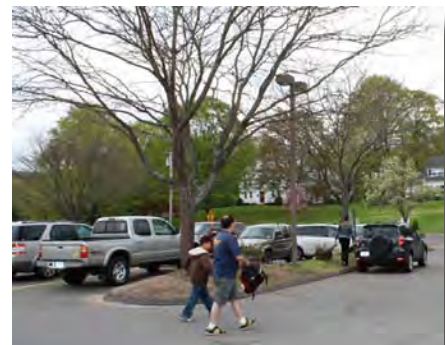
In addition, parents and students walking to and from the parked cars from the all-purpose room walk through various areas of the lot. There is staircase between the two rows of parking and a crosswalk that connects this staircase to the front doors of the school. While it would be safer if more parents and students used this crosswalk, there did not seem to be a big safety concern for the pedestrians in the lot because of the relatively low traffic volumes. Because students are accompanied by adults in the parking lot, this situation, while not ideal, does not seem to pose a significant safety concern.

Families walking back to their parked cars.

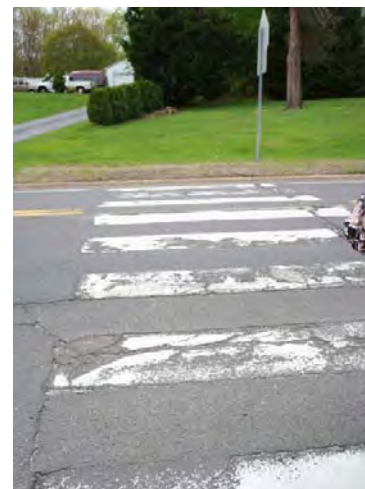
Faded crosswalk at school exit driveway.

There are two marked crosswalks across Route 154, one at the entrance driveway sidewalk and one at the end of the exit driveway sidewalk. The southern crosswalk (at the entrance driveway) is in good condition, while the northern crosswalk (at the exit driveway) is quite faded. There are no other pavement markings to notify motorists to the presence of pedestrians, especially school aged pedestrians or the school zone.

1. Install a sidewalk on the west side of Route 154 between the northern crosswalk and Christian Hill Road. This would provide a strategic connection between Haddam Elementary School and the Christian Hill area. There appears to be adequate space to construct a sidewalk along the property frontages at this location.
2. Re-mark the northern crosswalk (in front of school entrance driveway) on Route 154 to improve its visibility.
3. Update school zone signage on Route 154 near the

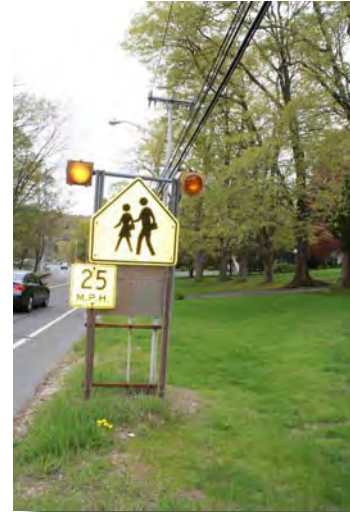
There is a sign assembly, about 500 feet before the school in each direction. These signs include a school warning sign and a 25 mile per hour posted speed limit sign. There are two blinking lights on each assembly that alert drivers to the signs during arrival and dismissal periods. In addition, there are two school crosswalk signs, with the downward pointing arrow, at each crosswalk (one in each direction). None of the school signs are retro-reflective.

Eastbound school sign assembly on Route 154.

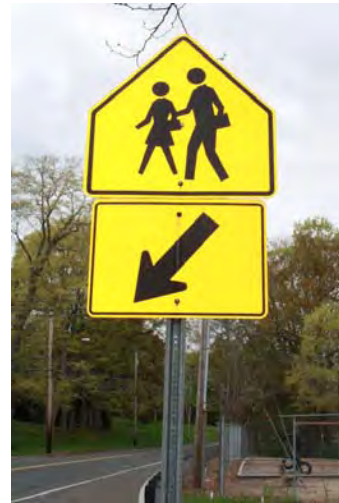
School crossing sign.
