FAIRFIELD TRAIN STATION  
VISUAL INSPECTION REPORT

January 2007

Prepared by the Bureau of Public Transportation  
Connecticut Department of Transportation

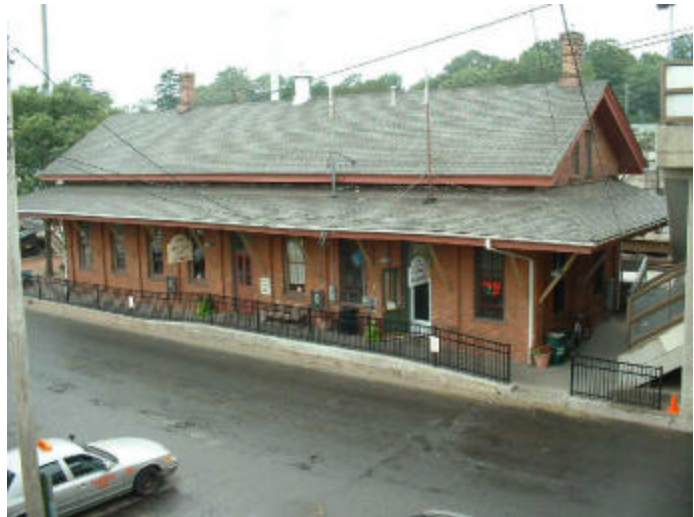
The old eastbound station waiting room has been converted to a restaurant (pictured above) with brick walks, black railing and freshly painted trim. The area immediately surrounding the establishment is equally clean. The remainder of the south side is bland, abutting the rear façades of the many Post Road establishments. A strip parking lot separates the buildings from the platform. Sidewalk cracks are clogged with weeds. The westbound station building has also been nicely restored. Unfortunately, it sits in the middle of the expansive bituminous parking lot.

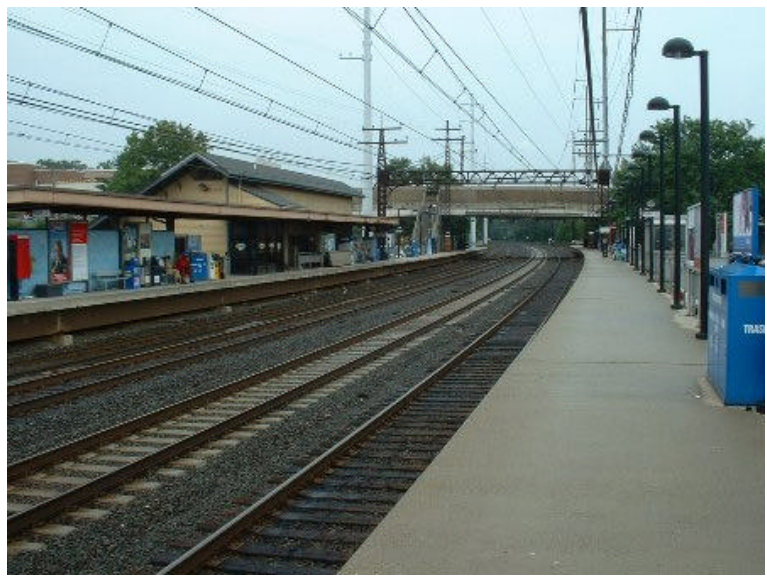
**Fairfield Platforms, Station Building and Overpass**

**Platforms** – The platforms at Fairfield Station are only six cars in length. Structurally, the platforms are in fair to good condition. Nearly all the joints between platforms are failing. Some of the stairs/ramps are cracked and spalling. Railing base plates are corroded. The bottom risers on several eastbound platform stairs exceed desired heights. The aluminum platform, stair and ramp railings are weathered with an occasional deformed panel. The trackside edge of the platform has a faded yellow stripe. Platform illumination appears to be sufficient. Rusty catenary supports rise up from both platforms.

- Add trailblazing signage along local streets and state highways.
- Add reverse trailblazing signage directing motorists back to the highways.
- Repair platform stairs and ramps.
- Clean and paint all elements of the canopies.
- Address eastbound stair problem with the excessive “first step” height.
- Repaint platform edge warning stripe.
- Replace shelter glazing as required.
- Add raised sidewalk and/or curbing between parking areas and the rear of platforms.
- Paint catenary structures (coordinate with Metro-North).
- Remove vending and newspaper from platforms and primary paths.
