MILFORD TRAIN STATION

VISUAL INSPECTION REPORT

January 2007

Prepared by the Bureau of Public Transportation
Connecticut Department of Transportation

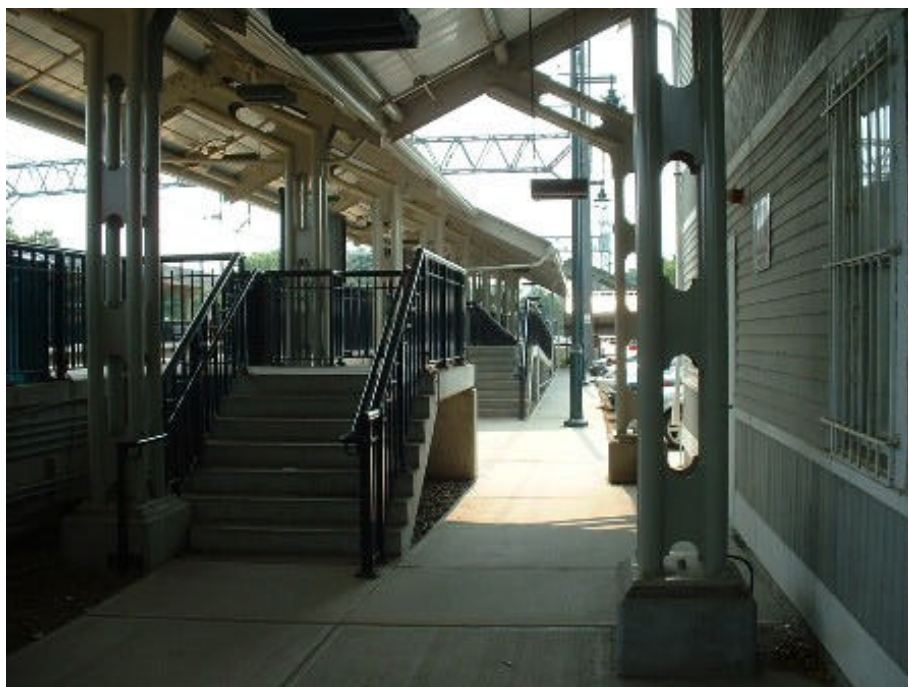
Area between Platform and Station Building

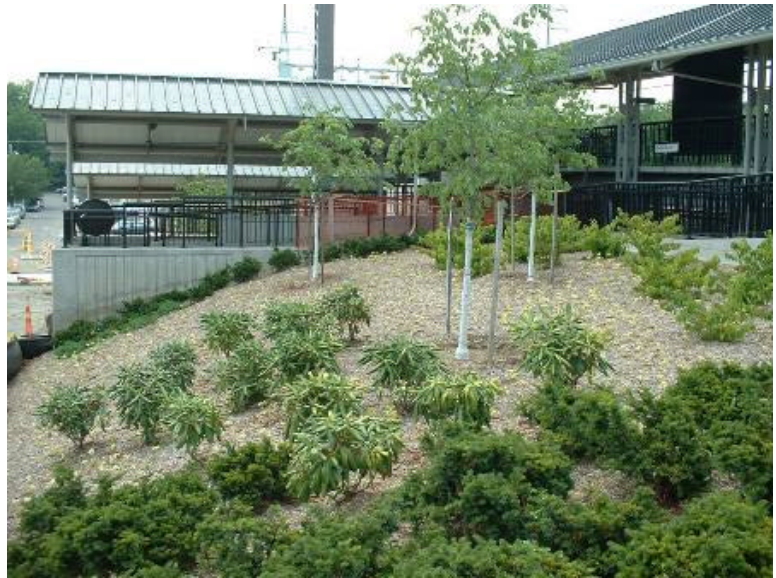
New Landscaping around Canopy and Ramps

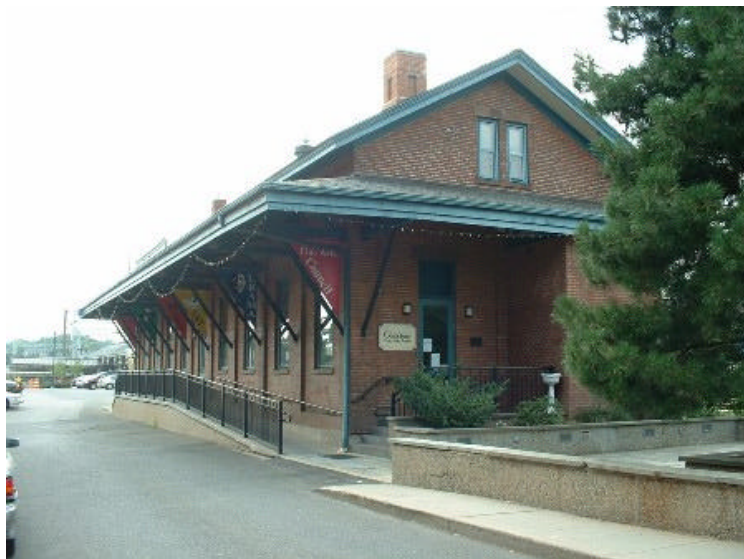
Station Building – The eastbound station building was closed at the time of this site visit. However, it was recently restored and should be in good condition. The westbound station building is the home of the Milford Center for the Arts.

Old Eastbound Station Building

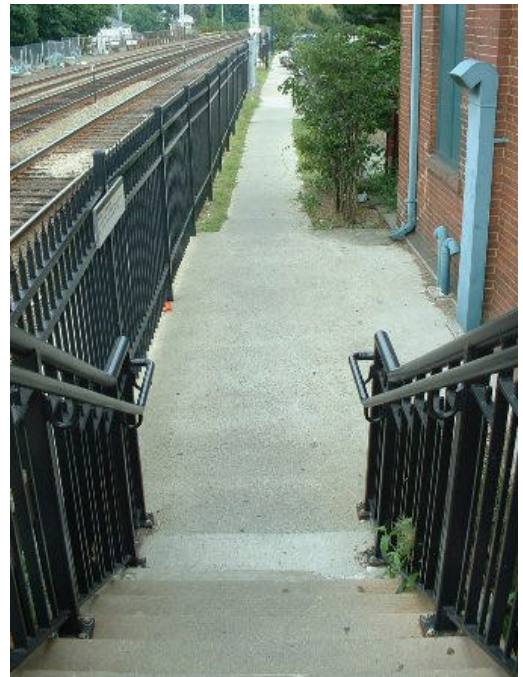
Walks/Paths – Paths to and from the parking areas have been disturbed by construction activities, as have sidewalks around the station. These will have to be evaluated after the completion of construction.

Path from Eastbound Platform
