NAUGATUCK TRAIN STATION VISUAL INSPECTION REPORT

January 2007

Prepared by the Bureau of Public Transportation
Connecticut Department of Transportation

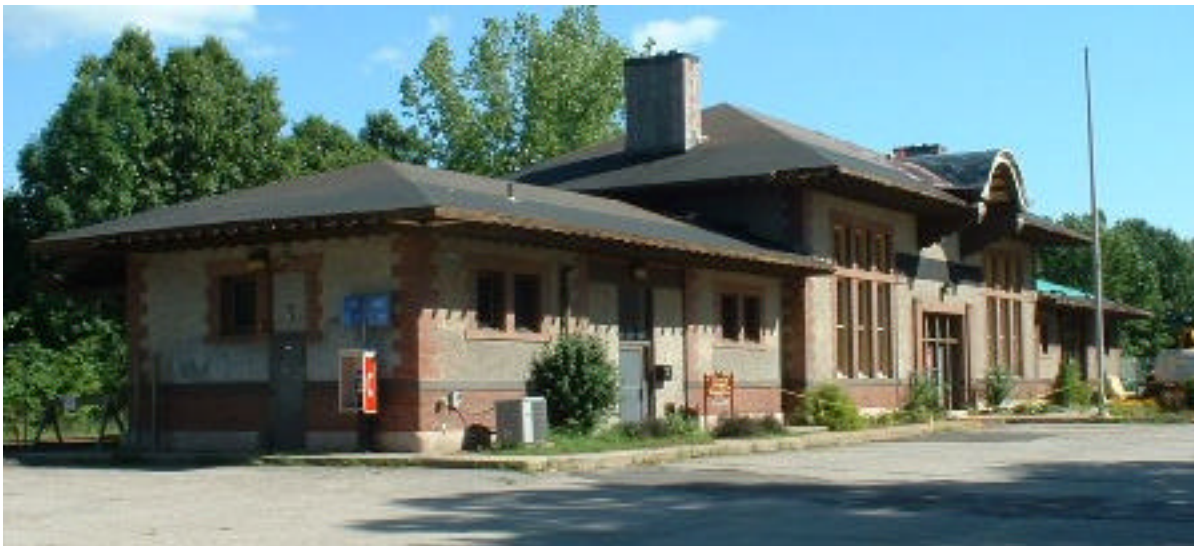
Station Building – There is no station building at this location. The old Naugatuck Railroad Station is privately owned and being rehabilitate for the local historical society.

Old Train Station being rehabilitated by the Naugatuck Historical Society
