NEW CANAAN TRAIN STATION

VISUAL INSPECTION REPORT

January 2007

Prepared by the Bureau of Public Transportation
Connecticut Department of Transportation

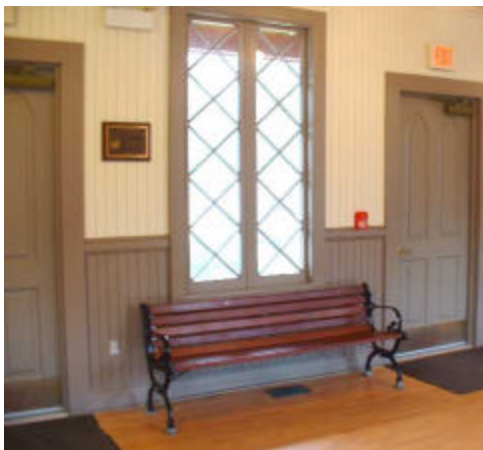
Station Building – The station building was restored inside and out about 10 years ago. Its foundation was replaced and the elevation of the floor was raised to the level of the new platform. A quick inspection of the facility confirmed that it is still in good condition.

Inside the New Canaan Station

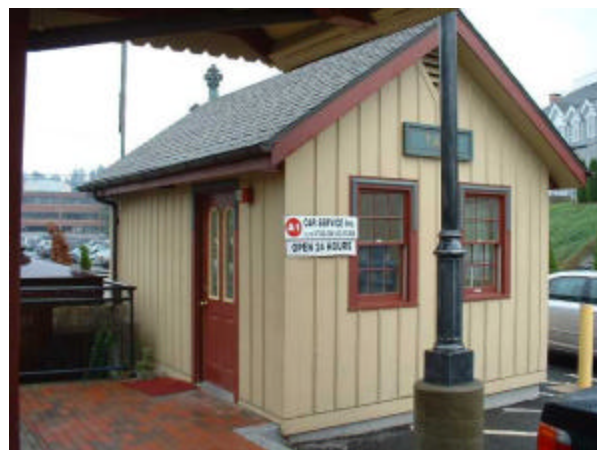
**Taxi Starter Shack at New Canaan Station
Waiting Room**

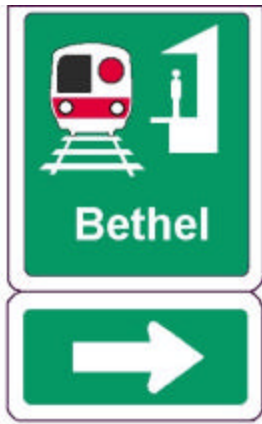
Highway Access – The New Canaan Train Station is relatively easy to find from the Merritt Parkway. However, to accommodate the occasional day-tripper, a few trailblazing signs should be added to the several state highways that pass within blocks of the facility.

Trailblazing Sign

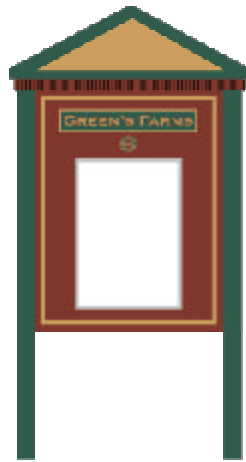
Kiosk (Historic Theme)

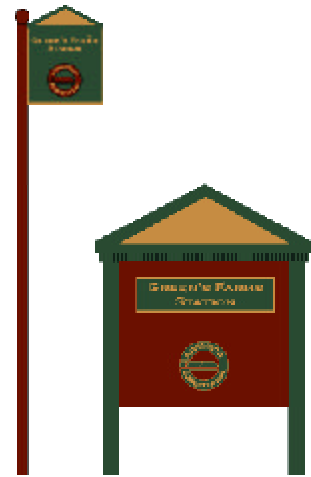
Signage – Signage in and around the station is adequate, although a review of the sign placement and content should be performed as part of a future project.

Station Signs

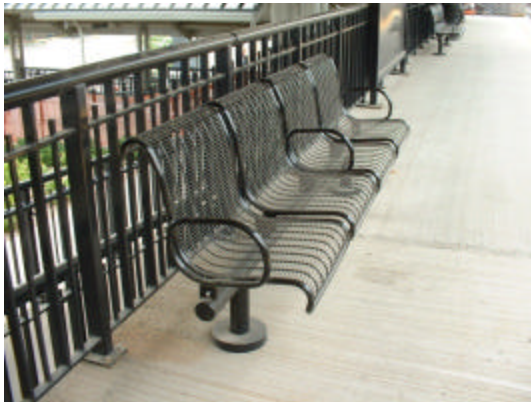
Bench (Contemporary) and Railing

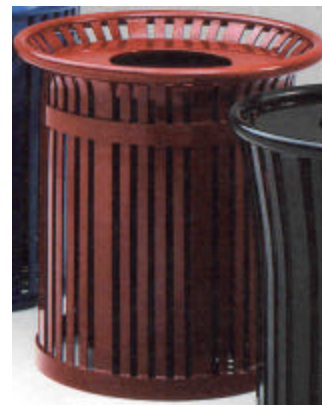
Trash Can (Black Preferred)

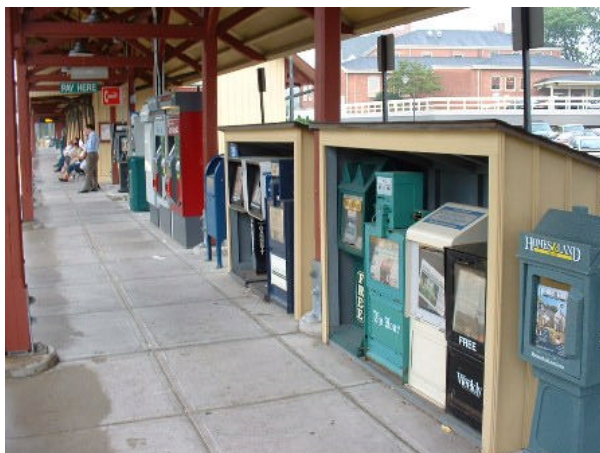
Vending Neatly Placed in Shelters

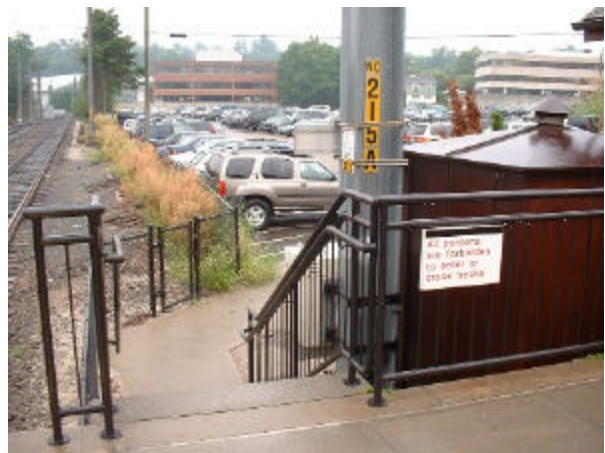
Path to Parking Lot at South End of Platform
