STATE STREET (NEW HAVEN) TRAIN STATION
VISUAL INSPECTION REPORT

January 2007

Prepared by the Bureau of Public Transportation
Connecticut Department of Transportation

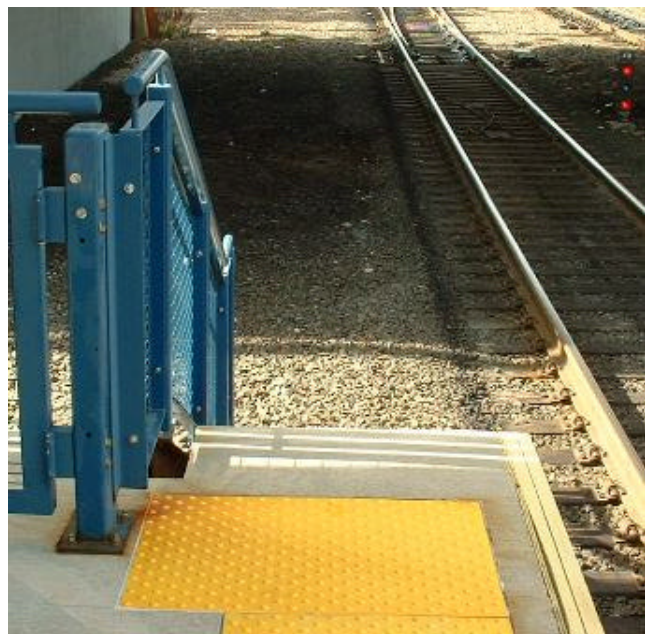
Platforms – The station has one center island platform which is in good condition. Stair risers and nosings are losing their paint and rusting. Railing paint is starting to fade, but attempts at touching up the surfaces have been successful. Tactile warning strips are in good condition. The platform edge wood rub rail has a few nicks. The end of platform guardrail appears to be offset more than necessary (1'-9"). If so, extend the railing along the end of the platform (perpendicular to the tracks) to the railroad's minimum lateral clearance.

Wide Gap at South End of Platform
