WATERBURY TRAIN STATION VISUAL INSPECTION REPORT

January 2007

Prepared by the Bureau of Public Transportation
Connecticut Department of Transportation

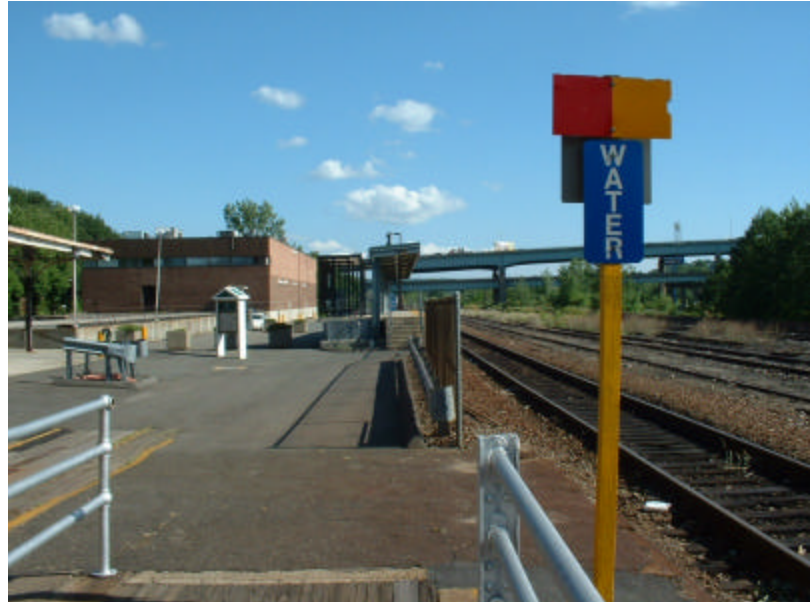
Fences – A highway guide rail and chain link fence separate the parking lot from the tracks. Although weathered, the fence is in good condition. The guide rail is dented but functional. The north end also has a weathered fence and dented guide rail in good condition. This fence combination only extends about 70 feet. Beyond that point, there is no protection of the railroad even though the old grade level platform extends north another 100 yards or so.

Replace Fence, remove highway guide rail, return fencing to building fence, provide gate
