# WESTPORT TRAIN STATION

## VISUAL INSPECTION REPORT

January 2007

Prepared by the Bureau of Public Transportation  
Connecticut Department of Transportation

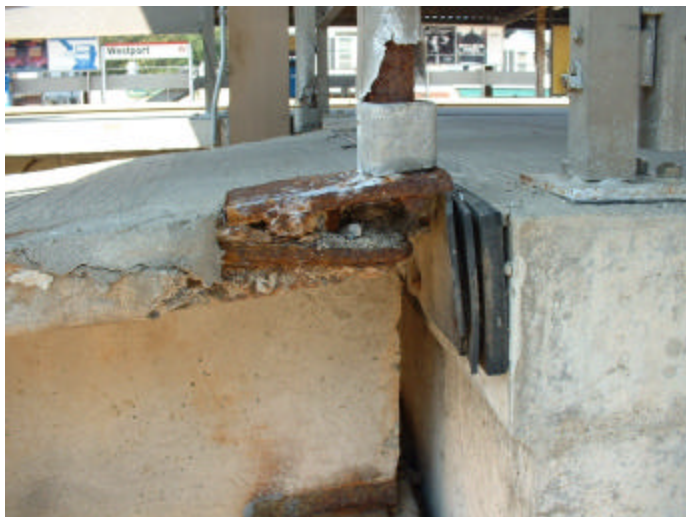
Stairs and ramps are plentiful, but their condition also depends on their location. Away from the new tunnel/elevator, stairs and ramps are crack and deteriorated. One stairway on the south (eastbound) side is closed because of the loss of concrete. Some stair handrails are worn.

**Ramp Corrosion and Spall**

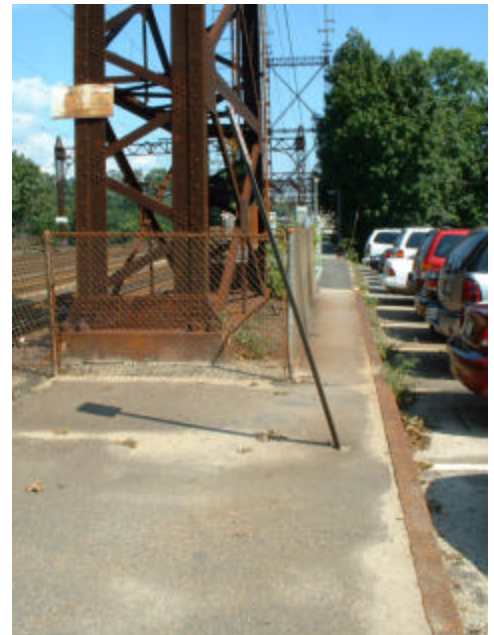
**Walks/Paths** – As noted, there are few designated paths around this station. Pedestrians use parking aisles or street sidewalks to get to the platforms. Surfaces are either bituminous or concrete ranging from fair to good. The path to the Saugatuck River crossings is awkward at best. The base of one of the high towers and associated electrical boxes encroach on the path, reducing it to about two feet in width. The surface is uneven with tripping hazards right up to the 90-degree bend onto the steel grated pedestrian bridge.

**Fences** – Chain link fence protects the railroad at both ends of each platform. The fence along the path to the river crossing is rusted and deformed. The adjacent wooden fence is slightly overgrown by vegetation and non-conforming.

**River Crossing Walk**
