**CONDITION APPRAISAL
(FY 2021)**

CONDITION APPRAISAL UNION STATION BUILDING

The Condition Appraisal of the Union Station Building was performed by DESMAN in accordance with the executed agreement by and between the New Haven Parking Authority and DESMAN (NHPA Project No. 21-001).

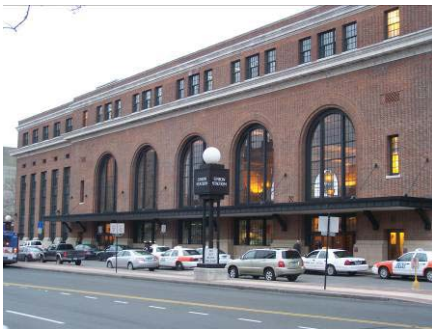
Photo #1

This 101 year old Building (Union Station Transportation Center), located in New Haven, Connecticut (**Photos #1 & #2**), was found to be in good condition. The Building is currently programmed to receive various repairs and modifications to various components of the facility as outlined later in this report.

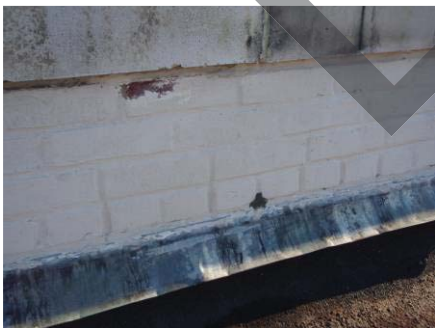
Photo #8

- Reworking of the facility's roof level parapet coping stones to eliminate water infiltration into the exterior masonry wall construction. This work was coordinated with the application of an architectural waterproof coating on interior surfaces of the parapet following miscellaneous brick removal/replacement and re-pointing of brick mortar (**Photo #8**).

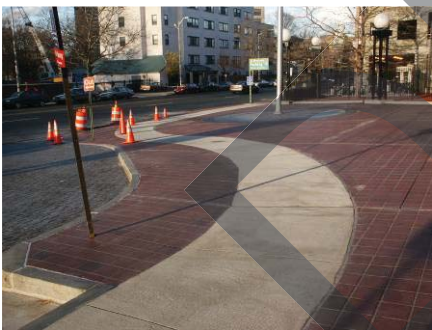
Photo #12

- The front passenger drop-off area and sidewalks were replaced. The previous construction of the sidewalk areas consisted of brick pavers set in sand beds, and over time the pavers settled due to moisture and cyclical freeze-thaw. Additionally, because the driveway area was originally constructed of bituminous concrete pavement in combination with brick and granite cross-walk and sidewalk areas, the pavement had become increasingly deteriorated due to contamination with motor oil from the taxis and other vehicles. The front passenger drop-off area now consists of a combination of stenciled and stamped concrete, providing an aesthetic treatment, as well as a more forgiving surface considerate to the level of usage this area receives (**Photo #12**).

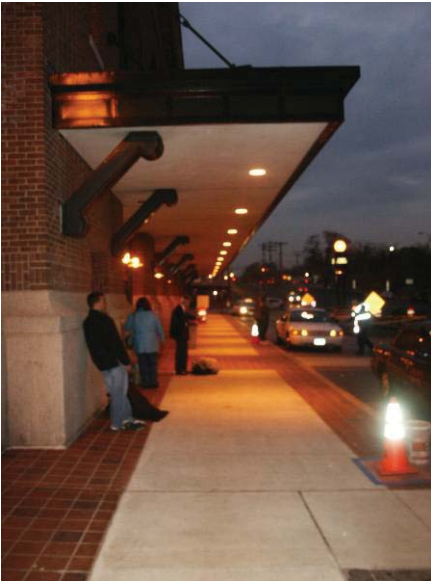
Photo #13

- Various exterior lighting fixtures were replaced or otherwise added around the perimeter of the station building to increase lighting levels as an enhancement to security (**Photo #13**).

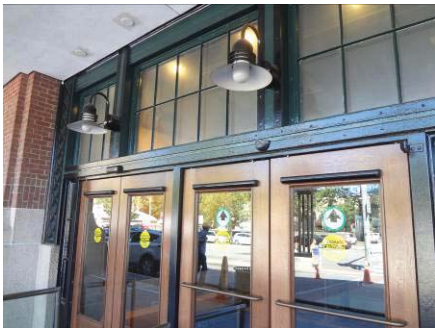
Photo #22

2017 All of the Station's entry/exit doors have been either replaced or repaired, with all hardware and automatic controls (**Photos #22 & #23**). This work was addressed as part of NHPA Project no. 10-005 A.

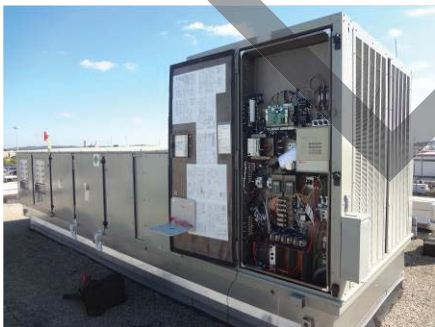
Photo #25

1. Replace Pneumatic HVAC Controls w/ Electronic Controls (**Photo #24**)
2. Replace 3 Packaged Rooftop Units (**Photo #25**)
3. Replace Eight (8) Gate Valves @ Control Valves
4. Replace two (2) Existing Recessed Wall Heaters in Main Entry

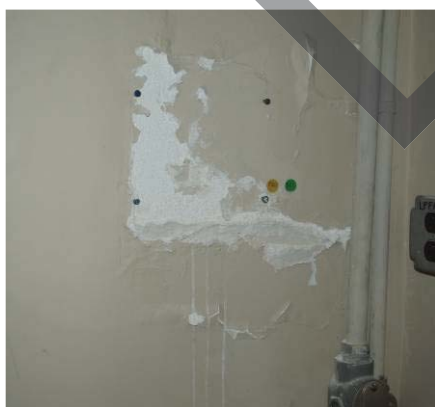
Photo #32

A review of the Station's stairwells indicates that each stair well access door on all levels would benefit from being refinished (**Photo #30**), as well as the handrails throughout the stairwells (**Photo #31**). In combination with this work, each stairwell has been identified as requiring a limited amount of plaster/sheetrock repair in combination with a fresh coat of paint (**Photo #32**).

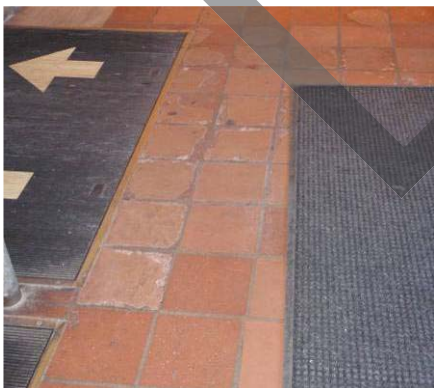
Photo #35

Though the floors are well maintained as evidenced by the high shine, cracked tiles should be maintained in accordance with Historic Preservation Guidelines. Quarry tile repair was identified as being required in the main lobby entry vestibule, the east entry vestibule and in limited areas of the main waiting room (**Photo #35**).

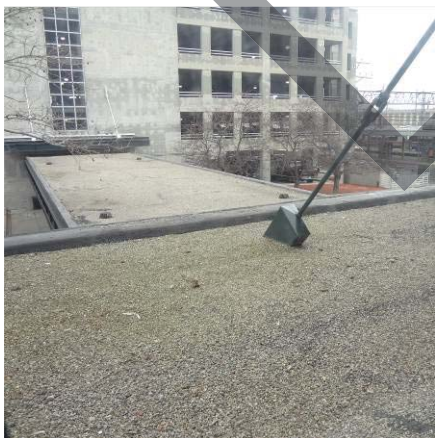
Photo #45

DESMAN also recommends that the condition of the roof system be monitored, including the various secondary canopy roofs as well (**Photo #45**). Even though the warranty expired in 2017, Desman does not necessarily recommend that NHPA plan to replace the roof in the immediate future. However, miscellaneous repairs are now a maintenance cost, and eventually, the miscellaneous maintenance costs would outweigh the cost of installing a new roof system and obtaining a new 20-year warranty. That said, a study of system options is currently in progress as part of Project No. 19-014.

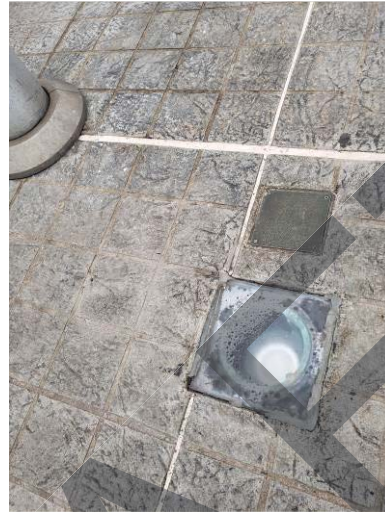
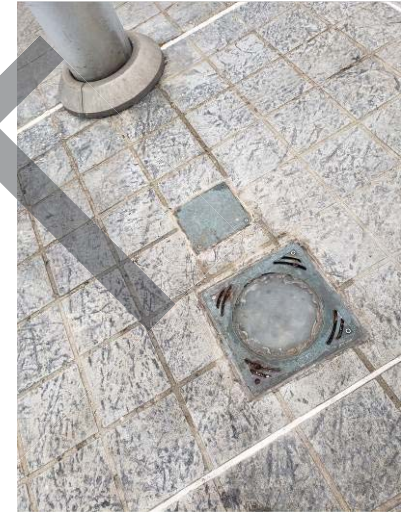
14. Lights around Flagpole: the embedded light fixtures surrounding the flagpole in the front of the Station are aged and damaged due to water (**Photos #107, #108 & #109**). DESMAN recommends that these fixtures be replaced.

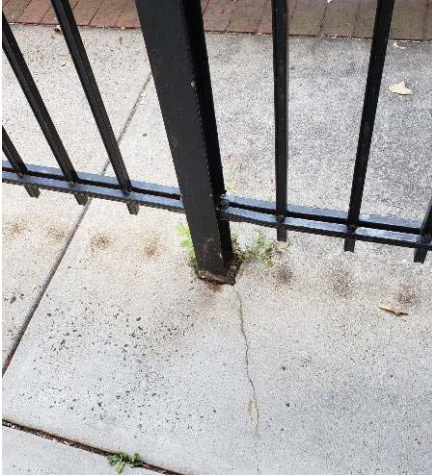
Photo #114

Various site elements have been damaged, such as moisture damage and corrosion to fencing. All elements and materials should be repaired as may be required. **(Photos #114 & #115).**

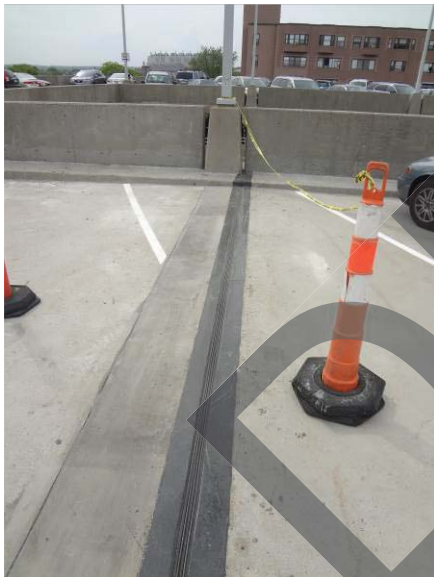
Photo #21

Expansion Joint Repairs: The expansion joints throughout the garage have all been replaced (**Photo #21**) as part of Project no. 08-016 B. At that time, however, the associated vertical glands were not replaced (**Photos #22 & #23**); DESMAN recommends that the vertical glands now be replaced as well, prioritizing the roof level accordingly.

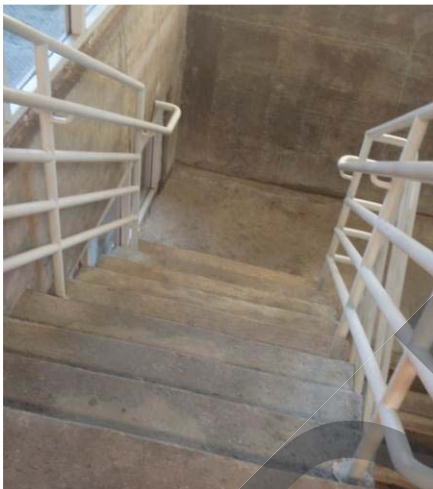
Photo #41

Epoxy Flooring/Supplemental Treads within West Stair: Aesthetic improvements may be considered throughout the stair towers, as well (**Photo #41**). Besides the re-painting of the handrail/guardrail system already programmed, Desman suggests that decorative flooring, such as supplemental treads or an epoxy coating system, be considered that could provide an aesthetic enhancement as well as non-slip resistance.

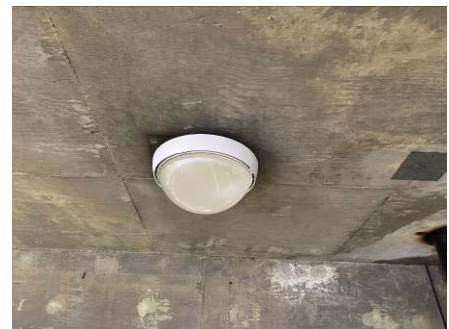
Photo #56

As noted, replacement of the existing light fixtures with new LED fixtures was performed as part of Project no. 08-016 C now complete (**Photos #55 & #56**).
