Docket No. 272 – Development and Management Plan Inspection

Underground Line Watercourse and Railroad Crossings

Date: November 28, 2007

Location: Crossings of Watercourses and Railroads in Segments 3, 4a and 4b

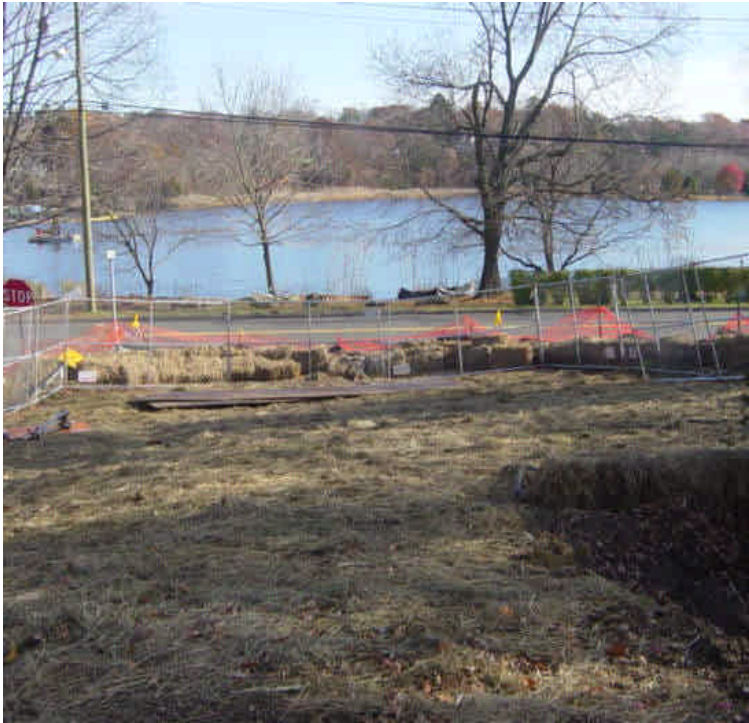
On the west side of the Saugatuck River, the previously exposed soil at the regraded drilling pit, has been stabilized with hay mulch.

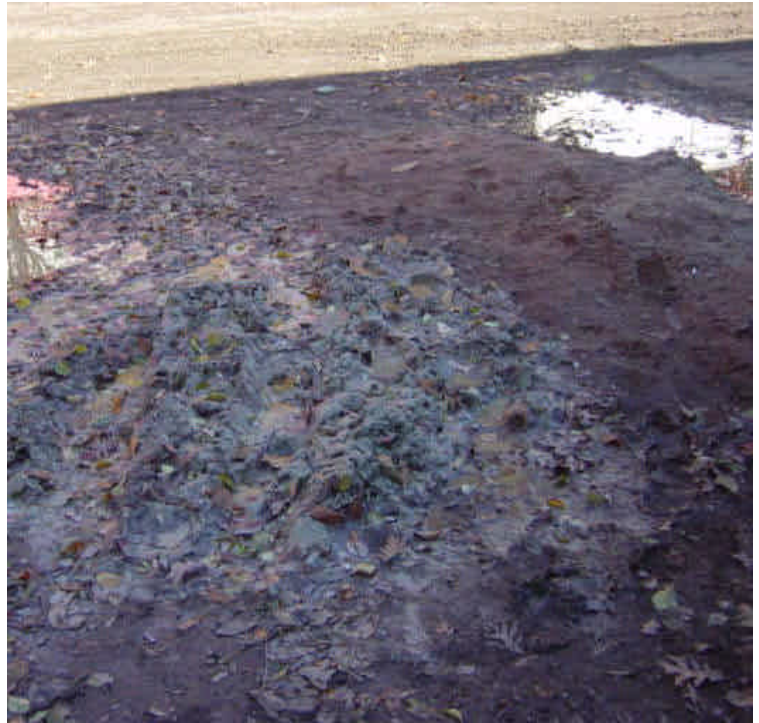
Several bags of (non-toxic) Max-Gel appear to have spilled near the bentonite reclamation machine on the east side of the Saugatuck River.

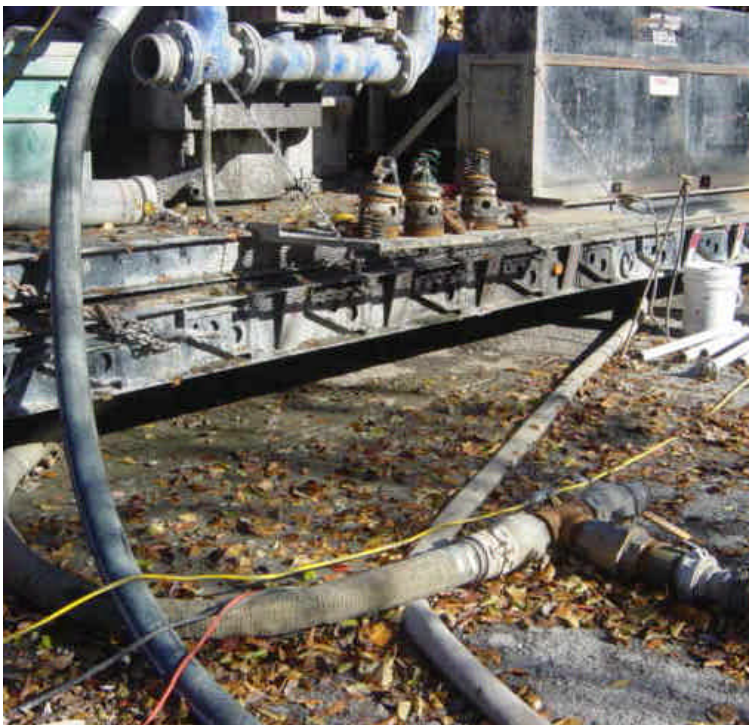
Slurry residue/drilling mud spills remain in several locations in the staging area on the east side of the Saugatuck River. Slurry spills were observed in multiple locations behind the bentonite reclamation machine and near the drilling pit.

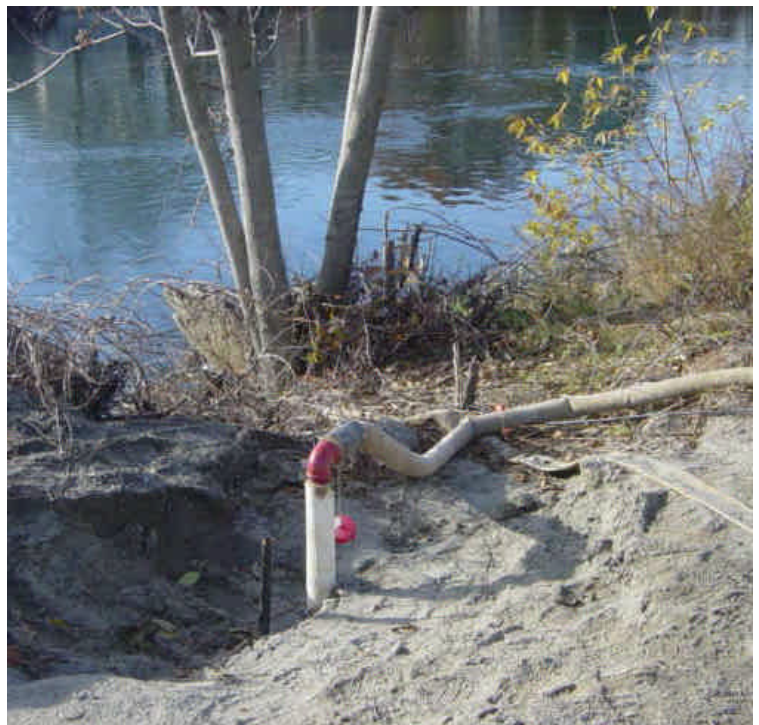
A water valve has been excavated on the northeast side of Ash Creek leaving an area of exposed soil adjacent to the bank. The exposed soil has the potential to run-off into the water.

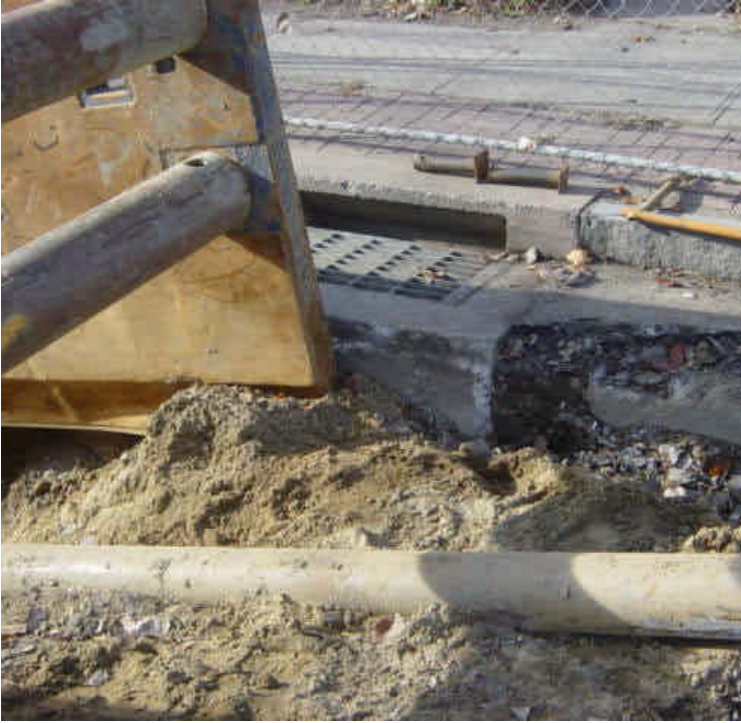
Horizontal directional drilling (HDD) continues near Ash Creek. A drilling pit has been excavated on the northeast side of the creek. A catch basin adjacent to the drilling pit is not protected.

<p>Catch basins near Ash Creek have been protected and surrounded with hay bales, except for the basin adjacent to the northeast drilling pit. 11/28/07</p>	<p>Place a gutter buddy (or similar) in any catch basins located down gradient of exposed soils to prevent sediment from entering basin. 11/28/07</p>	<p>Needs attention.</p>
Housatonic River	<p>A small area of soil has been excavated near the bank on the northeast side of Ash Creek to provide access to a water valve. The exposed soils have the potential to run-off into the creek. Controls were not in place. 11/28/07</p>	<p>Place sediment control measures along the down gradient side of the slope between the exposed soils and the creek to prevent sediment from entering the resource area. 11/28/07</p>	<p>Needs attention.</p>
	<p>Perimeter controls are in place around the work area on the west side of the Housatonic River but a large amount of drilling mud was present on the pavement. 11/28/07</p>	<p>Continue to monitor and maintain controls carefully. See soils section for more details. 11/28/07</p>	<p>NA</p>

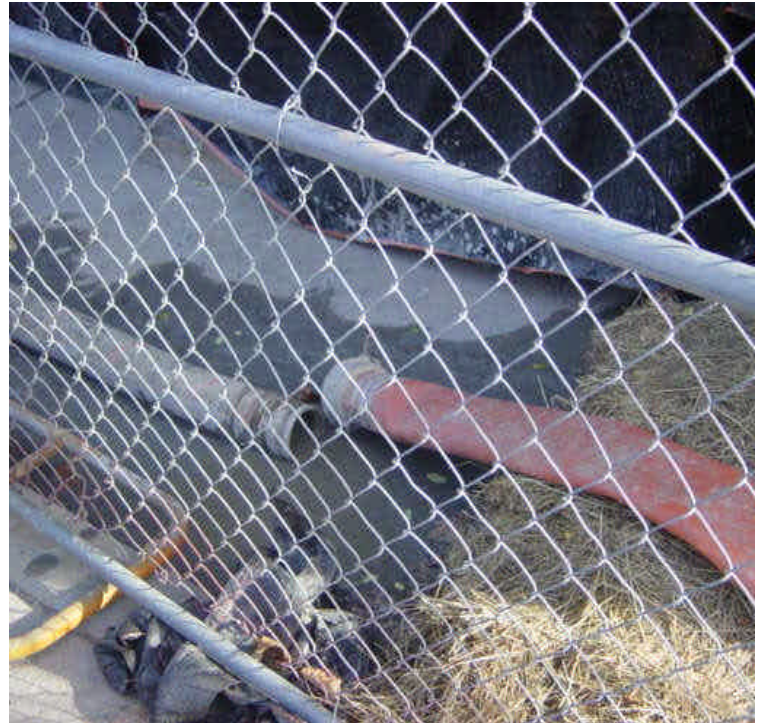
Hoses behind the betonite reclamation machine near Ash Creek have been disconnected, causing drilling material to spill onto the roadway. Although the adjacent catch basin is protected, attempt to sweep up the residue.

<p>Hoses behind the bentonite reclamation machine near Ash Creek have been disconnected and slurry material has spilled on the pavement. The adjacent catch basin is protected. 11/28/07</p>	<p>Remove and properly dispose of slurry material. Use caution when disconnecting hoses to prevent incidental slurry spills. When feasible, implement secondary containment to capture any residual material remaining in the hoses. 11/28/07</p>	<p>Needs attention</p>
Housatonic River	<p>Drilling pit on the west side of the Housatonic River appears to be adequately sized, but has been located several feet from where the drill string actually enters the ground. Drilling material is not being aimed directly into the drilling pit and a significant amount is flowing over the paved areas. 11/28/07</p>	<p>Modify the drilling pit set-up to fully encompass the drilling area and minimize the amount of drilling fluid flowing over the paved surface. Remove (sweep) the material and dispose of it. Provide additional containment measures to minimize unnecessary impacts throughout the staging area. 11/28/07</p>	<p>Needs evaluation/attention.</p>

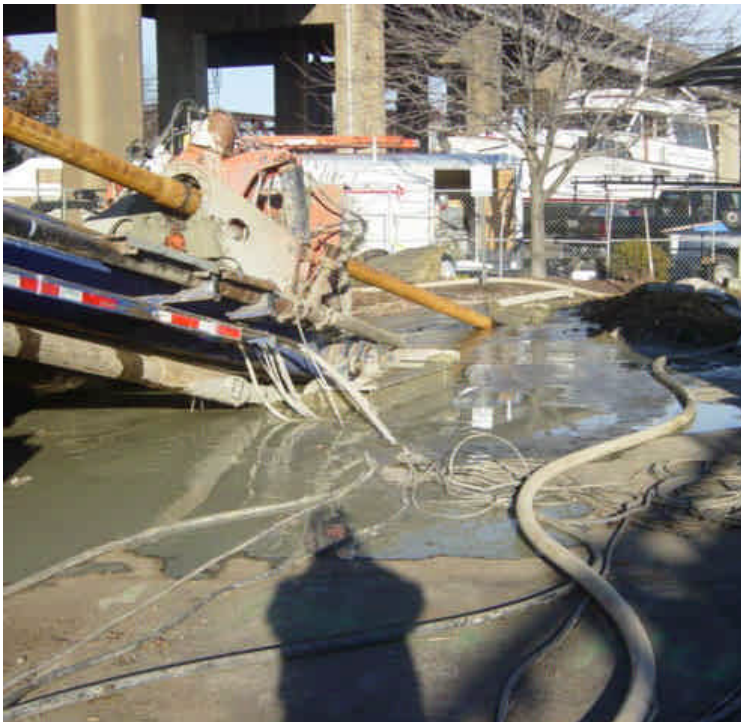
HDD is underway on the west side of the Housatonic River. The drilling pit appears to be adequately sized, but has been located several feet from where the drill string is actually entering the ground. Slurry material is not being aimed directly into the drilling pit and is flowing over the paved area. Perimeter controls are in place around the staging area, but slurry material should be better contained to minimize unnecessary impacts.
