Docket No. 272 – Development and Management Plan Inspection

Underground Line Watercourse and Railroad Crossings

Date: December 5, 2007

Location: Crossings of Watercourses and Railroads in Segments 3, 4a and 4b

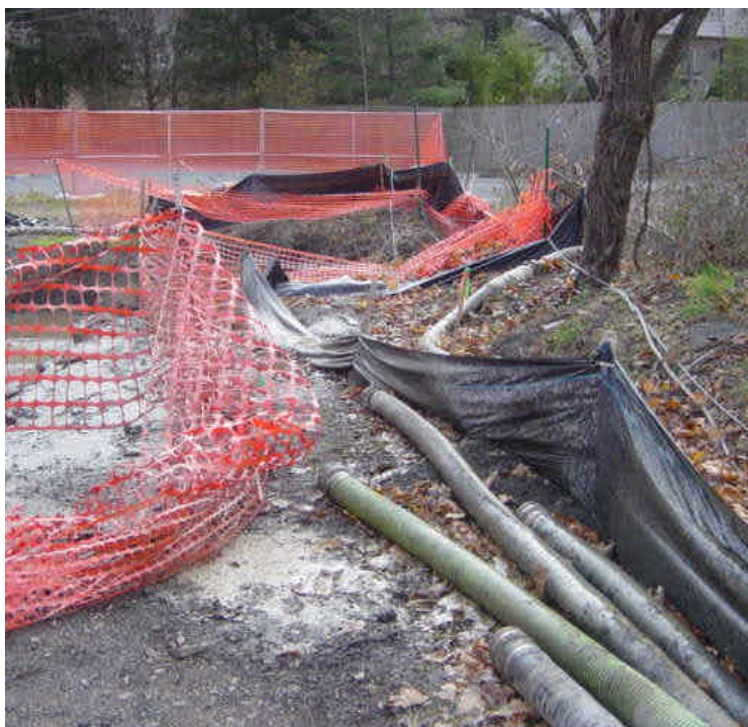
The silt fence around the drilling pit on the east side of the Saugatuck River is sagging and needs attention. Drilling fluid splashed beyond the contained limits of the silt fence.

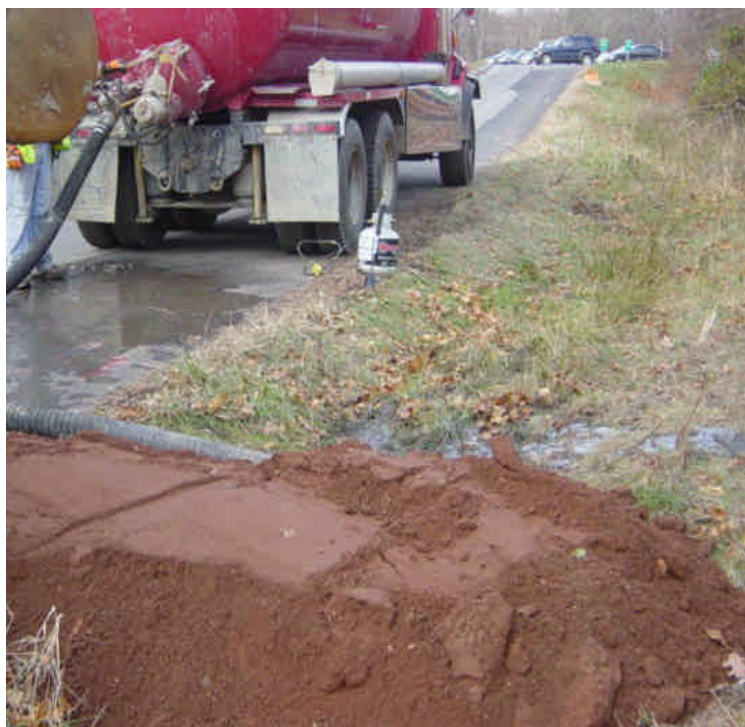
On the east side of the Saugatuck River, a small frac out occurred near the access driveway adjacent to the staging area. A sand berm was in place to contain the material and crews appeared to be adequately handling the situation. Ensure exposed sand from the berm will not migrate toward the river.

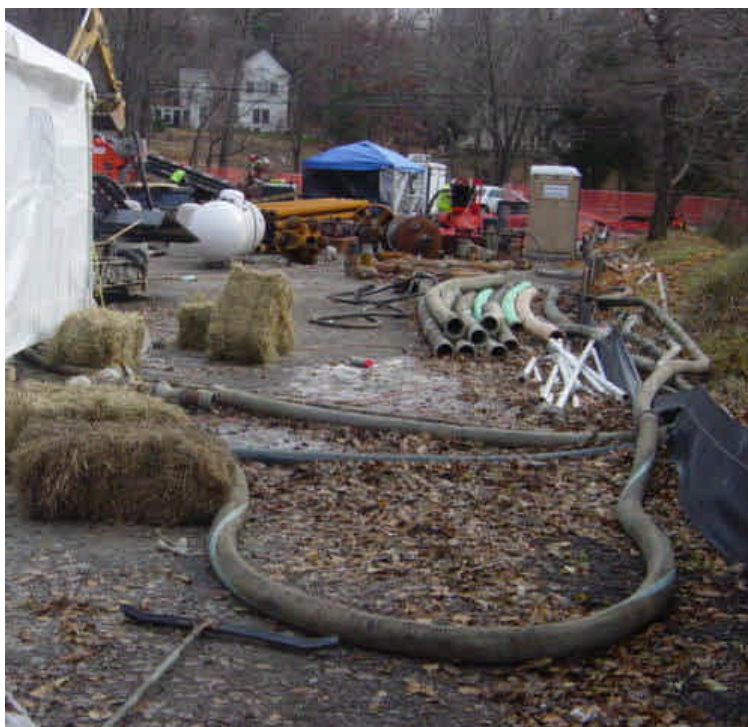
Areas of Inspection	Observation	Recommended Action	Corrected Action
Saugatuck River	<p>Slurry material was previously spilled in the staging area on the east side of the Saugatuck River near the bentonite reclamation machine, the drilling pit, and a frac tank. Some since 11/15. 12/05/07</p>	<p>Remove and properly dispose of slurry material where possible to minimize unnecessary impacts. 11/21-12/05/07</p>	<p>Needs attention.</p>
	<p>Sand material has been stockpiled near the entrance to the staging area on the east side of the Saugatuck River. No controls are in place around the stockpile. 11/15-12/05/07</p>	<p>Install erosion controls to properly contain the stockpiled material. 11/15-12/05/07</p>	<p>Needs attention.</p>
	<p>On the east side of the Saugatuck River, a small frac out occurred near the access driveway adjacent to the staging area. A sand berm was placed to contain the material and crews appeared to be adequately handling the situation. 12/05/07</p>	<p>Continue to proactively monitor areas during drilling activity and maintain containment. Ensure the soil from the berm cannot run-off to resource areas. 12/05/07</p>	<p>A frac-out was observed and contained on land. Needs evaluation.</p>

Slurry material was previously spilled in the staging area on the east side of the Saugatuck River near the bentonite reclamation machine, the drilling pit, and a frac tank.

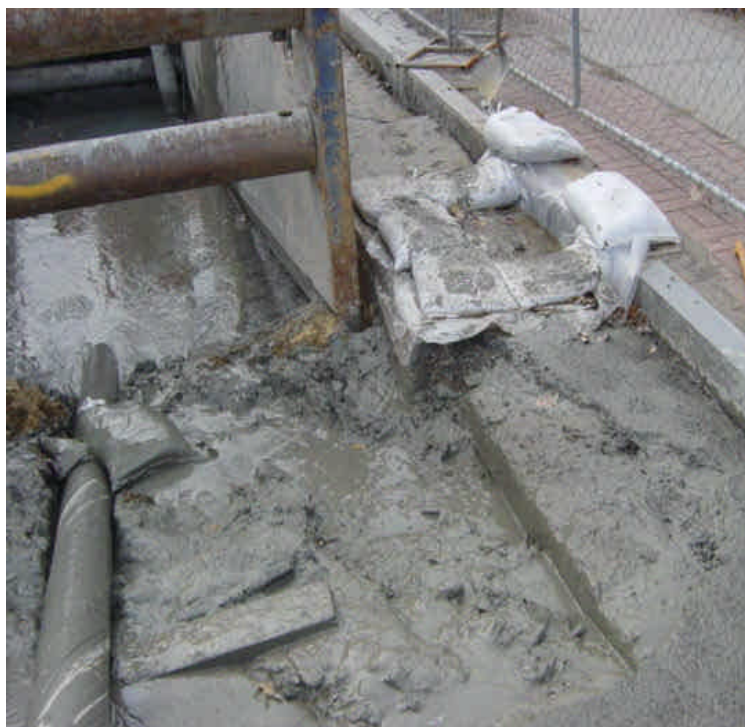
<p>Catch basins near Ash Creek have been protected and surrounded with hay bales, including the basin adjacent to the northeast drilling pit. However a significant amount of drilling mud was noted on the roadway near a CB. 12/05/07</p>	<p>Place a gutter buddy (or similar) in any catch basins located down gradient of exposed soils to prevent sediment from entering basin. Remove accumulations of drilling mud/slurry. See spills/material section. 12/05/07</p>	<p>The northeastern catch basin has been protected.</p>
Housatonic River	<p>The small area of soil previously excavated/ exposed soil on the northeast side of Ash Creek at the water valve, has been contained with silt fence and haybales. 12/05/07</p>	<p>Maintain the sediment control measures between the exposed soils and the creek to prevent sediment from entering the resource area. 12/05/07</p>	<p>Silt fence and haybales have been installed.</p>

A significant amount of drilling slurry has spilled on the pavement on the east side of Ash Creek near the drilling pit. Although the catch basin has been protected, sweep and remove the material.

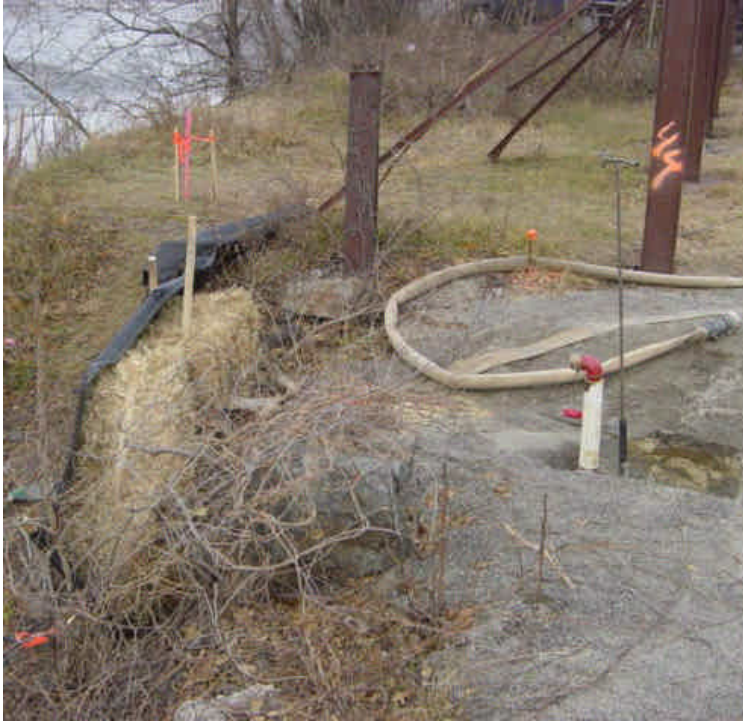
The small area of soil excavated on the northeast side of Ash Creek near the water valve has been contained with silt fence and haybales to minimize the potential for sediment entering the creek.

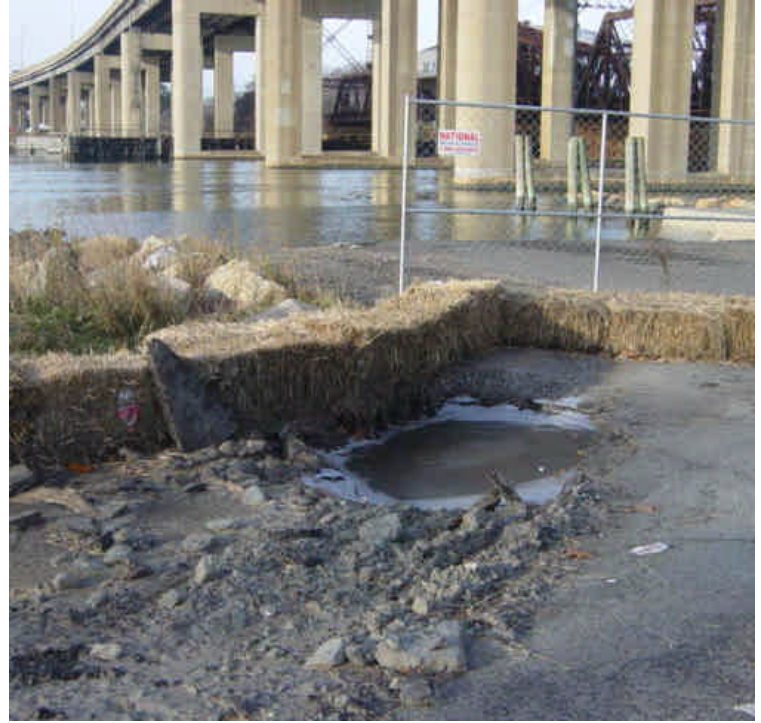
Areas of Inspection	Observation	Recommended Action	Corrected Action
Housatonic River	On the east side of the Housatonic River, two holes approximately 5' to 10' in diameter formed in the paved parking area due to pressure from the HDD operation (similar to a frac out). Crews excavated the area and used a vac truck to contain any remaining material. 12/05/07	unnecessary impacts. 12/05/07 Continue to monitor the area for future material releases. Modify control measures accordingly as the conditions change. 12/05/07	NA
	On the west side of the Housatonic River excavated asphalt, soil, and other debris has been temporarily stockpiled near the perimeter of the protected work zone. 12/05/07	Relocate temporary stockpile to a location within the work zone where the material can be adequately contained. See erosion control section 12/05/07.	Needs attention.
	Drilling pits on the west side of the Housatonic River have combined into one large drill pit. At the time of the inspection the containment appeared to be adequate, but the drill pit's storage capacity was reaching its limit. 12/05/07	Provide additional containment measures to minimize unnecessary impacts throughout the staging area. See soils section for more detail. 12/05/07	Pits were combined but area still needs evaluation.

On the east side of the Housatonic River, holes formed in the pavement due to pressure from the HDD operation (similar to a frac out). Crews excavated the area and used a vac truck to remove any remaining material. Haybales were placed around the area to provide additional containment.

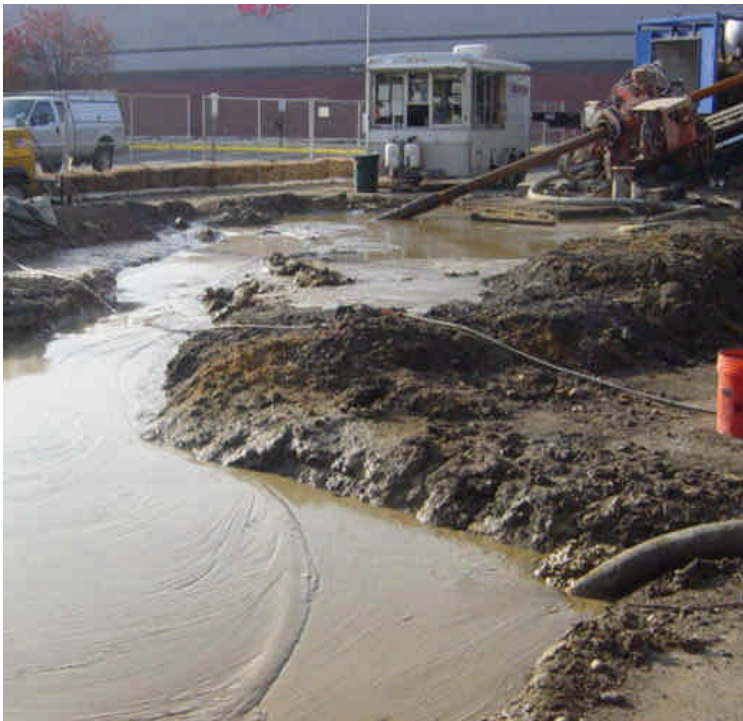
Areas of Inspection	Observation	Recommended Action	Corrected Action
	<p>Drilling pits are excavated on both sides of the Housatonic River. Drilling pits on the west side of the Housatonic River have a small dirt/sand berm around portions of the perimeter. Drilling mud is less than 6" from overtopping the pit in some locations. 12/05/07</p>	<p>Ensuring adequate storage capacity for drilling muds is essential. Impacts from storm events and related run-off must also be considered. A large amount of stormwater could result in a serious discharge from the pit to the resource area. Consider expanding the pit, additional containment, or a contingency plan for large storms 12/05/07</p>	<p>Needs evaluation.</p>
<p>State species of concern, threatened and endangered species.</p>	<p>According to the D&M plan, state-listed species are not located in this work area.</p>	<p>None.</p>	<p>NA</p>
<p>Vegetative clearing (including trees to save or danger trees noted) or stabilization</p>	<p>Although not marked on the D&M, a row of hedges/shrubs was removed (9/18) from the west side of the river near sta. #235+75. The contractor states that the property owner removed the shrubs in preparation for the HDD work. 12/05/07</p> <p>Shrubs were removed a few weeks ago from the west side of the river near sta. #234+50 as per the D&M Plan 12/05/07</p>	<p>If shrubs were removed by the property owner prior to HDD work, then discuss and reach an agreement with the property owner regarding the final restoration measures. 12/05/07</p> <p>When work is completed, restore the area as indicated in the D&M plan. 12/05/07</p>	<p>Contractor states the property owner removed the shrubs. Needs evaluation for restoration.</p> <p>NA at this time.</p>

Drilling pits on the west side of the Housatonic River have a small dirt/sand berm around portions of the perimeter. Drilling fluid/mud is less than 6" from overtopping the drilling pit in some locations. Ensure that capacity is adequate.

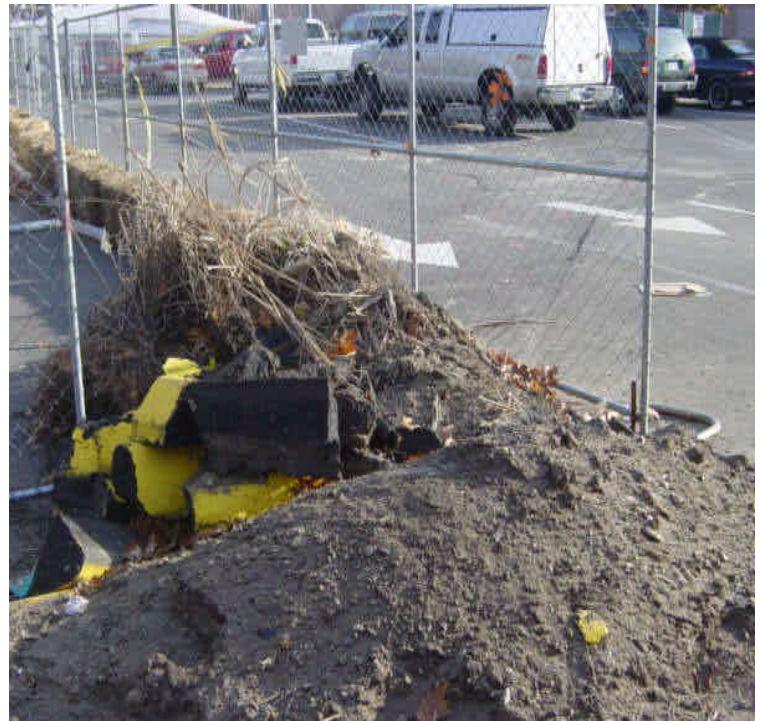
<p>Perimeter controls are in place around the work area on the west side of the Housatonic River but some sediment and asphalt debris had been temporarily stockpiled at/on the haybales. 12/05/07</p>	<p>Pull materials back to ensure the perimeter controls remain effective. 12/05/07</p>	<p>Needs attention</p>

On the west side of the Housatonic River, excavated asphalt, soil, and other debris has been temporarily stockpiled at the perimeter haybales containing the work zone. Pull the material back to ensure the controls remain effective.
