Docket No. 272 - Development and Management Plan Inspection

Underground Line Watercourse and Railroad Crossings

Date: December 12, 2007

Location: <u>Crossings of Watercourses and Railroads in Segments 3, 4a and 4b</u>

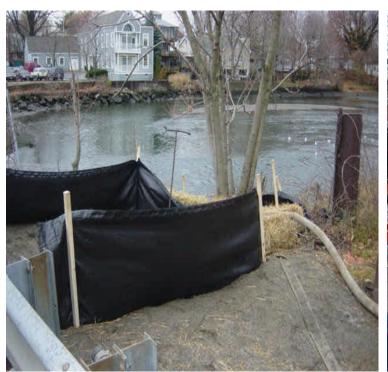
On the east side of Ash Creek silt fence and hay bales remain to prevent sediment from entering the creek near the water valve.

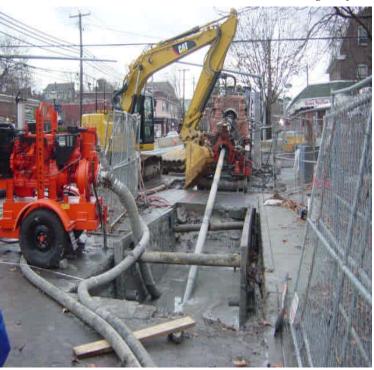
On the west side of Ash Creek, drilling continues. Adjacent catch basin remains protected. Slurry spills are common during active work but contractors state that the area is cleaned regularly.

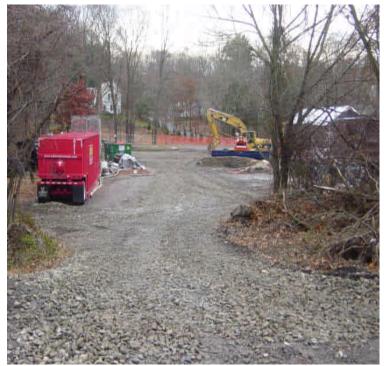
Crushed stone has been placed over the staging area on the east side of the Saugatuck River to reduce sediment tracking.

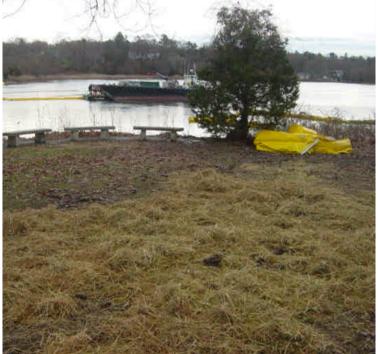
Hay mulch has been spread over exposed soils in the park area along Riverside Avenue. In the background, clean-up efforts from several drilling frac-outs continue along the Saugatuck River.

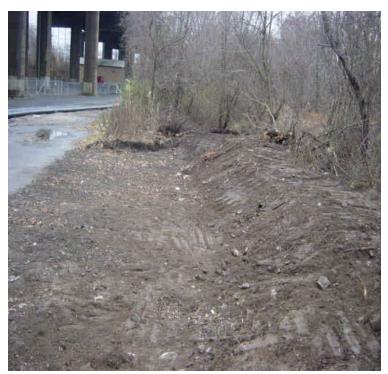
On the east side of the Housatonic River, a dirt berm has been re-graded and has been pushed closer to the wetlands. No silt fence or hay bales were observed between the exposed soil and the wetlands. Stabilize exposed soils and add controls.

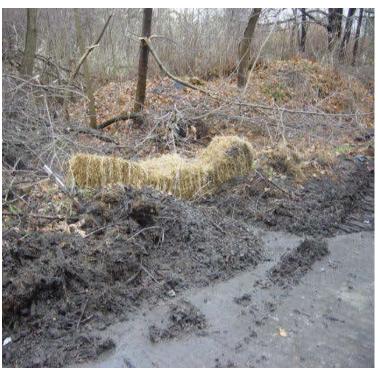
On the east side of the Housatonic River, a hay bale barrier has installed to trap sediment before it reaches the adjacent resource area. Controls should be extended to contain all exposed soil.

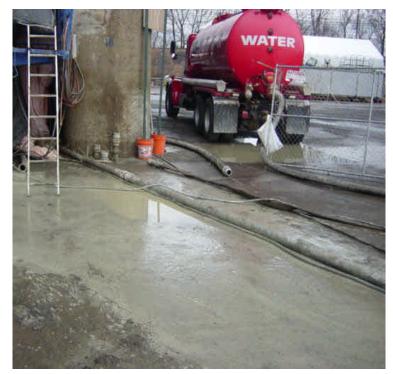
On the west side of the Housatonic River some drilling slurry has been spilled on the pavement when various hoses were disconnected. The spill was cleaned up and only residual material remained.

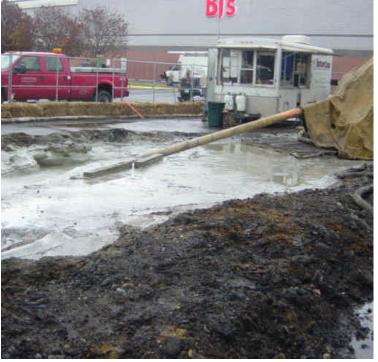
On the west side of the Housatonic River, the dirt berm around the drilling pit has been built-up and appears to be slightly higher than during the previous inspection. Slurry levels and capacity of the pit need to be monitored carefully.
