**Docket No. 272 – Development and Management Plan Inspection**

**Underground Line Watercourse and Railroad Crossings**

**Date:** December 21, 2007

**Location:** Crossings of Watercourses and Railroads in Segments 3, 4a and 4b

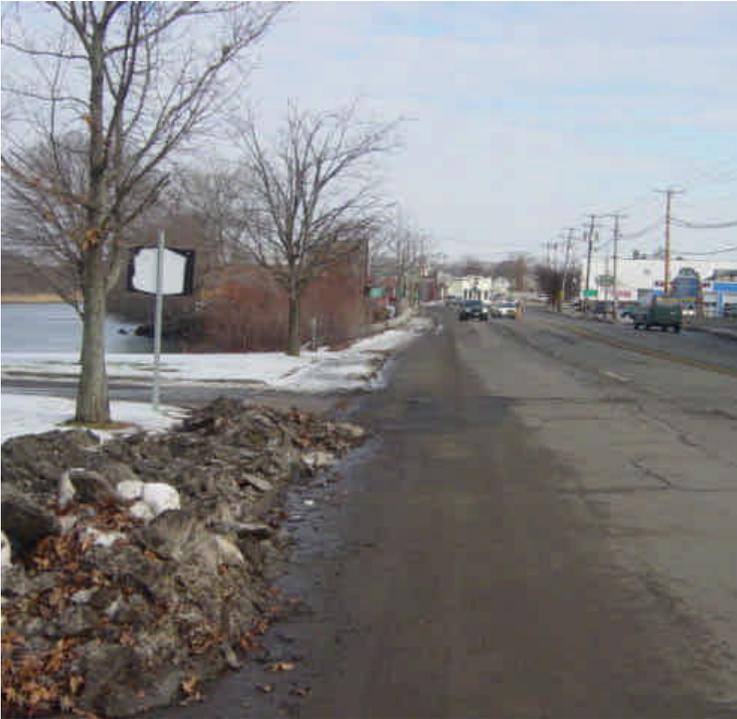
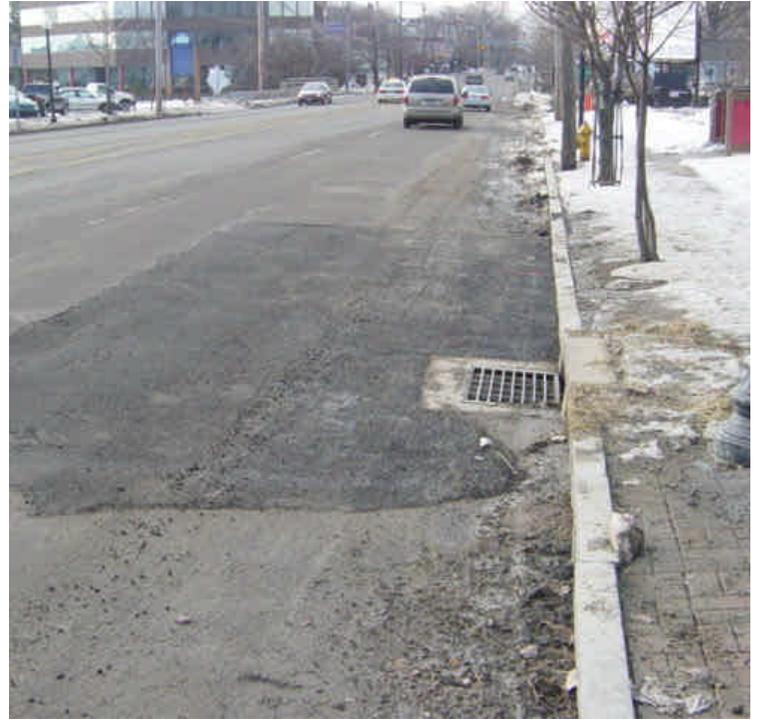
**In preparation for a two week holiday break, the contractors had removed the temporary lane closures on either side of Ash Creek. The drill pit had also been backfilled and paved for the break.**

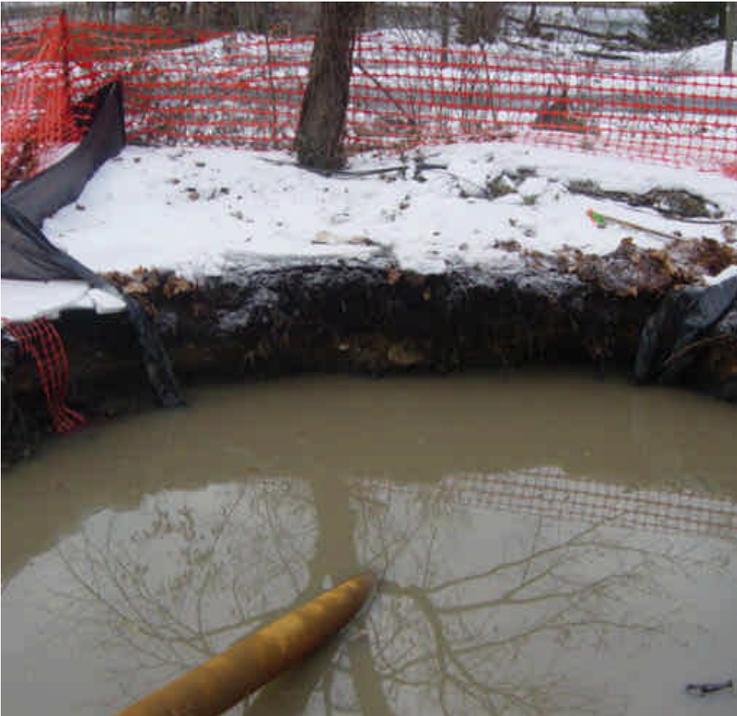
**When work resumes after the break, the silt fence needs repair around the drill pit on the east side of the Saugatuck River. The pit has some additional capacity for storm runoff.**

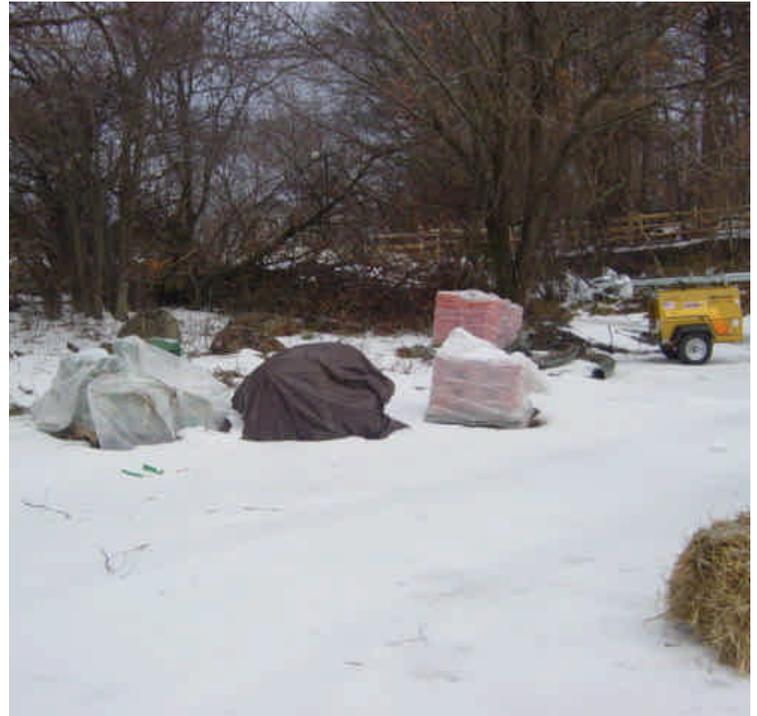
**Materials at the staging area on the east side of the Saugatuck River have been covered in tarps and stored during the several week break in activities.**

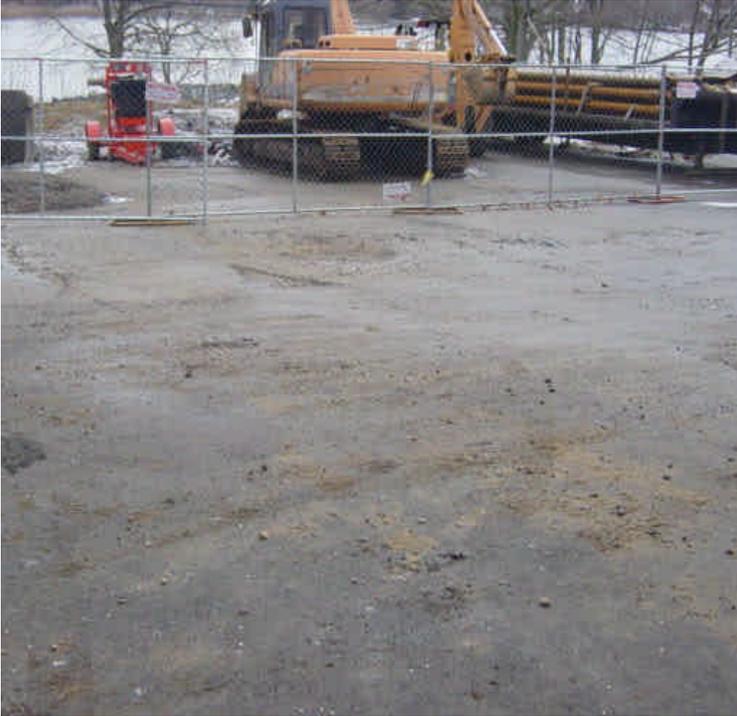
**On the west side of the Saugatuck River, some sediment remains on the pavement of the driveway and church parking lot adjacent to the staging area. This area was temporarily opened to traffic during the break in work.**

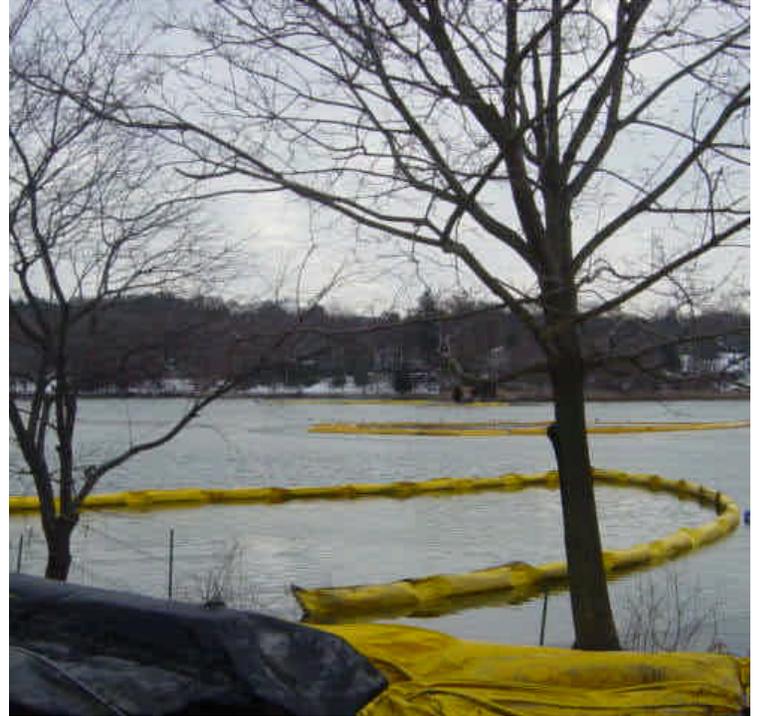
**Booms remain in the Saugatuck River as a precautionary measure to contain materials from previous frac-outs.**

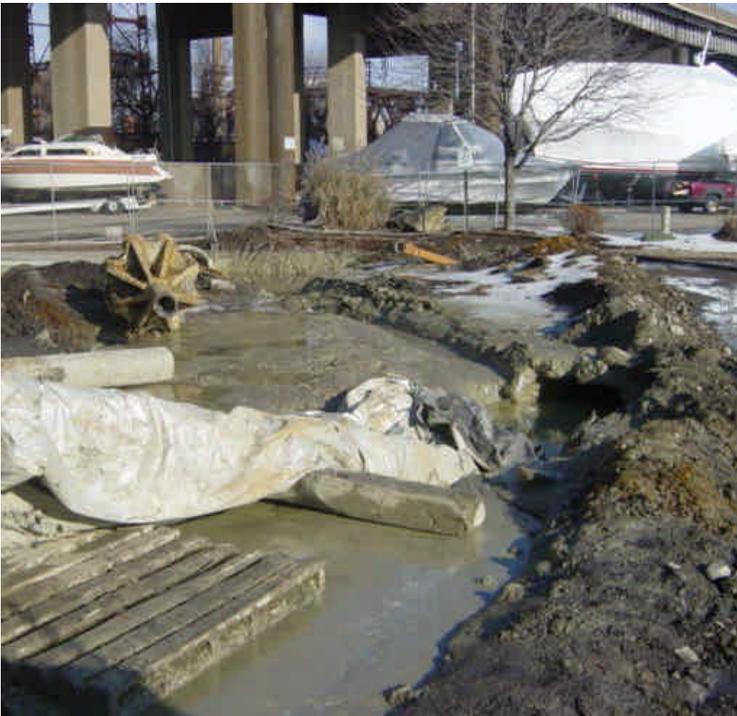
**On the west side of the Housatonic River, the drill pit was left inactive during the holiday break. Ensure adequate capacity here, including enough to accommodate stormwater run-off**

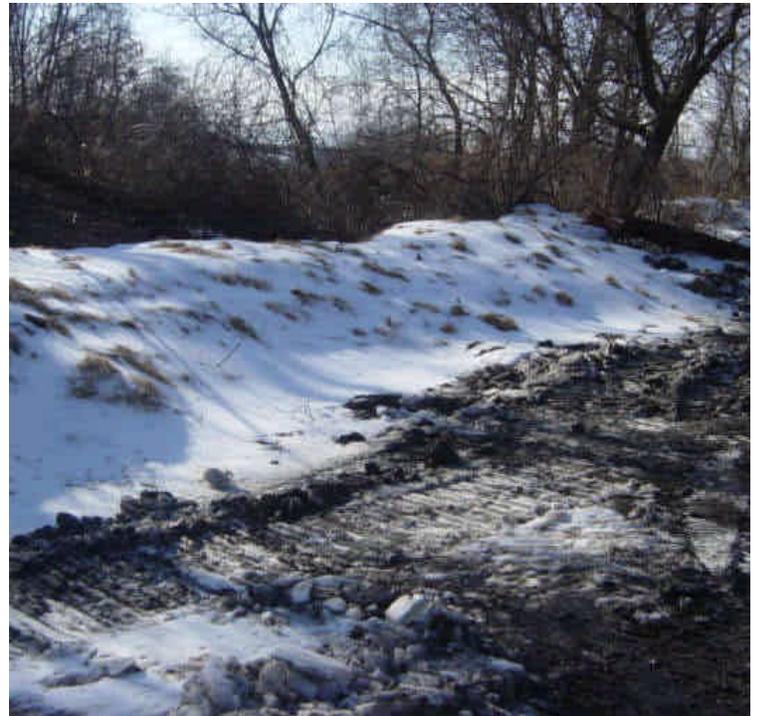
The newly graded dirt berm located adjacent to	Add controls if necessary. Permanently stabilize area	The area was mulched but controls may still

Areas of Inspection	Observation	Recommended Action	Corrected Action
	<p>a resource area on the western side of the staging area (on the east side of the Housatonic River) has been mulched. However, there are no other controls between the berm and the resource area. 12/21/07</p>	<p>when feasible. 12/21/07</p>	<p>be needed.</p>
<p><b>Inland Wetland and Watercourse encroachment and mitigation</b></p>	<p>The HDD of the Saugatuck River and associated wetlands in Westport will continue in two weeks. Booms remain in the river to contain materials from previous frac-outs. 12/21/07</p>	<p>Continue to implement the approved monitoring plan for the crossing of the Saugatuck River provided in the D&amp;M plan. 12/21/07</p>	<p>NA</p>
	<p>The HDD of Ash Creek and associated wetlands in Fairfield and Bridgeport will continue in two weeks. 12/21/07</p>	<p>Continue to implement the approved monitoring plan for the crossing of Ash Creek provided in the D&amp;M plan 12/21/07</p>	<p>NA</p>

**On the east side of the Housatonic River, the dirt berm adjacent to the resource area on the western side of the staging yard was mulched with hay. Controls may still be needed between the berm and the wetland.**

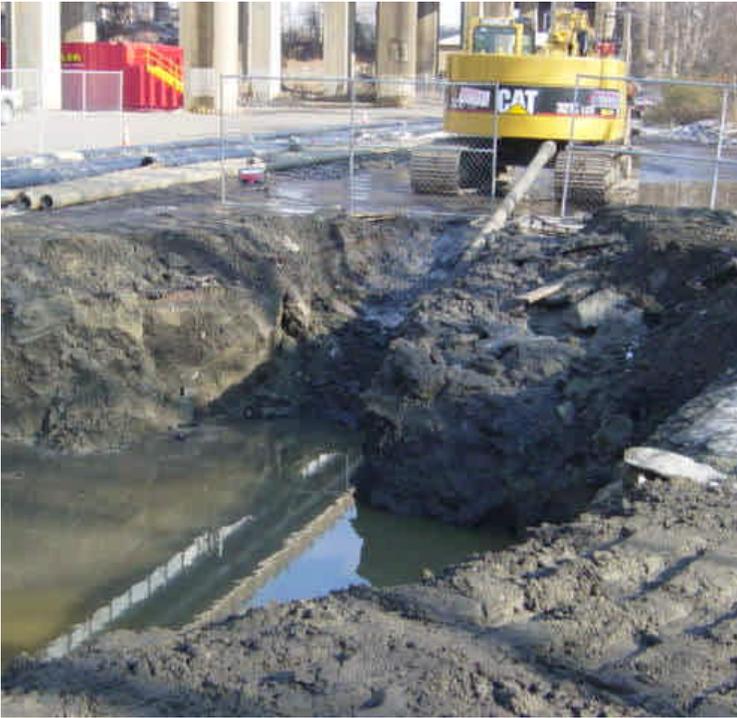
**The drill pit on the east side of the Housatonic River was left with additional capacity during the break in activity.**

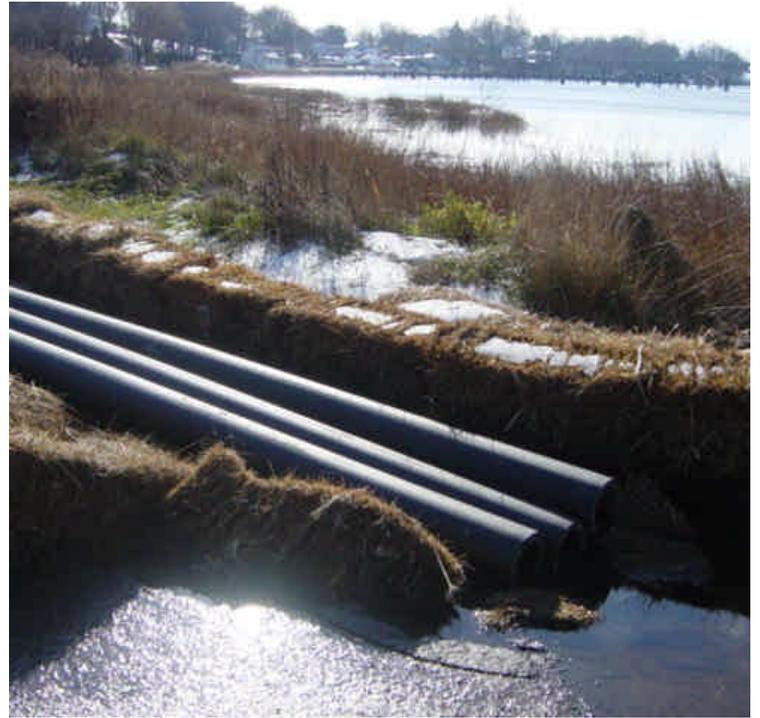
**A haybale barrier remains in place along the edge of the staging area. Haybales have fallen into the hole created during a previous frac-out in this area.**

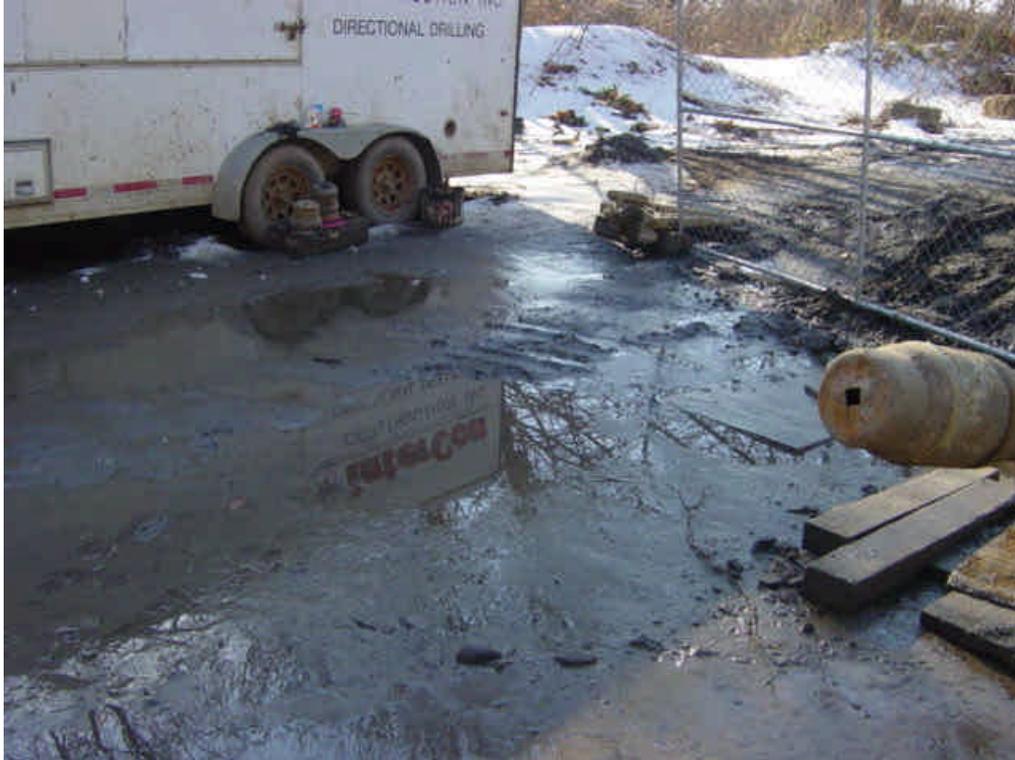
Areas of Inspection	Observation	Recommended Action	Corrected Action
	<p><b>12/21/07</b></p> <p><b>A new frac-out was observed on the east side of the Housatonic River within the paved area. There was also an area of run-off and slurry by the drill shaft. 12/21/07</b></p>	<p><b>12/21/07</b></p> <p><b>While the areas are contained within the staging area, slurry should be cleaned up to avoid unanticipated impacts. 12/21/07</b></p>	<p><b>Needs regular attention.</b></p>
<p><b>Additional Observations</b></p>	<p><b>On the east side of the Housatonic River, piles of asphalt debris were observed at the parking lot under I-95 (12/12). This appears to be due to other projects (not M/N related). 12/21/07</b></p>	<p><b>None. 12/21/07</b></p>	<p><b>NA</b></p>

**An area of runoff/drilling mud remains adjacent to the drill shaft on the east side of the Housatonic River. It is currently contained but should be cleaned up to remove a potential source of sediment and to avoid unnecessary impacts.**
