## Docket No. 272 - Development and Management Plan Inspection

## **Underground Line Watercourse and Railroad Crossings**

**Date: January 11, 2008**

Location: Crossings of Watercourses and Railroads in Segments 3, 4a and 4b

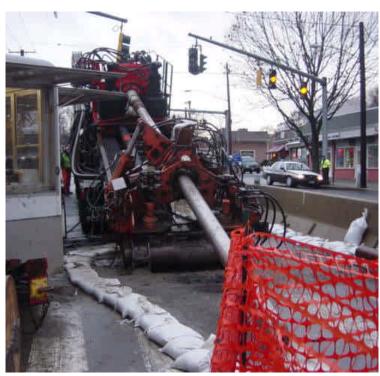
On the west side of Ash Creek, work has resumed following the break. The drill rig remained in place while work was temporarily inactive due to mechanical problems.

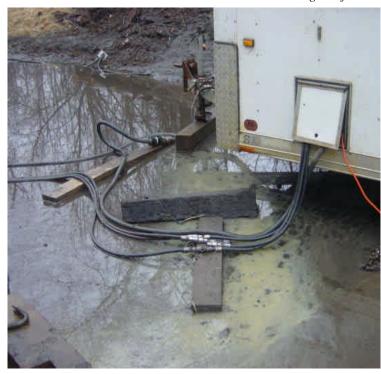
On the east side of the Housatonic River, sediment remains on the paved area. The sediment should be removed prior to work resuming in this area to reduce potential tracking or unanticipated impacts.

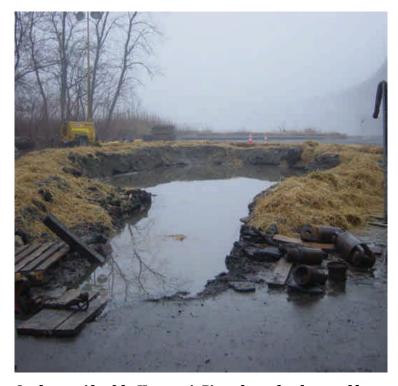
On the east side of the Housatonic River, the earthen berm and hay bales around the drill pit appeared to be functioning well. The berm was recently mulched.

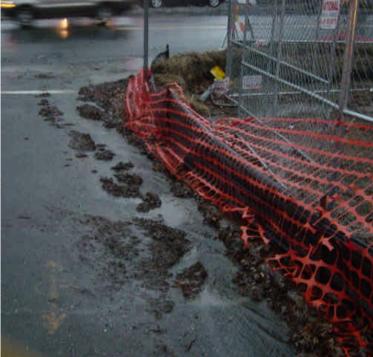
Stone and geo-textile fabric remains in the park on the west side of the Saugatuck River near sta. #236 where vac trucks and other vehicles have access. However, sediment from the work area is still reaching the roadway and (controlled) catch basins. 1/11/08	Ensure that catch basins located down gradient of areas where vehicles are exiting the work zone have gutter buddy/silt sack (or similar) in place. Sweep roadway as necessary. 11/21/07-1/11/08 Reinforce controls at the work site to prevent sedimentation. 1/11/07	Needs attention
	Haybales and mulch remain in place around the drill pit on the west side of the Saugatuck River. The silt fence along	Repair damaged sections of silt fence. Continue to monitor and maintain the controls to ensure they adequately contain the area.	Needs attention.

On the west side of the Saugatuck River, runoff was carrying sediment downgradient into a protected catch basin. Attention is needed to keep sediment off the roadway.
