Docket No. 272 - Development and Management Plan Inspection

Underground Line Watercourse and Railroad Crossings

Date: January 24, 2008

Location: <u>Crossings of Watercourses and Railroads in Segments 3, 4a and 4b</u>

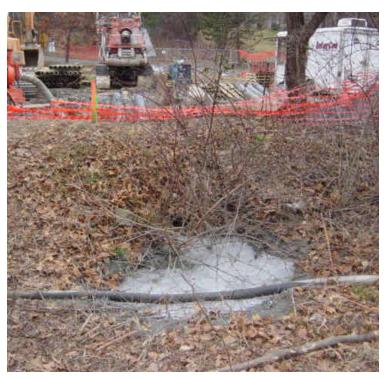
On the east side of the Saugatuck River two minor frac outs were observed on land between the access drive and drilling pit. The slurry material should be contained, and properly removed.

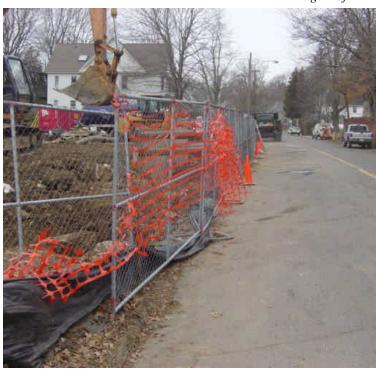
On the west side of the Saugatuck River, the silt fence along Lincoln Street needs repair.

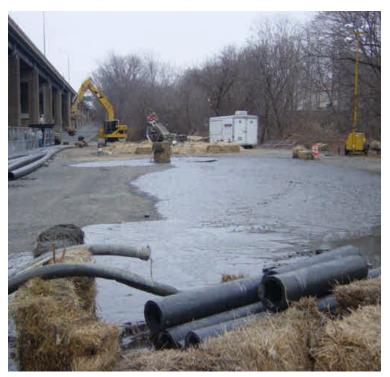
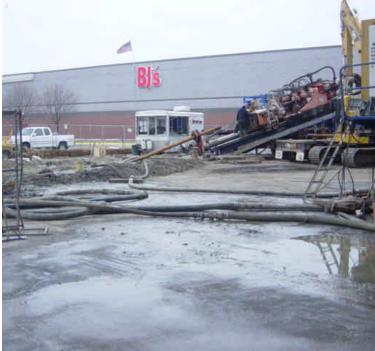
Drilling continues under the Housatonic River. Crews have been experiencing a loss of drilling fluid returns over the past several days, but divers have been surveying the area and there have been no signs of any frac-outs within the project limits. On the east side of the Housatonic River a large volume of drilling fluid was observed on the surface of the paved area. Hay bales were in place to contain the area and crews were working with vacuum trucks to remove the material.
