Docket No. 272 – Development and Management Plan Inspection

Underground Line Watercourse and Railroad Crossings

Date: January 31, 2008

Location: Crossings of Watercourses and Railroads in Segments 3, 4a and 4b

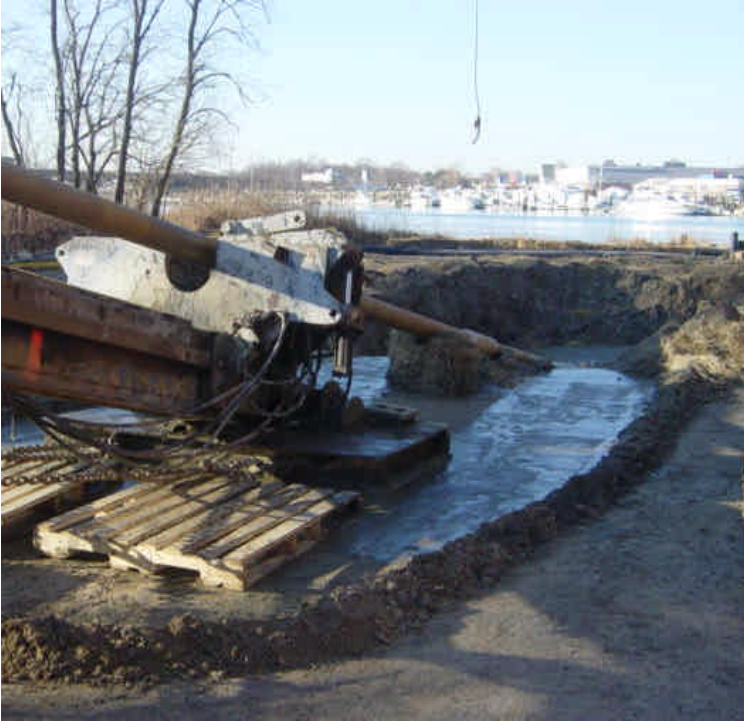
On the east side of the Housatonic River the drilling pit is adequately contained with a sand berm. Hay mulch also remains on portions of the containment berm for stabilization.

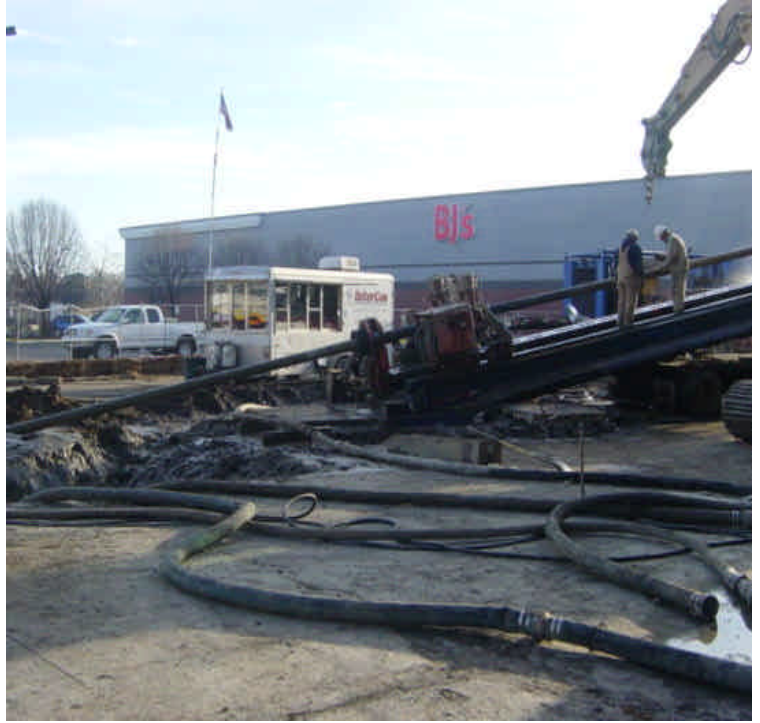
On the west side of the Housatonic River, a minor amount of slurry/mud was noted on portions of the paved surfaces in several areas throughout the staging yard.

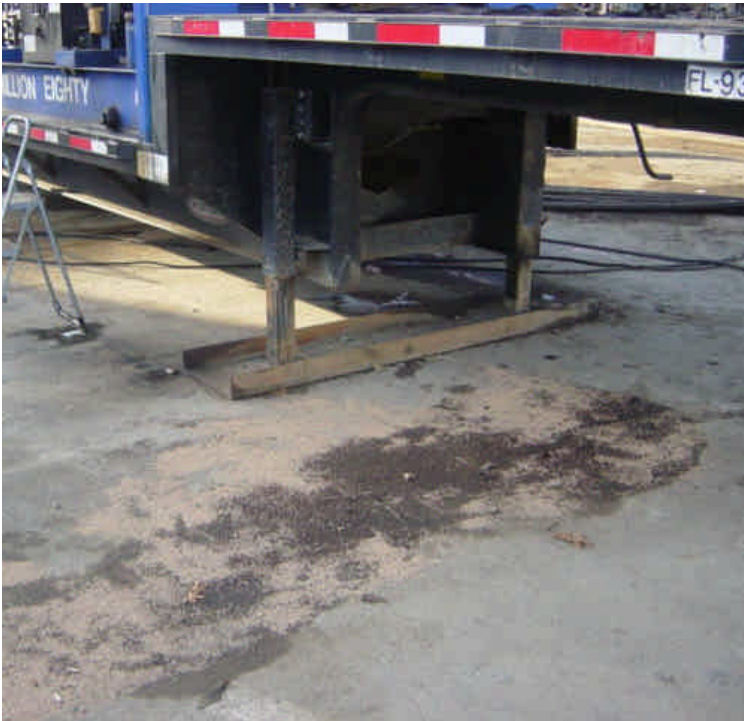
Spilled substance near the generator trailer appeared to be properly handled. At the time of the inspection, the spill was covered with an absorbent material.

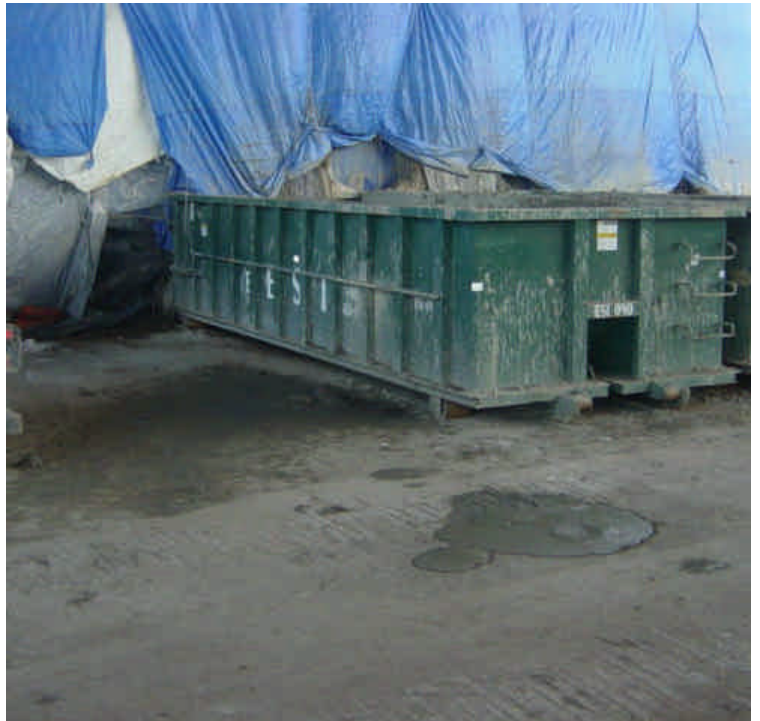
Mud and slurry material were observed on the paved surface near the bentonite reclamation machine.

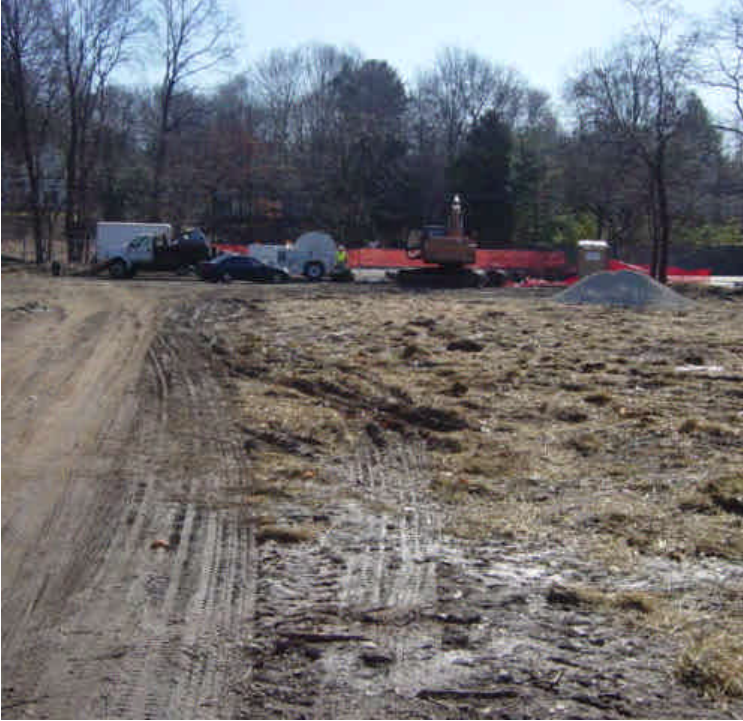
On the east side of the Saugatuck River, most of the drilling equipment has been removed from the staging area. Some minor ruts were noted off the edge of the access drive.

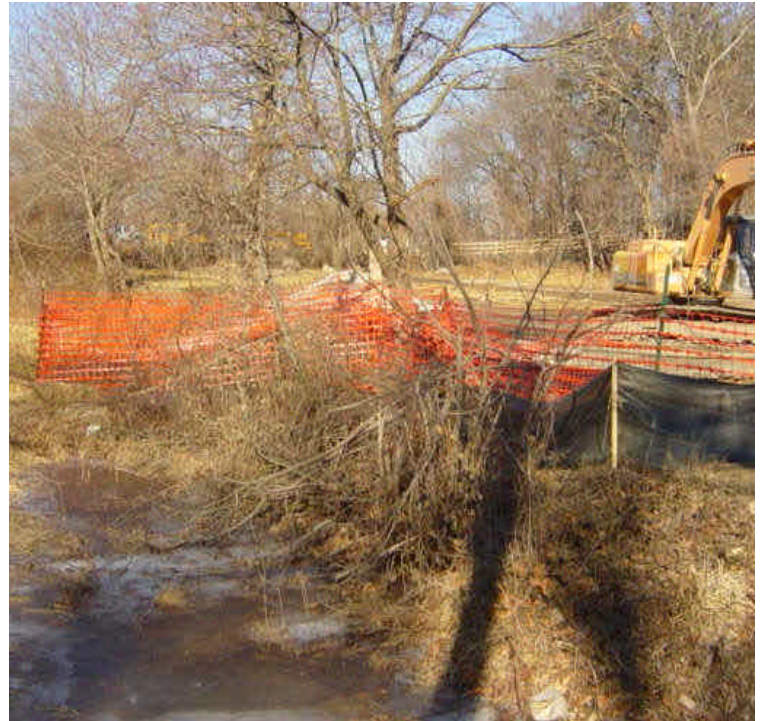
| Areas of Inspection | Observation | Recommended Action | Corrected Action |
|---|--|--|--|
| | <p>Two minor frac outs and resulting holes were observed (on land) between the access drive and drilling pit on the east side of the Saugatuck River. Fencing remains around this area. Both areas were frozen over at the time of the inspection. 1/31/08</p> | <p>Properly contain and remove the material. Restore the area to pre-construction conditions. 1/24-1/31/08</p> | <p>Needs attention.</p> |

On the east side of the Saugatuck River, two small holes have formed between the drilling pit and the access drive. The area will need to be properly cleaned, stabilized, and backfilled.

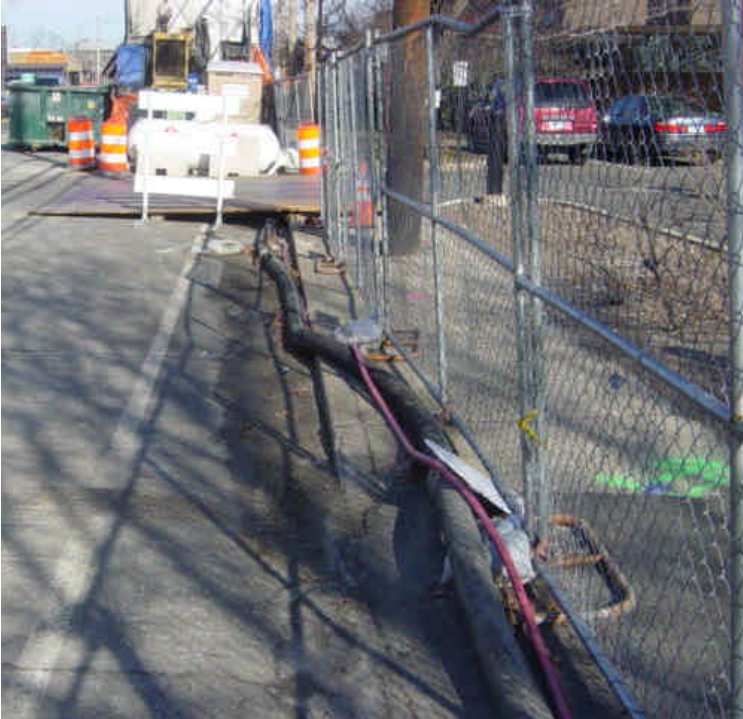
Sediment has accumulated along the curb on Post Road near Ash Creek. Continue to sweep work area to reduce tracking and unnecessary impacts.

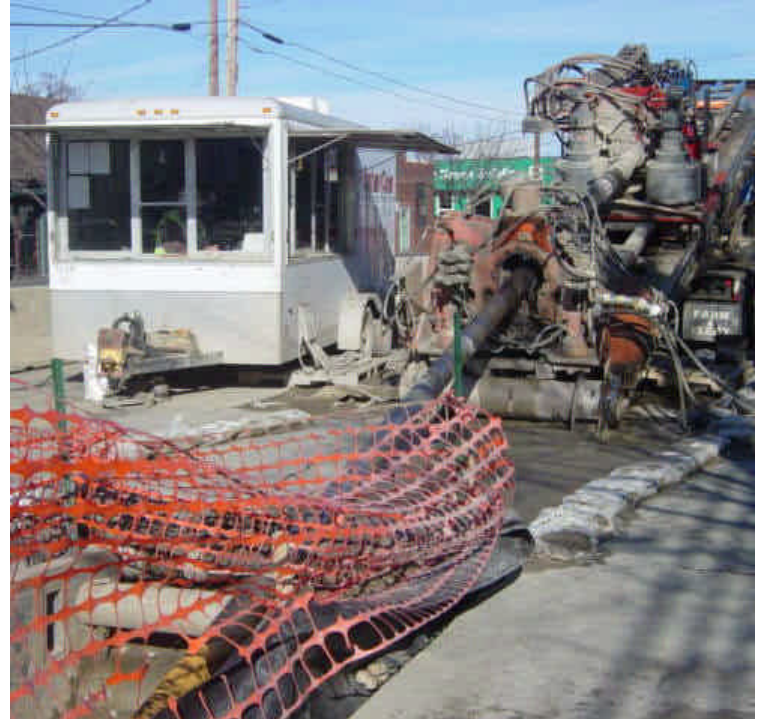
| Areas of Inspection | Observation | Recommended Action | Corrected Action |
|---|---|--|--|
| <p>Additional Observations</p> | <p>The sandbags being utilized near Ash Creek are beginning to deteriorate as a result of the changing freezing/thawing temperatures. Some of the bags have begun to tear and sand is spilling onto the pavement. 1/31/08</p> <p>On the east side of the Saugatuck River a broken light standard was observed near the entrance drive to the staging area where the construction trailer had been previously located. 1/31/08</p> | <p>Replace sandbags as necessary to avoid unnecessary impacts. 1/31/08</p> <p>Replace the broken light standard as part of final restoration efforts. 1/31/08</p> | <p>Needs attention.</p> <p>Needs attention.</p> |

On the east side of Ash Creek, drilling continues. The drilling pit is adequately contained with sand bags. Some of the bags are deteriorating as a result of the changing temperatures and may need to be replaced.
