Docket No. 272 – Development and Management Plan Inspection

Underground Line Watercourse and Railroad Crossings

Date: February 7, 2008

Location: Crossings of Watercourses and Railroads in Segments 3, 4a and 4b

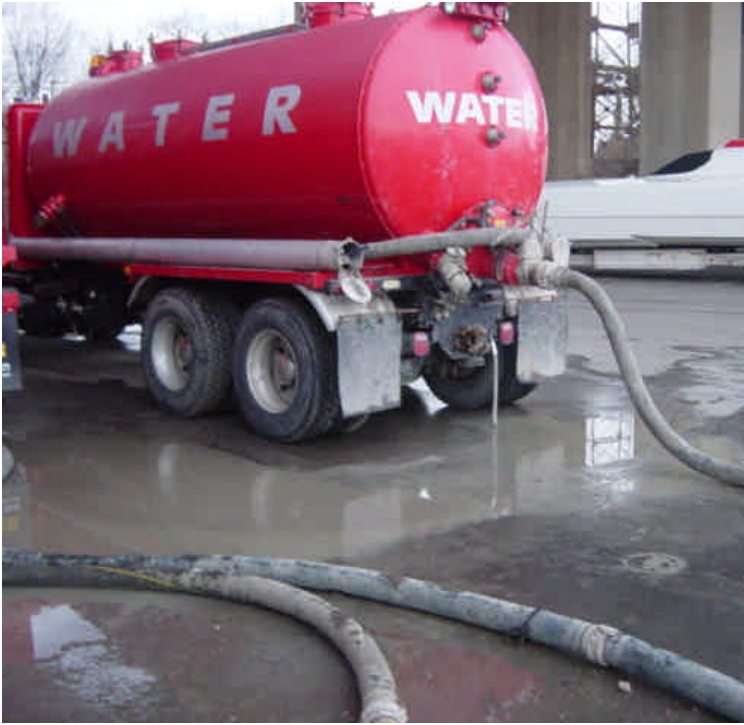
On the west side of the Housatonic River, a minor amount of incidental water/slurry was observed on the paved surface near the northeast corner of the staging area.

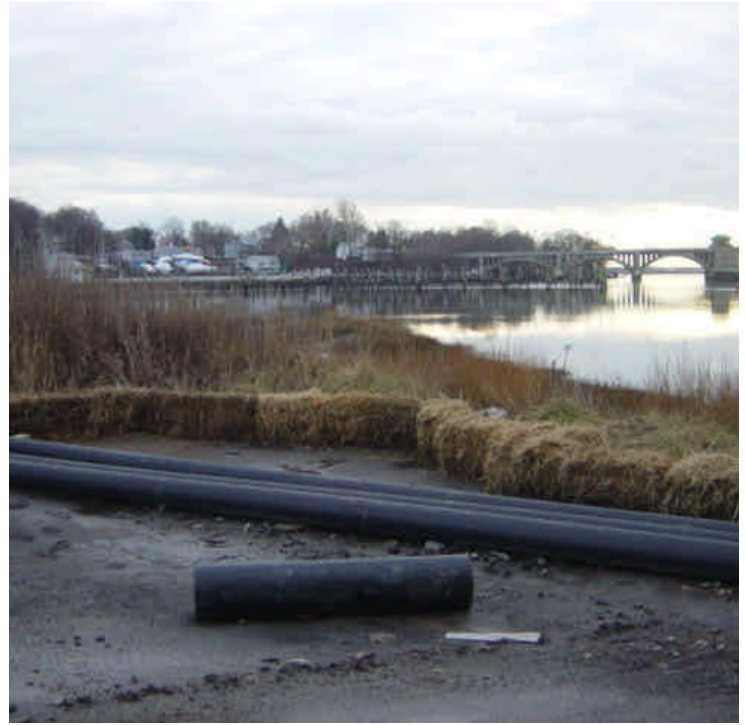
On the east side of the Housatonic River a haybale barrier remains in place near the end of the paved surface.

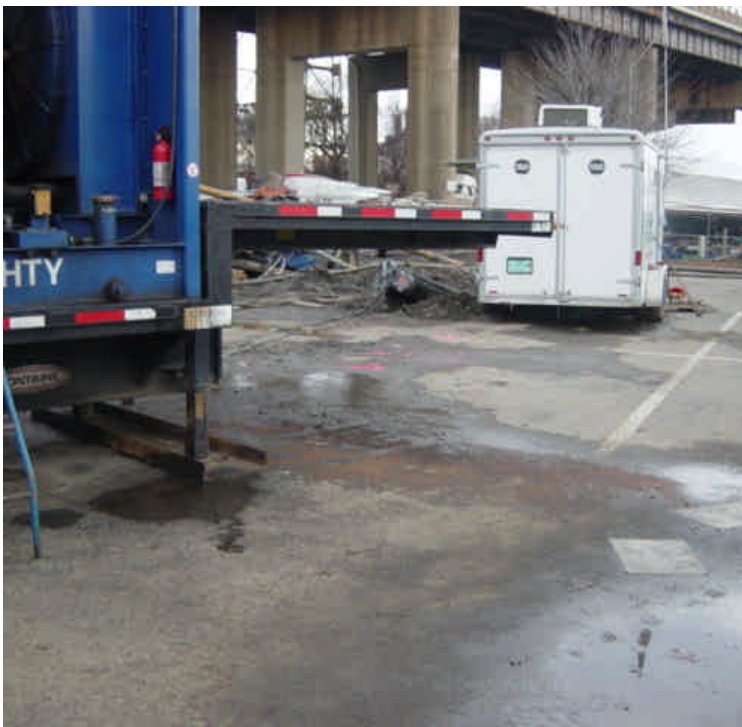
A spill/leak was observed near the generator trailer. Absorbent material appeared to be spread over most portions of the spill and absorbent booms were also utilized. Isolate the source of the spill/leak and provide containment and repair.

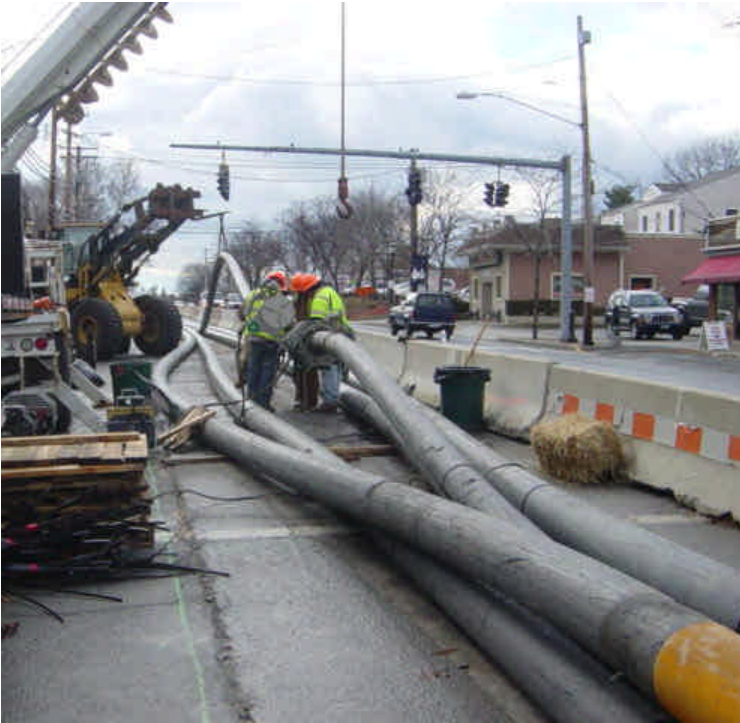
Crews at Ash Creek are fusing the final sections of conduit and preparing to pull the conduit through the boring.

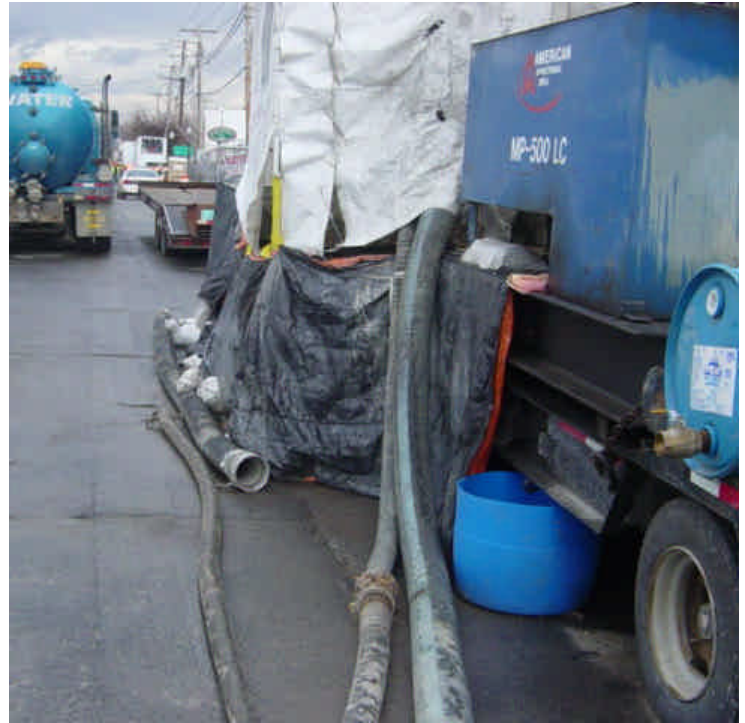
At Ash Creek, a large bucket has been placed under a piece of equipment to contain any leaking fluids.

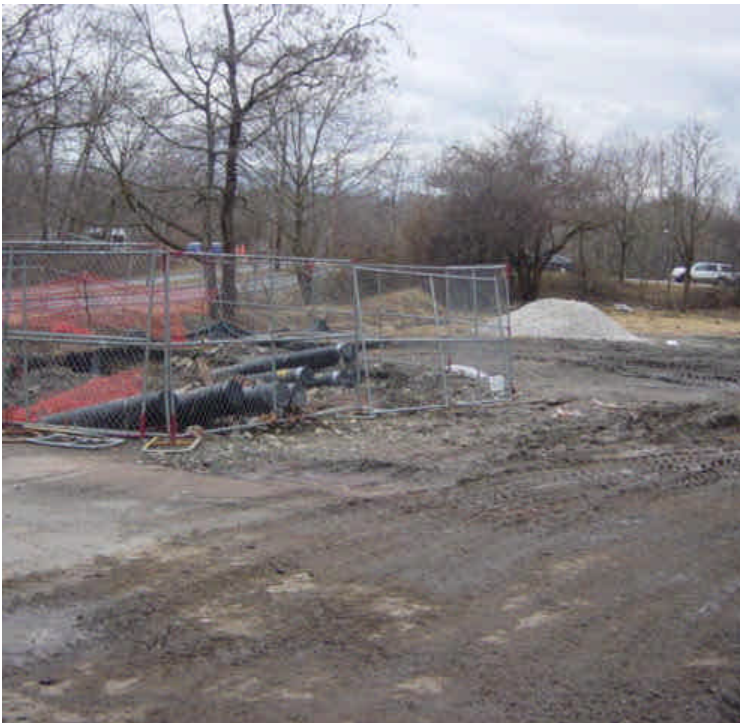
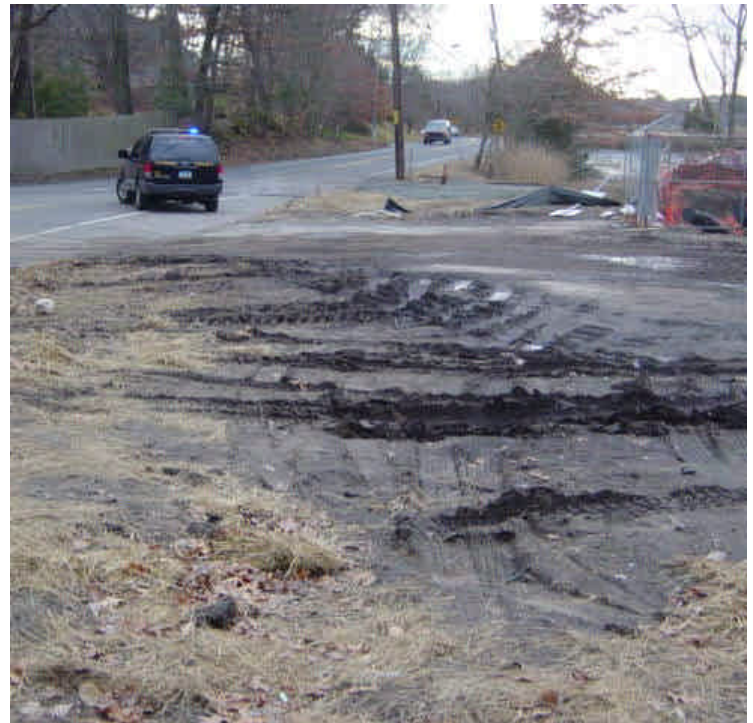
On the east side of the Saugatuck River, the drilling work has been completed and all of the equipment has been removed from the site. Heavy ruts were observed along the shoulder of Imperial Ave. (photo on the right). Chain link fencing was previously positioned in this area and had prevented vehicles from entering the staging area directly from Imperial Ave. The fence has since been relocated to around the drilling pits. (photo on the left).
