Docket No. 272 – Development and Management Plan Inspection

Underground Line Watercourse and Railroad Crossings

Date: February 14, 2008

Location: Crossings of Watercourses and Railroads in Segments 3, 4a and 4b

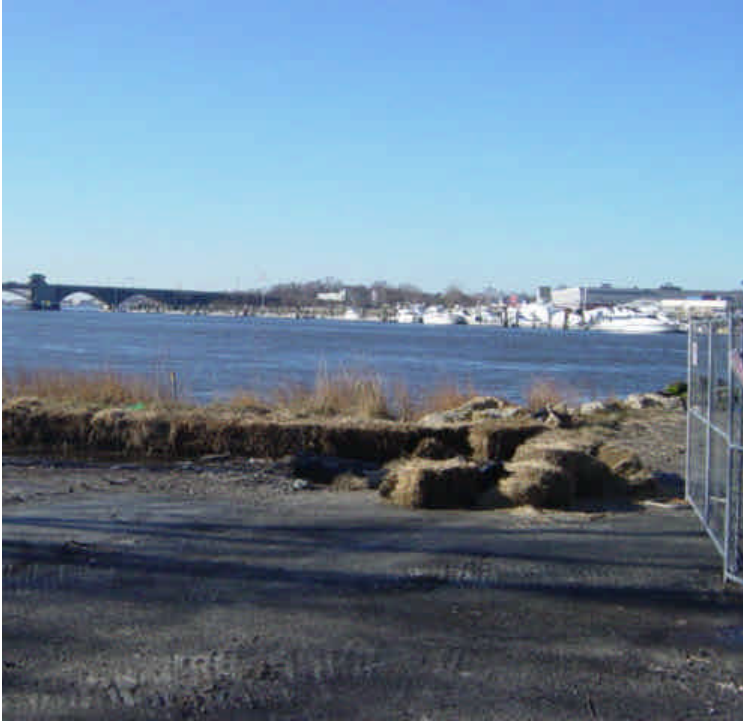
On the east side of the Housatonic River, a hay bale barrier remains in place near the edge of the paved surface.

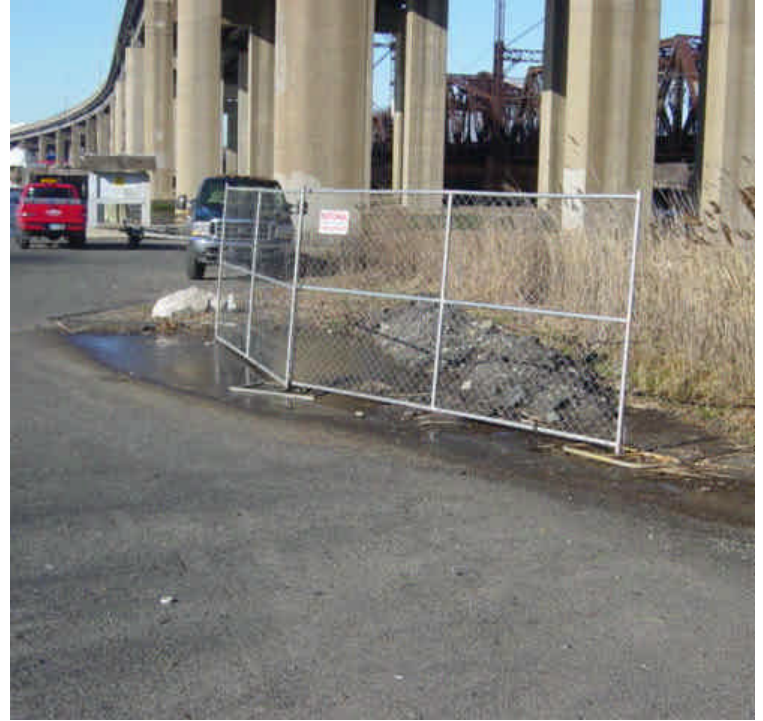
On the east side of the Housatonic River just adjacent to the work area, a small section of pavement had collapsed due to drilling activities. The area remains fenced.

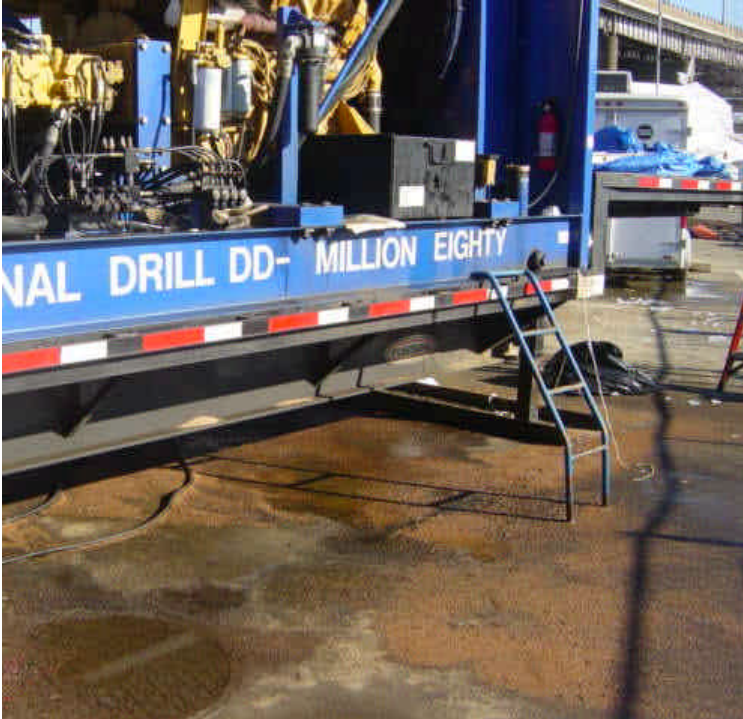
The spill/leak that has been observed for the last two weeks near the generator trailer is worsening. Absorbent material remains spread over some portions of the spill and absorbent booms were in use. However, material continues to leak and a small pool of yellow liquid was observed adjacent to the hay bale barrier. Repair the leaking machinery ASAP and provide additional containment and clean-up.

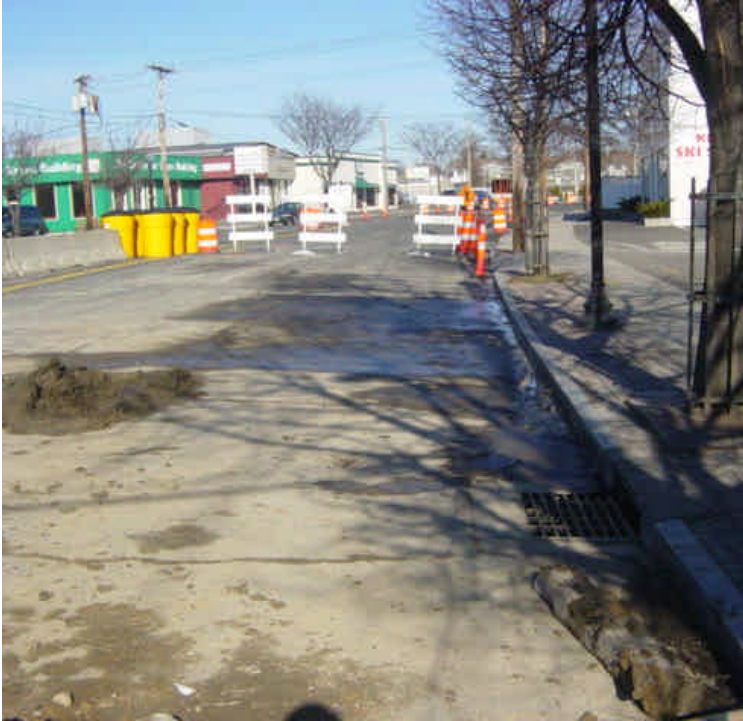
The drilling rig and bentonite reclamation machine have been removed from the temporary work zone at Ash Creek. A minor amount of sediment and debris remain throughout the work area. Hay bales protecting the catch basins have been removed.

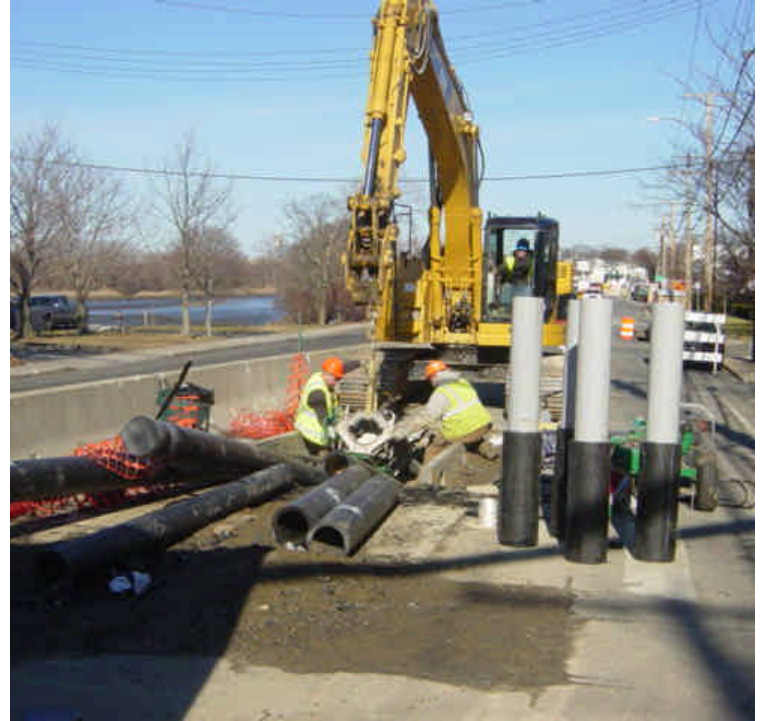
Crews at Ash Creek are fusing the final sections of conduit and preparing to cap the ends and temporarily backfill the drilling pit.

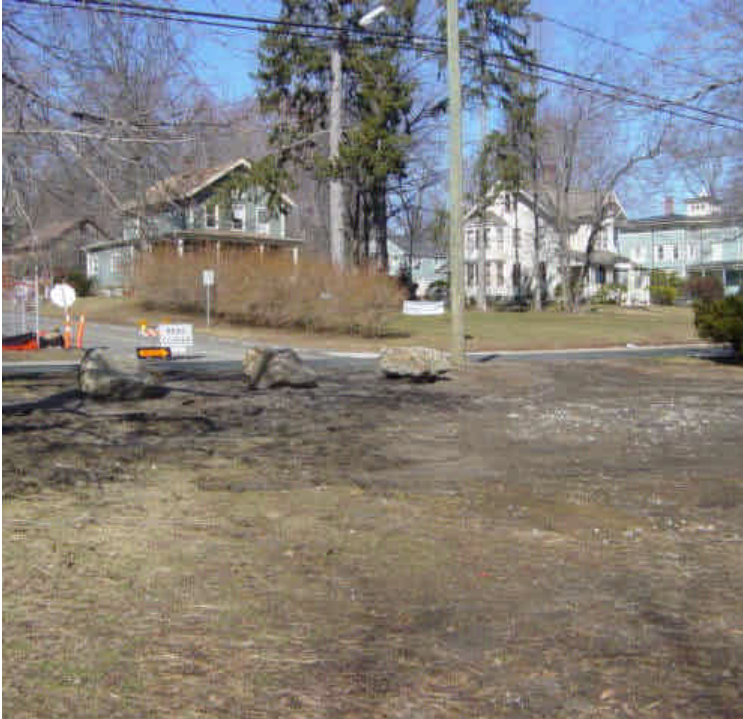
Clean-up efforts within the Saugatuck River have been completed. The crushed stone has been removed from the park area near Riverside Ave. where vacuum trucks had accessed the river. Minor ruts remains in this area. Final restoration will be needed during the growing season.

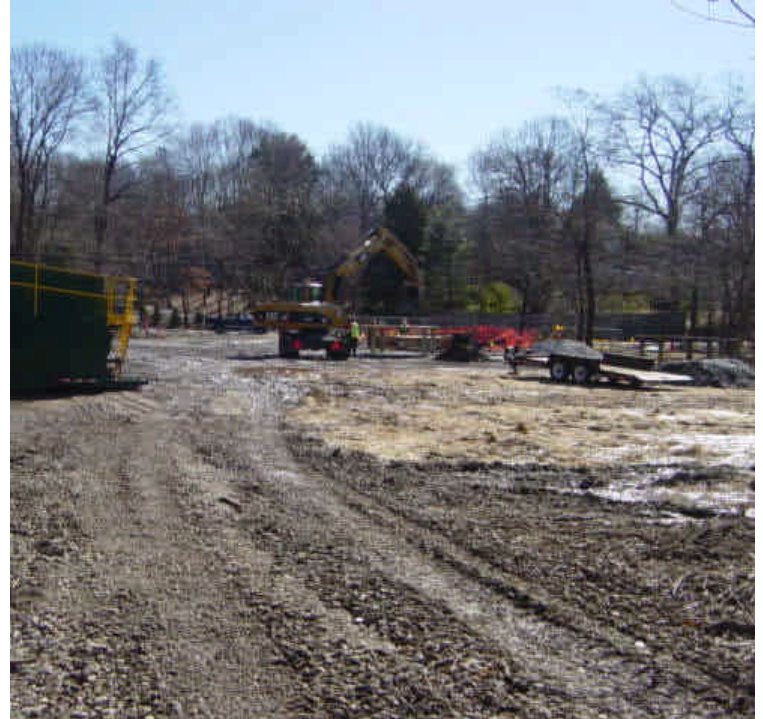
The staging area on the east side of the Saugatuck River has been partially restored. Additional restoration efforts are still required in some areas.
